Australian Transport Safety Bureau

Aviation Safety Investigator

Investigation briefs

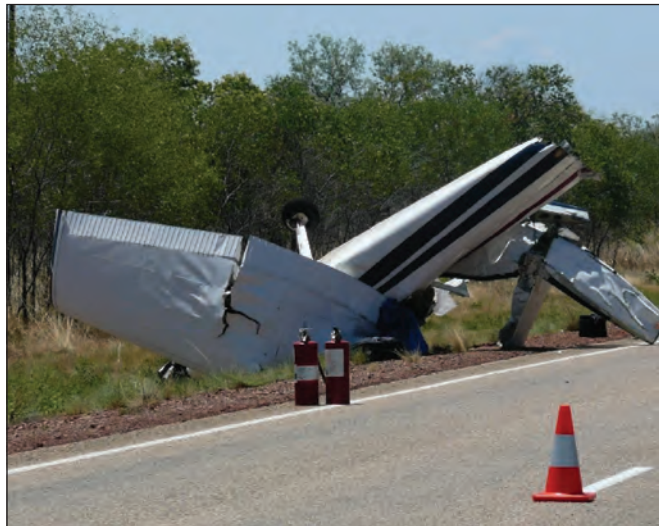
On 10 November 2007 at approximately 0830 CST, a Cessna Aircraft Company 172N, registered VH-WLQ, with two pilots and a passenger on board, departed Katherine, NT on a private, visual flight rules flight to Tennant Creek. At about 1030, the aircraft struck a powerline that spanned the Stuart Highway 20 km north of Elliott and was 15 m above the surface of the road.

The aircraft's tail section contacted the powerline, breaking the tail rearwards from the aft fuselage and rendering the aircraft uncontrollable. The aircraft impacted the highway in a steep nose-down attitude and came to rest inverted on the verge beside the highway. The three occupants were fatally injured. The aircraft was destroyed.

In accordance with the extant Australian Standards affecting the marking of powerlines and their supporting structures, there was no requirement for the powerlines to be fitted with high-visibility markers.

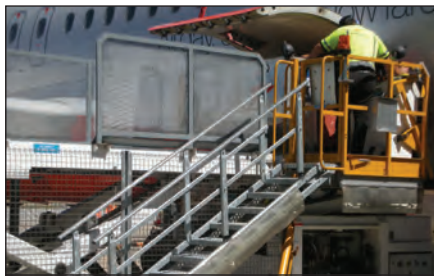
The pallet loader operator reported that, after a period of normal operation, an electrical burning smell was detected in the area of the loader's engine compartment. The supervising leading hand noticed a fire in that compartment and alerted the operator to dismount the pallet loader. The pallet loader operator detached the fire extinguisher from the loader and extinguished the fire.

The ignition source for the fire was most probably intense electrical arcing within the pallet loader engine's starter motor solenoid.

As a result of this incident, the Aerodrome Emergency Planning Advisory Group undertook both to modify its Aerodrome Emergency Plan format to include relevant on-apron emergencies, and to examine the leadership aspects of turn-around operations as they might affect on-apron emergency planning. In addition, the ground vehicle maintenance provider issued a Service Bulletin requiring the immediate inspection of the condition and routing of the starter motor wiring loom in all similar pallet loaders.

As a result of this, and a second fire in a similar pallet loader that occurred at Adelaide Airport on 27 May 2008, the operator retrofitted all of its affected pallet loaders with a replacement starter motor that significantly reduced the risk of electrical arcing. ■

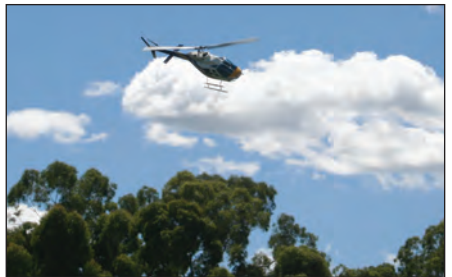
On 1 March 2008, at about 1300 Eastern Daylight-saving Time, the pilot of a Bell Helicopter 206B Jetranger III was flying over a property on a private flight with four passengers. Witnesses reported that the helicopter was making low-level passes, at about 100 ft above ground level over the property. At the completion of one low-flying pass, the helicopter was observed by witnesses on the ground to bank steeply to the left, roll out, and descend into surrounding trees. The helicopter impacted the trees and was destroyed. One of the occupants was discovered outside the helicopter's cockpit/cabin area. All of the five occupants sustained serious injuries.

The weather was fine and not considered a factor in the accident. Examination of the wreckage did not indicate any mechanical defects of the helicopter, rotor system or engine that would have resulted in loss of controlled flight. The examination also confirmed significant rotational RPM of the main rotor blades at the time of impact.

The investigation found that the pilot's action to conduct low flying did not comply with Civil Aviation Safety Authority regulations. In addition, the helicopter was operated at a gross weight in excess of the helicopter manufacturer's maximum take-off weight, which also did not comply with the regulations. The operation of the helicopter in this configuration limited the controllability of the helicopter during the flight. Had the helicopter been operated within the manufacturer's weight limitations and at 500 ft or more above ground level, the pilot would have had more time to assess and react to the situation. The operation of the helicopter outside of those parameters exposed both the helicopter's occupants and observers on the ground to a hazardous situation. ■
