Australian Transport Safety Bureau

Aviation Safety Investigator

Investigation briefs

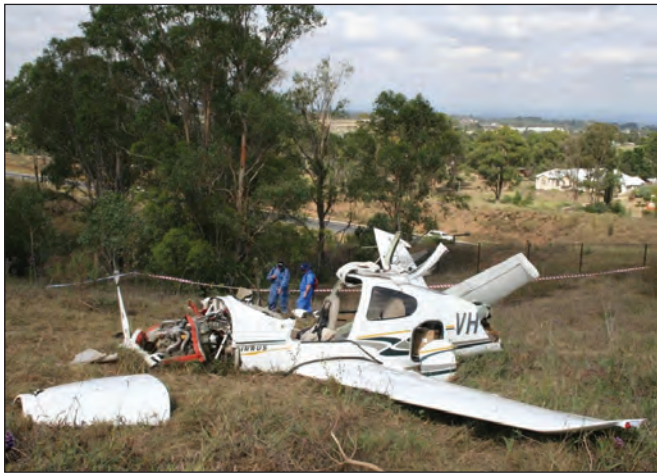
Some of the emergency services personnel who attended the aircraft accident had no prior knowledge of the CAPS and the potential dangers it posed, if it had not been deployed. The ATSB warned the attending police site controller of the existence and potential danger of the CAPS. Following consultation with the ATSB and an aircraft manufacturer's representative, emergency service

personnel subsequently cut through the roof of HYY to remove the injured occupants.

An examination of the wreckage indicated that the aircraft struck several trees before heavily impacting rising terrain. The impact completely detached the right main landing gear assembly and fractured the fibreglass laminate structure of the left main landing gear. Both wings were extensively damaged and both internal wing fuel tanks were breached. The rear fuselage and empennage assembly broke away from the main fuselage at a point behind the rear baggage compartment and came to rest alongside the main wreckage. The flight control cables between the rear fuselage and the main wreckage remained intact.

The investigation determined that the engine stopped due to the loss of a blanking cap from the un-metered fuel pressure test port in the engine fuel system. Testing showed that the engine would not operate with the cap missing. The investigation revealed that, instead of the normal steel cap, a plastic

blanking cap had probably been inadvertently fitted to the test port on the engine during maintenance and that the plastic cap had detached from the test port just prior to the accident.

The pilot had activated the CAPS at an estimated height of 90 to 120 ft above ground level, well below the aircraft manufacturer's recommended decision altitude for successful parachute deployment. The rocket fired, however the parachute did not deploy and the rocket became entangled in the aircraft's empennage. It

is possible that the entanglement of the rocket and deployment harness around the tailplane and flight controls may have affected the controllability of the aircraft, resulting in the aircraft diverting from the intended flight path.

Following examination of the CAPS components from this aircraft and further functional testing of production CAPS components in the US, the aircraft manufacturer issued an Alert Service Bulletin incorporating design changes to the CAPS in the worldwide fleet of Cirrus aircraft.

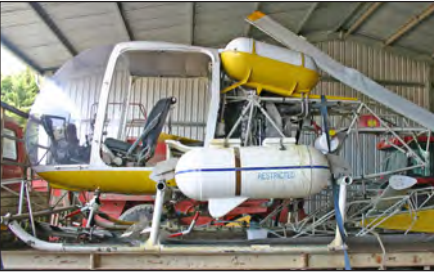
On 20 December 2006, a Kawasaki KH4 helicopter lost collective pitch control and impacted terrain while performing agricultural aerial spray operations approximately 21 km NE of Mount Gambier, SA. The helicopter was substantially damaged but the pilot was uninjured. When the accident site was surveyed, the main rotor mast and main rotor blade assembly were found to have separated from the helicopter. They were located a short distance away.

Examination of the wreckage revealed that the helicopter's main rotor mast thrust bearing had failed catastrophically in flight. That bearing was a critical item for safe operation and continued airworthiness. It supported the full weight of the helicopter and transferred thrust loads generated by the main rotor blades. The bearing had performed satisfactorily for a considerable time in service and it was not considered a premature failure.

The investigation was unable to establish conclusively the factors that led to failure of the mast bearing. No evidence was found of manufacturing or material defects. Nor was there any evidence of improper installation procedures or maintenance practices.

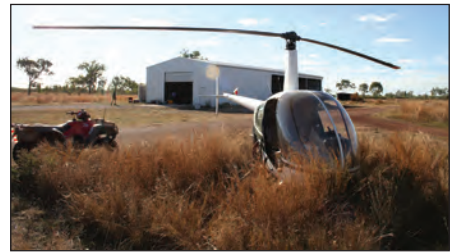
The pilot reported that, during the initial climb after takeoff, and at a height not above the tops of the surrounding trees, the helicopter was struck by a gust of wind that resulted in height loss and activation of the helicopter's 'low RPM' warning horn.

In response to the warning horn, the pilot reported that he opened the throttle, with the effect of over-riding the engine RPM governor, lowered the collective lever, and pushed forward on the cyclic stick.

During the recovery manoeuvre by the pilot, one of the visitors was struck in the head by the helicopter's main rotor and was fatally injured.
