Australian Transport Safety Bureau

# Aviation Safety Investigator

## Fuel Mismanagement Issues

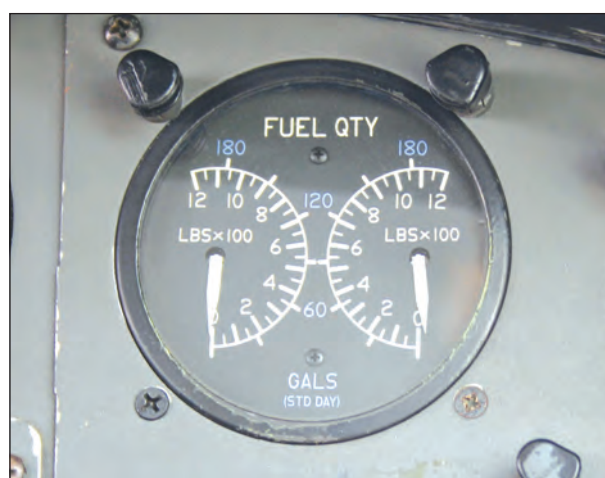
Aircraft maintenance engineers who inspected the aircraft reported that 3 L of fuel was drained from the right tank and 90 L was drained from the left tank. The

fuel quantity gauge was indicating 150 lbs (95 L) in the right tank. An engineer found that one of the electrical circuits in the right fuel quantity indication system had a high resistance. After wiring in the circuit was repaired, the fuel quantity gauge correctly indicated zero fuel in the right tank. Calibration of the fuel quantity indication system was carried out and during that process, the left and right signal conditioners were found to be unreliable and were replaced or repaired.

The operator amended its fuel documentation and fuel planning procedures to include a secondary means of verification of fuel on board to cross-check the electric fuel indication system.

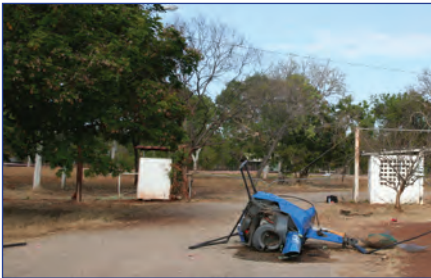
The helicopter struck powerlines at the entrance to the sports ground before impacting the ground. The passenger stated that the helicopter appeared to be operating normally until that time.

Bystanders were able to remove the seriously-injured passenger from the wreckage; however, the pilot received fatal injuries. The helicopter was seriously damaged.

Examination of the wreckage did not identify any mechanical defects that would have affected the safe operation of the helicopter. The flight at 'tree top height' left little margin for error and toxicological testing of the pilot revealed an alcohol concentration of 0.254%. While the post mortem report indicated that this alcohol level was '...sufficient to have caused some degree of both mental and motor dysfunction' the possibility for post-alcohol impairment to have negatively affected the pilot's performance could not be quantified. ■
