Australian Transport Safety Bureau

# Aviation Safety Investigator

# Investigation briefs

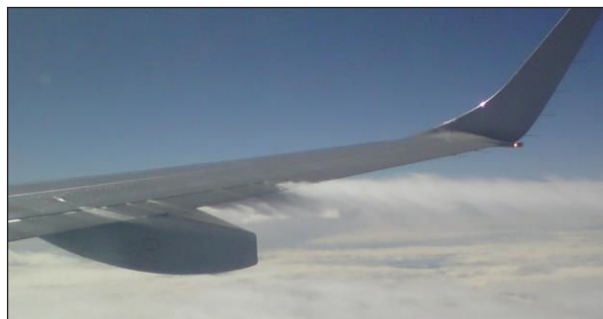
the occurrence, the aircraft was passing through FL250 at 290 KIAS when it encountered turbulence. The turbulence recorded values ranged from 0.6 to 1.4 positive absolute g, a range of about 0.8 g, which lasted for about two and a half minutes.

The data confirmed the fuel disparity between fuel burn and fuel removed from the fuel tanks, with a difference of around 680 kg (1,500 lbs). The operator reported that the aircraft departed with 12,800 kg of fuel and that after landing and taxiing, 9,600 kg remained, with a total of 600 kg lost due to the venting/leakage.

The venting/leakage was determined to be the result of a design issue related to maintaining positive air pressure in the fuel surge tanks in the aircraft's wings. The fuel vapours noted by the cabin crew during the climb were the result of

venting/leaking from the wing fuel surge tanks and eventually from the NACA inlet. The fuel leakage noted by the cabin crew during the approach to land at Brisbane Airport was likely the result of residual fuel released during the flap extension.

Although the operator was unaware of the problem, on this occasion the aircraft was being operated generally within the recommended operating parameters when the fuel leakage occurred. The turbulence sustained by the aircraft during climb out, along with a momentary airspeed increase and the large variations in vertical speed, probably contributed to the fuel leakage.

The aircraft manufacturer has developed a new float vent valve design to eliminate the problem. The design change has been introduced into newly manufactured aircraft and a service bulletin with recommendations to replace the current float vent valve with a redesigned valve will be issued in 2009. ■

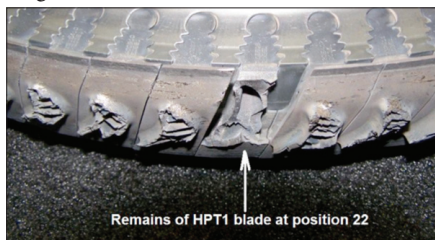
The operator's maintenance organisation carried out an internal inspection of the failed engine and found that all of the blades on the high pressure turbine stage-1 disc were sheared off.

A subsequent investigation by the engine manufacturer revealed that a high pressure turbine stage 1 (HPT1) blade had separated from the blade disc below the blade platform. The manufacturer identified that the failure was due to low-cycle fatigue, causing the remaining HPT1 blades to separate from the disc. That led to the subsequent engine in-flight shutdown. The mechanism of the failure was similar to previous engine failures that had occurred since November 2003.

At the time of the incident, the aircraft operator was engaged in a programme to replace all of the life improvement package 3 standard HPT1 blades in their fleet of engines with a new HPT1 blade. ■

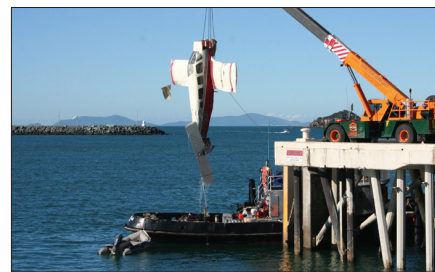
The aircraft decelerated rapidly and came to rest, floating in an upright position for about 1 minute. All of the occupants evacuated and were later recovered by a rescue helicopter. The engine power loss was consistent with fuel starvation. There had been insufficient time to resume power by selecting reserve fuel from such a low altitude before ditching.

The aircraft had an inner fuel tank and an outer fuel tank in each wing. Each fuel tank independently fed a fuel selector. The operator's fuel management policy was to use the tip tanks for flight fuel and to use the main tanks for 60 litres of reserve fuel. Both tip tanks were filled at Mackay for flight fuel as a standard procedure and fuel selection was alternated between the tip tanks for each flight.

Following the event, the aircraft operator amended the aircraft fuel management procedures to require a minimum of 30 L of fuel in the selected fuel tank for any take off. ■

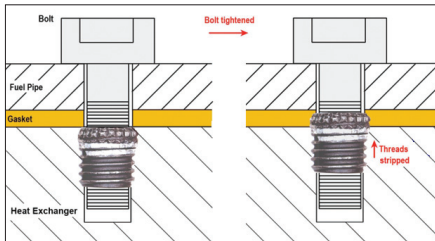
A subsequent examination of the number-2 engine revealed that fuel was leaking from the main fuel return pipe where it connected into the oil/fuel heat exchanger. The pipe connection was of flanged plate design, held in position by four bolts tightened into threaded inserts on the oil/fuel heat exchanger body. The threaded inserts had failed, pulling free of the heat exchanger body.

Bolt tightening sequence showing thread stripping and insert migration into the gasket

The investigation found that the failure of the inserts was the result of over tightening that had occurred during previous maintenance. The oil/fuel heat exchanger had not been subjected to the key lock insert modification.

As a result of a number of in-service failures of the fuel return pipes, the oil/fuel heat exchangers were subject to several modification requirements including the replacement of the threaded inserts with key locked inserts. The fitment of the key lock inserts resulted in a higher torque value for the fuel return pipe attachment bolts.

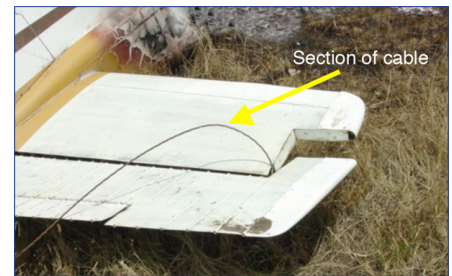
Examination of the wreckage did not identify any mechanical defects that would have affected the safe operation of the aircraft. Evidence from a number of sources suggested that the pilot was aware of the location of the powerline and was familiar with the area.

The investigation concluded that the pilot overflew a property at Kernot at very low level and did not see powerlines that were located about 600 m from the house in sufficient time to avoid a wirestrike. After breaking the powerlines, the aircraft impacted the ground and caught fire.
