Australian Transport Safety Bureau

Aviation Safety Investigator

Investigation briefs

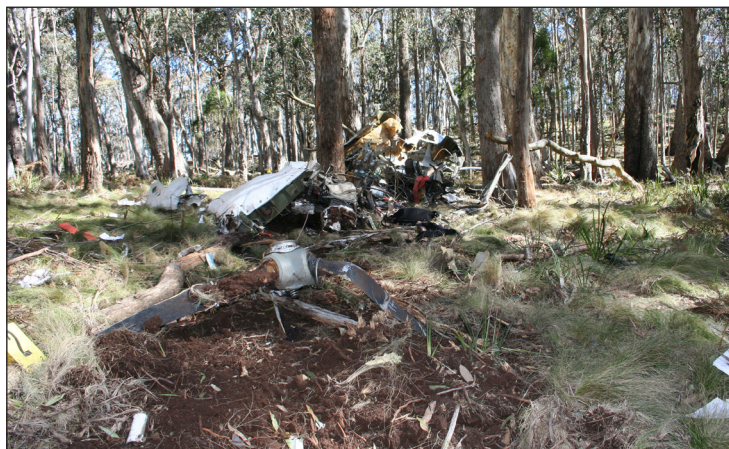
Australian Search and Rescue was notified. The wreckage of the aircraft was located the following day on top of a 3,800 ft ridge in rugged terrain, approximately 56 km north-north-east of Scone Airport. All three occupants were fatally injured and the aircraft was destroyed.

The weather in the area at the time of the occurrence was not suitable for VFR flight and included low cloud, rain showers and high winds. It is likely that the pilot was attempting to remain below the cloud base to maintain visual reference with the ground. The pilot's licence allowed for day VFR flight only. The aircraft's approximate heading at the time of impact indicated that the pilot may have been

The aircraft's wreckage trail indicated that the aircraft was travelling at approximately cruise speed and descending at a fairly low rate, if at all, when it impacted rising terrain at 3,800 AMSL. That evidence indicated that the aircraft was most likely in controlled flight at the time it impacted with trees. ■

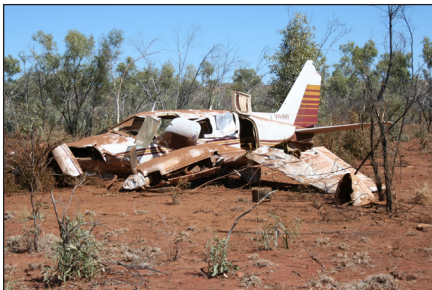
ATSB Investigation AO-2008-048

When the ATSB investigated, both fuel selector handles were found set to the outboard fuel tank positions and the emergency fuel pumps were selected OFF.

The engines were inspected externally with no preimpact defects identified. The engine fuel systems were disconnected at the main fuel inlets and only a small amount of fuel was present, although the pilot had ensured the aircraft had adequate fuel for the return flight.

Examination of the wreckage clearly indicated that there was sufficient fuel on board the aircraft to complete the flight safely. Had the pilot selected the fuel selectors to the inboard tanks when the engine surged and subsequent power loss occurred, normal operation would have been restored.

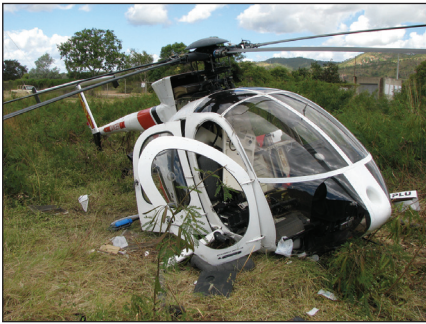
ATSB Investigation A0-2008-025

Examination and testing of the engine confirmed that, with the exception of post-impact damage to the fuel control unit, the engine was capable of operating within normal parameters.

The configuration of the fuel system was such that, when subjected to significant nose-up and right-roll helicopter attitudes, it required an increased amount of fuel to limit the possibility of exposing the fuel pick-up, and subsequently feeding air to the engine.

During the powerline stringing operation, transition from the hover to line pulling, created a worst-case scenario, resulting in the majority of the fuel being located at areas furthest from the fuel pick-up point.

The investigation determined that the pilot in command was operating the helicopter with a fuel tank quantity that did not guarantee continuous operation of the engine at the noseup and right-roll flight attitude required for powerline stringing operations.

As a result of the accident, the operator revised its fuel management procedures for powerline stringing operations. ■

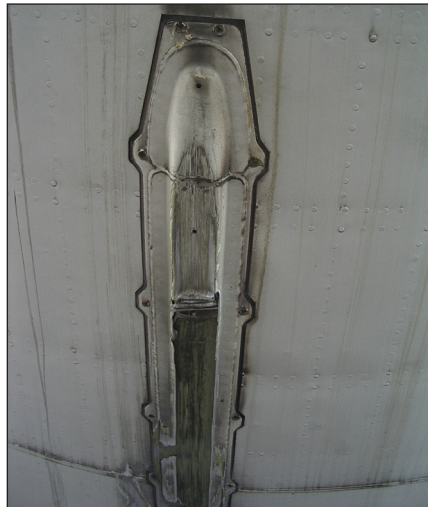
ATSB Investigation A0-2008-074

Damage to the aircraft consisted of abrasion to the tail strike indicator through to the fuselage skin and abrasion to the fuselage skin. There was also damage to the aircraft's structural frame under the tail strike indicator. The operator had provided guidance and training for pilots in respect to tail strikes, in the initial endorsement training and in subsequent recurrent simulator training. However, that training emphasised tail strike on takeoff rather than on landing. The aircraft manufacturer had identified an increase in the number of BAe 146-300 tail strikes and has recommended a number of procedural changes for flight crew. The aircraft operator has implemented those changes and issued notices to flight crew highlighting the risks and conditions for tail strike. ■
