ATSB TRANSPORT SAFETY REPORT
Aviation External Investigation AE-2009-045
Final

Engineering examination

Fractured main landing gear axle

Gippsland Aeronautics GA-8 Airvan - VH-BFS

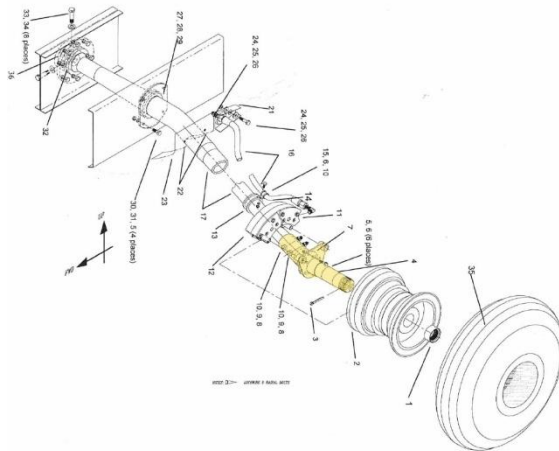
The main landing gear assembly was as shown in Figure 1, with the axle assembly highlighted in yellow. The axle assembly is shown in Figure 2 and has the leg attach sleeve highlighted. According to drawings received from the aircraft manufacturer, the leg attach sleeve was manufactured from 4130 steel to MIL-S-6758, and fillet welded to the axle. A doubler was also welded to the underside of the joint as shown.

Figure 1: Main landing gear, with axle assembly highlighted

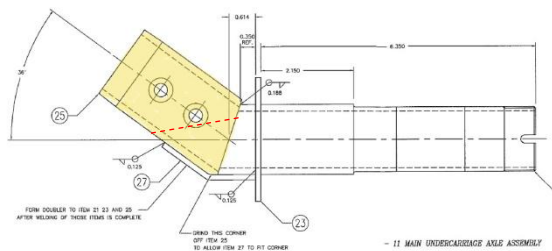
Figure 2: Axle assembly. Below the dotted line represents the portion of the leg attach sleeve ground away during landing.

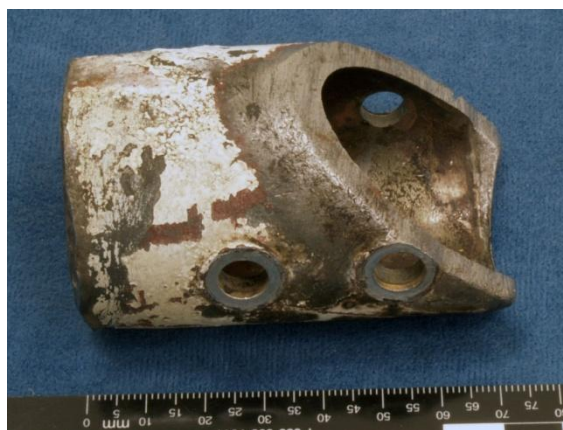
Figure 3: Leg Attach Sleeve

Figure 3 shows the leg attach sleeve as removed from the aircraft. Much of the underside of the sleeve (and fracture surface) was ground away as a result of the aircraft landing on the fractured axle stub. The remaining fracture was evident extending through the welded elbow joint between the sleeve and axle. A section of fillet weld was present on the fracture surface (Figure 4). The associated fracture surface morphology was typical of ductile overload, with no evidence of prior or progressive cracking noted.

As a result of gross abrasion sustained during the aircraft landing, the amount of material lost from the leg attach fracture surfaces (including the doubler from the underside of the axle assembly) precluded an accurate determination of the failure mechanism.

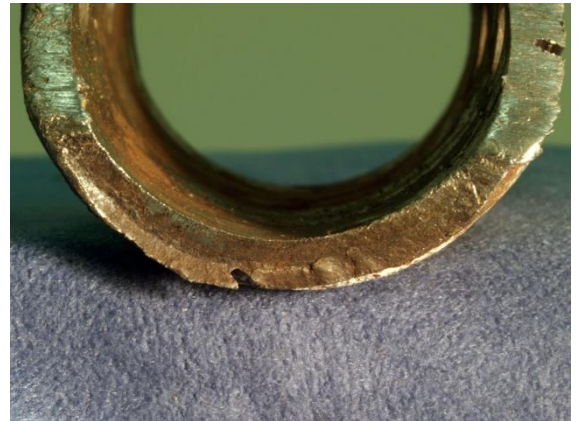
Figure 4: Remaining portion of weld

Considering the assembly design, the fillet weld would likely have been the region of highest stress in the axle assembly and therefore, in the absence of material or manufacturing defects, it is probable that the fracture would have originated and progressed through the weld along its full path.

The onset of failure under low nominal stress conditions, that is, during flight, suggested a progressive or fatigue-type mechanism, rather than a gross transient overload event. However, there was no evidence of fatigue on the remaining fracture surface.

Future increased examination vigilance and possible enhanced inspections of the leg attach sleeve welds of other GA8 aircraft is suggested in view of the nature of the failure sustained.

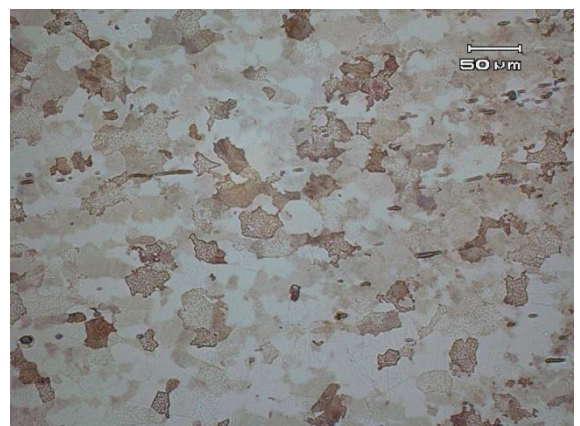
A metallographically-prepared and etched cross section taken through the sleeve, normal to the fracture surface, presented an equiaxed ferrite/pearlite microstructure (Figure 5). The average Vickers hardness of the steel was measured at 205 HV₂₀. Both the microstructure and hardness were consistent with 4130 steel in the normalised condition and on inquiry, the aircraft manufacturer confirmed that the axle assemblies were subject to a post-weld, normalising heat-treatment during production. There were no microstructural defects or anomalies observed in any of the examined sections.

Figure 5: Steel microstructure (2% nital etch)
