Australian Transport Safety Bureau

The dangers of wave turbulence

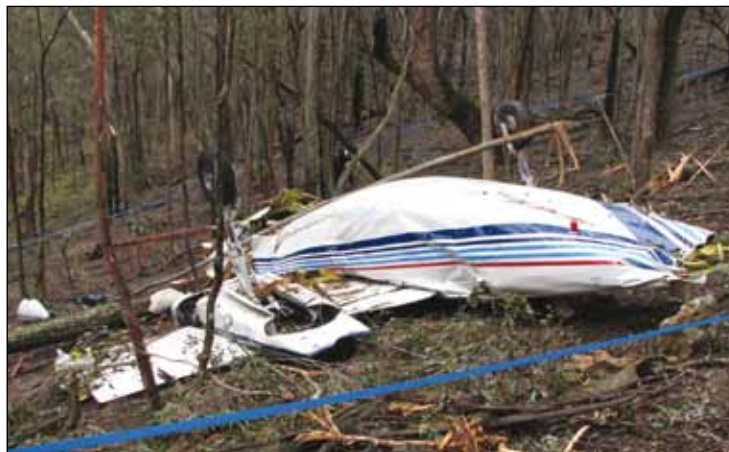
the timbered ranges near Clonbinane, approximately 50 km north of Melbourne. At about 2200, a ground search party confirmed that the wreckage was that of YJB and that there were no survivors. The aircraft had been seriously damaged by excessive in-flight aerodynamic forces and impact with the terrain. It had descended almost vertically through the tree canopy.

The wreckage and its distribution pattern were consistent with an in-flight breakup during cruise flight, with the aircraft being subjected to rapid and extreme aerodynamic forces during normal cruise flight at 7,000 ft. Examination of the damage to the structure revealed no evidence of any pre-existing defect, such as metal fatigue or corrosion. The wing structure failed in negative overstress. The symmetrical nature of that failure was indicative of a breakup in straight flight, consistent with the radar data, rather than during a turn or a spiral descent. That type of failure of the aircraft's structure can be explained by either the rapid onset of an extremely powerful downward gust, or by forward elevator control application

by the pilot (possibly in response to a sudden nose-up pitching movement), or a combination of both.

As a result of this investigation, the Australian Transport Safety Bureau reissued the publication *Mountain Wave Turbulence* (available for download at www.atsb.gov.au), and distributed the investigation report to all Australian operators of the Aero Commander aircraft. A safety advisory notice was also issued to aircraft operators and pilots, encouraging operators to review their procedures and to ensure awareness of the implications of the combination of aircraft weights and speed, and of the ambient conditions; in particular, when flying in, or near areas of forecast severe turbulence. ■

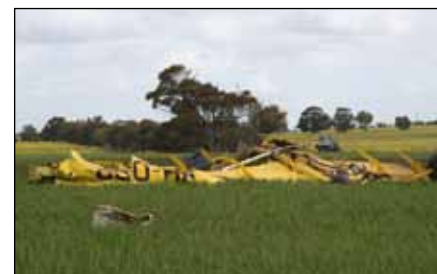
Debris from the aircraft's spray boom, and a substantial number of tree branches, were found at the base of a 23 m high tree that was located at the corner of one of the fields that were intended for spraying. The tree was significantly taller than the other trees that ran along the western boundary of the field. There was extensive damage to the leading edges of the aircraft's wings, consistent with the damage observed to the tree canopy.

The aircraft impacted the ground about 150 m north of the tree, in an inverted, steep nose-down attitude and slid inverted for about 50 m, before coming to rest. Numerous items of aircraft wreckage were distributed along the wreckage trail.
