**ATSB TRANSPORT SAFETY REPORT**

Aviation Occurrence Investigation – AO-2007-030

**In-flight engine failure  
23 km N of Ardrossan, SA  
25 July 2007  
VH-OAA**

**Cessna Aircraft Company ‘Conquest II’ 441**

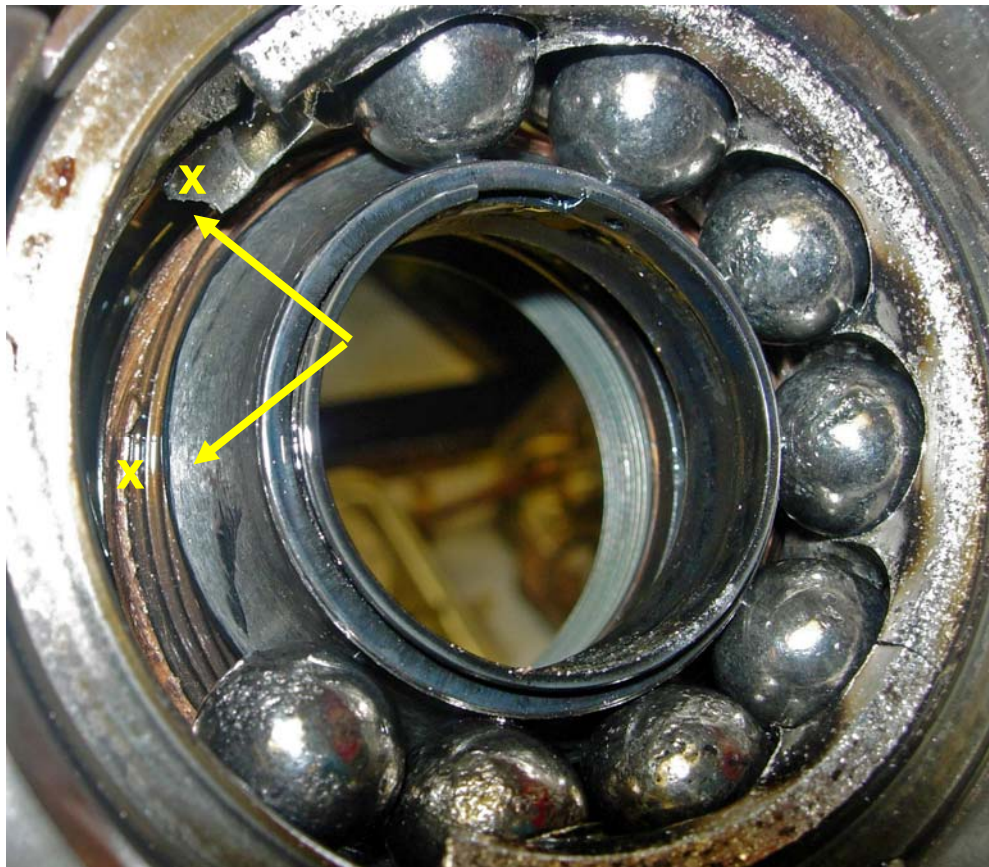
The engine was a Garrett TPE331-8-402S (serial number P31430C). The initial teardown findings showed that the compressor bearing at the front end of the compressor section had catastrophically failed (see Figure 1 and Figure 3 for location). The bearing cage had fractured and two of the balls had come loose. Those loose bearing components had collided with and caused damage to numerous internal rotating engine components.

**Figure 1:** The compressor bearing as found within the right engine showing the location of the missing bearing balls and fractured cage (arrowed)

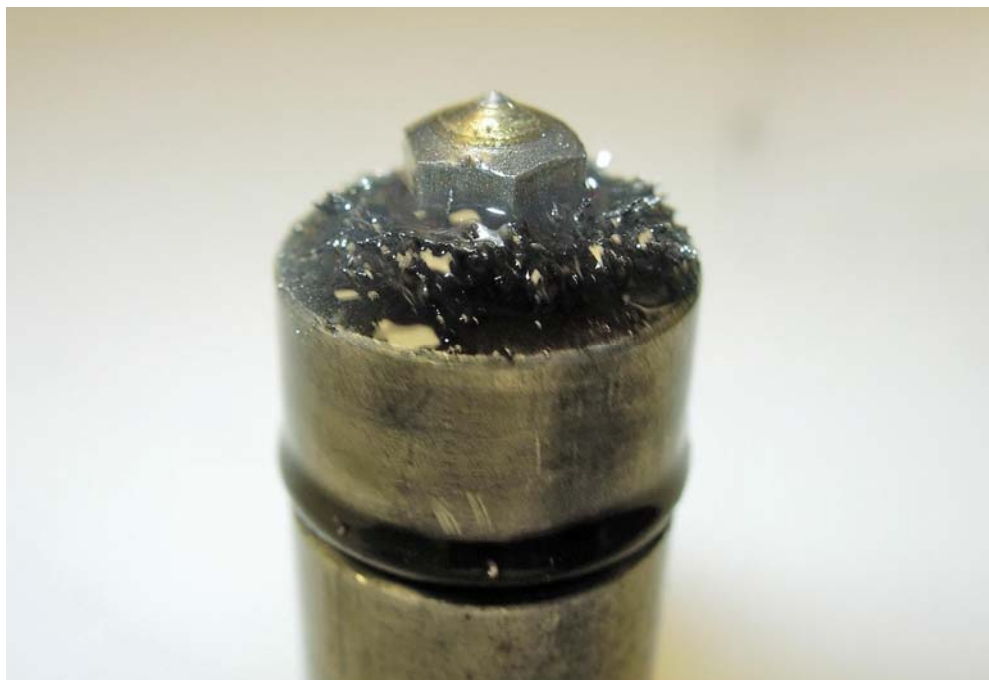
The engine had been fitted with a magnetic chip detector, which was installed on the lower portion of the reduction gearbox (Figure 2). When there is abnormal wear occurring inside the engine, magnetic poles on the detector attract and retain the metallic chips from the engine lubrication oil. The detector is removed and examined for signs of contamination as part of routine maintenance checks of the aircraft. Although not mandatory, the aircraft was not equipped with an electrically connected engine chip detector system which provides a warning light in the cockpit.

**Figure 2:** A picture of the reduction gearbox chip detector with metal particles clearly visible

The right engine had been manufactured with a magnetic chip detector that was fitted to the lower portion of the propeller reduction gearbox. The function of the chip detector was to magnetically attract wear material products from the engine oil during service. When removed from the engine during maintenance, a visual inspection of the detector will establish whether or not engine deterioration has been occurring. A significant quantity of metallic debris from the failed compressor bearing was found to have accumulated on the chip detector when it was removed during the right engine disassembly.

Owners and operators of Cessna 441 aircraft have the option of upgrading the magnetic chip detector system by wiring it to a warning light in the cockpit of the aircraft. When the magnetic plug of an electrified system accumulates a sufficient quantity of metallic debris, the cockpit warning light will illuminate and alert the pilot of an engine problem. Although the fitting of such devices are not mandatory, had the aircraft been equipped with an electrically connected engine chip detector system, it is likely that the pilot would have had advanced warning of an impending engine failure.

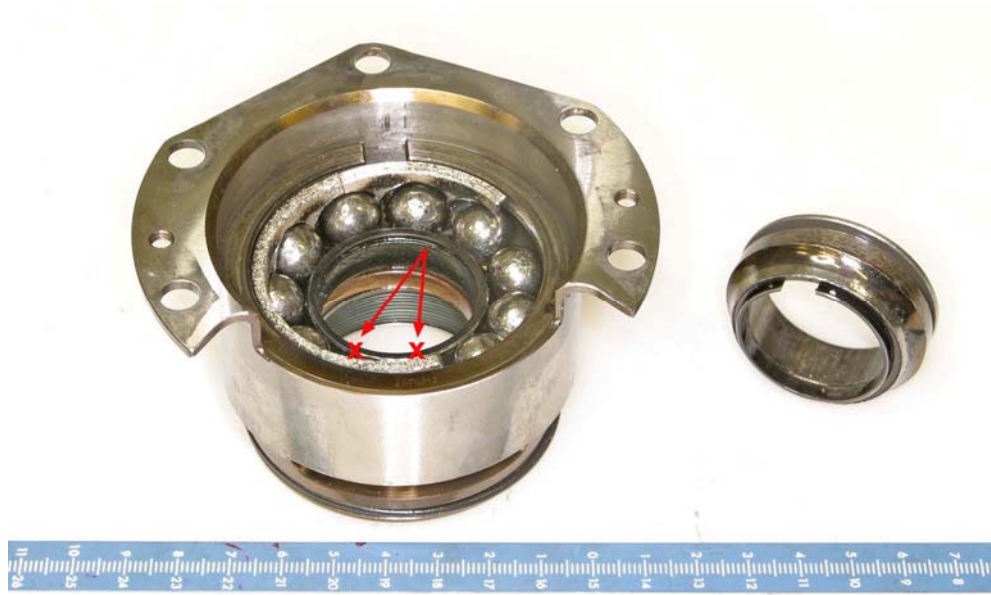
The ATSB's examination (Appendix A) found that the compressor bearing had collapsed from severe mechanical and thermal distress (Figure's 1 and 4). The part and serial number details for the compressor bearing matched the operator's maintenance documentation and confirmed that it had been installed into the engine during the July 2006 overhaul.

**Figure 4: The compressor bearing as recovered from the right engine showing the major area of damage (arrowed)**

All of the bearing balls were severely damaged and displayed numerous indentations and extensive shallow spalling<sup>3</sup>. The bearing cage had fractured into several pieces and was heavily deformed. A section of the fractured cage had separated from the assembly and had probably been consumed by the engine's rotating hardware. Both halves of the inner race exhibited spalling and deformation from thermal and mechanical distress.

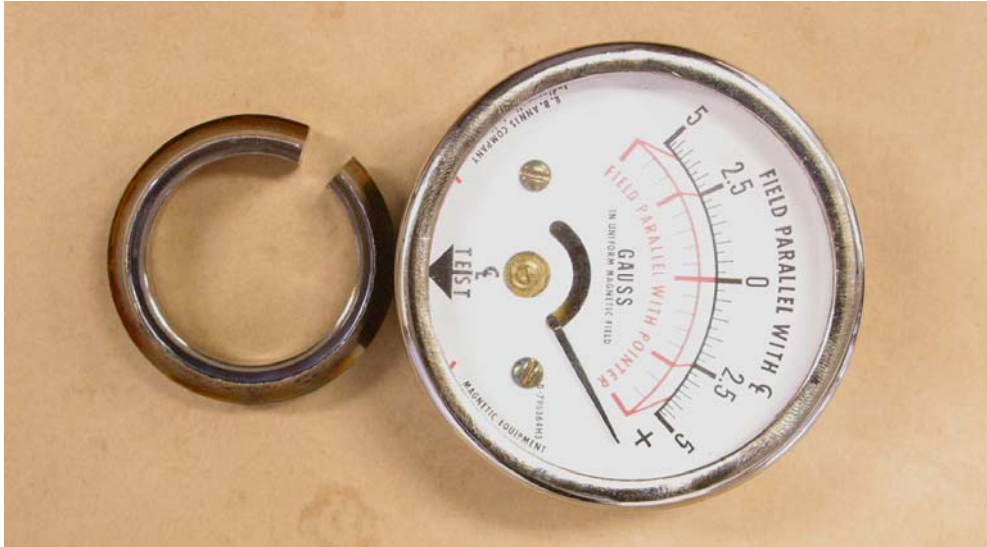
**Figure 5: Inner race magnetisation as measured with a Gauss meter**

Note: The inner race had been sectioned for metallurgical examination

One aspect that explains the compressor bearing failure was the level of residual magnetism found in each of the bearing elements. The residual magnetism was particularly strong in the housing and inner race of the compressor bearing. Other engine components exhibiting similar residual magnetic properties included the attachment flange on the propeller shaft. The observed magnetisation suggested that the turbo machinery bearing components had been exposed to direct electrical current (DC). Residual magnetism can be created from the passing of electrical current through a component.

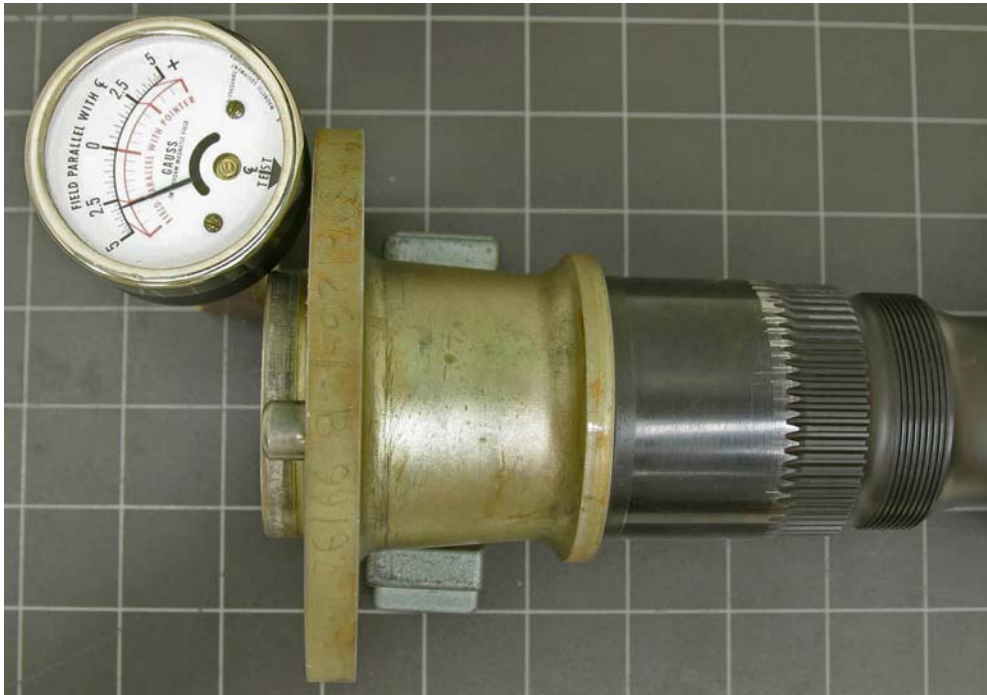
**Figure 6: The flange on the propeller shaft showing considerable residual magnetism**

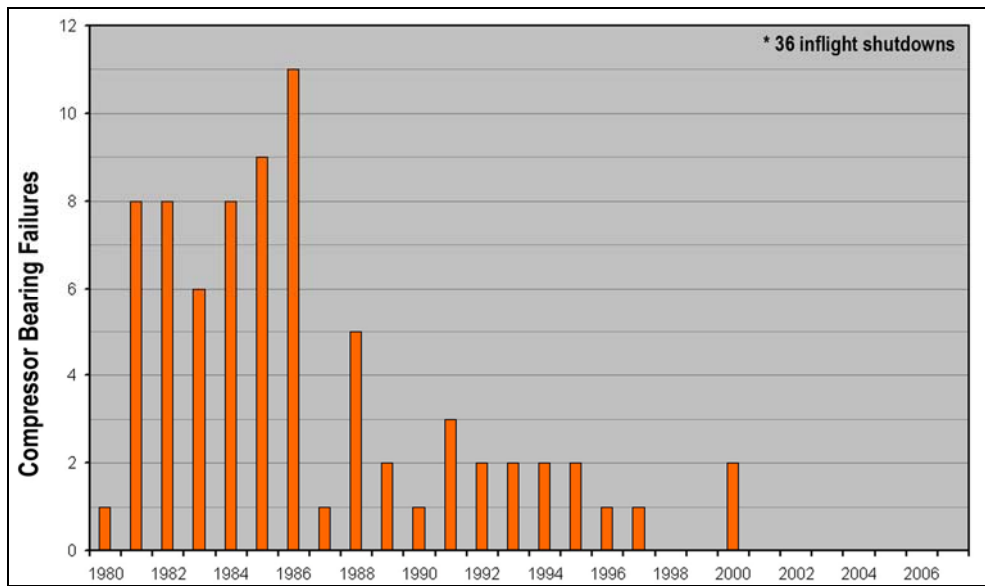
The engine manufacturer also supplied historical data on the known reliability of compressor bearings within the world fleet of TPE331-series engine. The data showed that since 1980, 75 engines had sustained compressor bearing failures. The number of compressor bearing failures that resulted in an in-flight engine shutdown totalled 36. The data also indicated that there had been very few instances of bearing failures within the last 10 years of world-wide engine operation. A plot of the yearly number of bearing failures is shown in Figure 7.

The plotted data indicated that a peak failure rate occurred through the mid-1980s. The rising failure rate was attributed to propeller strikes that led to damage to the compressor bearing. The manufacturer subsequently revised the TPE331 engine maintenance manual by requiring the compressor bearing to be replaced after such a strike. Following those changes, an improvement in TPE331 engine reliability was achieved.

**Figure 7: History of compressor bearing failures from TPE331-series engines**

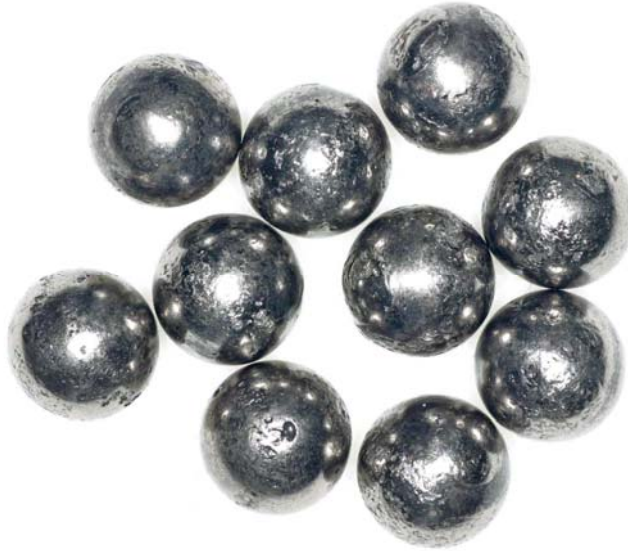
When the engine was initially disassembled and the compressor bearing examined, only eight of the 10 bearing balls were found within their assembly. Two of the balls had come loose from their bearing retainer and had migrated within the internal cavities of the engine. Those bearing balls were recovered after complete disassembly of the engine. All 10 bearing balls were severely damaged (Figure 8). The surfaces of each damaged ball displayed numerous indentations and extensive spalling. The spalled layers were quite shallow and confined to the surface. Much of the surface damage had been over run, with smearing, heavy wear and significant deformation present on the rolling contact surfaces. Such deformation signalled that sliding contact of the balls against the inner and outer races had occurred.

**Figure 8: The rolling surface of each bearing ball had spalled**

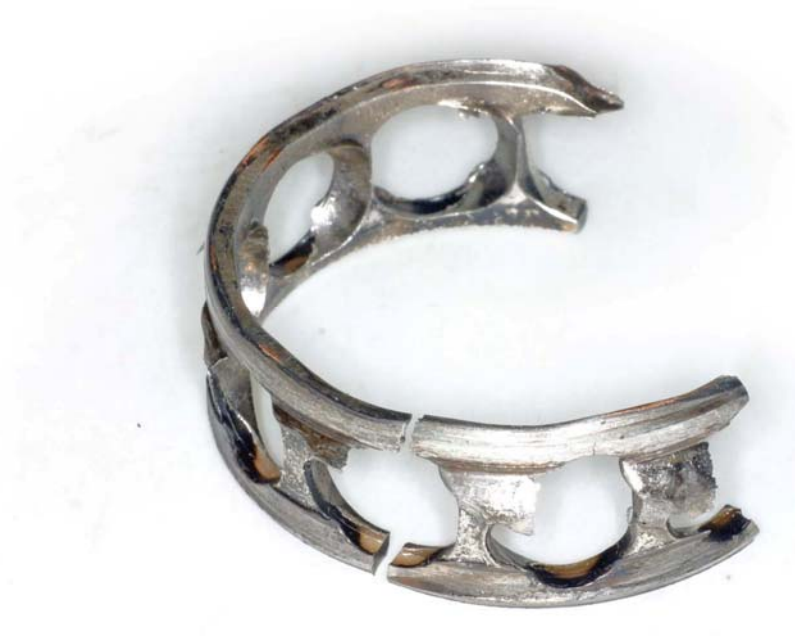
The silver-plated cage (or retainer) was heavily deformed and had fractured into several pieces (Figure 9). A significant section of the cage had separated from the bearing assembly. That section was not recovered; it had probably been consumed by the engine's rotating hardware. Other damage included a significant degree of distortion and wear within each of the cage pockets. A large increase to the internal pocket dimensions was observed. The external surface layer of silver plating was worn through to the steel backing in many places from sliding contact with the inner and outer raceway.

Figure 9: Close-up of the fractured and heavily deformed cage

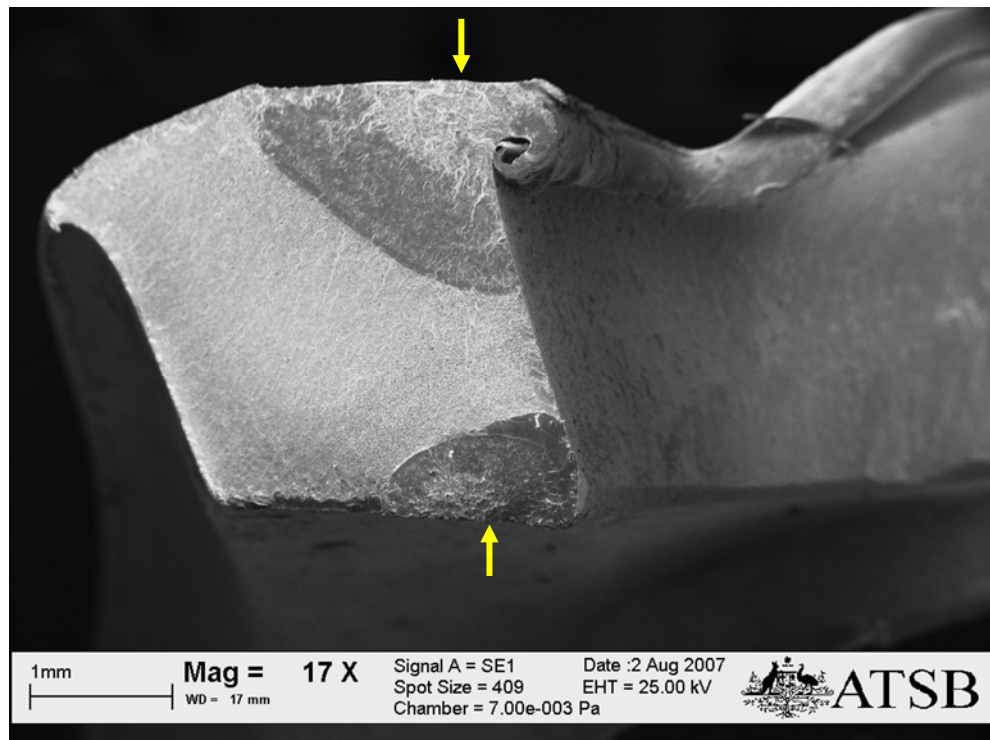
The cage had fractured centrally through the pocket cross members and high magnification examination of the fracture surfaces clearly showed that fatigue cracking had propagated through each section (Figure 10). Intergranular<sup>5</sup> regions were observed at the fatigue crack origins. X-ray analysis of the fractures showed the presence of silver from the plating throughout the intergranular regions at the crack origins. This indicated that silver plating had melted and had embrittled<sup>6</sup> the high strength steel. Furthermore, it indicated that the compressor bearing temperature had exceeded 962 degrees Celsius (the melting temperature of silver) during the failure sequence.

Figure 10: SEM image of one of the bearing cage fracture surfaces showing the origins of fatigue cracking (arrowed)

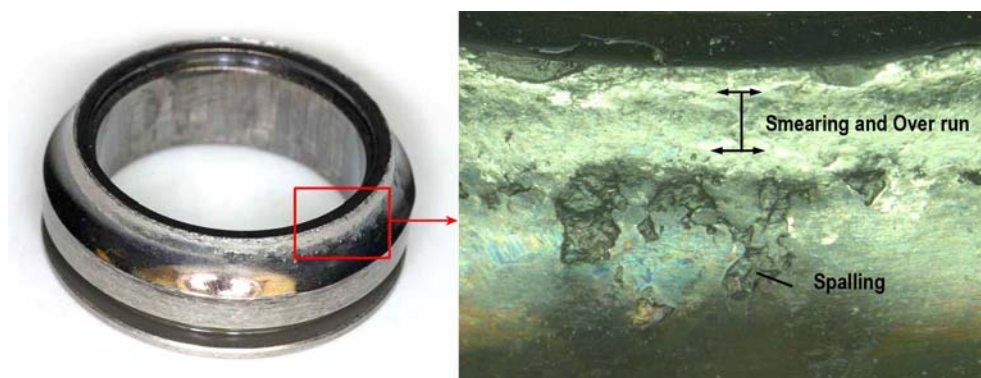
The contact surfaces of the puller-groove half of the inner race exhibited some evidence of spalling. Spalling, otherwise known as rolling contact fatigue, is a mechanism usually associated with the final stages of component life. Much of the spalled surfaces had been smeared and over run through rolling contact with the balls. This is shown in Figure 11.

**Figure 11: Image montage of the inner race puller-groove raceway surfaces showing over run and spalling damage**

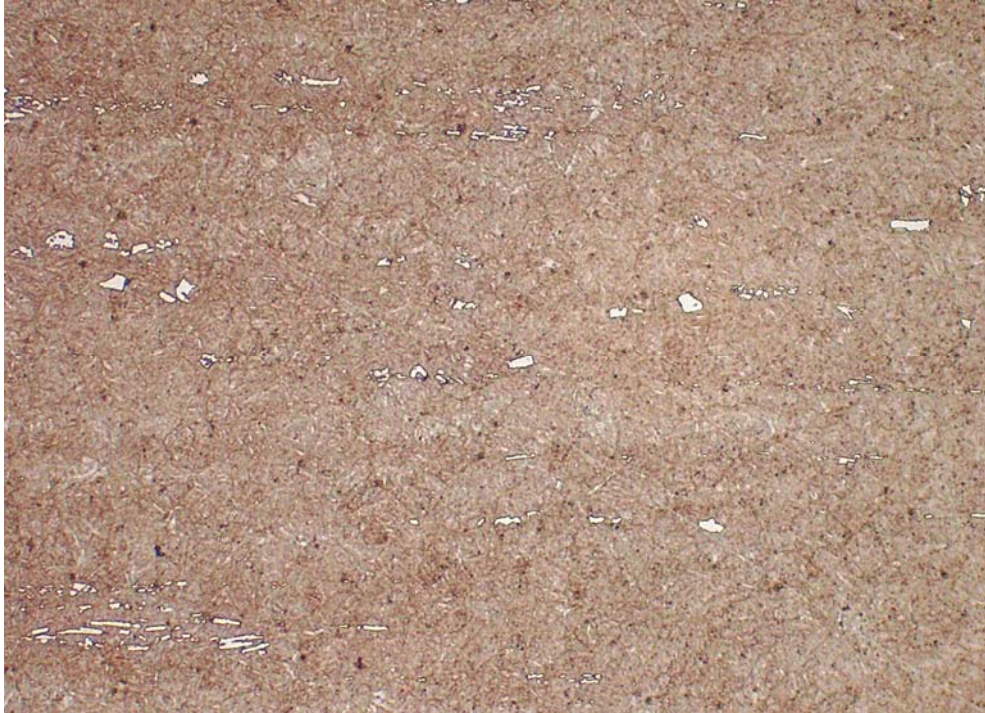
The core microstructure of each element exhibited a through-hardened quenched and tempered martensite structure typically found in most aerospace bearing applications (Figure 12). Pockets of highly transformed microstructure associated with the smeared surface zones of the bearing balls were found. This indicated that the balls had been frictionally heated during the final breakdown process as the balls slid and skid against the races. Sectioning of the cage and race also revealed highly heat affected areas.

**Figure 12: Section through a bearing ball showing the least heat affected microstructure**
