ATSB TRANSPORT SAFETY INVESTIGATION REPORT
Marine Occurrence Investigation No. 215
Final

Independent investigation into the engine room fire
on board the Singapore registered general cargo ship

Java Sea

24 May 2005

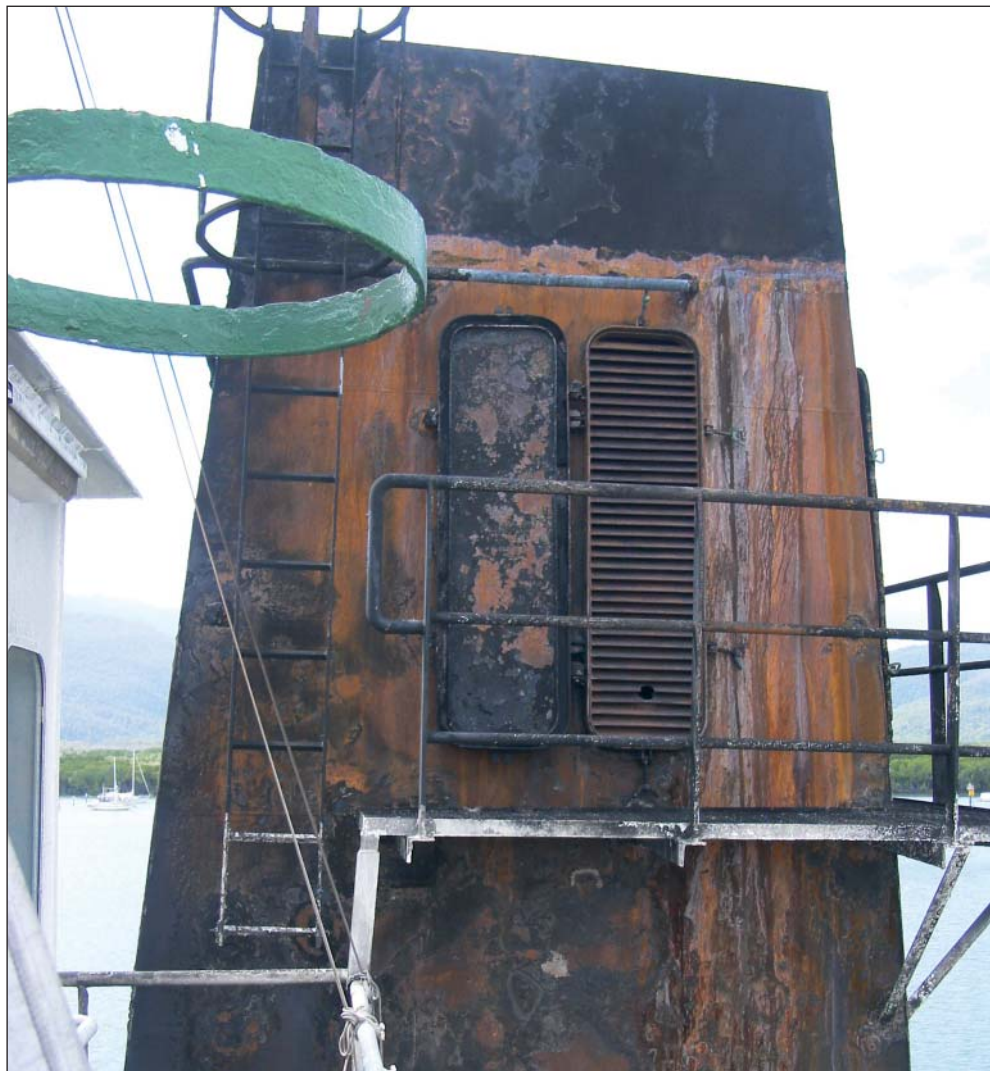
Figure 5: Funnel casing ventilation openings and closing dampers

The Australian Transport Safety Bureau investigation found that the fixed fire extinguishing system was ineffective in extinguishing the fire because the ship's crew could not close the funnel casing ventilation dampers; the diesel generator was not shut down before the system was activated; and the oil tank quick closing valves were not operated.

Ship owners, managers and masters of ships with ventilation openings in funnel casings which have similar closing arrangements to those on board *Java Sea* should assess their adequacy in consultation with the ship's classification society and Flag State administration.

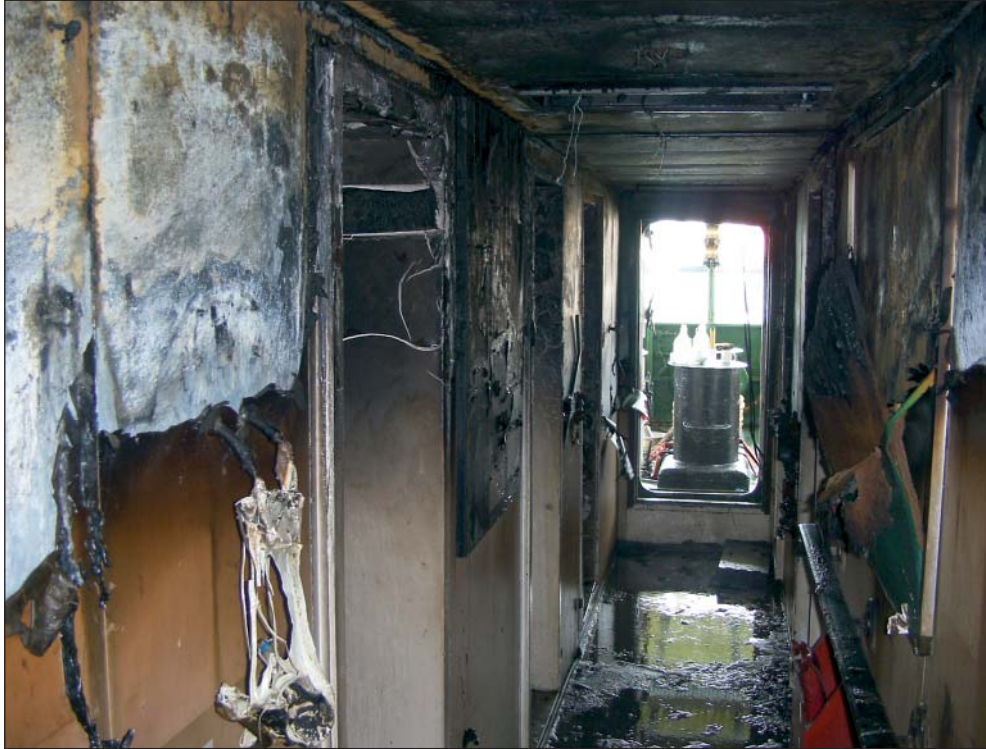
Figure 6: Damage to accommodation alley way

The evidence indicated a low spread, high intensity fire, causing major damage to the first level of the aft section of the engine room, extending upwards into the funnel casing (Figure 5). The thermal fluid head tank and main engine cylinder oil service tank located in the vicinity were burnt out. Smoke and radiant heat damage was confined to the engine room upper level, the main switchboard and local electrical cables, and the first and second levels of accommodation immediately adjacent to the fire (Figure 6).

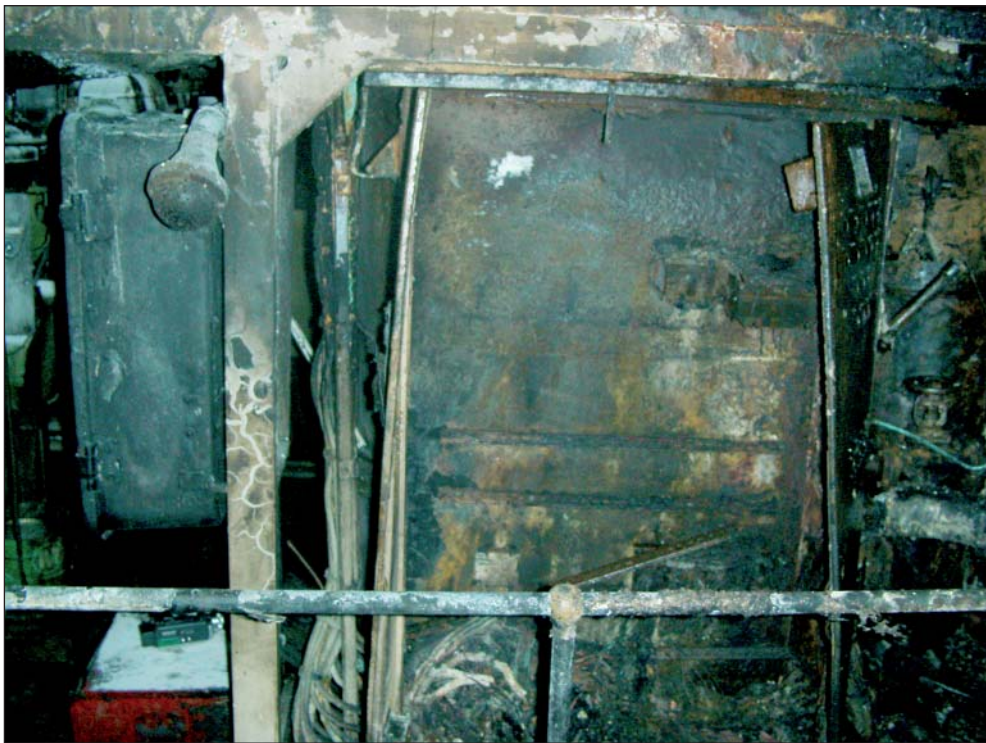
Figure 7: The remains of the oil-fired thermal fluid heater control cabinet

The main engine exhaust heat-exchanger, the oil-fired thermal fluid heater and the associated circulating pumps, piping and control cabinet (Figure 7) were extensively damaged. This made an objective assessment of the exact cause of the fire difficult.

It is also possible that leaking thermal fluid may have sprayed into the oil-fired thermal fluid heater control cabinet via one of the cooling openings in the side cabinet. Once inside the cabinet, the thermal fluid may have been ignited by electrical sparking from a contactor, relay, the cabinet's cooling fan motors or through direct contact with an overheated component. While this scenario is much less likely than ignition from the heater exhaust uptake, it would explain why the control cabinet was completely burnt out (Figure 7). However, it is also possible that the cabinet doors were left ajar and that the components inside the cabinet were completely incinerated at a latter stage in the fire and were not the source of ignition.

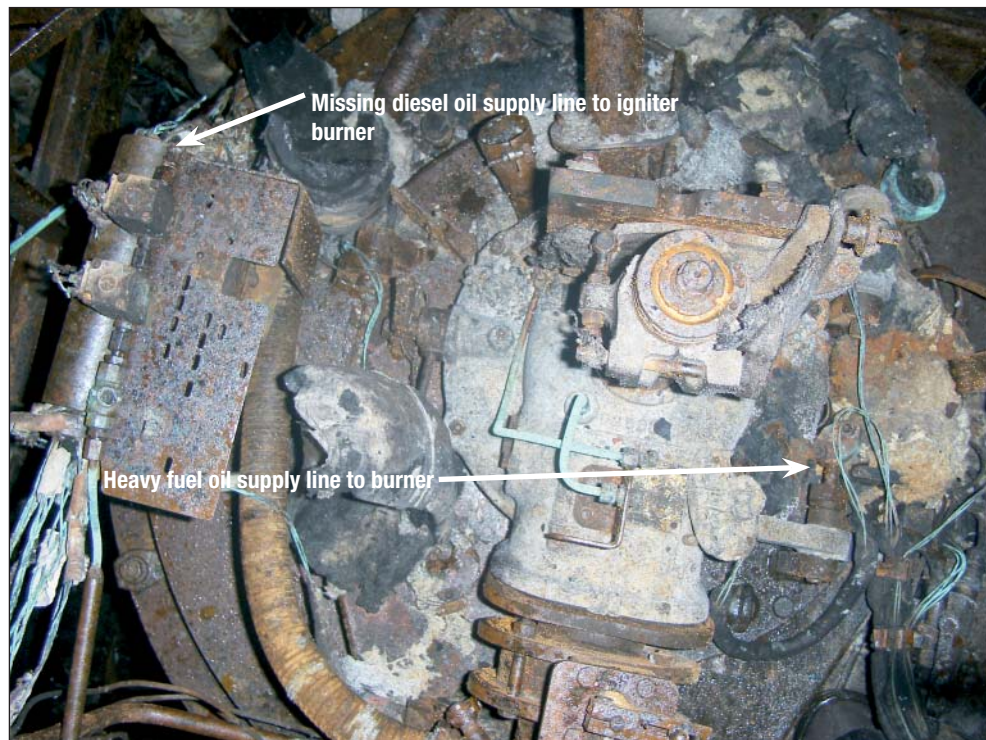
Figure 8: Top of the oil-fired thermal fluid heater

It is possible that one of the diesel oil or heavy fuel oil pipes or seals in the supply systems for the oil-fired thermal fluid heater burner unit may have been damaged and leaking (Figure 8). The steel heavy fuel supply line for the burner was fitted with a rotary union to allow the burner assembly to be withdrawn from the top of the boiler. The union is subject to repeated wear during maintenance and therefore

it is a potential source of fuel leakage. Similarly, the flexible fuel line between the diesel pilot burner assembly and the diesel supply shut off solenoids would have been subjected to a high rate of wear due to regular removal of the pilot burner assembly to service its fuel nozzle and igniters. Flexible fuel pipes subject to similar conditions of service have been responsible for a number of fires in the past and must be replaced on a regular basis to ensure that they do not leak as a result of maintenance related mechanical damage.

Had one of these pipes or seals been leaking it is probable that the fuel would have accumulated for a time and then run off the top of the oil-fired thermal fluid heater. The trim of the ship would have directed the leaking fuel towards the back of the heater. Eventually the fuel would have pooled at deck level behind the heater, the area that was identified as the seat of the fire.

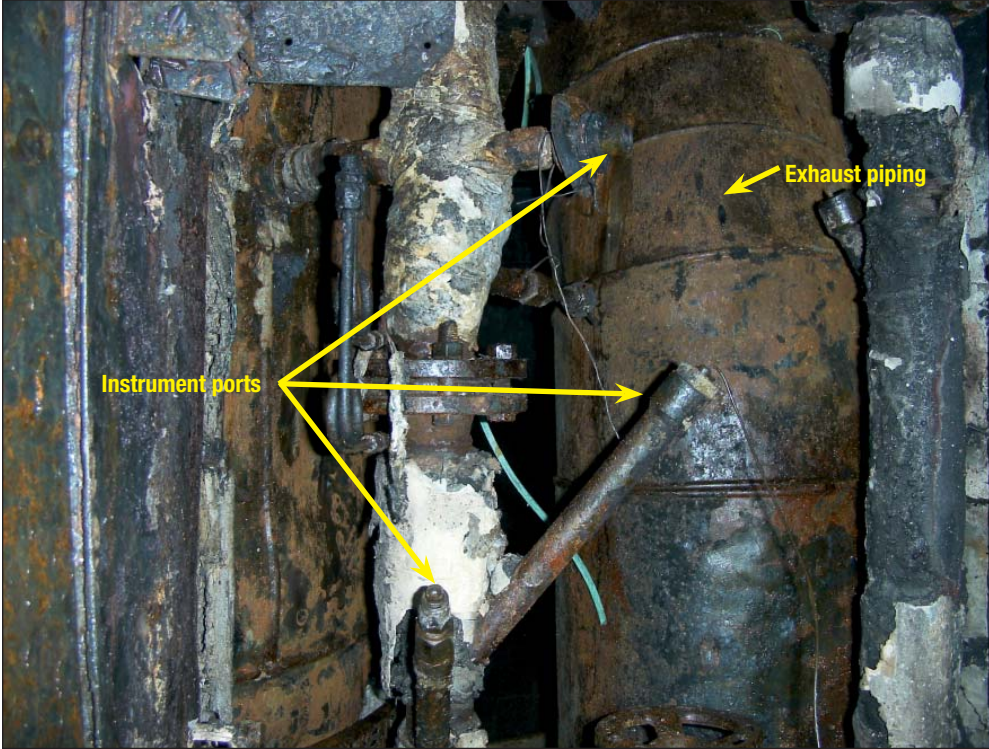
Figures 9: Thermal fluid piping and instrument ports

There were a number of thermal fluid circulating and trace heating pipes located on the bulkhead immediately aft of *Java Sea's* oil-fired thermal fluid heater. Any one of these pipes or their associated pressure gauge or flow switch lines (Figures 9 and 10) may have developed a leak, which would have led to a relatively large volume of hot thermal fluid, under pressure, escaping from the system in a short period of time.

An inspection of the area following the fire revealed that a flanged coupling in the head tank's outlet line was leaking. The coupling was located directly over the top of the oil-fired thermal oil heater and it appeared that at some point the fire had been hot enough to deform the bolts holding the flanges of the coupling together. At this point, with the quick closing valve open, any oil left in the tank would have flowed out of the coupling directly onto the seat of the fire.

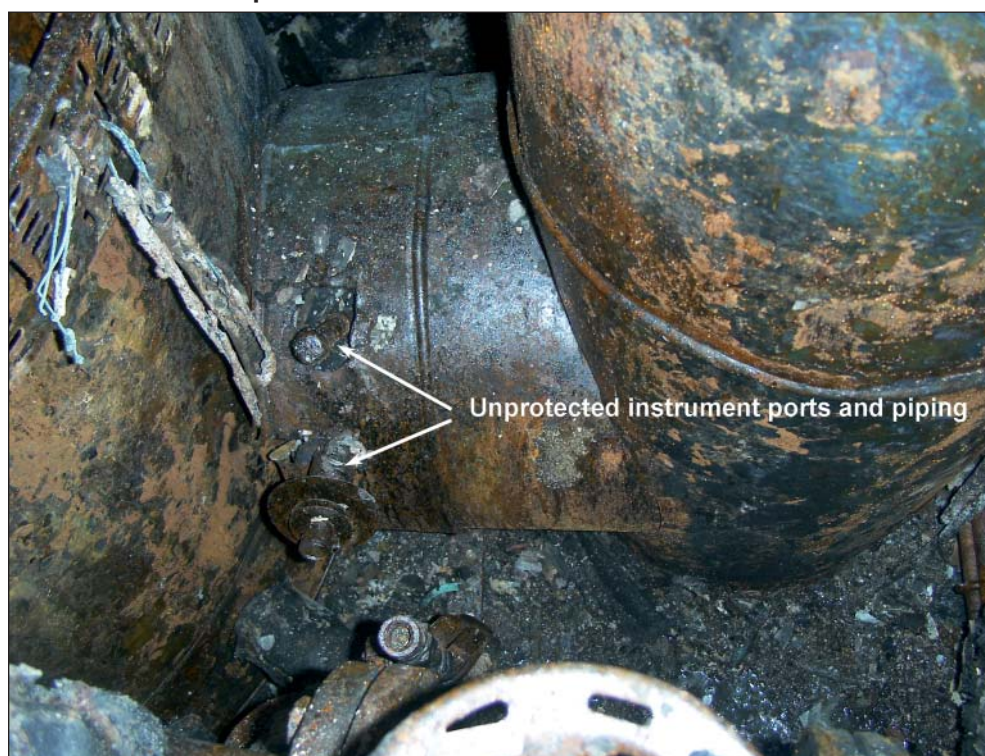
Figure 11: Oil-fired thermal fluid heater exhaust piping indicating the unprotected instrument ports

Combustion gases leave the oil-fired thermal fluid heater just above deck level through exhaust piping that leads to the funnel. There were instrument ports fitted in the exhaust piping, and these ports and the exhaust piping surrounding them was not protected by any insulation or metal cladding (Figure 11). With the burner firing, the temperature of the steel instrument ports would have approached that of the heater exhaust gases (250 to 300° C), well above the flash point of either diesel oil or thermal fluid.

A leak from one of the thermal fluid pipes adjacent to the heater, particularly a spray from an instrument port or gauge line fitting, would probably have impinged on the hot exhaust piping and ignited. Similarly, if fuel had leaked from the burner fuel lines it may have accumulated on the top of the heater and eventually run down the side of the heater, at its after end, directly onto the unprotected sections of the hot exhaust piping.

While it was not possible to conclusively identify the source of ignition, the most likely scenario is that leaking thermal fluid came into contact with the hot, unprotected sections of the oil-fired thermal fluid heater's exhaust piping.
