ATSB TRANSPORT SAFETY INVESTIGATION REPORT
Marine Occurrence Investigation No. 217 & 219
Final

Independent investigation into the grounding of the
sail training ship

Leeuwin II

in Prince Frederick Harbour, Western Australia

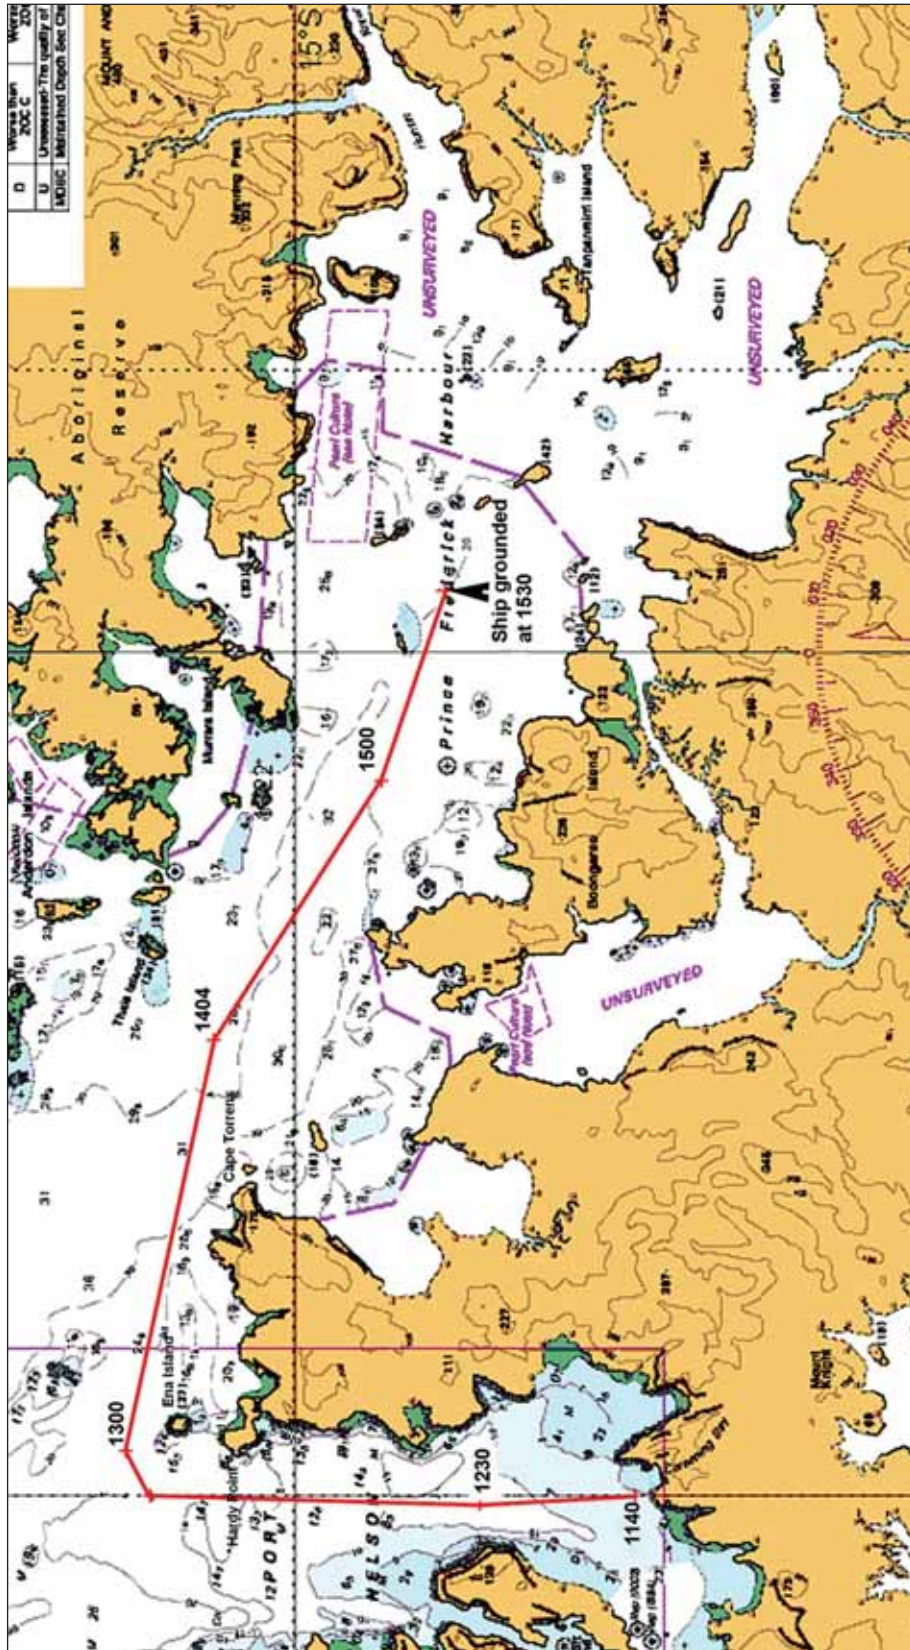
Figure 4: Section of chart AUS 730 indicating the ship's route from Careening Bay (re-constructed from the deck log book)

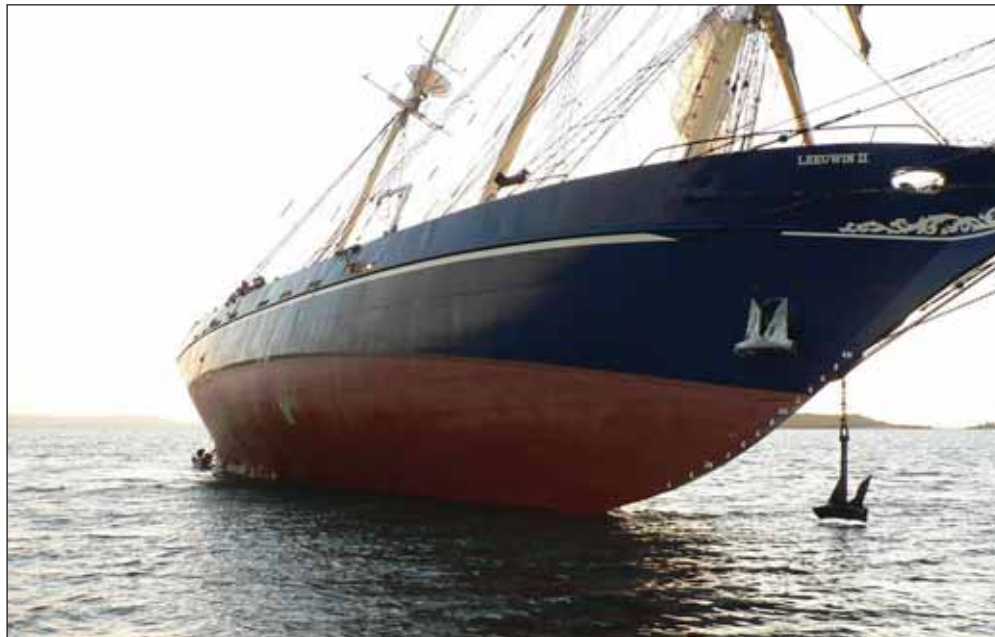
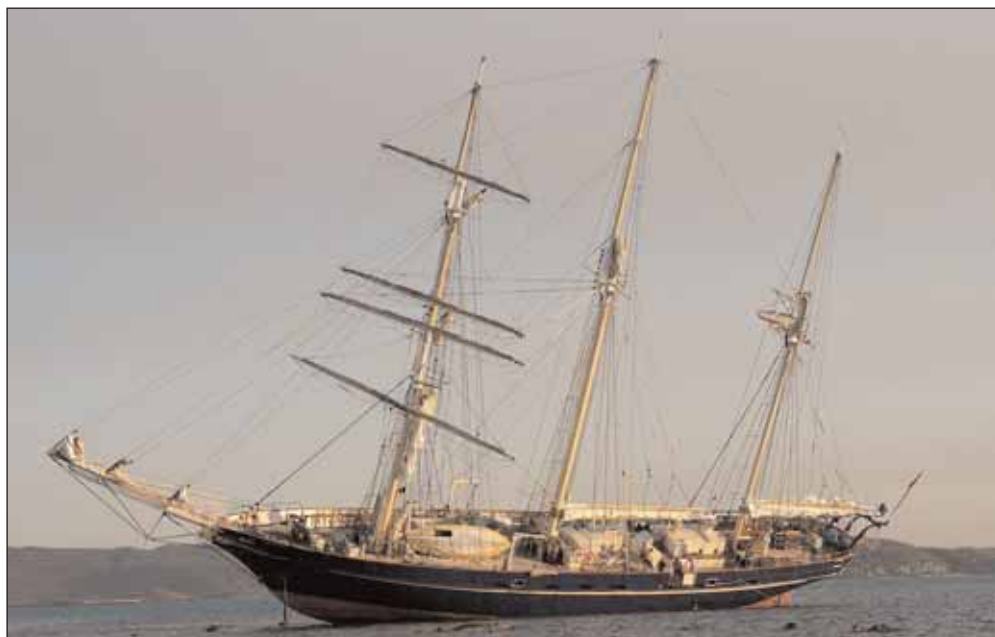
The ship listed further to port as the tide continued to ebb. It eventually stabilised with the mast at an angle of approximately 26 degrees from the vertical (Figures 5 and 6). The movement of the ship to port had been gentle and occurred in a number of stages.

Figure 5: *Leeuwin II* aground

Figure 6: *Leeuwin II* aground

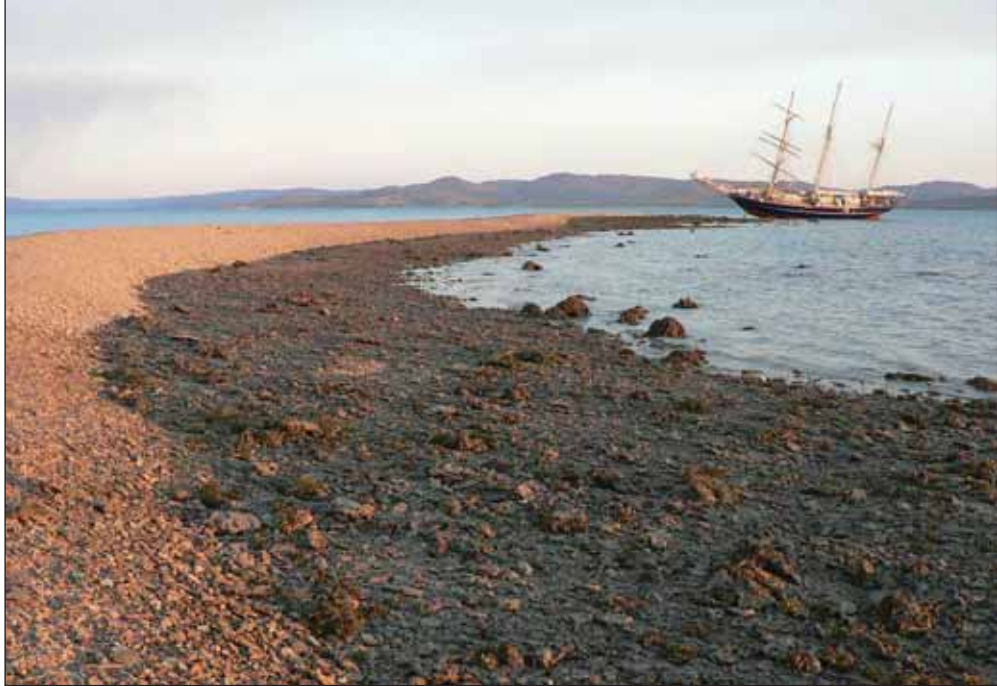
At 0730 on 23 July *Leeuwin II* resumed its voyage to Darwin, arriving there at 0830 on 29 July. On arrival an underwater inspection of the hull was organised. Little damage was noted, only the loss of some paint and the minor deformation of shell plating on the port side of the hull around the midships.

Figure 7: Shoal and Leeuwin II at low tide

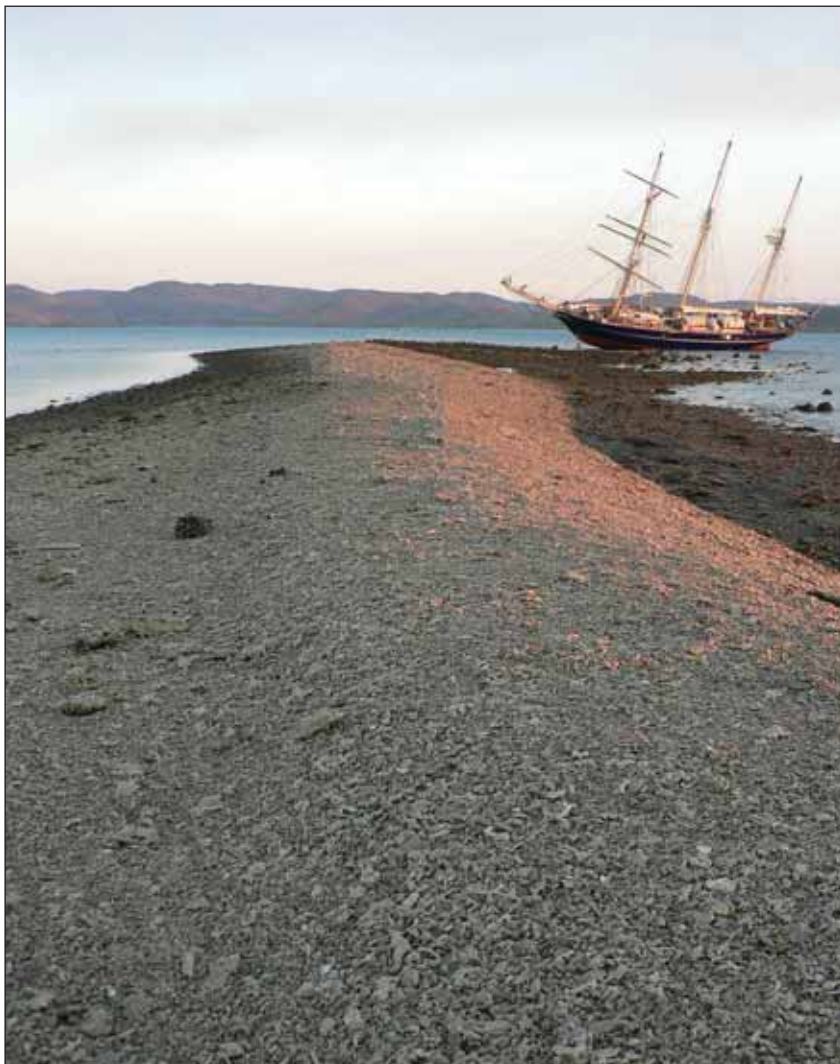
Figure 8: *Leeuwin II* and shoal

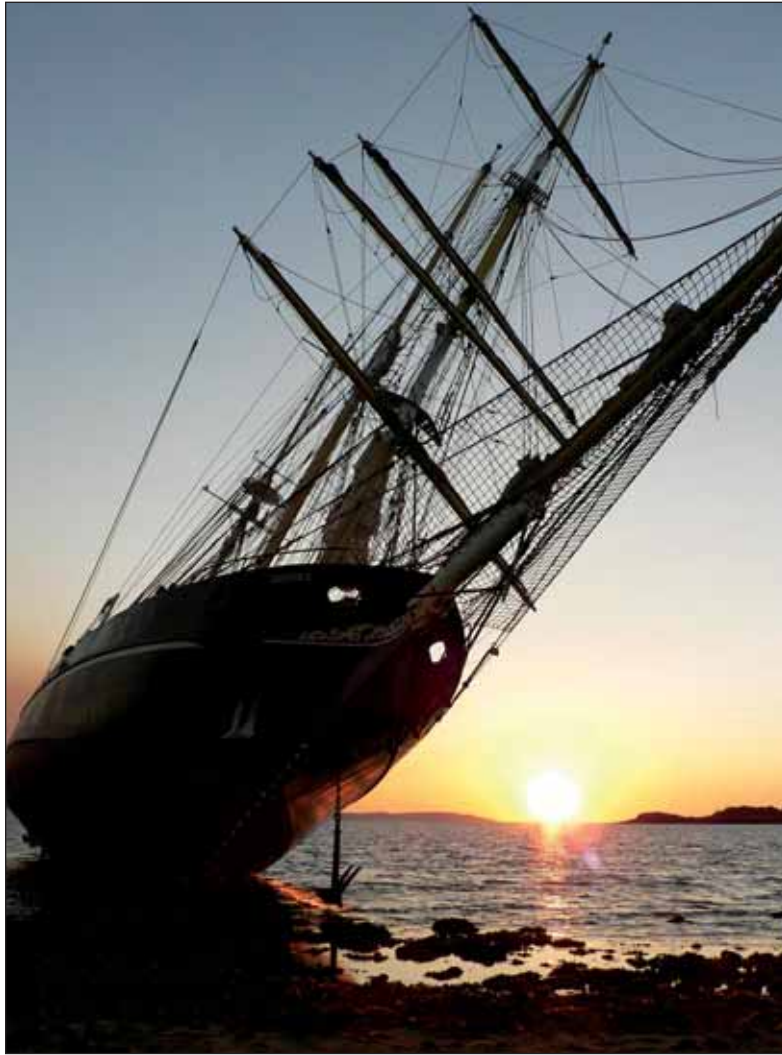
Figure 9: *Leeuwin II* at low tide

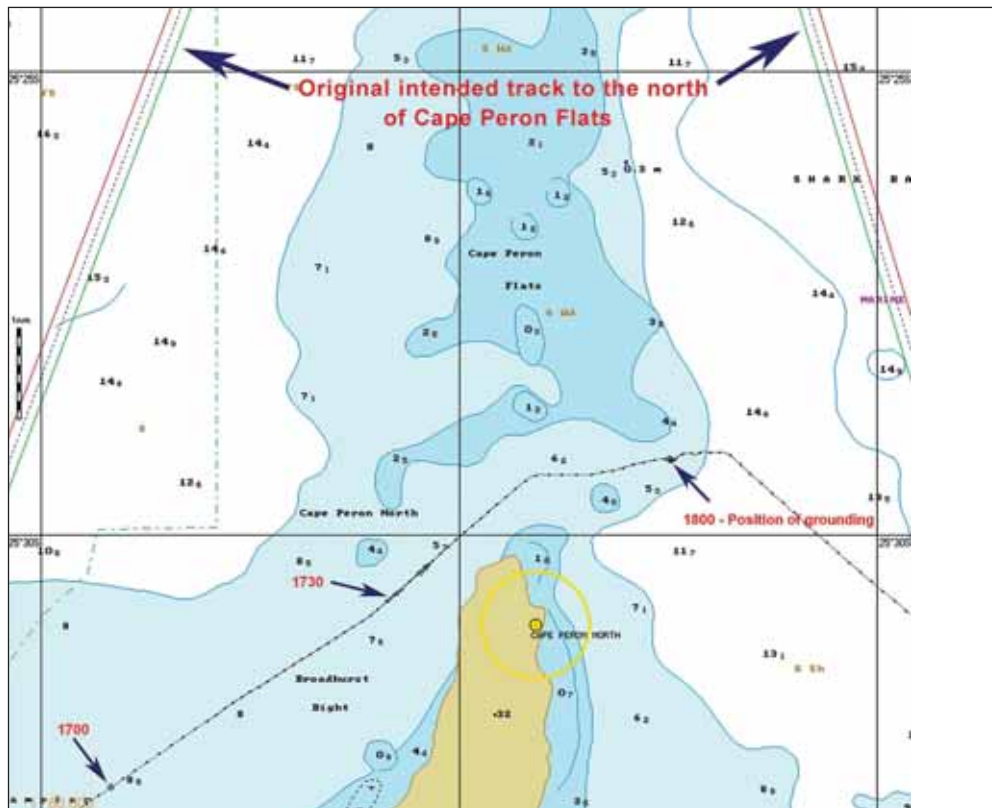
Figure 12: *Leeuwin II*'s track and grounding position at 1800

At about 1757, on a heading of 108°(T), the vessel shuddered. The engines began to race and the vessel's gyro stopped swinging to starboard. The master immediately checked the GPS and radar and, noting that the position was not changing, realised that the vessel had grounded near the 5.3 m charted shoal.

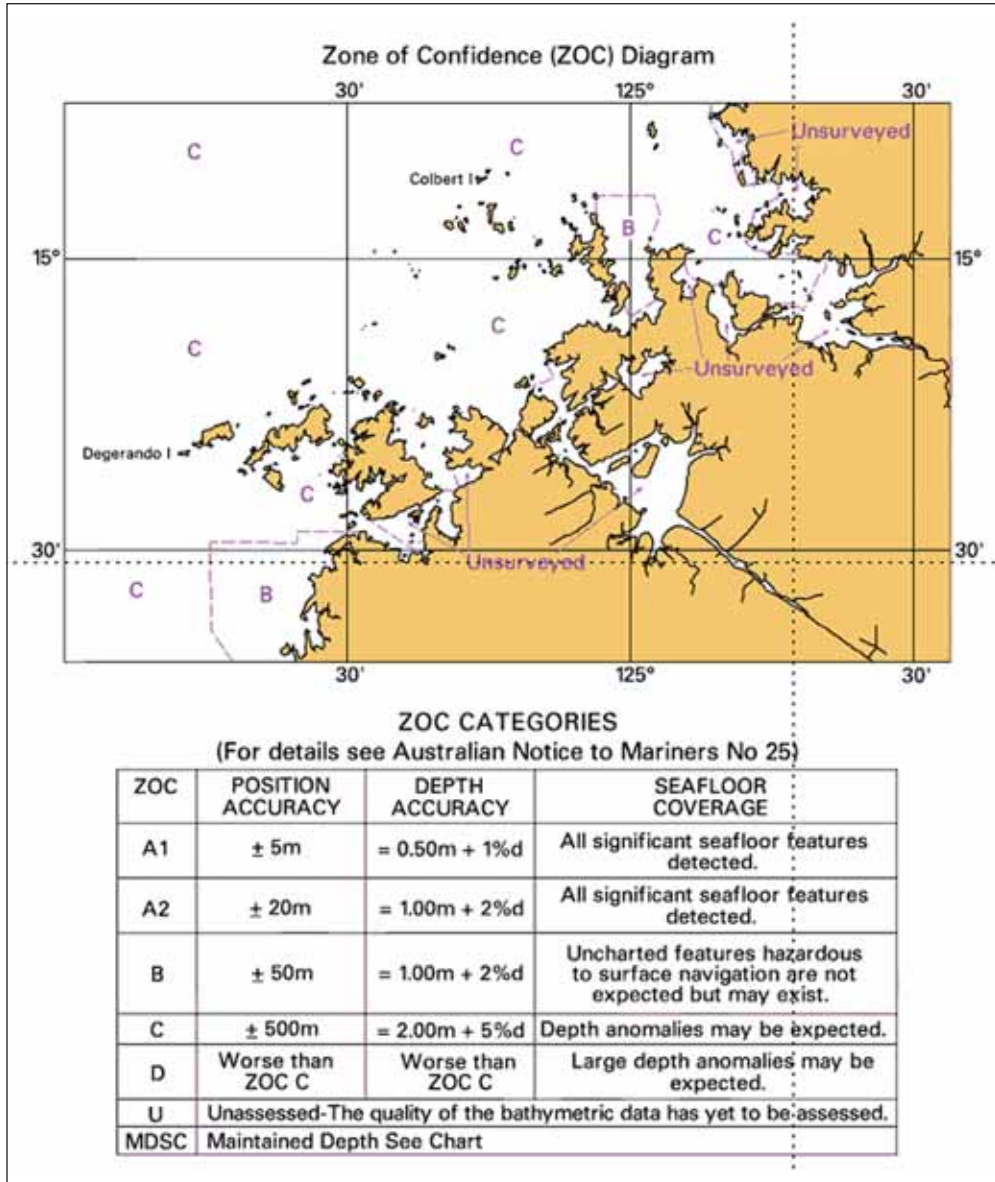
Figure 13: ZOC diagram for navigation chart AUS730

The survey used as the basis for chart AUS730 was that carried out by Lieutenant Phillip Parker King in the 1820s.

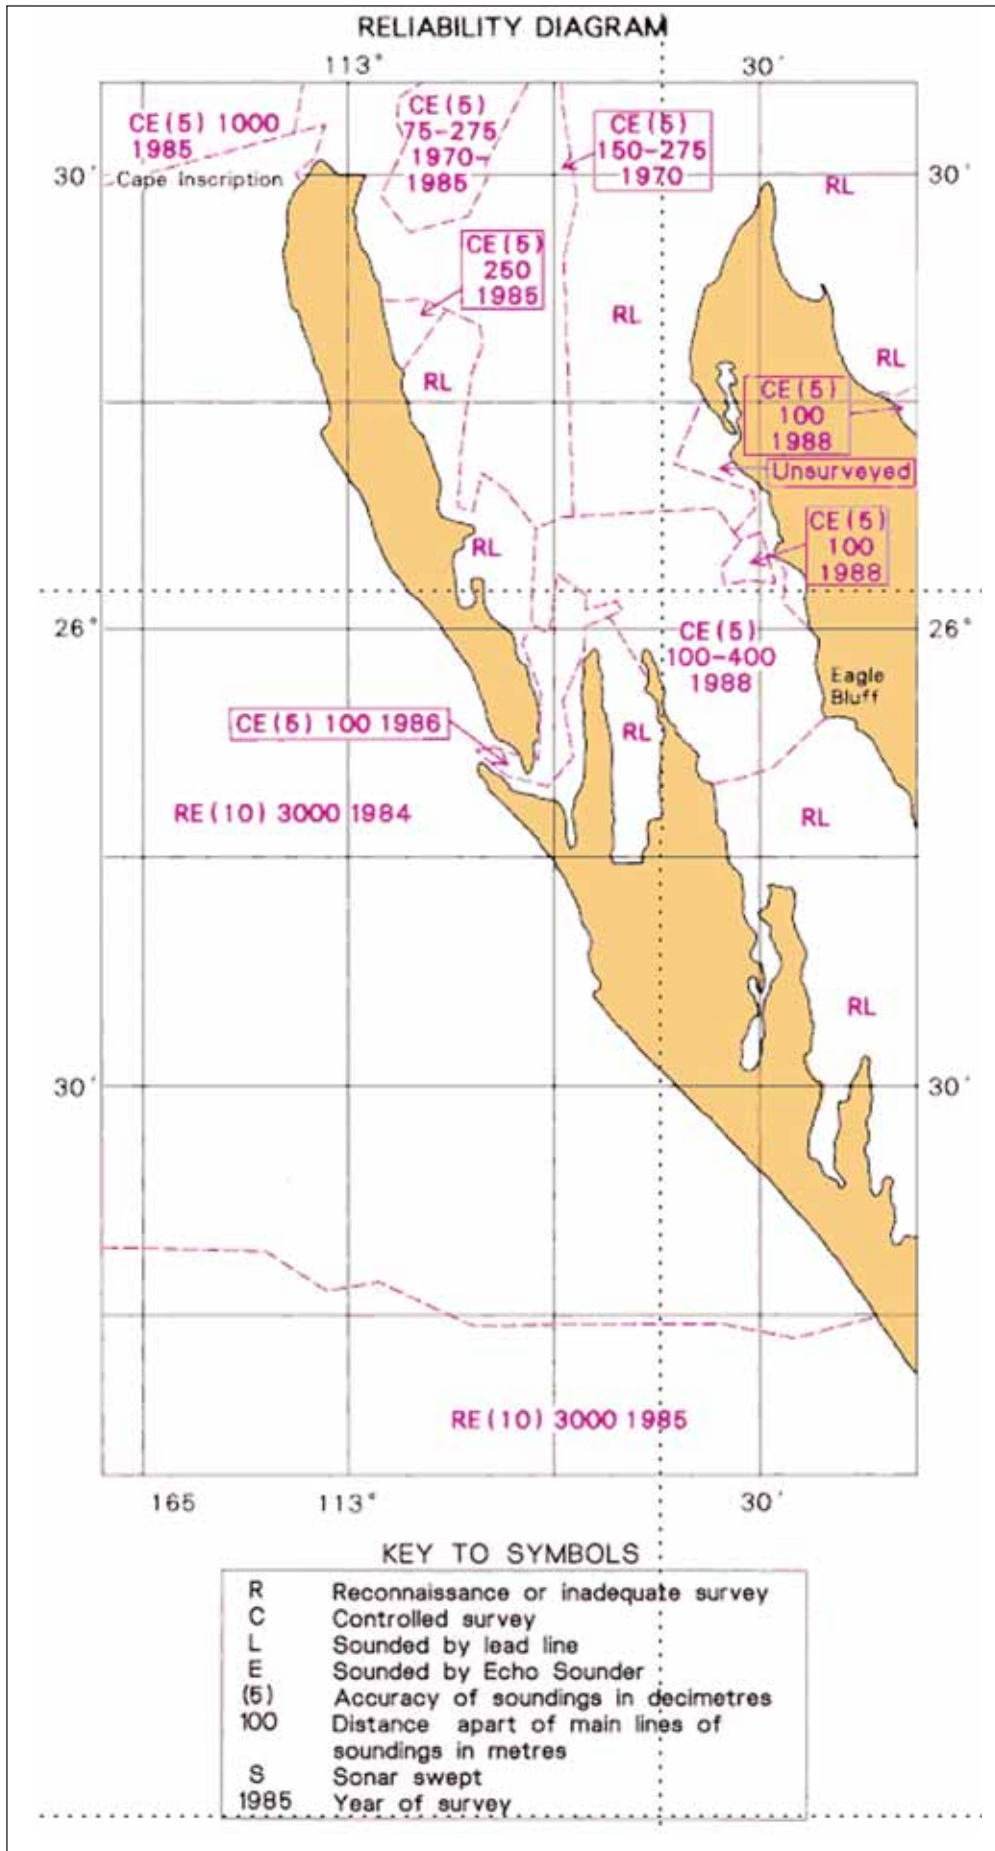
The reliability diagrams on these three charts (AUS749 shown in Figure 14) clearly indicate that sounding data in the vicinity of Cape Peron North and Cape Peron Flats was obtained using lead line soundings⁷ and is inadequate.

Figure 14: Reliability diagram printed on Chart AUS749

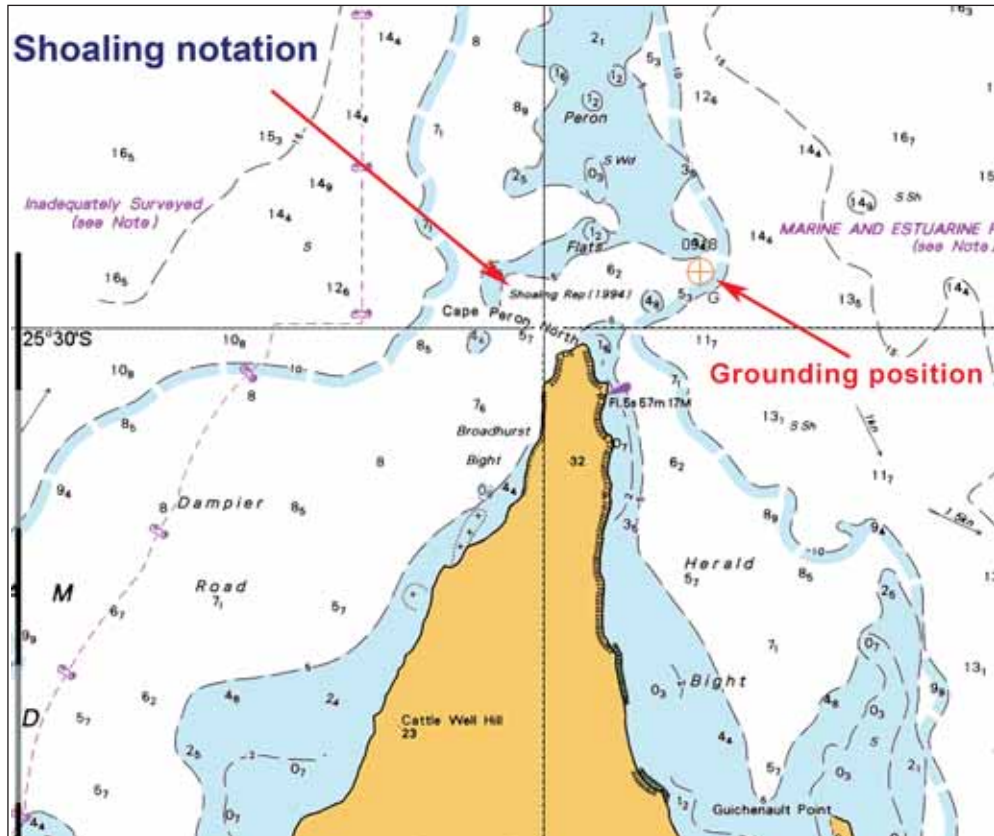
Additionally, there is a printed warning on AUS747 and AUS748 (Figure 16) in the inshore route used by the master on 16 September which states that shoaling was reported in this area in 1994. This warning was not present on either AUS749 (Figure 17) or the ECS chart (Figure 12), both of which were in use at the time of the grounding. The master stated, however, that he was aware of the warning of the reported shoaling as printed on AUS747 and AUS748 prior to his deciding to transit the inshore route.

Figure 16: Western portion of navigation chart AUS748

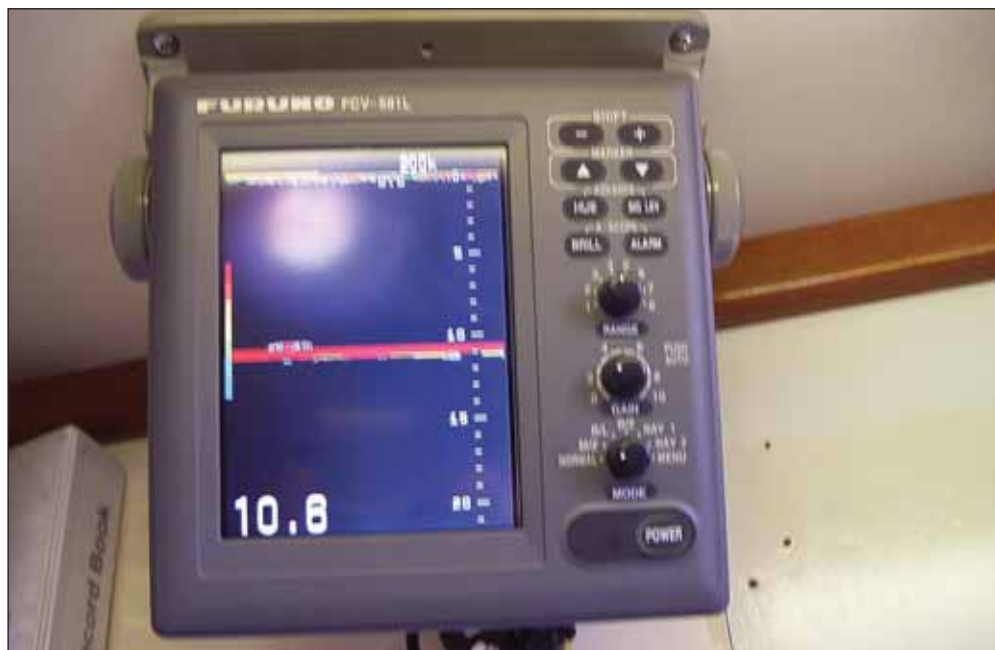
Figure 18: Echo sounder on board *Leeuwin II*

The echo sounder transducer is fitted in the midship section of the vessel, only recording the depth under this part of the vessel and not at the bow. The echo sounder does not look forward or to either side.

When operating in shoal water with minimum under keel clearance, an echo sounder is not effective in showing that a vessel is about to ground. Had *Leeuwin II* been fitted with a unit such as a forward scanning sonar, the shoaling ahead of the vessel may have been detected, and the groundings avoided.

The Leeuwin Ocean Adventure Foundation should consider the practicalities of installing a forward scanning depth indicating device on board *Leeuwin II*.

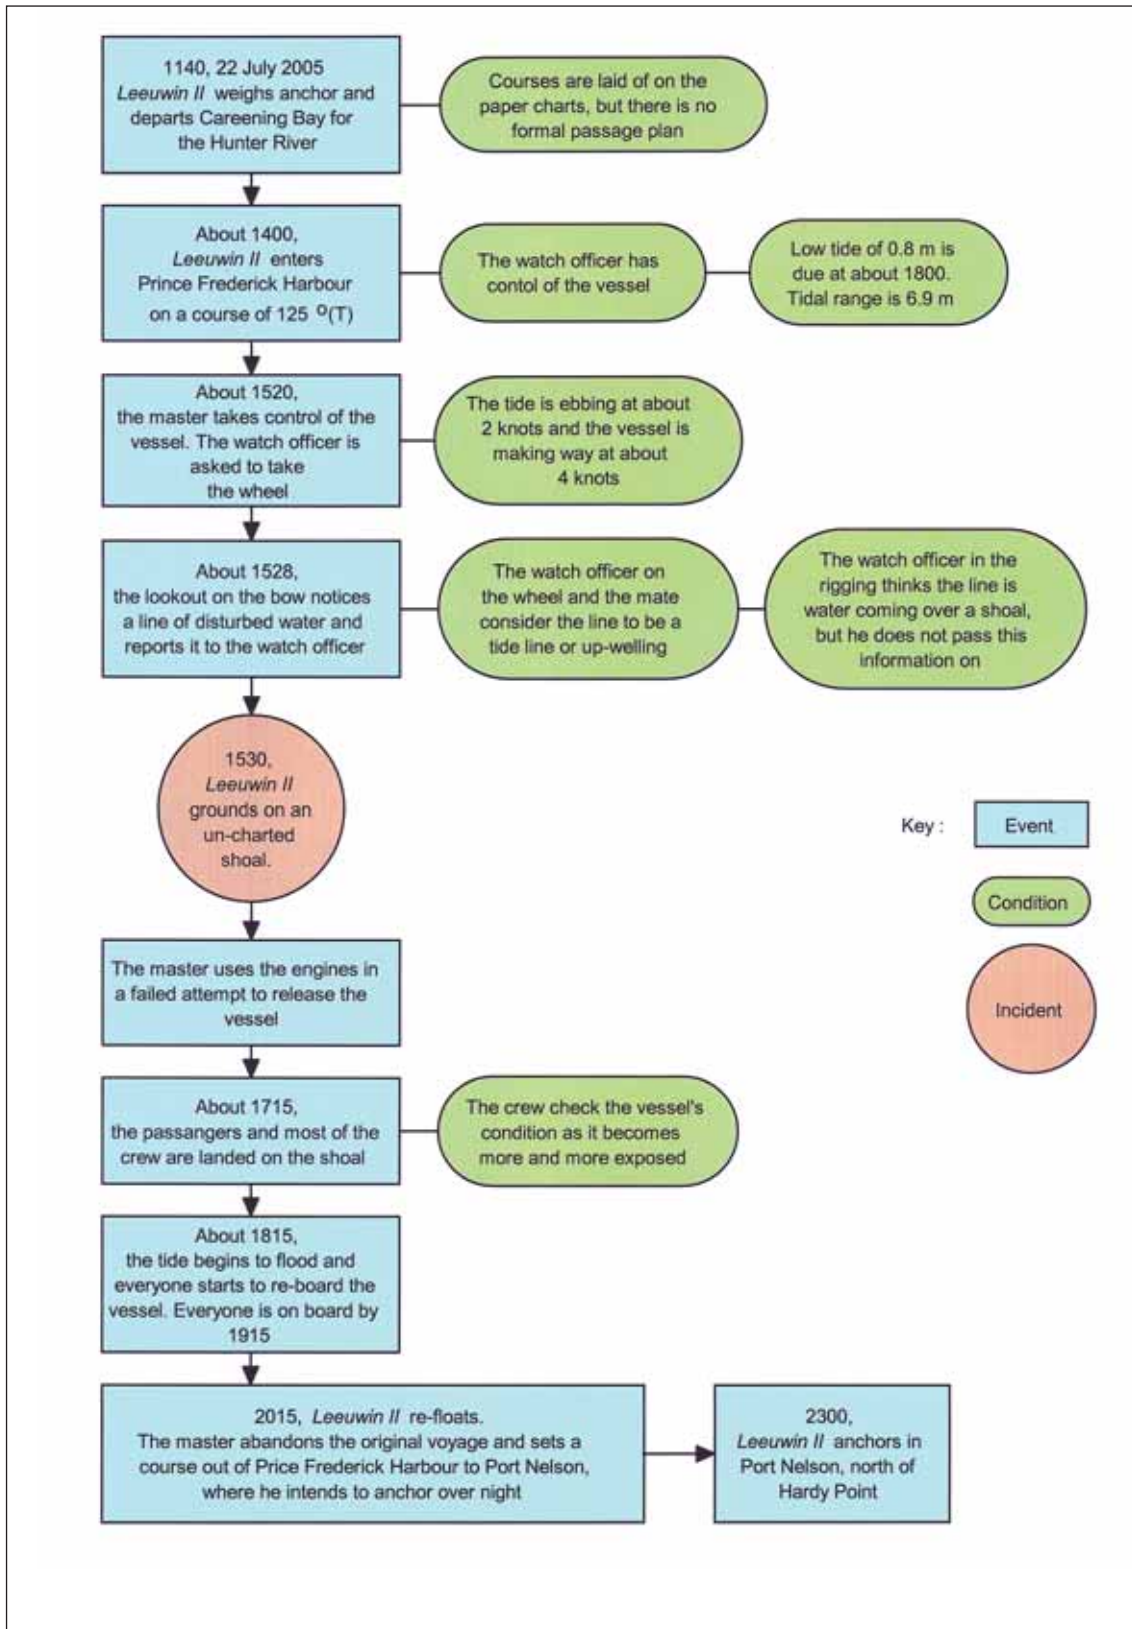
Figure 19: Prince Frederick Harbour events and causal factor chart

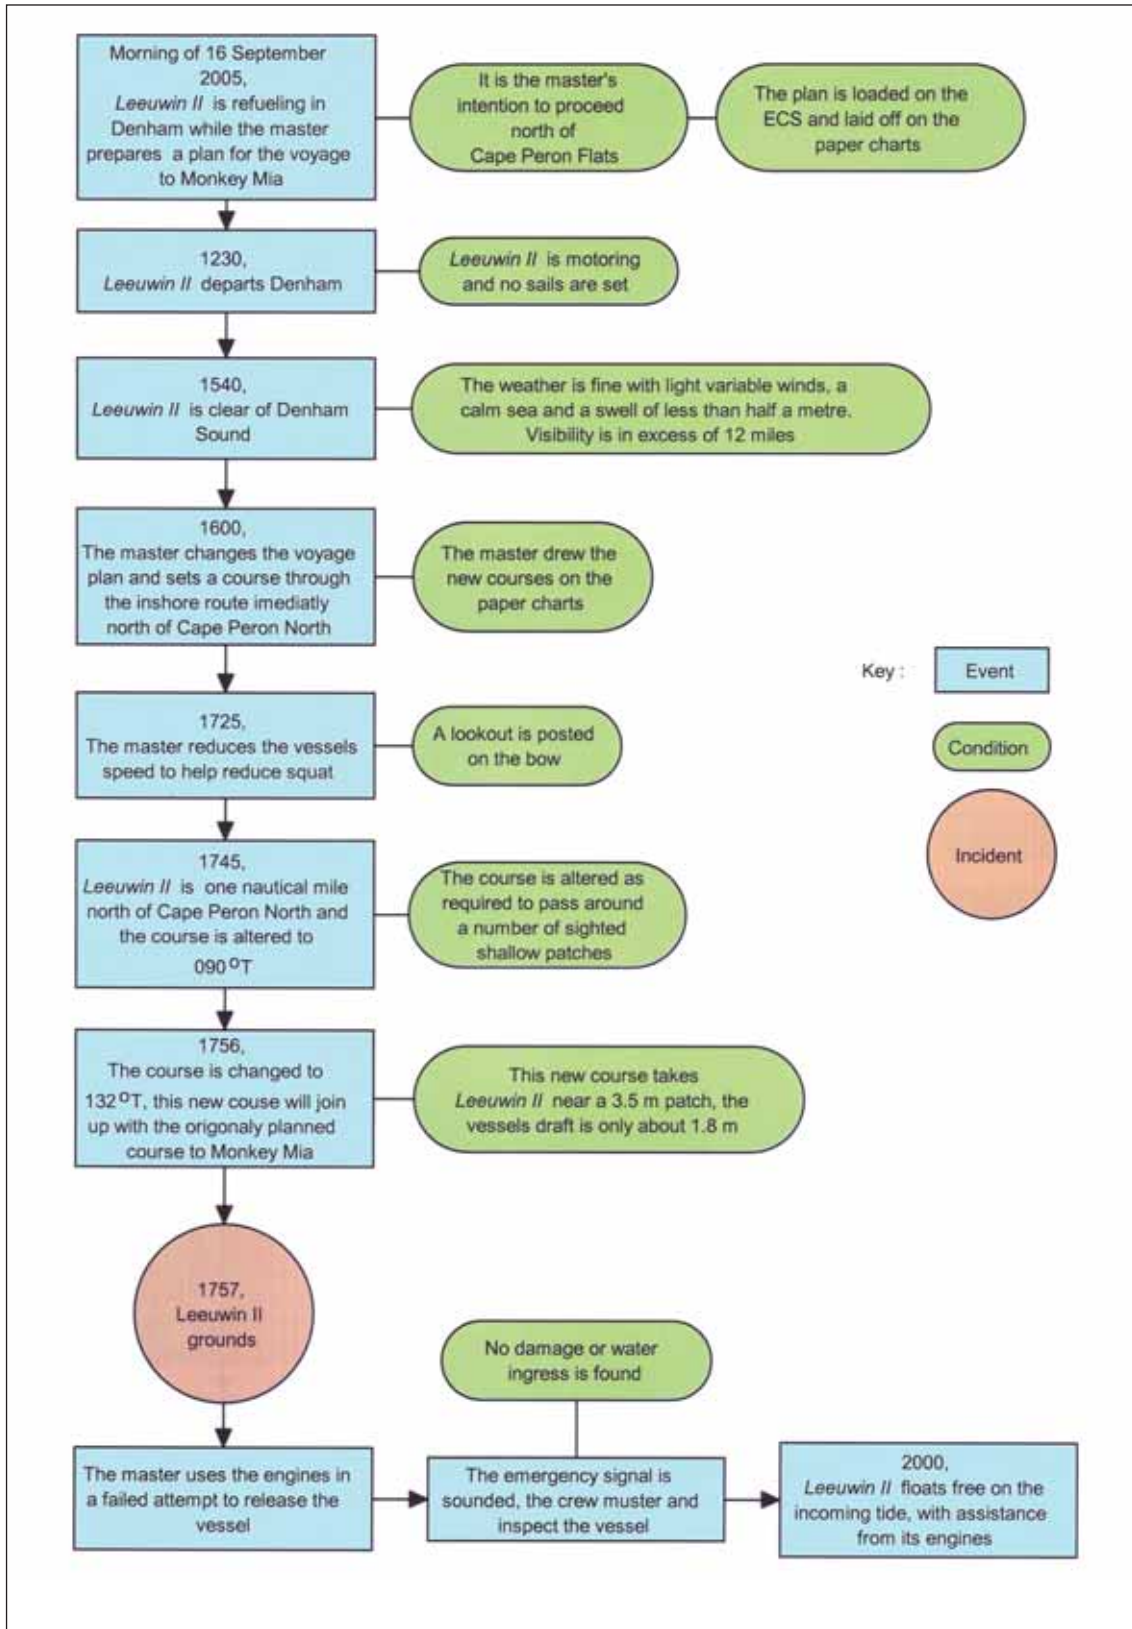
Figure 20: Shark Bay events and causal factor chart
