# Crew member burnt on board ship off Carnarvon, Western Australia

21 April 2005

## Crew member burnt in explosion while working on hydraulic pipeline on board *Hui Shun Hai*

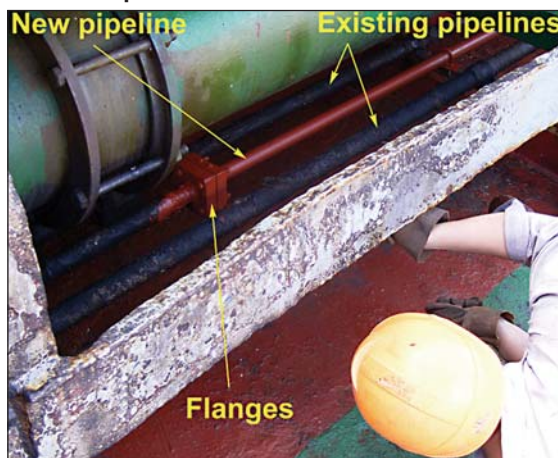
**Figure 2: Welder's position on the deck prior to the explosion**

In order to access the after flange on the section of pipe which was to be replaced, the welder had to lie on the deck, on his left side, and angle the oxygen-acetylene cutting head up behind another hydraulic pipe (Figure 2).

At 0842, while the welder was in the process of cutting off the third bolt joining the flanges, they separated and hydraulic oil in the pipe, under high pressure, escaped. This oil ignited when it came into contact with the oxygen-acetylene flame.

A fireball about seven metres in diameter enveloped the welder and the oxygen-acetylene bottles nearby.

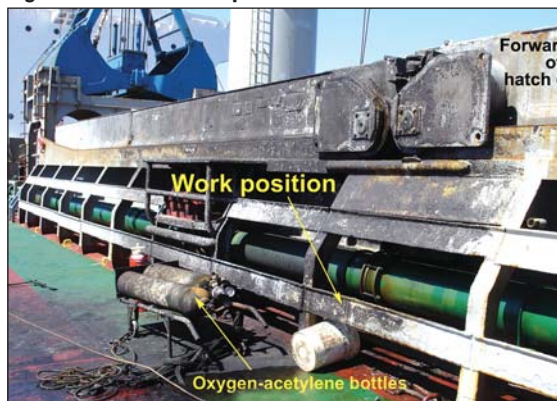
Figure 4: Location of explosion

The trolley on which the oxygen-acetylene bottles were mounted was located in very close proximity to where the welder was working on the flange nuts (figure 4).

While the oxygen-acetylene bottles did not explode, their proximity to the source of the explosion could have resulted in a significantly worse incident occurring.

It is also considered that the trolley carrying the oxygen-acetylene bottles was placed too close to the area of work.

Given the lengths of rubber hosing connecting the bottles to the cutting head, it may well have been prudent for the trolley and bottles to have been positioned well away from the area of work being undertaken. Had this been done, the risks associated with using these flammable gases would have been lessened.

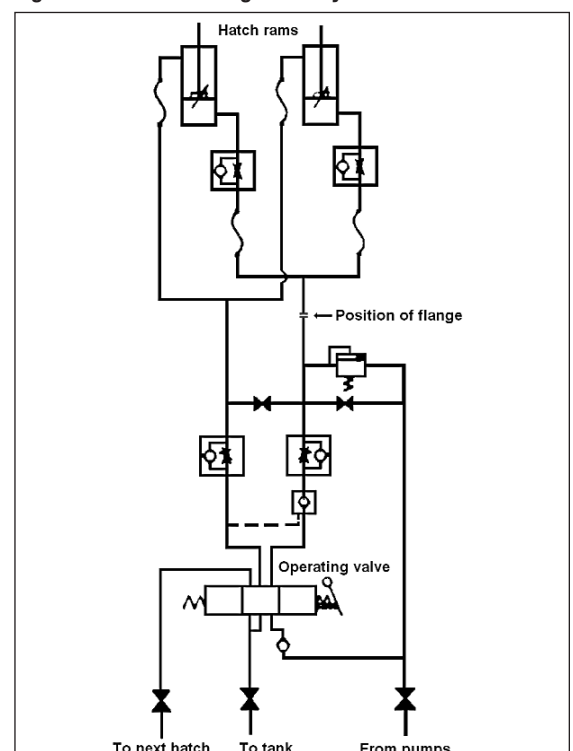
Figure 5: Schematic diagram of system

However, no-one involved in the work on number four hatch that morning had considered the pressure in the hydraulic circuit. This residual pressure was present due to the loaded state of the hatch cover actuating rams with the covers only partially open. The hydraulic rams were the only thing holding the covers in the half open position and resulted in oil pressure, due to the weight of the hatch covers, still being present in the supply side of the ram's pistons.

There was no securing device to enable the covers to be locked in the half open position (only in the fully open position), which would have allowed the pressure to be released from the hydraulic system. Had the covers been in either the fully open or closed position, the pressure in the hydraulic circuit could have been relieved, rendering the line safe to work on.

The break in the hydraulic pipe, which allowed the oil to escape, also released the pressure in the hydraulic rams supply line and the hatch covers slowly closed.

The fact that the ship's crew did not realise that the half open hatch cover would result in residual oil pressure in the hydraulic system was directly causal in this incident.

Ship's managers and masters should review their safety management systems and the associated permit to work arrangements, to ensure that hydraulic systems are correctly isolated and relieved of pressure before work on the system has commenced.
