Australian Transport Safety Bureau

# Aviation Safety Investigator

## V-belt failure contributes to helicopter accident

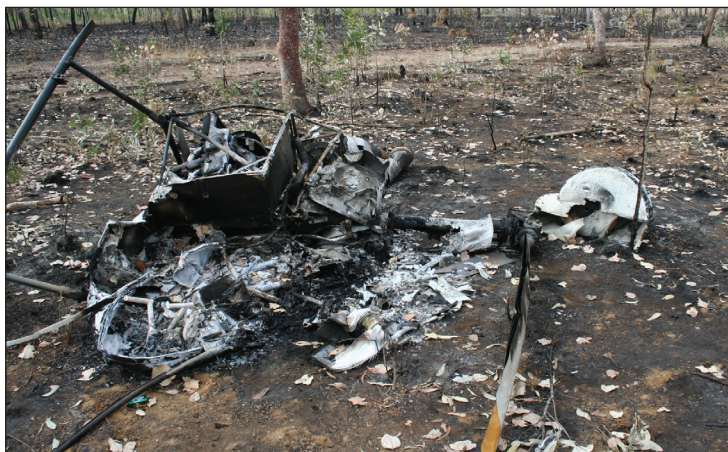
The investigation determined that the helicopter's main rotor system drive belts probably failed or were dislodged, resulting in a loss of drive to the rotor system that necessitated an autorotative landing over inhospitable terrain. The

helicopter manufacturer's maintenance documentation advised that a burning rubber smell may be indicative of impending V-belt failure as a result of belt or actuator bearing damage. Examination of the clutch actuator and sprag clutch bearings found no evidence of damage that would account for the reported smell. Therefore, V-belt damage was isolated as the likely source of the burning smell. That was consistent with the findings from a number of other Australian V-belt failure or dislodgement events. The pilot's decision to return the helicopter to the station without shutting down to visually inspect the V-belts probably contributed to the development of the accident. The investigation also identified a number of

safety factors relating to unsafe decision making. During the flight immediately preceding the accident flight, operation of the helicopter outside of the centre of gravity limits, and at a gross weight that exceeded the maximum allowable for the helicopter, increased the risk of controllability issues, component fatigue and V-belt damage.

As a result of this accident, and a number of other similar events that were identified during this investigation, the ATSB has

commenced a Safety Issue investigation to determine if there are any design, manufacture, maintenance or operational issues that increase the risk of a failure of the rotor system drive belt in the R22 helicopter.

V-belt failure or dislodgement was identified as a factor in a number of overseas and Australian R22 accidents. In response, the Civil Aviation Safety Authority issued airworthiness bulletin, AWB 63-006 *Issues related to the Robinson Helicopter Corporation (RHC) R22 main rotor drive system*. ■

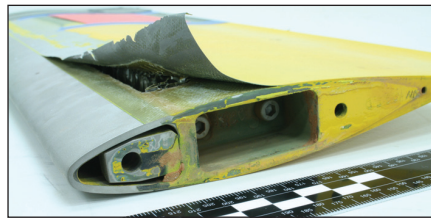
While conducting a survey flight at Ambalindum Station (approximately 135 km north-east of Alice Springs, NT), the pilot of a Robinson R22 Beta helicopter, registered VH-HZB, noticed severe vibration of the main rotor assembly and cyclic controls. The pilot landed the helicopter immediately, and a subsequent inspection revealed that a length of aerofoil skin had peeled back from the leading edge on the underside of one of the main rotor blades.

The main rotor blades were subsequently removed from the helicopter and the tips sent to the ATSB's Canberra laboratories for examination. Initial inspection revealed extensive erosion of the paint on the leading edge, and debonding of the stainless steel skin along the bond line on the underside of one of the main rotor blades. The debonding was considered to have been influenced by the extensive surface erosion observed.

A review of the current information surrounding Robinson helicopter blade debonds found a number of previous incidents involving a similar failure mechanism. Additionally, the issue of main rotor debond had been addressed by a number of airworthiness directives (ADs) issued by the Civil Aviation Safety Authority (CASA) and the Federal Aviation Authority, along with a number of safety alerts and service letters issued by the manufacturer.

The investigation also found no evidence to suggest that the actions contained within the current CASA Airworthiness Directive addressing blade debonding issues (AD/R22/54) had been integrated into the helicopter's maintenance routine. The logbooks and maintenance release documents for the helicopter have since been updated to include reference to AD/R22/54 Amdt 3. ■
