Outline of Incident

On the 2nd September 1986 at 0205 hours Eastern Standard Time the Malaysian general purpose Freedom type cargo vessel ALAM INDAH of 9094 gross tons, on passage from Penang, Malaysia, to Mackay, Australia, ran aground on Chapman Island Reef in position 12 degrees 53 minutes South 143 degrees 36 minutes East. The vessel was refloated, without assistance, at about 0527 hours Eastern Standard Time and, after an inspection for damage and seaworthiness by the ship's Officers, resumed passage to Mackay at 0606 hours Eastern Standard Time on the 2nd September 1986. There was no report of injury to any person nor of any pollution occurring as a result of the grounding.

ROUTE OF 'ALAM INDAH'

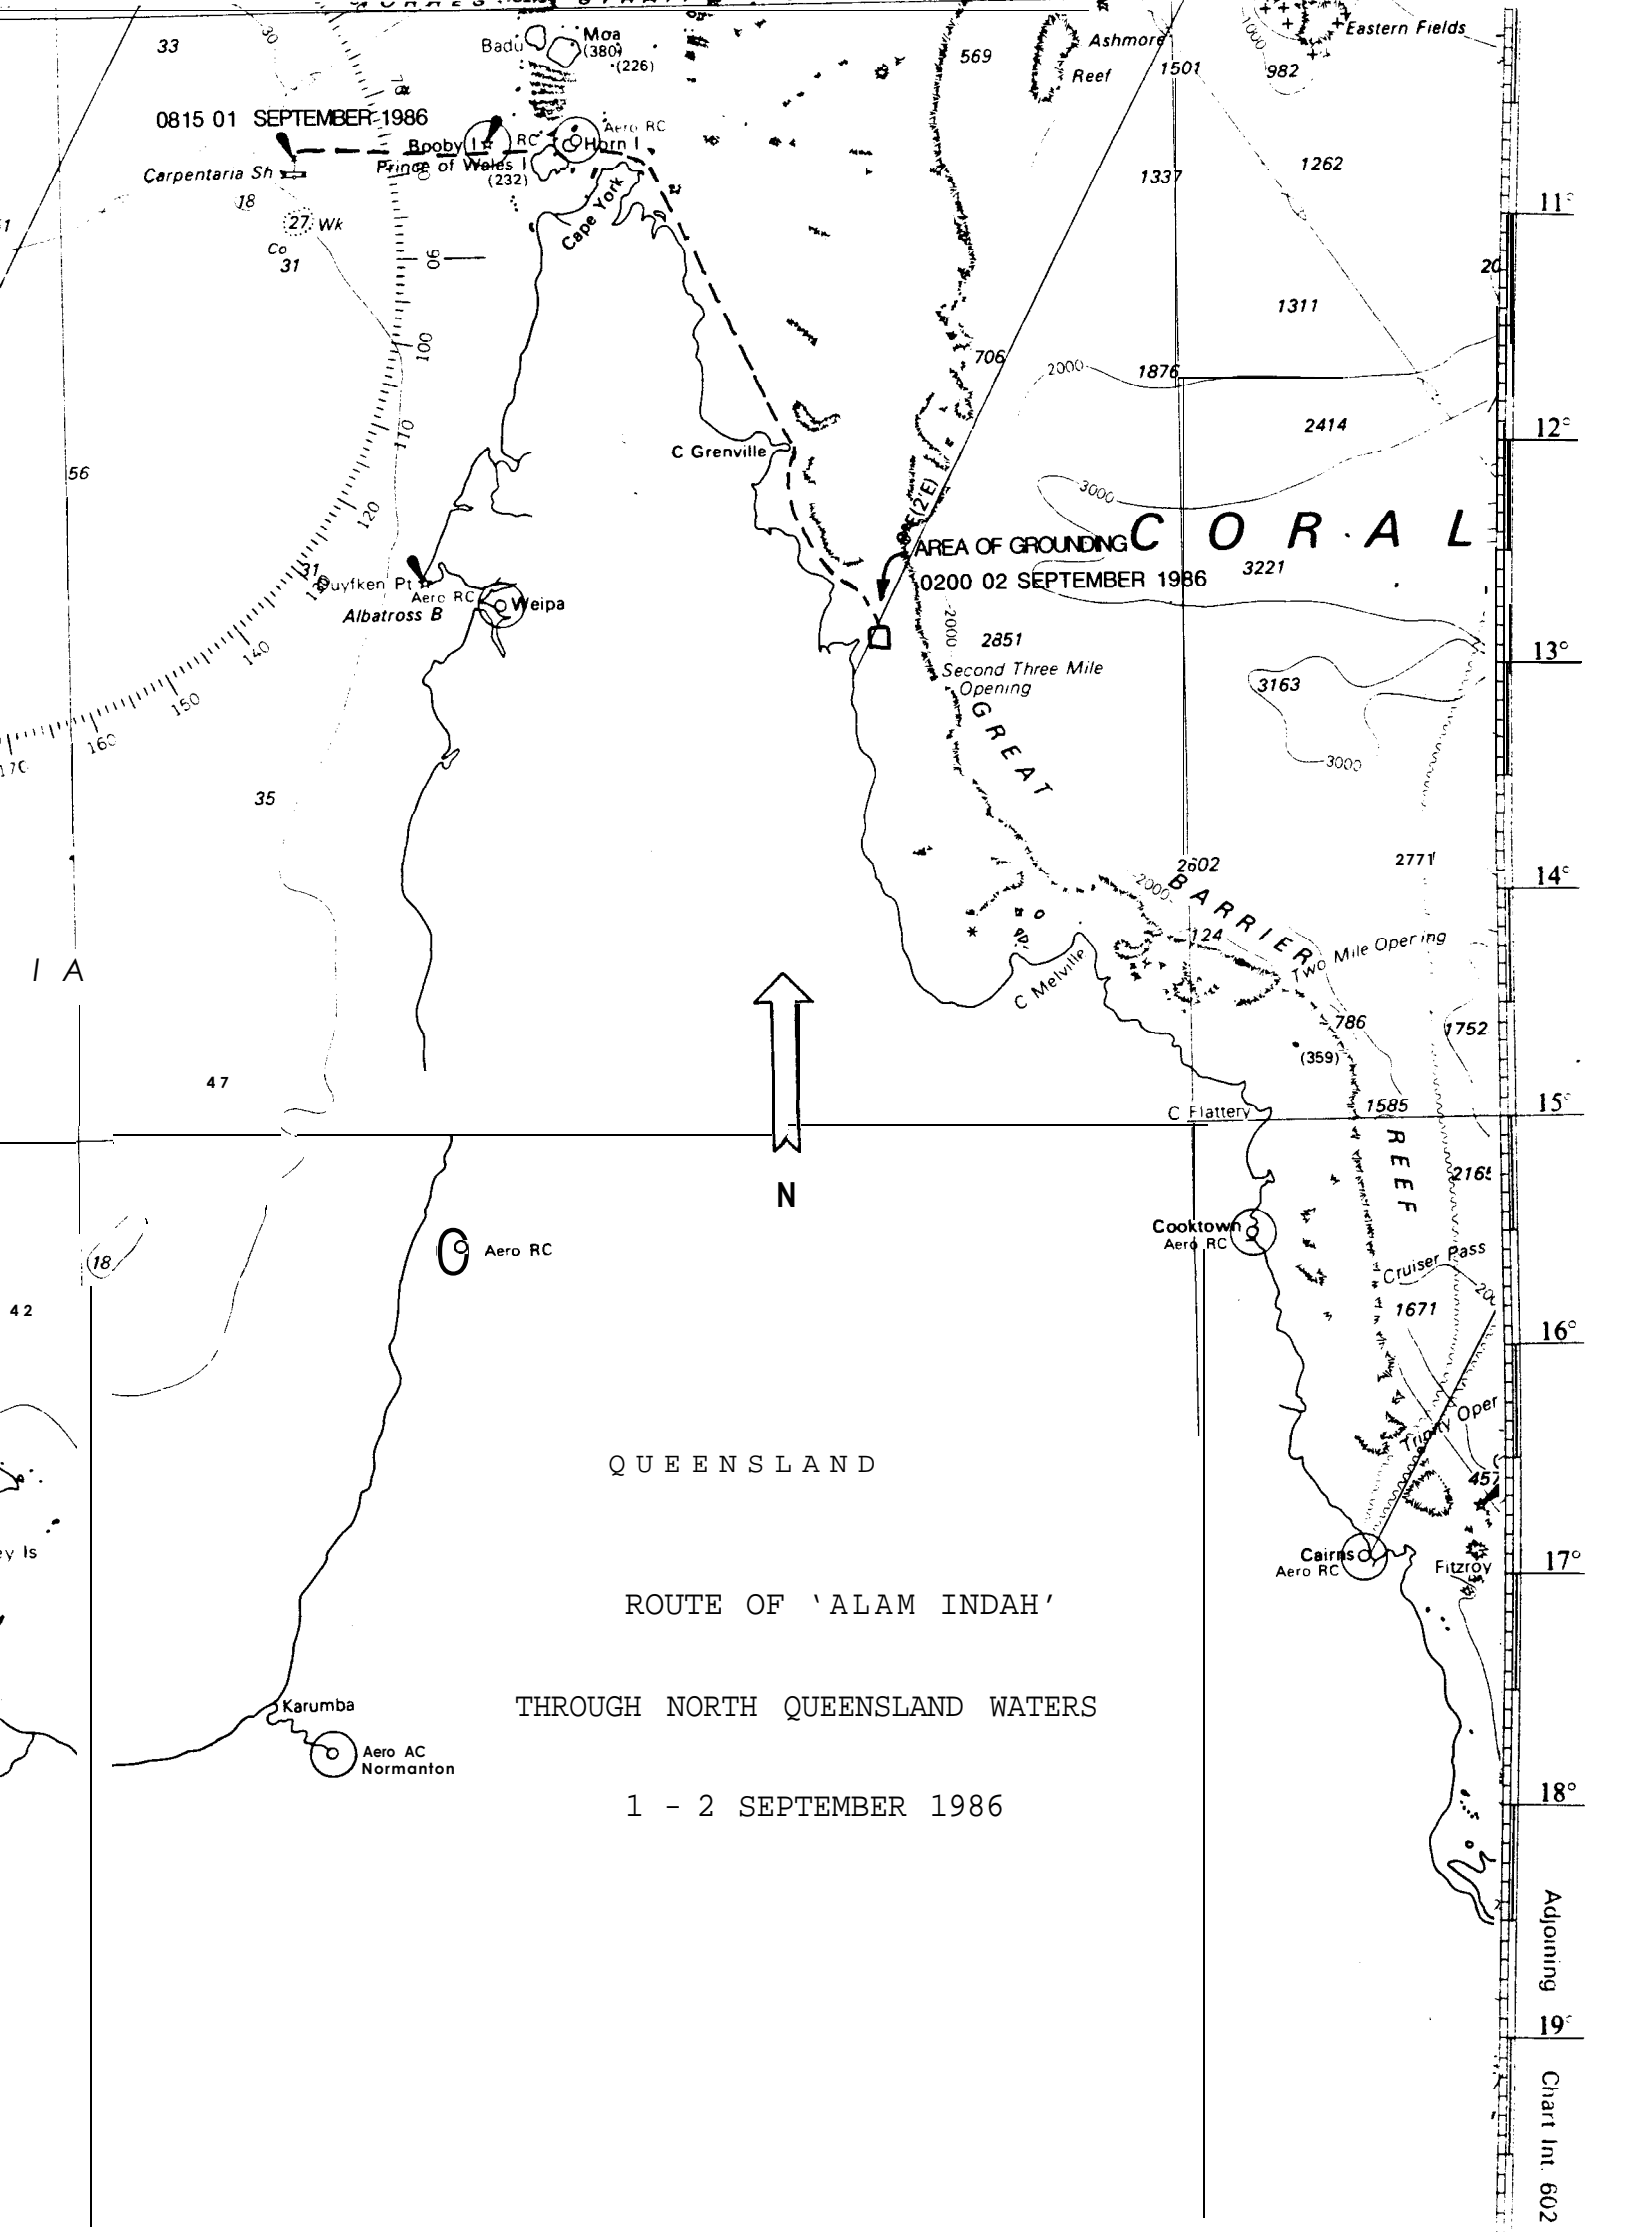
AREA OF GROUNDING

THROUGH NORTH QUEENSLAND WATERS

1 - 2 SEPTEMBER 1986

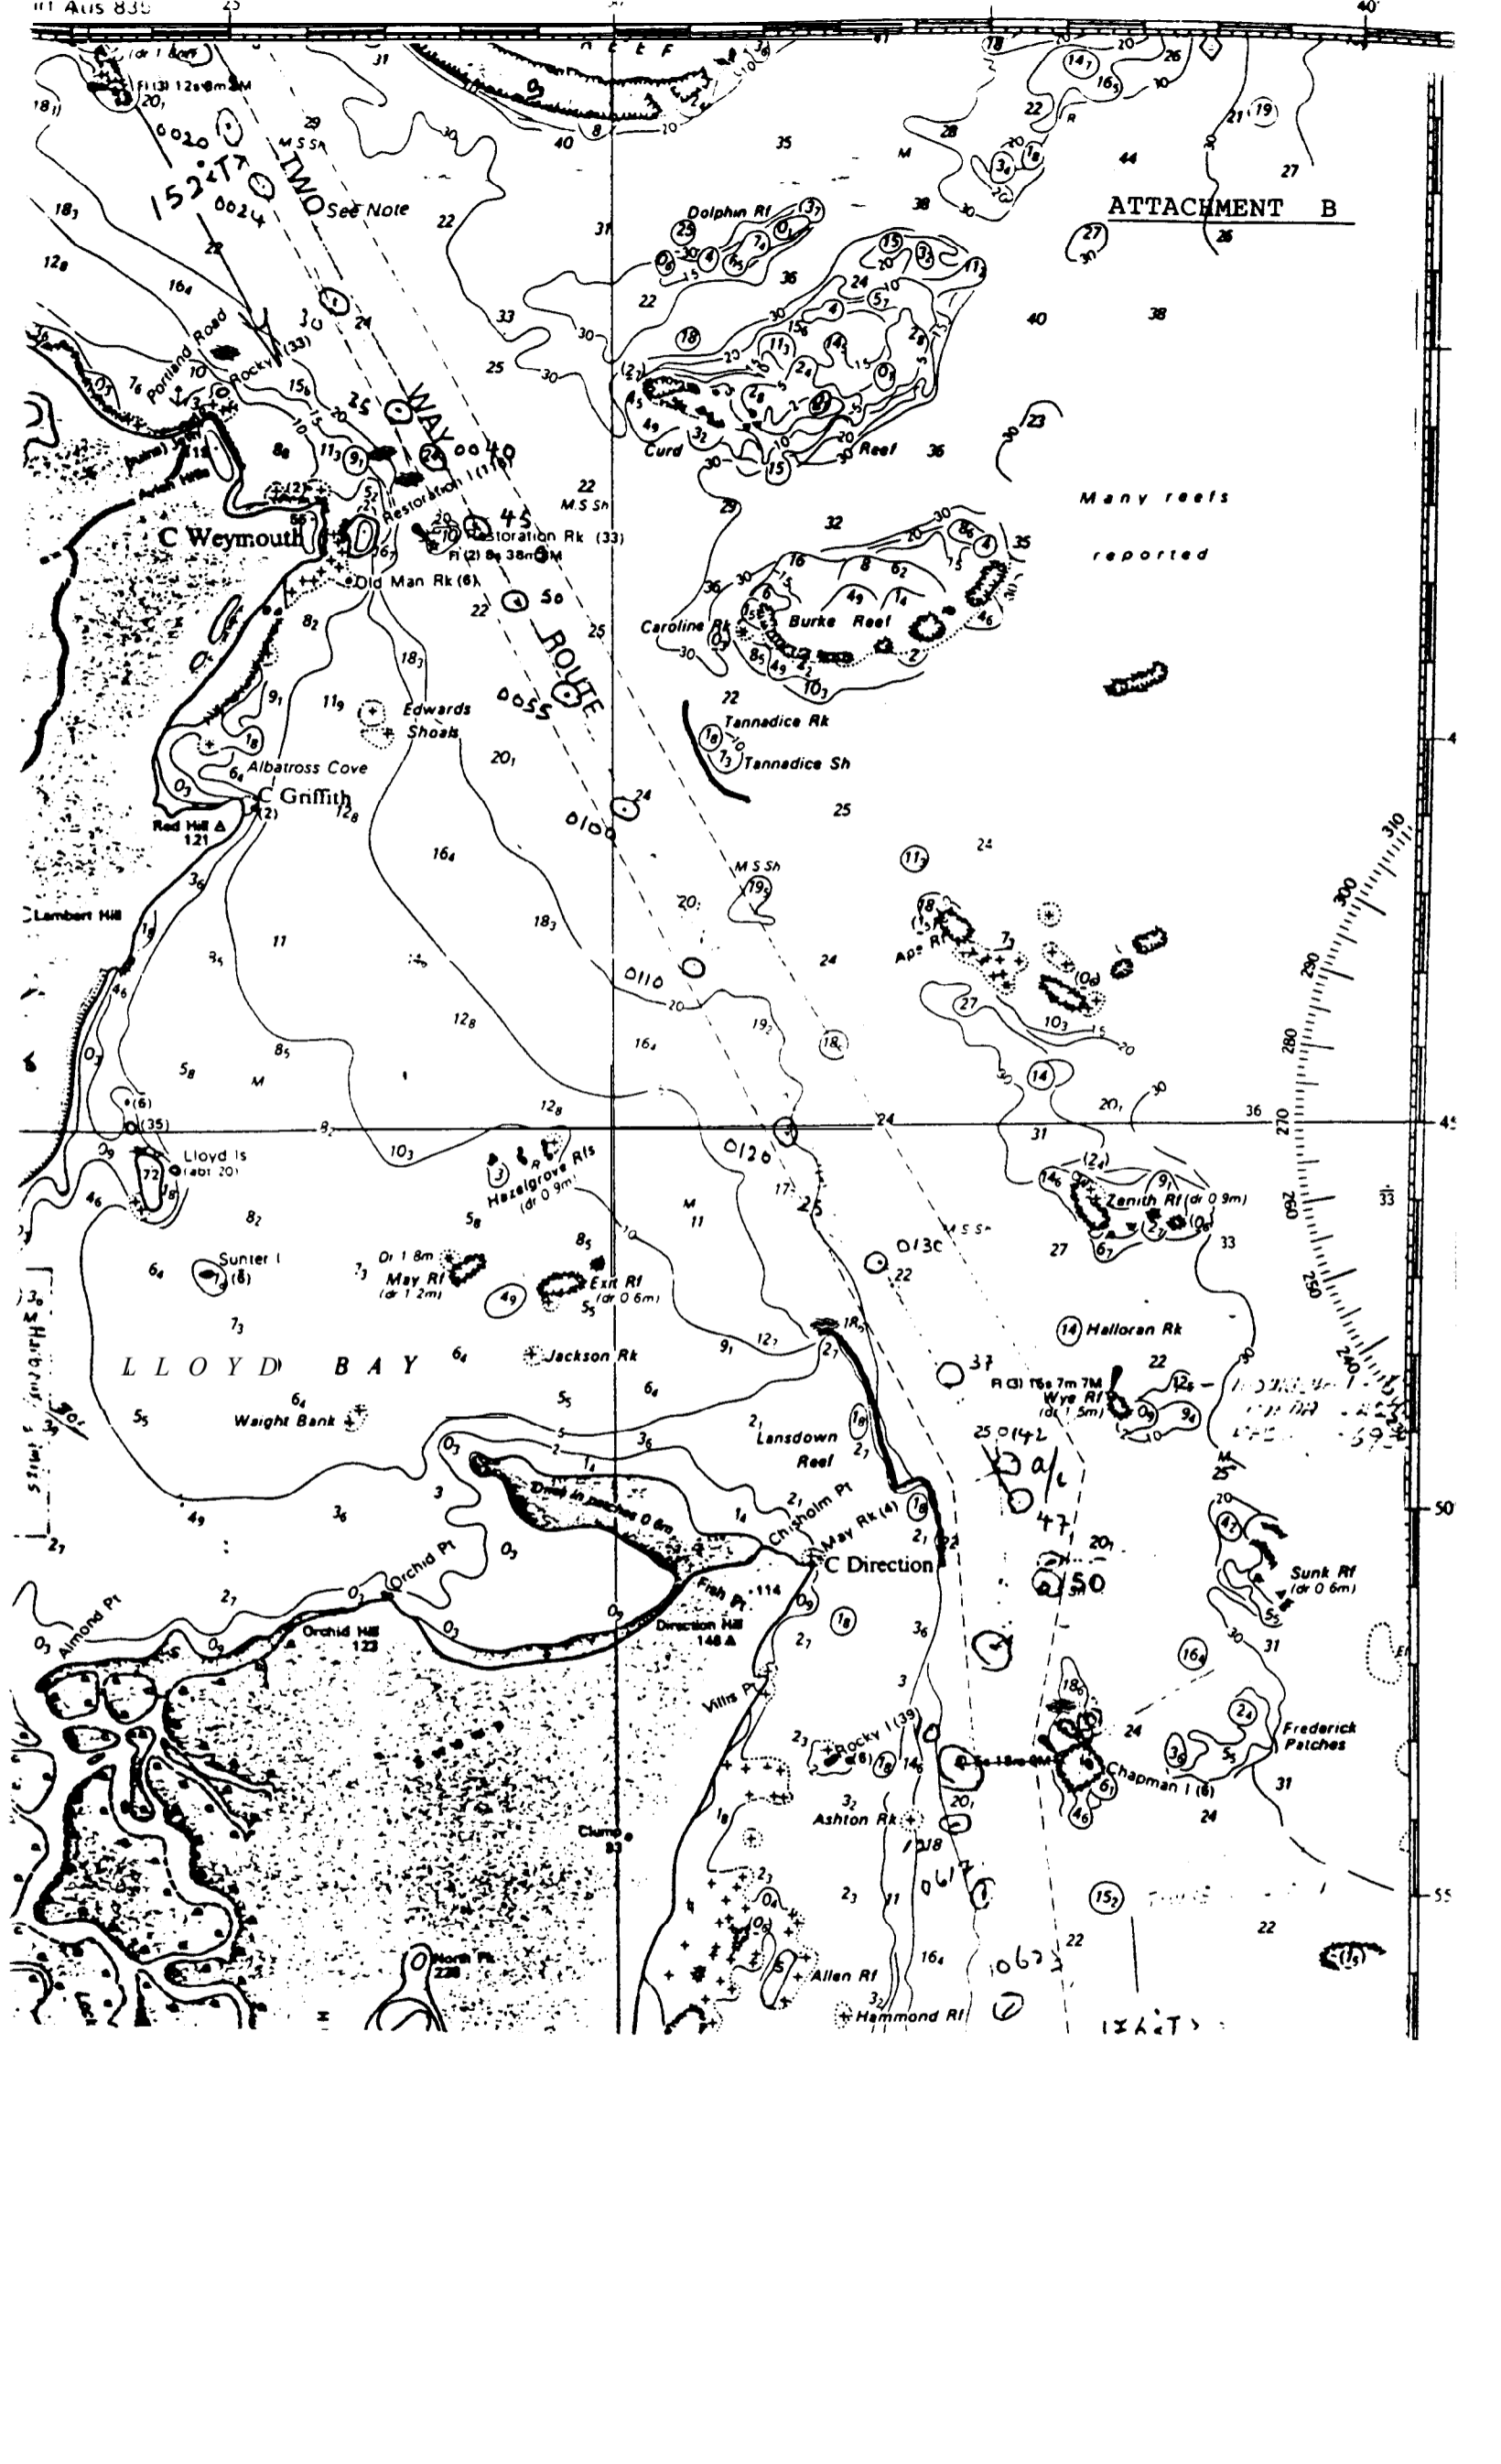
ATTACHMENT B

3. The distance from Wye Reef to the point of grounding is 3.4 miles. Allowing for the rudder movements described earlier in the report it is possible that the ship made good a speed of 8.87 knots between 0142 and the stated time of grounding at 0205. However it is probable that the

time of grounding was closer to 0200. The times given for the stated helm movements, and the relative heading of the ship at grounding are not consistent with the probable manoeuvring characteristics of such a vessel in ballast and trimmed 2.5 metres by the stern. The time stated by the Second Officer of 0203 for ordering starboard helm would be more consistent with the time of grounding, but not with the wheel being put 10 degrees to port at 0147 approximately.
