**Departmental investigation  
into the grounding of the  
bulk carrier  
TASSOS N  
off the port of Fremantle W.A.  
on 10 January 1997**

**Report No. 107**

Navigation Act 1912  
Navigation (Marine Casualty) Regulations investigation  
into the grounding of the bulk carrier  
**TASSOS N**  
off the port of Fremantle W.A.  
on 10 January 1997

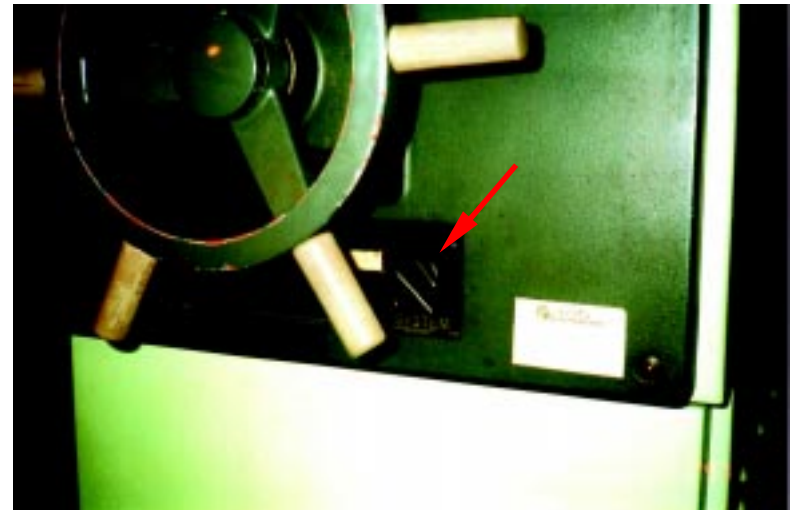
Front of steering console showing system change-over switch beneath wheel

Both the electrical telemotor system and servo-control systems are fully duplicated and either no.1 or no.2 system is selected by a manual change-over switch on the front of the bridge steering unit. (See photo page 4)

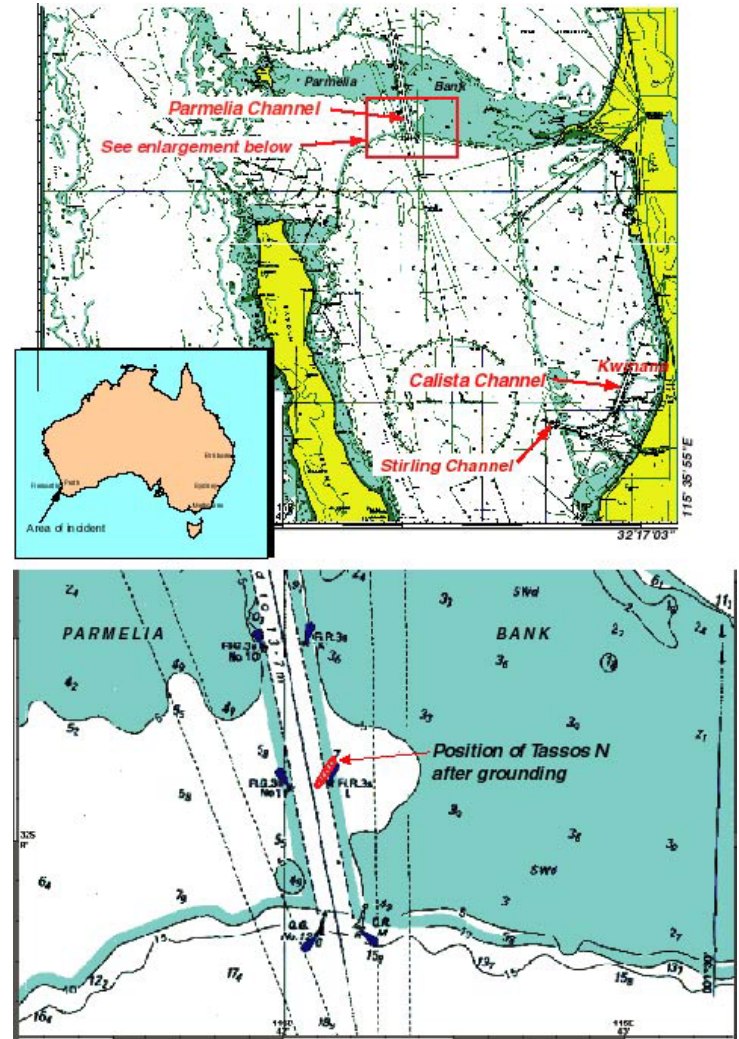
Portions of chart Aus 117 showing position of grounding of *Tassos N*

The anchor ran out to 7 shackles, leading on the port quarter. Shortly after, the vessel touched bottom at a speed of 8 to 9 knots and eventually grounded on a heading of 032° with 'L' beacon abeam and lying only 30 metres from the bridge.

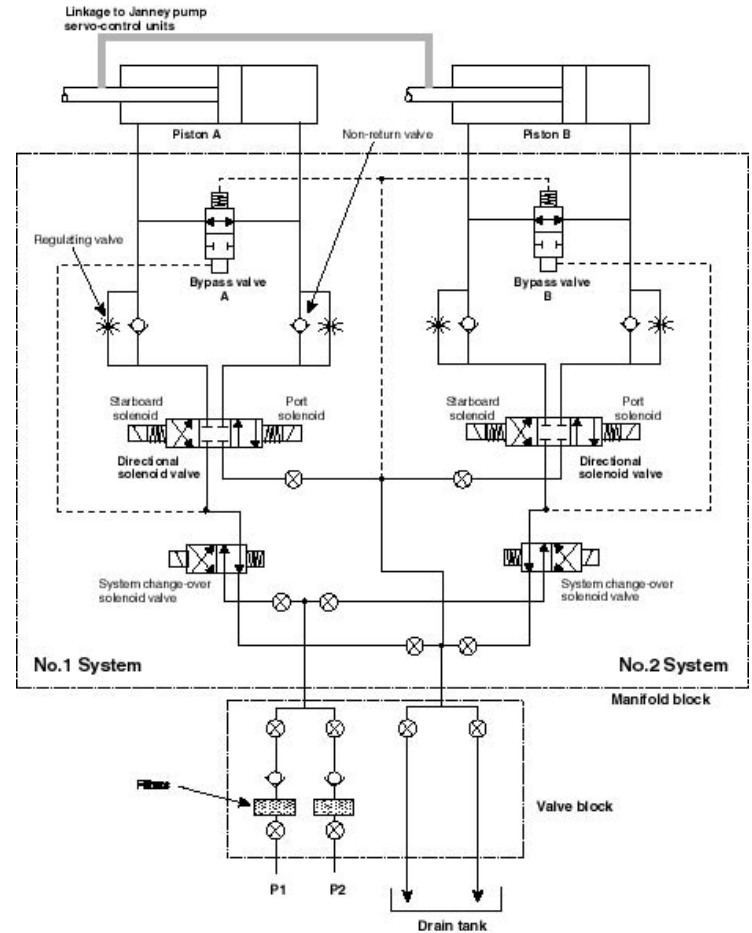
### M.V. TASSOS N

Schematic of steering telemotor servo-control hydraulic system

A diagram of the hydraulic circuit for the servo-controller power unit is shown on previous page. Servo oil pressure is provided by auxiliary hydraulic pumps driven off the main steering pump motors. When no oil pressure is being supplied by these pumps, both A and B oil paths are opened by the bypass valves A and B. These bypass valves close as soon as oil pressure, at about 10 kg/cm<sup>2</sup>, is introduced into the supply ports P1 or P2.

Assuming that No.1 system is selected on the bridge, No.1 change-over solenoid valve will open and oil will be admitted to No.1 directional flow-control solenoid valve. If a starboard steering signal is received from the bridge via the electrical telemotor system, the “starboard” solenoid of this valve will be energised and the ports will open allowing oil to flow through the non-return valve to the piston A, thus moving the actuating linkage and putting the Janney variable-delivery pumps on stroke and moving the rudder to starboard. The exhaust oil from the left side of piston A, meanwhile, passes through the regulating valve to the exhaust oil system and back to the hydraulic tank. The speed at which the rudder moves to starboard is normally controlled by adjustment of this exhaust oil regulating valve.

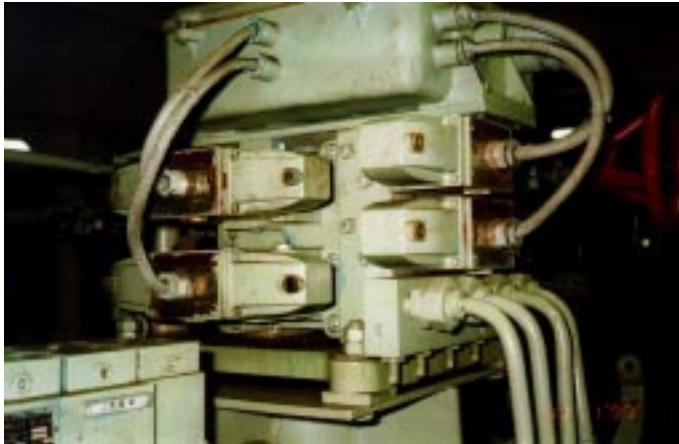
**Directional solenoid valves on Servo-control unit.  
No. 1 system "port" solenoid arrowed.**

Immediately after the grounding, the Chief Engineer engaged the emergency steering wheel in the steering flat and tested the operation of the steering gear from that position. Upon finding that it worked quite satisfactorily, attention was directed to the servo-control system. With further movements of the wheel on the bridge and number one telemotor and servo-system selected, it was found that the movement of the directional solenoid valve was slow and erratic in response to port helm movements, but satisfactory when starboard helm was applied, indicating a fault in this solenoid valve.

The solenoid valves are manufactured by Tokyo Kogyo (Osaka) and are labelled “Toyo-Okii” Model HO3 43 SGS BCA-03A. They are mounted directly on the power unit. (See photograph previous page)

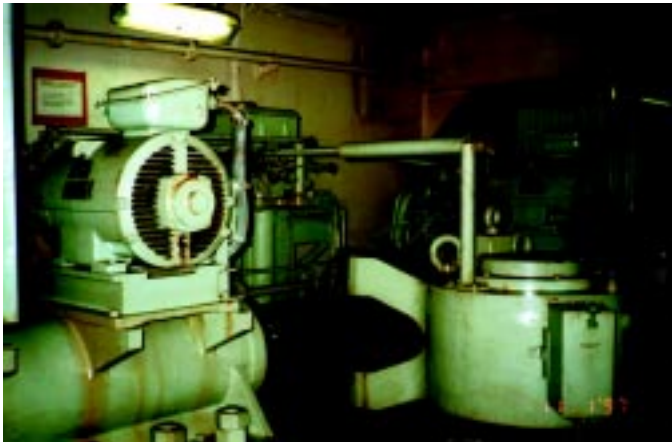
**Tassos N steering gear showing port hydraulic ram,  
rudder stock, port and starboard steering motors and  
servo-control unit (centre background).**

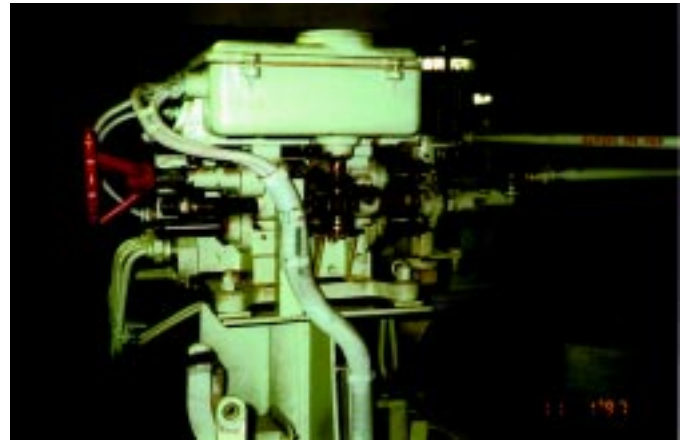
**Steering gear hydraulic servo-control unit type J2C  
PV006 showing emergency steering wheel**

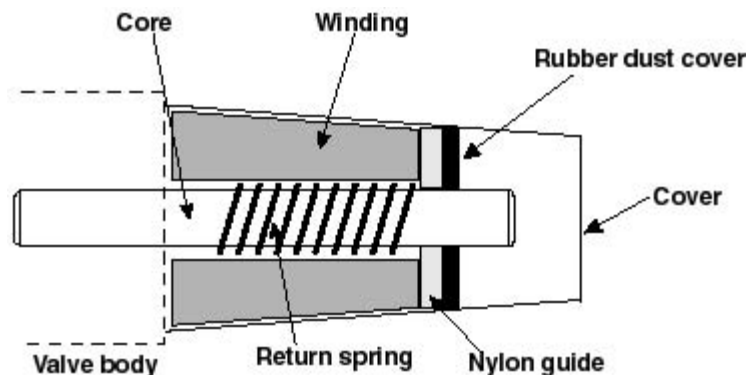
**Diagrammatic sketch of "port" actuating solenoid**

The “port” solenoid was opened up and examined. It was found that a rubber dust cover on the end of the solenoid core had perished and broken up. (See sketch above).

Some small pieces of the perished rubber had found their way into the space between the core and the solenoid return spring, hence preventing free movement of the core when power was applied to the “port” solenoid. The solenoid was cleaned and spare parts fitted. Later that morning, the steering gear was

1. *Tassos N* grounded as a direct result of the failure of the steering gear.
2. The steering gear failed following the perishing and breaking-up of the rubber dust seal within an actuating solenoid on the servo-control hydraulic power unit. As a consequence of this failure, small pieces of rubber jammed the movement of the solenoid causing the failure of No.1 steering system.

extensively tested to the satisfaction of the Bureau Veritas surveyor and was found to be operating satisfactorily.

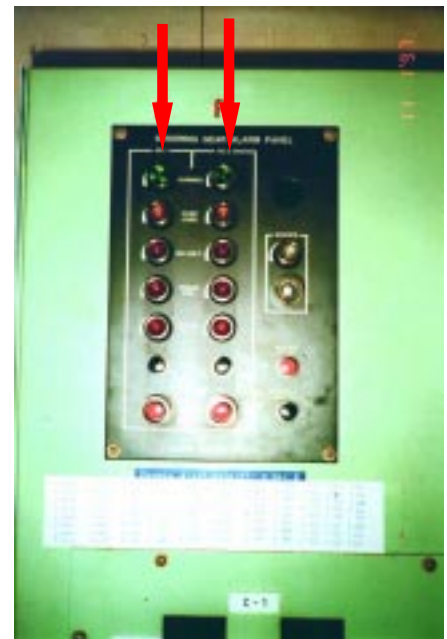
The steering system is fitted with running indication lights for the two motors and alarms which will indicate such things as electrical failure or automatic hydraulic system change-over as described previously. Failure of the telemotor system or the servo-control system, as occurred before the grounding, would not activate any of the steering alarms and, indeed, no alarm sounded. Immediately after the grounding, the Pilot observed that both of the green steering motor running indication lights were illuminated.

Bridge gear alarm panel showing green port and starboard steering motor indicator lights. (TOP)
