Australian Transport Safety Bureau

Aviation Safety Investigator

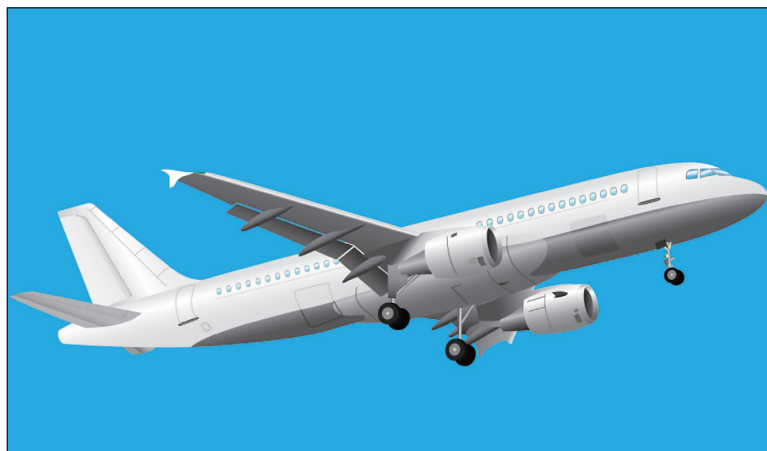
On 21 July 2007, an Airbus Industrie A320-232 aircraft, registered VH-VQT, was being operated by Jetstar on a scheduled international passenger service between Christchurch, New Zealand and Melbourne, Australia. Prior to their departure, the crew had been informed that weather conditions at Melbourne Airport meant that an instrument approach to the decision height for the approach was likely.

Upon reaching the decision height on the instrument approach into Melbourne, the crew did not have the prescribed visual reference to continue the approach to land and commenced a missed approach. During the initial part of the approach, the pilot in command had not correctly moved the thrust levers to the 'take-off/go-around' position and so the aircraft's automated flight mode did not transition correctly to the go-around phase. The crew, however, were unaware that the aircraft had not transitioned to the expected flight modes. The aircraft continued to descend towards the runway, reaching a minimum recorded height of 38 ft above the runway before it responded to manual flight crew inputs and began to climb away. After a second missed approach, which was completed within expected parameters, the aircraft was diverted to Avalon Airport, where it landed uneventfully.

The aircraft manufacturer had published its go-around procedure with the requirement to check and announce the aircraft's flight mode as part of the initial actions of the go-around. That requirement was included to ensure that the crew could confirm the necessary changes to the aircraft's flight mode.

The aircraft operator, however, had changed the go-around procedure and

moved the positive confirmation of flight mode to a much later position in the procedure. The changed procedure required that a call be made after a positive rate of climb was obtained. In this instance, due to the aircraft continuing to descend, with the crew distracted by unexpected warnings and a subsequent increased workload, this call could not be made by the flight crew, and so the standard operating procedure in support of the go-around effectively paused at that point. As a result, the crew never obtained positive confirmation of the aircraft's flight mode.

The operator had not conducted a risk analysis of the change to the procedure.

As a result of this occurrence, the aircraft operator changed its go-around procedure to reflect that of the aircraft manufacturer. It also

changed its SMS to require a formal risk management process in support of any proposal to change an aircraft operating procedure. The operator is in the process of reviewing its flight training requirements, has invoked a number of changes to its document control procedures, and has revised the incident reporting requirements of its SMS.

In addition, the aircraft manufacturer has enhanced its published go-around procedures to emphasise the critical nature of the flight crew actions during a go-around. ■

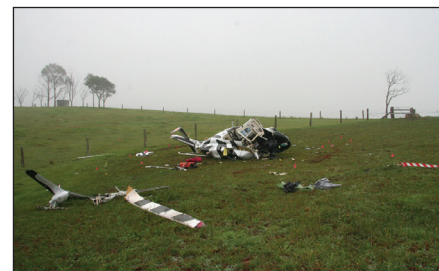
ATSB Investigation AO-2009-077

The pilot later stated that, shortly after takeoff, at approximately 1120 Eastern Daylight-saving Time, while the helicopter was in a high hover, he looked inside the cockpit at his instruments for a few seconds. When the pilot looked outside again, the helicopter was in what he described as 'white out conditions'. The pilot experienced a complete loss of visual orientation with the surroundings due to the helicopter being enveloped by cloud. The pilot attempted to maintain a neutral hover in the expectation of regaining adequate visibility to land, however, the helicopter was inadvertently moving to the north at a slow speed. The pilot stated that he then saw trees and a spur line through the cloud and that the helicopter appeared to be in a sideways crab motion to the left. With limited visual reference, the pilot attempted to land, however, the helicopter impacted the ground with significant vertical force and came to rest on its right side. As a result, the pilot was seriously injured and the passenger was fatally injured. The helicopter was seriously damaged.

The duration of the flight, not including start up and static hover, was approximately 1 minute and 20 seconds. During that time, the helicopter travelled a distance of approximately 550 m.

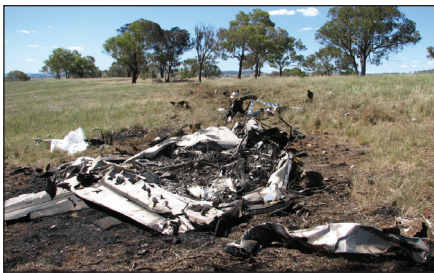
ATSB Investigation AO-2008-076

After refuelling at Bathurst Airport, the pilot departed for Port Macquarie in dark-night conditions with light rain in the area. About 2 minutes and 30 seconds after the pilot reported he was airborne, residents of Forest Grove to the north of Bathurst Airport heard a sudden loud noise from an aircraft at low altitude. Shortly after, there was the sound of an explosion and the glow of fire. The aircraft was found to have impacted terrain, resulting in serious damage to the aircraft. The four occupants were fatally injured.

The aircraft descended at a steep angle before impacting the ground at high speed, consistent with uncontrolled flight into terrain. Due to fire and impact damage, and limited information about the sequence of events after take-off, the evidence available to the investigation was limited.

Based on analysis of the available information, an airworthiness issue was considered unlikely to be a contributing factor to this accident. The investigation was unable to establish why the aircraft collided with terrain; however, pilot spatial disorientation or pilot incapacitation could not be discounted.

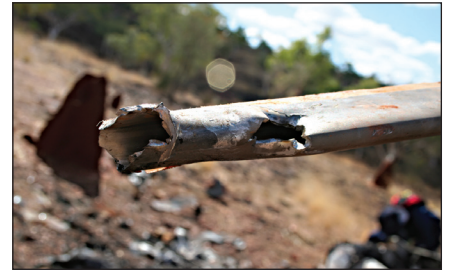
ATSB Investigation AO-2009-018

On 5 May 2009, two Robinson Helicopter Company R22 Beta II helicopters, registered VH-PHT and VH-HCB collided midair about 15 km south-east of Springvale Station, WA. Both helicopters had departed the station just prior to sunrise to conduct mustering operations.

The helicopters were due to refuel at about 0830 at a place to be arranged, depending on the progress of the mustering operation. When the pilots failed to respond to radio calls from ground personnel, a search helicopter departed a nearby station and noticed a fire while en route to Springvale Station. On arrival overhead the fire, the pilot was able to identify the remains of the two helicopters and observed that the respective pilots appeared to have sustained fatal injuries. Both helicopters were seriously damaged as a result of impact forces associated with the midair collision, the impact with terrain and post-impact fires. The wreckage was scattered over an area of about 260 m by 100 m.

The circumstances of the accident were consistent with a midair collision while the pilots were positioning to commence the muster. The converging flight paths of the helicopters, pilot fatigue and sun glare from the rising sun are identified as contributing safety factors.
