**Departmental investigation
into the grounding of the Danish flag ship
SVENDBORG GUARDIAN
south of Murdering Point,
Queensland on 24 June 1995**

Report No. 82

Australia
Department of Workplace Relations
and Small Business

Published: December 1995

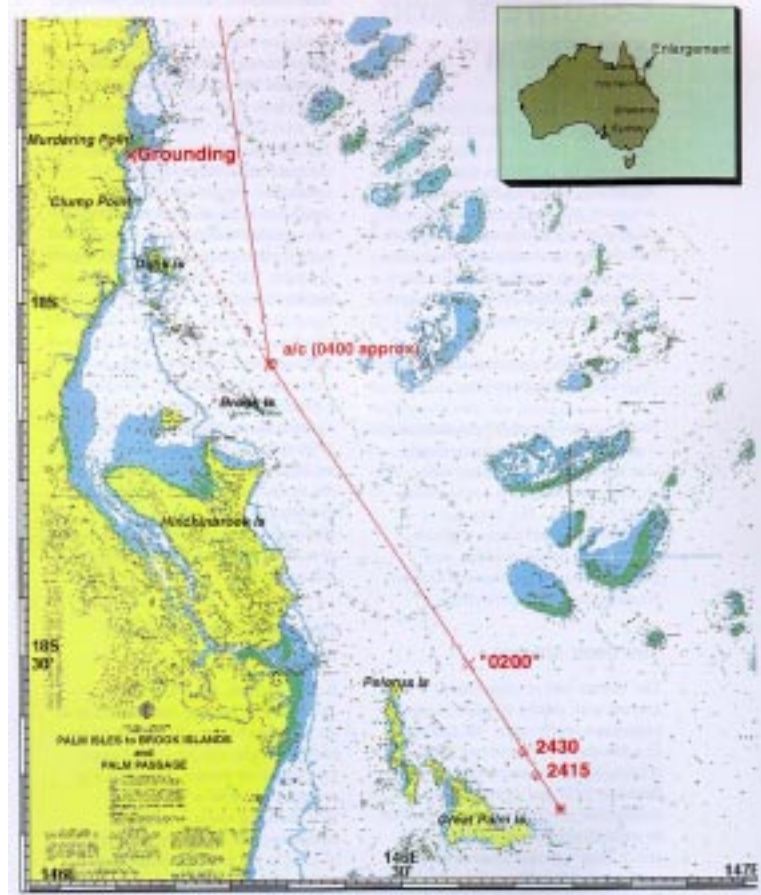
Projected and actual courses followed

The ship, on automatic pilot, continued with nobody on the bridge. The chart was clearly marked with an alteration of course position off Brook Islands, at 18° 05'S 146° 18'E, a position it was anticipated should have been reached at about 0400. With nobody on the bridge, the ship maintained a steady course until it grounded at about 0600.
