# Derailment of train 5PS6 near Golden Ridge Western Australia

30 January 2009

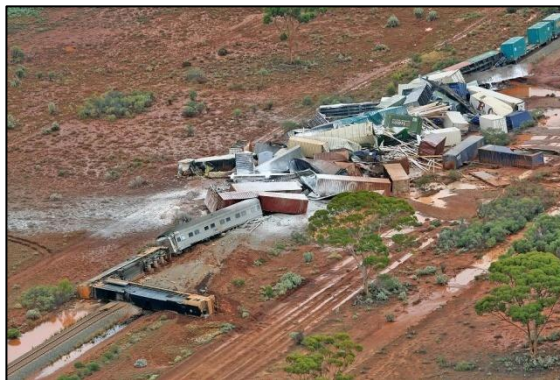
**Figure 2: Aerial view of derailment site**

The second locomotive had rolled onto its side but remained parallel to the track. The crew van derailed but remained upright and parallel to the track. The following 18 wagons (including 7 multiple platform freight wagons) derailed in a tangled pile (Figure 2).

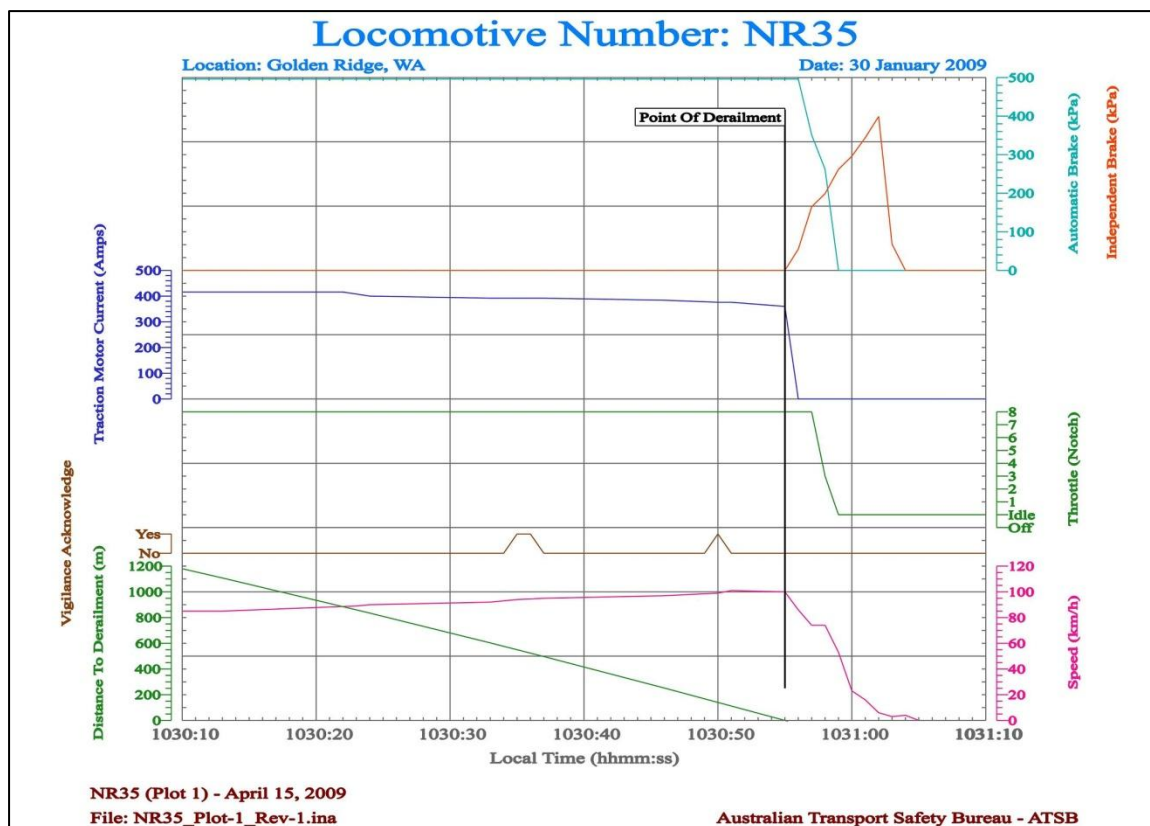
Figure 3: Extract from locomotive NR35 data log

An examination of the locomotive data log for NR35 confirmed that the driver conducted a running brake test after departure from Parkeston. In the 60 seconds before the derailment, the data log showed that the train had accelerated from 90 km/h to 101 km/h under full power. At the point of derailment, the train was travelling at 101 km/h (Figure 3). The data log also indicated that the vigilance control was operated 5 seconds prior to the derailment and that no braking occurred before the derailment. The derailment started at the head-end of the train.

Evidence from the data log supports the drivers' statements concerning their actions and the sequence of events leading up to the derailment in that there was nothing unusual about the journey prior to the derailment. Site observations confirmed that track washaway damage was unlikely to have been visible to the drivers as they approached the derailment site.

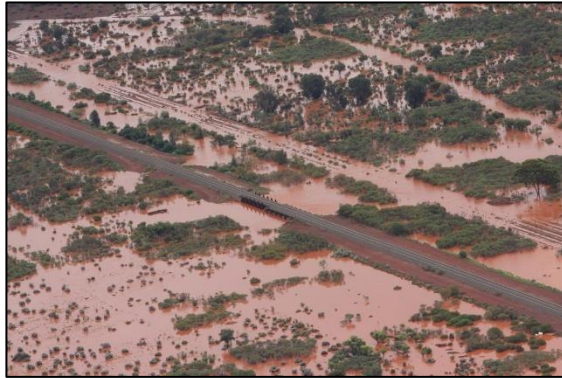
**Figure 4: Extensive flooding observed 6.85 km before the derailment site**

The track leading into the derailment site was intact with no evidence of track degradation through washaway. The first evidence of any track washaway was at the culvert where the train derailed. This supports the train drivers' accounts that, although they were looking forward, they did not see the washaway and were not aware of it even as the train derailed. The photograph at Figure 4 provides some indication of the magnitude of flooding that was visible to the drivers of 5PS6 as they travelled towards the derailment site. The two drivers stated that they were debating the need to report their observations to train control at the time of the derailment. Figure 4 was taken at the 1745.600 km point (6.85 km before the derailment site) at about 1423, some 4 hours after the derailment.

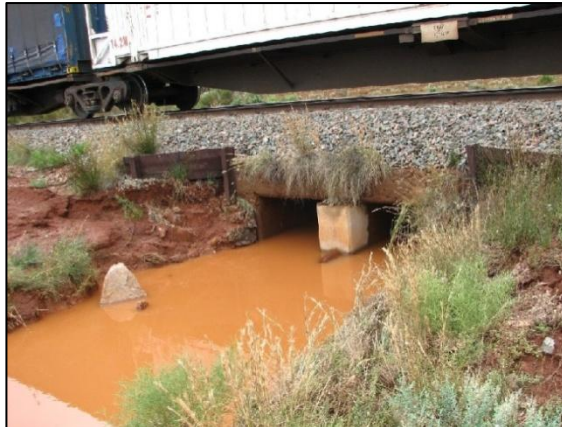
**Figure 5: Culvert 110 m before the derailment site**

The culvert at the 1738.860 km point (Figure 5), 110 m before the derailment site, was found to be in good condition with little evidence of blockage or debris build-up at the culvert inlet/outlet.

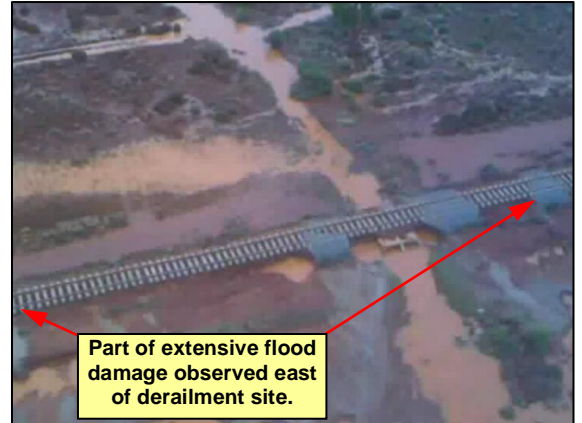
**Figure 6: Flood damage to track east of derailment site**

Track to the east of the derailment site had been visibly overtopped by significant floodwaters and had lost both ballast and capping layer materials for considerable distances. The photograph at Figure 6 is representative of damage to the track over a 12 km distance east of the derailment site.

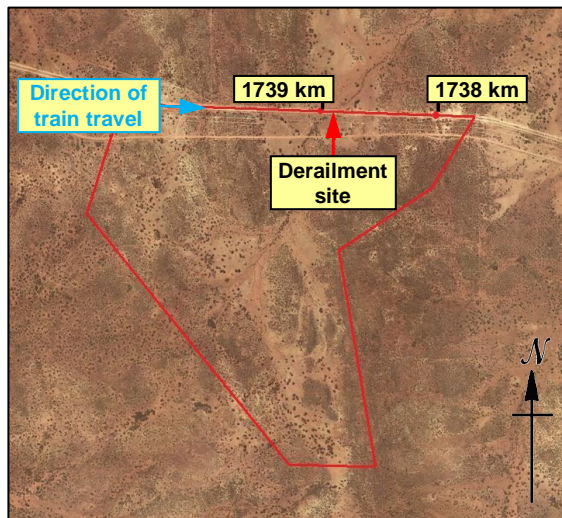
**Figure 7: Catchment area**

An examination of topographic information supplied by Landgate Western Australia<sup>5</sup> for the area drained by culverts at the derailment site, established that the effective catchment area was approximately 600 hectares (Figure 7).

If the water inflow from the catchment area exceeds the culvert capacity during periods of very heavy rainfall/runoff, the excess water will back-up behind the rail embankment and then flow through the ballast and over the track at its lowest point.

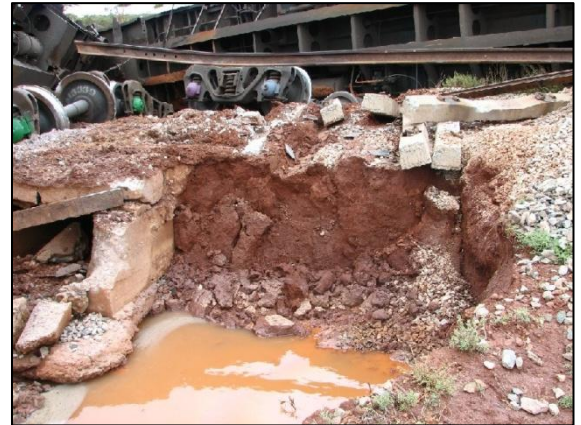
**Figure 8: Culvert at derailment site**

This overflow would remove the ballast, and eventually the embankment, due to the hydraulic pressure of the moving water. Observations near Golden Ridge confirmed that water had flowed over the embankment for significant distances and washed away the ballast and parts of the embankment itself. Figure 8 shows the embankment at the derailment site.

The flood runoff resulted from extreme rainfall falling on a wet catchment over a three hour period. In the absence of recorded data it is impossible to assign a definite average recurrence interval (ARI) to the rainfall, but the limited available evidence suggests that the rainfall could have had an ARI of between 50 and 100 years.

The overall culvert flow capacity was estimated to be 28 m<sup>3</sup>/sec<sup>8</sup> and therefore the culverts at the site of the derailment appear to comply with the requirements of the ARTC CoP (ETG-10-01).

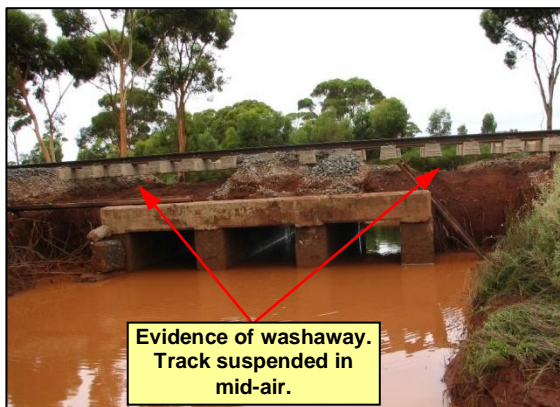
**Figure 9: Culvert at 1736.500 km.**

Figure 9 shows a similar culvert (1736.500 km) within the flood affected area exhibiting extensive damage to the ballast and track formation.

In conclusion, the ARTC CoP does not specify hydrological design parameters, including the height of water ponding against the formation layer, and this could lead to under specified track drainage arrangements and an increased risk of track damage arising from flash flood events. However, the precipitation event near Golden Ridge well exceeded the requirements of a 1 in 50 year peak flow rate specified in the ARTC CoP.

It is considered that a review of culvert capacity is desirable and should include consideration of the adequacy of the existing standard, the risk to current/future rail traffic loadings/types<sup>10</sup>, available rainfall data, potential changes in climatic conditions<sup>11</sup> and the history of any flood damage to the line which could indicate that remedial action is required in a particular area.
