ATSB TRANSPORT SAFETY INVESTIGATION REPORT
Rail Occurrence Investigation No. 2005/002
Final

Derailment of
Pacific National Train 6MP4
Koolyanobbing, Western Australia
and
Pacific National Train 6SP5
Booraan, Western Australia

30 January 2005

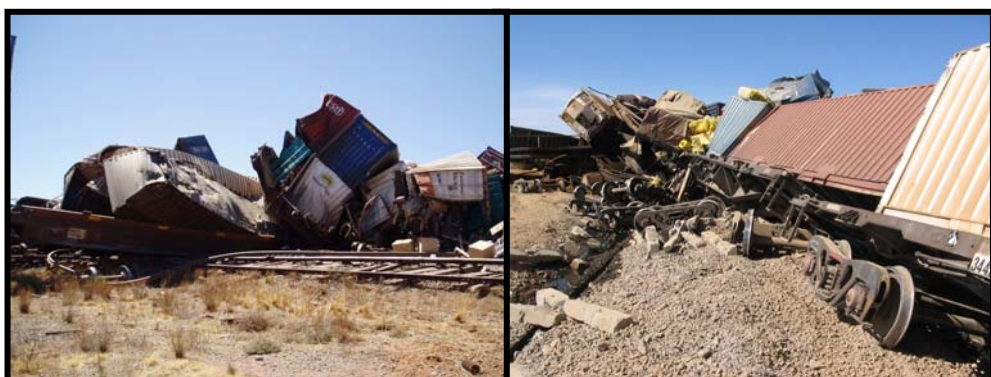
A total of 23 wagons were derailed (four of which were 5-unit wagons), with the majority of derailed rollingstock and damaged civil infrastructure extending over a 205 metres section of track. Derailed rollingstock also extended over a rural road level crossing, considerably increasing the risk of injury, especially considering the road provided access to local mining operations.

A total of 19 platforms and wagons were derailed (four of which were 5-unit wagons), with the majority of derailed rollingstock and damaged civil infrastructure extending over approximately 175 metres.

Figure 1: Derailed wagons at Koolyanobbing (left) and Booraan (right)

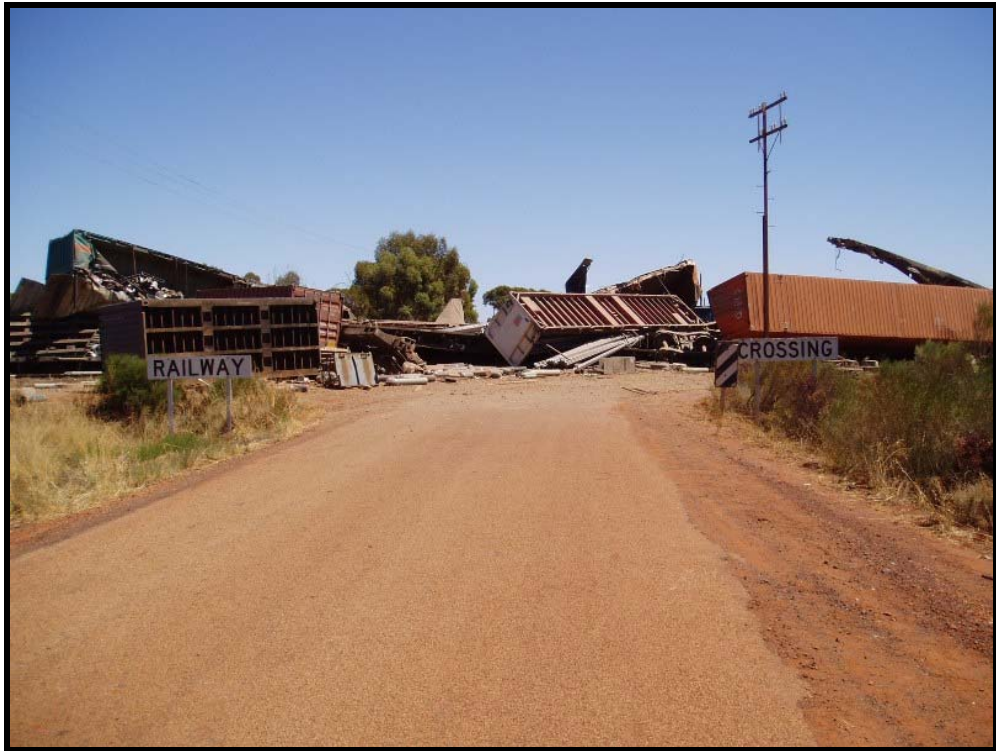
While no person was seriously injured had the locomotives derailed, the risk of injury to the locomotive drivers would have increased. It should also be recognised that both derailments occurred in the vicinity of rural road level crossings. Had road vehicles been at the level crossing at the time of the derailment, the risk of serious or fatal injury would have increased significantly.

Figure 3: View of the level crossing at Koolyanobbing

At Koolyanobbing, 290 metres of standard gauge track, the turnout and the catch points at the siding required replacement. The road level crossing across three tracks required rebuilding with the replacement of three trackside signals, two flashing light assemblies and the associated trackside equipment enclosure.

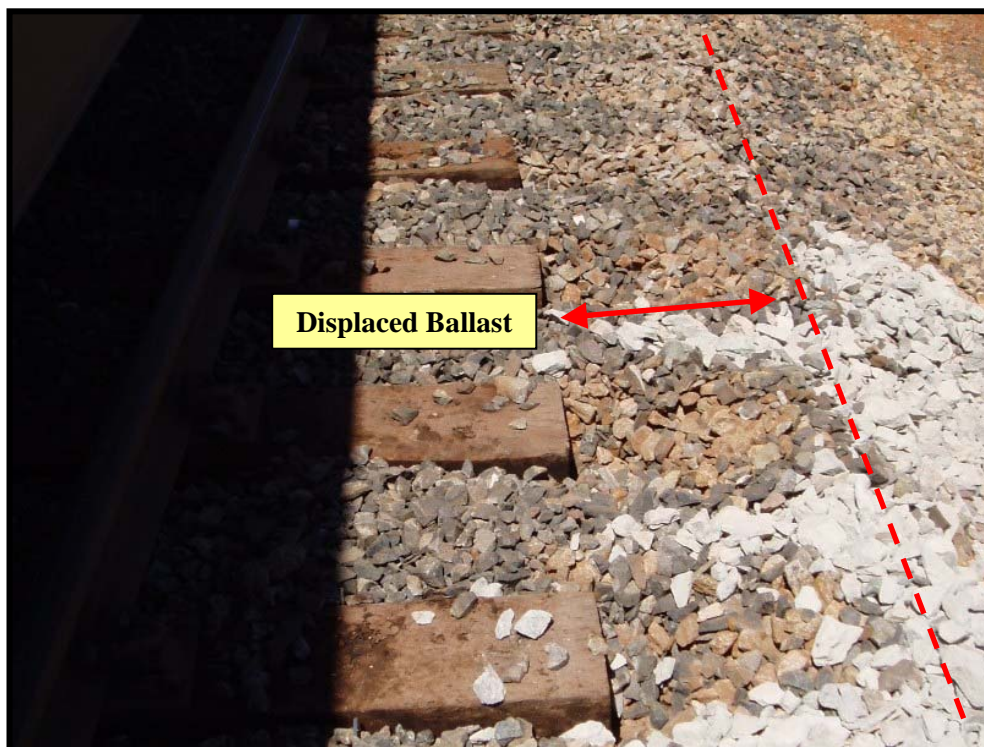
Displaced ballast was observed at the ends of some sleepers through the turn-out. While this may indicate that a track misalignment existed before the passage of

6MP4, it could also have occurred as a result of the derailment. Beyond this point, there was significant damage to the track structure. There was no sleeper or rail damage observed throughout the curve before the derailment site.

Figure 4: Displaced ballast at ends of sleepers at Koolyanobbing

The majority of derailed rollingstock and damaged civil infrastructure extended for 205 metres, beginning at the turn-out. Displaced ballast at the ends of some sleepers through the turn-out suggests that the track had shifted laterally. No sleeper or rail damage was observed east of this location at Koolyanobbing.

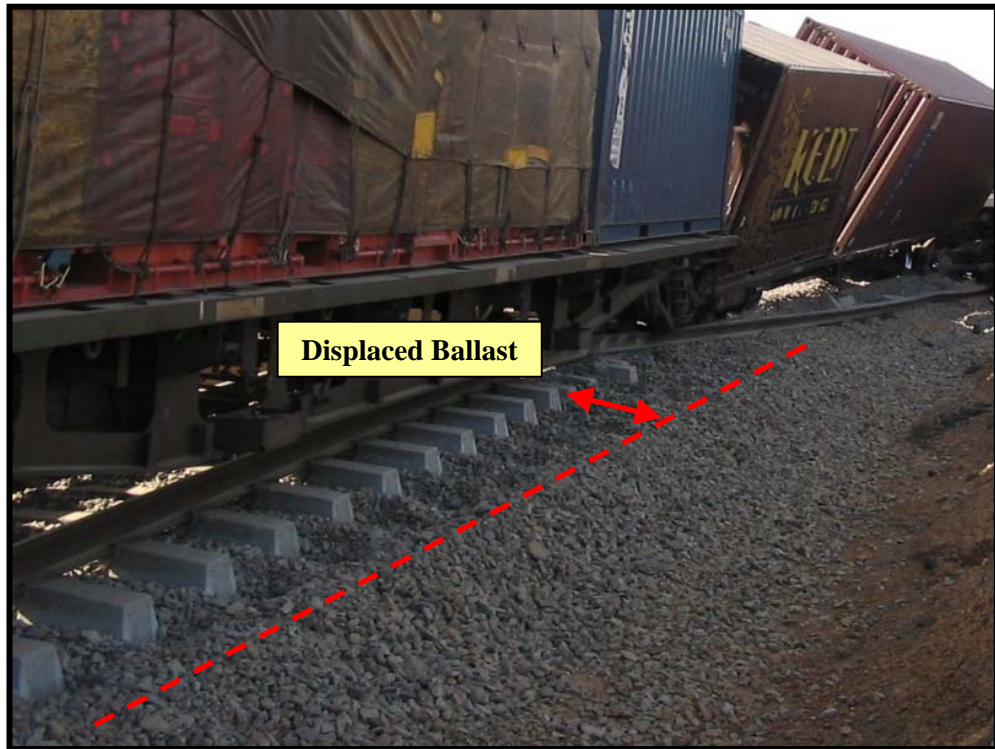
The Booraan site was also similar to Koolyanobbing in that displaced ballast was observed at the ends of some sleepers at the eastern approach to the derailment site, with damage to the track structure to the west of this point only. There was no sleeper or rail damage observed throughout the curve before the derailment site.

Figure 5: Displaced ballast at ends of sleepers at Booraan

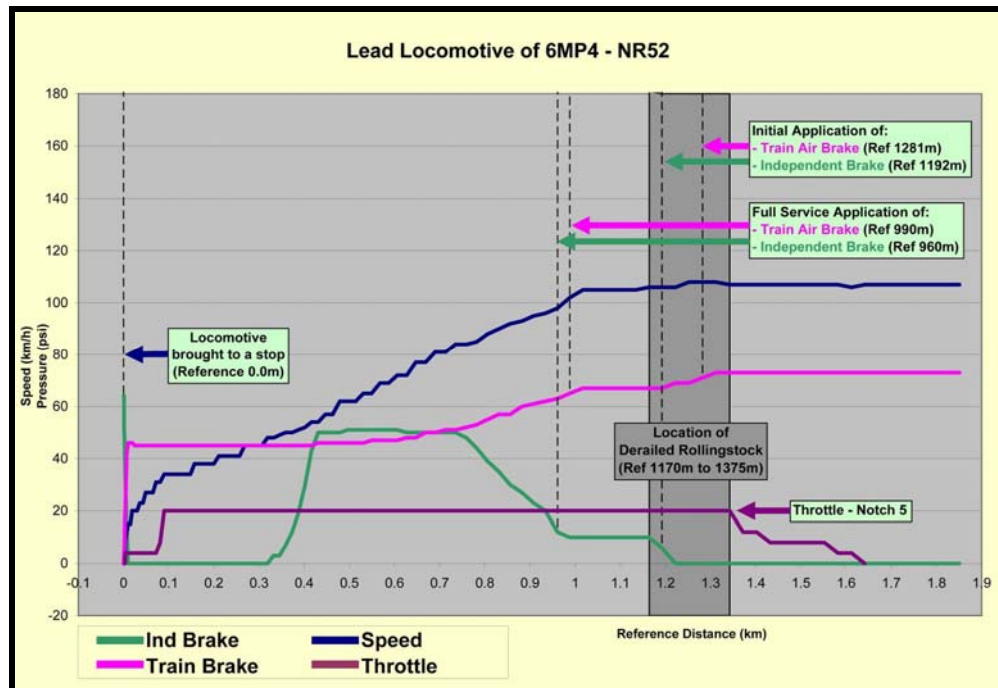
The driver of 6MP4 had only just achieved throttle notch five as the locomotives approached the turn-out. Within two seconds the driver made an initial 50kPa brake pipe reduction (train brake) and allowed the independent (locomotive) brake to apply automatically. Full service application of the train brake was made approximately 10 seconds after the initial application and the independent brake was allowed to fully apply.

Figure 6: Graphical representation of NR52 locomotive data log (Lead locomotive of 6MP4)

Although the independent brake was allowed to automatically apply, the retention of throttle notch five and gradual reduction of brake pipe pressure indicates that the driver was endeavouring to keep the train from bunching. Approximately 1000 metres past the turn-out, the driver released the locomotives' independent brake before reducing the throttle and bringing the train to a stop at a point 1300 metres after the initial brake application. These actions are consistent with an attempt to prevent derailed wagons colliding with the locomotives due to the locomotives' greater braking force when compared to wagons, either loaded or empty.

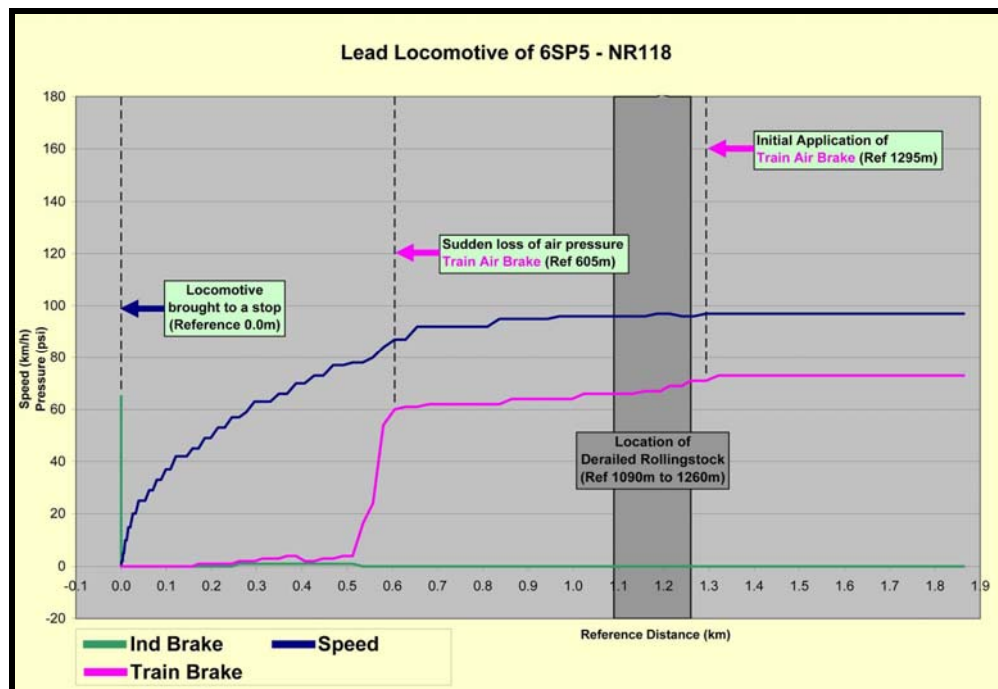
East of the Booraan derailment site 6SP5 was travelling at approximately 97km/h down a slight gradient with the locomotive controls at idle. Approximately 150 metres after exiting the curve, the driver of 6SP5 made an initial application of the train's air brakes. The driver continued to increase the braking effort in gradual increments for approximately 700 metres after the initial application until a sudden loss in brake line pressure indicated that the brake line and, most likely, the train had parted. The front section of the train stopped 1300 metres after the initial brake application.

Figure 7: Graphical representation of NR118 locomotive data log (Lead locomotive of 6SP5)

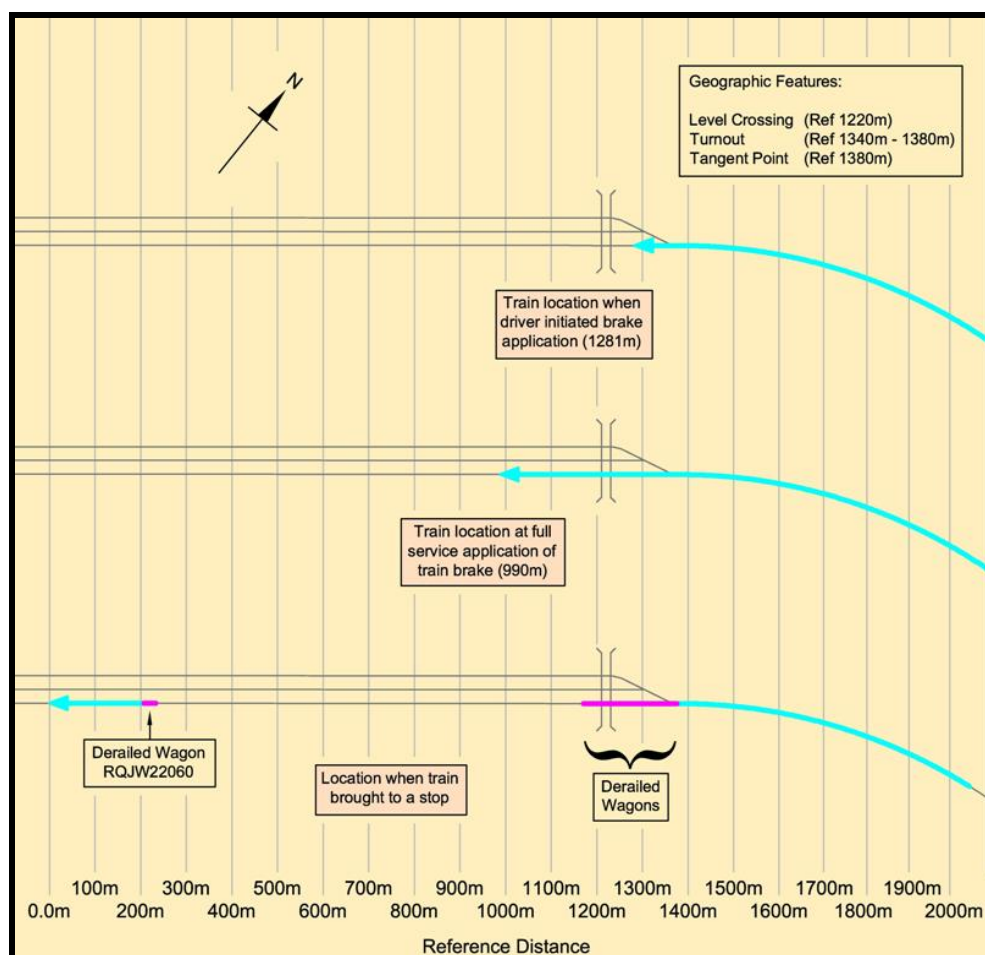
The first wagon to derail was approximately 200 metres behind the lead locomotive. If the cause of the derailment was a defective wagon, then the behaviour of the wagon could possibly have alerted the driver to a potential rollingstock fault, which would prompt the driver to take some action. Had this been the case, it would be reasonable to expect evidence of track damage approximately 200 metres east of the point at which brake application occurred. However, analysis of the locomotive data log indicated that the driver first applied braking as the locomotive traversed the derailment site. When the locomotive brake was applied, the wagon that was the first to derail was apparently travelling normally as there was no track damage east of the derailment site.

Figure 8: Representation of 6MP4 as it progressed through the derailment site

When considering the physical site evidence and mapping it against the locomotive data log, it is unlikely that any observed rollingstock fault would have initiated the driver's actions. Similarly, the drivers reported actions are supported by both the locomotive data log and the physical site evidence.

Analysis of evidence suggests that the most probable cause for the derailment of 6MP4 at Koolyanobbing was a track misalignment within the turn-out.

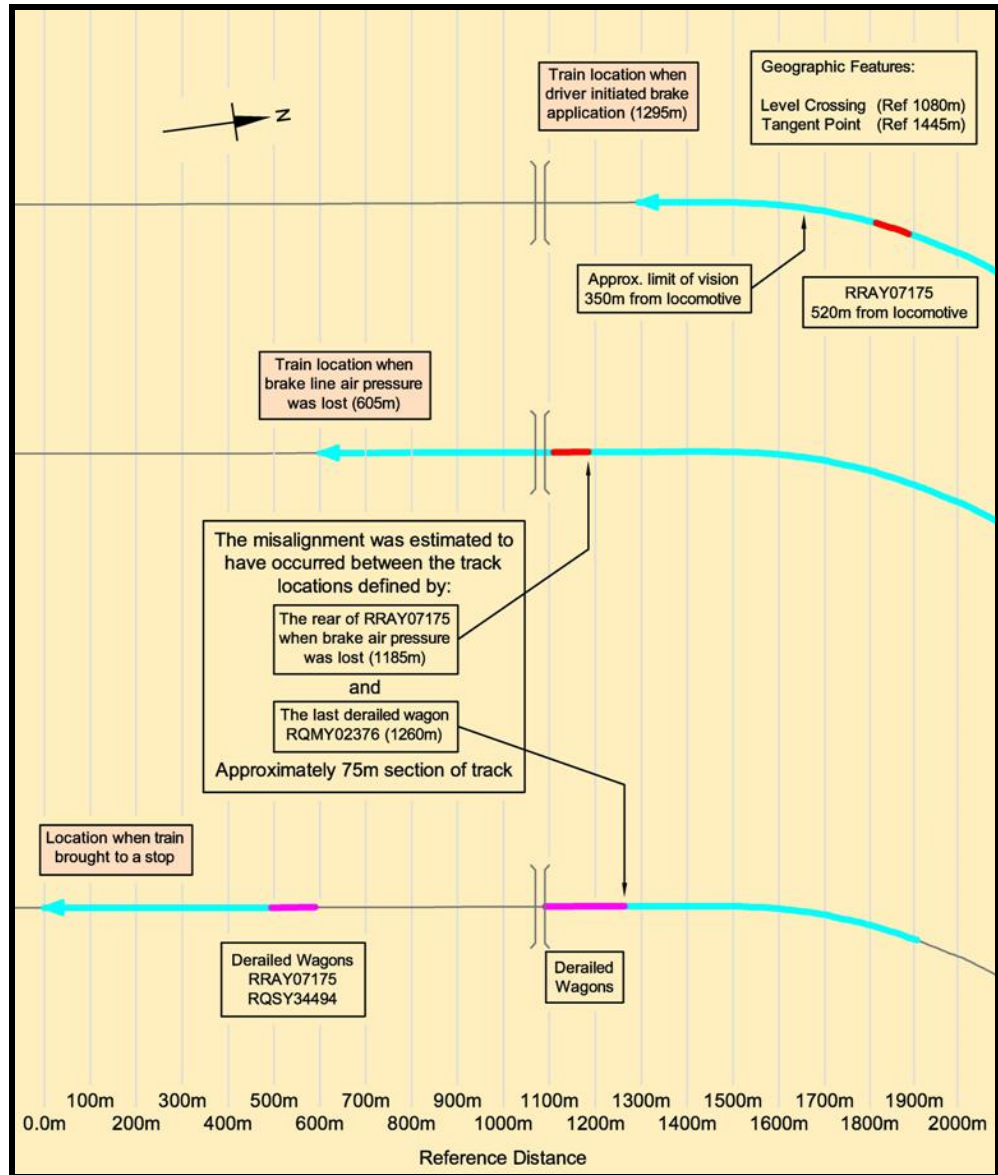
It is reasonable to assume that the uncontrolled loss of brake pressure occurred due to the separation of the train between the 13th and 14th wagons. From the locomotive data log, it is possible to position this point 67 metres from the first damaged sleeper. It is likely that any track condition prompting an action from the driver would be located between the first damaged sleeper and the point at which wagons became sufficiently unstable to result in a train separation.

Figure 9: Representation of 6SP5 as it progressed through the derailment site

Analysis of evidence suggests that the most probable cause for the derailment of 6SP5 at Booraan was a track misalignment located within a 75 metre section of track beginning approximately 185 metres past the curve’s tangent point.

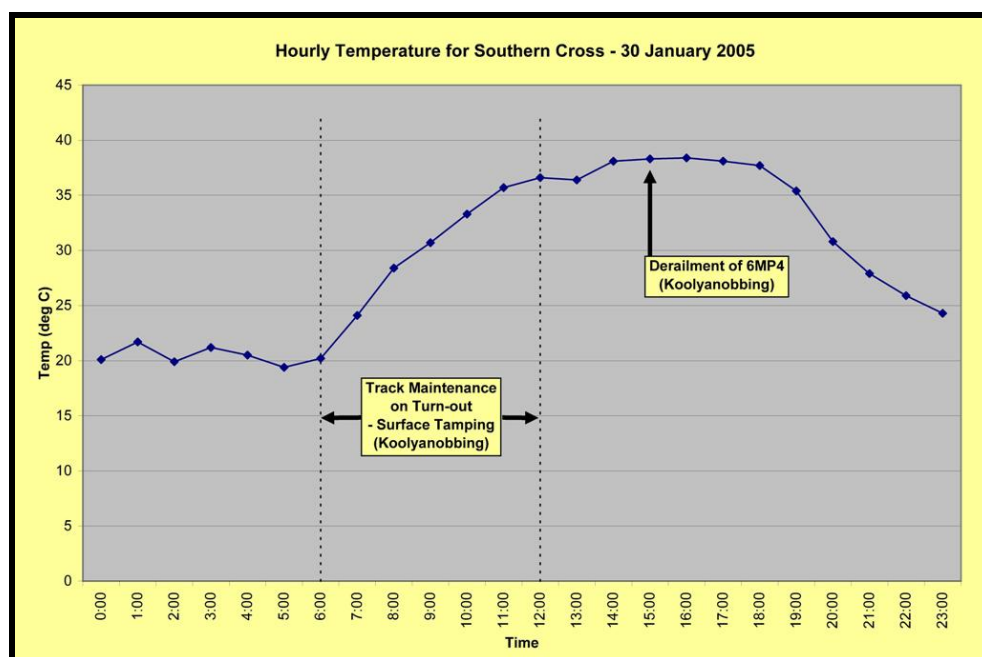
On the morning that the derailment occurred, track tamping was conducted over the turn-out as part of an ongoing turn-out maintenance programme. It is likely that a reduced friction bond due to replaced sleepers, compounded by track tamping loosening the ballast and further reducing the friction bond between sleeper and ballast, contributed to a reduced resistance against lateral movement.

Figure 11: Hourly temperatures in the vicinity of Koolyanobbing showing the time during which track tamping was conducted and the time of derailment

While a reduced resistance against lateral movement was likely and longitudinal forces within the rail were in compression and likely to increase the risk of track misalignment, in this case these alone were not sufficient to cause a misalignment in the form of a track buckle in well constructed and maintained track. However, three hours after completion of track tamping, 6MP4 encountered a track misalignment and derailed.

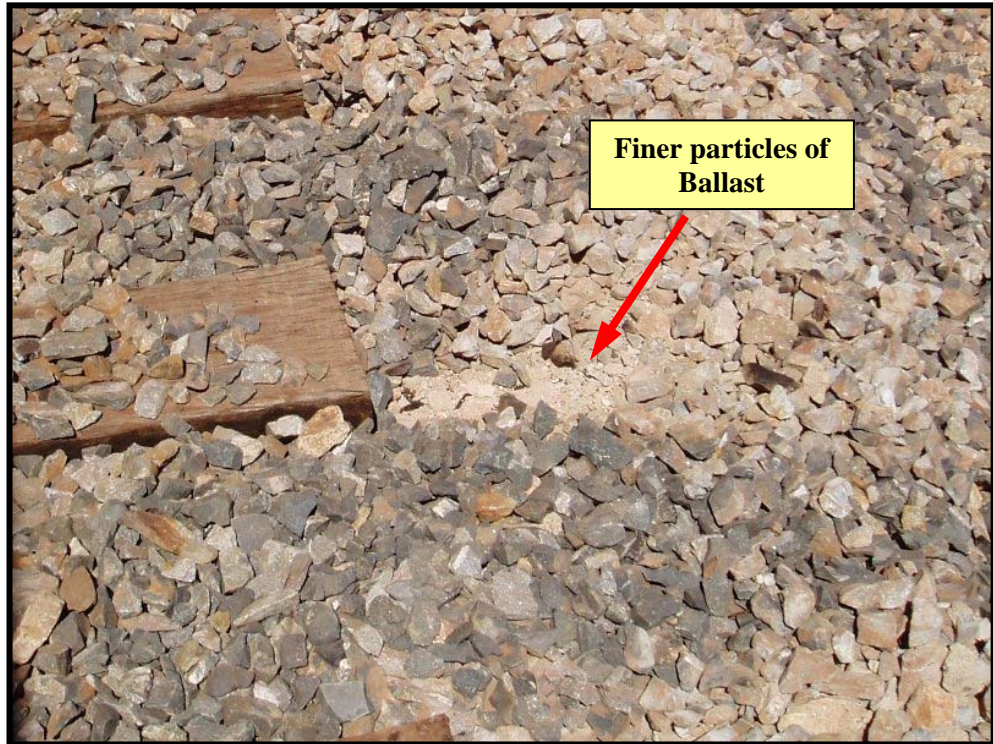
Figure 12: Broken down ballast

Another factor that may have contributed to a reduction in lateral stability is the possible break down of ballast. Figure 12 illustrates a sleeper that may be supported, at least partially, on finer particles of ballast. However, the investigation concluded that the contribution to reduced lateral stability that ballast breakdown provided was likely to be minor when compared to the effect of track maintenance.

Again, reduced resistance against lateral movement due to sleepers supported on degraded ballast alone is not sufficient in this case to cause a misalignment in the form of a track buckle. A lateral force must be applied to the rail and sleepers such that their resistance is exceeded and the track structure is permitted to move laterally.

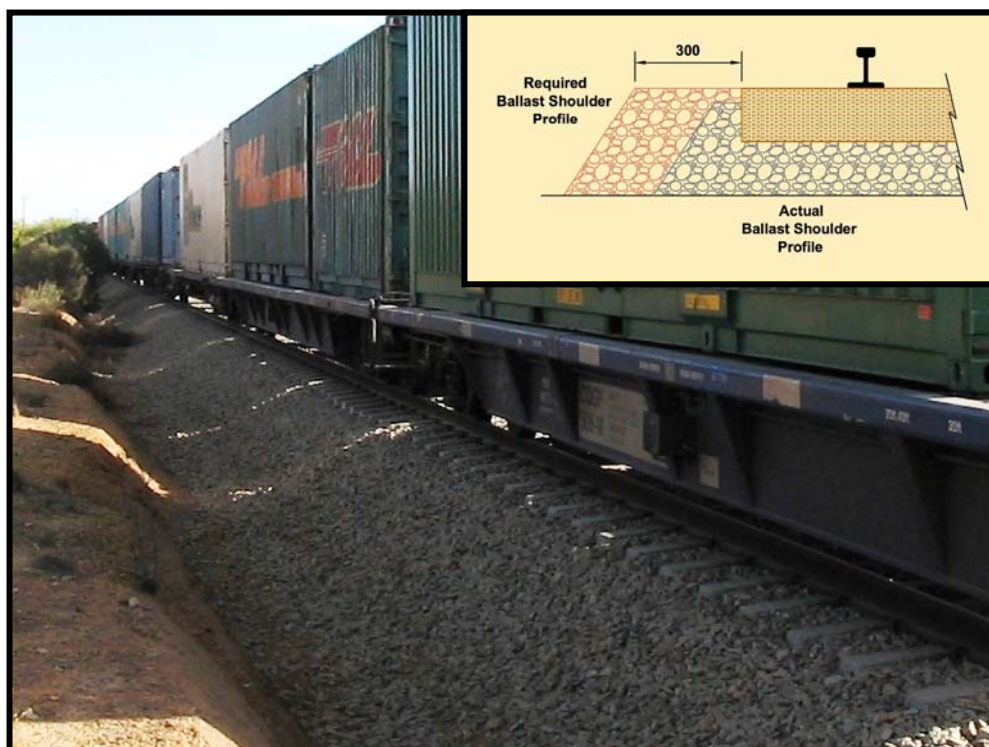
When considering the track structure at Booraan, the rail was supported on concrete sleepers, was in good condition, and had a full ballast profile for the crib. However, the ballast profile did not demonstrate a full shoulder width in all areas. Figure 13 shows the rear half of freight wagon CQGY0508 which was coupled behind the last derailed wagon of 6SP5. Survey measurements¹² indicate no lateral track deflection in this area, implying minimal or no track disturbance. The inset diagram illustrates the estimated actual ballast profile for sections of track structure immediately before the derailment site and what would be considered a full ballast profile.

Figure 13: Ballast Shoulder

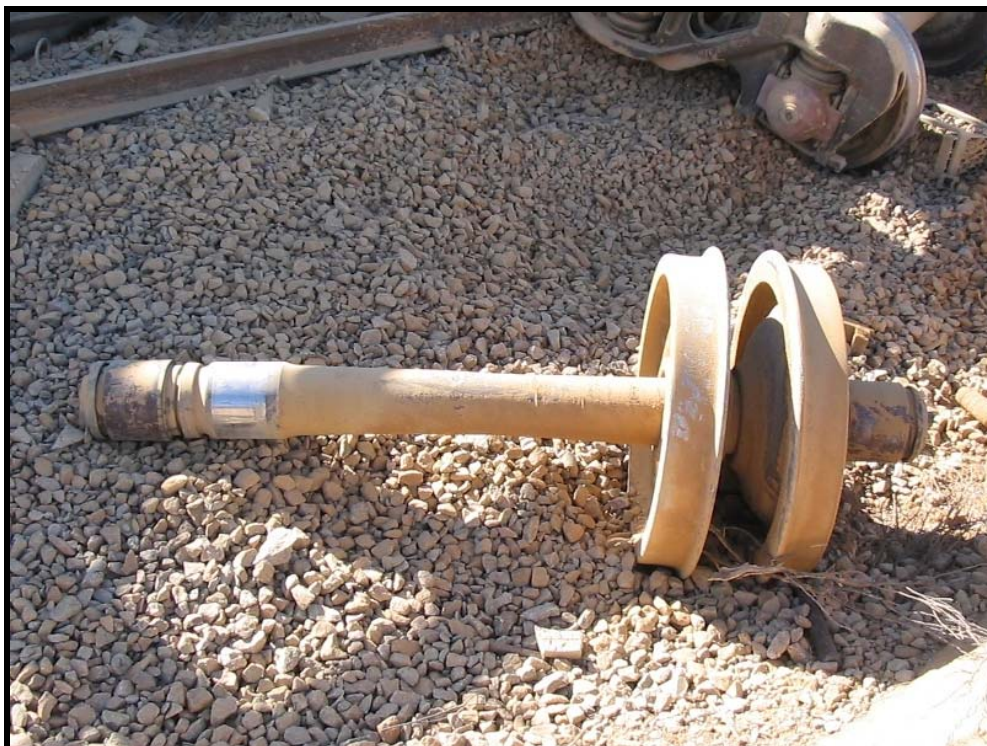
Figure 14: Wheel moved fully off the wheel seat

An examination of the wheel-sets showed no evidence to suggest that the wheels had moved before the derailment of 6SP5. Considering the history of the wheel-sets, it is unlikely that the wheels moved off their respective wheel seats under normal running conditions. The most likely cause for the movement of the wheels was an impact during the derailment of 6SP5. This is not uncommon during heavy freight wagon derailments of this magnitude.

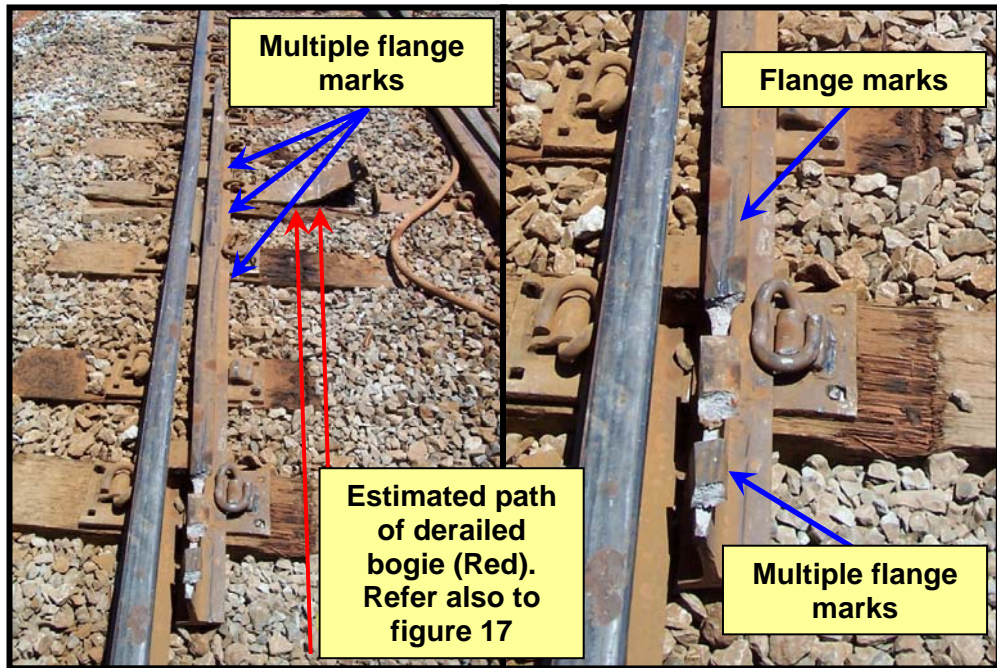
The fractured check-rail and the damaged infrastructure in the immediate vicinity the mechanism of fracture was carefully considered. A significant number of flange marks were evident indicating that a number of wheels had derailed over the check-rail (Refer to figure 16). It is also evident that at least one bogie had derailed before the check-rail and travelled past the check-rail while derailed to the right (Refer to figure 17). Considering the number of derailed wheels passing over the check-rail, and that at least one bogie had derailed before the check-rail, the most probable cause of the fractured check-rail is multiple wheel impacts during the derailment of train 6MP4.

Figure 16: Fractured check-rail showing wheel derailment markings

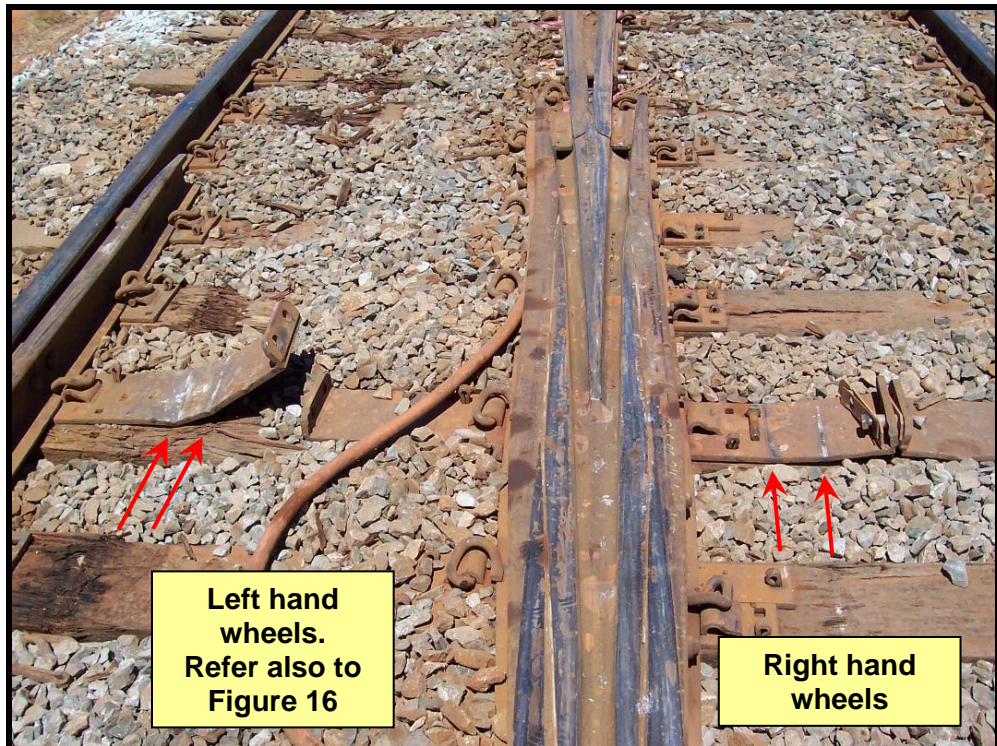
Figure 17: Estimated path of derailed bogie past the fractured check-rail

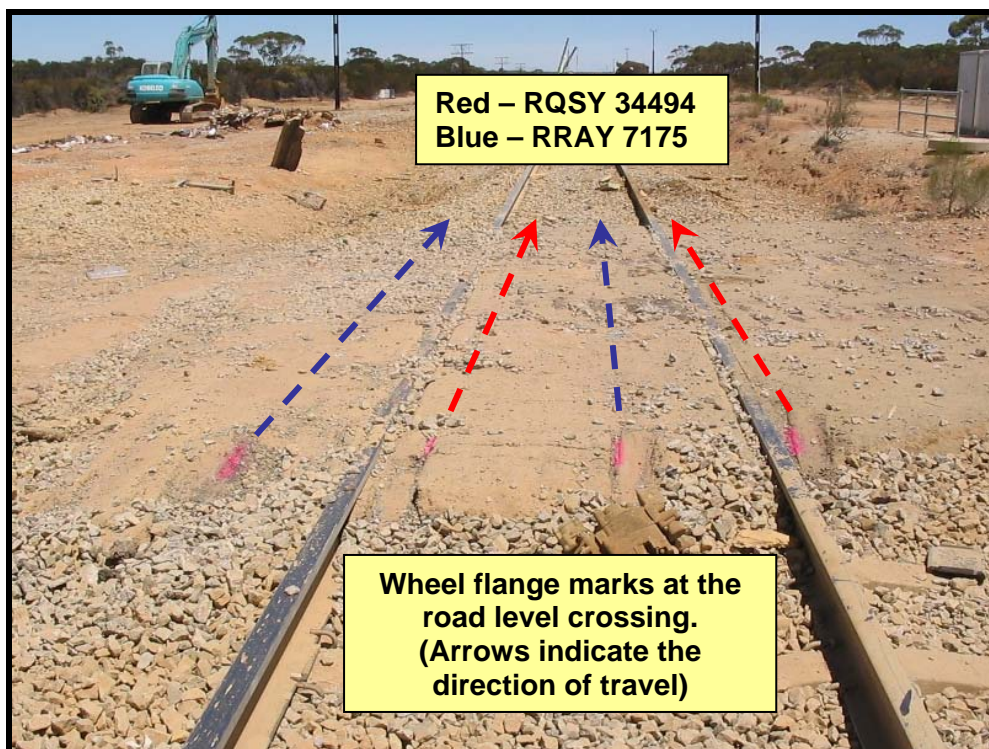
pack RRAY wagon, with only its lead bogie under the body, was dragged along the left hand ballast shoulder.

Figure 18: Wheel flange markings at road crossing

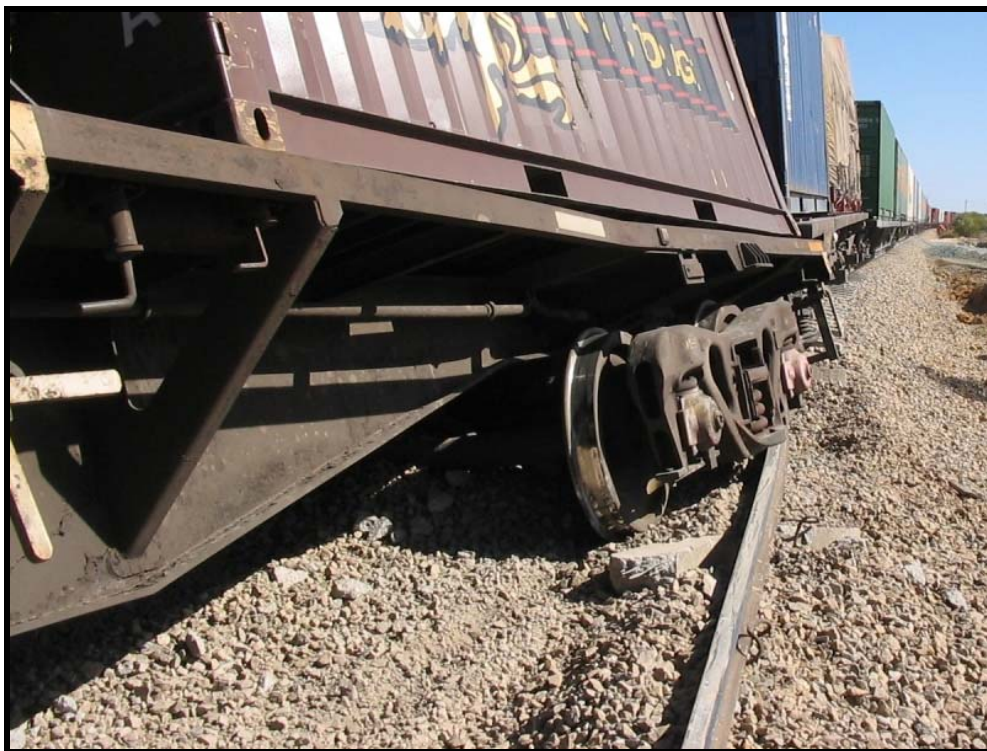
unlikely that any one wheel could be identified as the cause of the rail damage. Similarly, it is unlikely that the markings on the running face of the left rail could be conclusively attributed to any wheels of the first few bogies derailed at Booraan.

Figure 20: Damaged sleepers and spread gauge

Considering the direction of derailment for the rear bogie of wagon RQSY34494 and the leading bogie of RRAY7175, it is considered unlikely that a dislodged rear bogie of wagon RQSY34494 contributed to the derailment of train 6SP5. It is more likely that the bogie dislodged as a consequence of the derailment, possibly as the bogie struck the bitumen road crossing.
