Australian Transport Safety Bureau

Chief Commissioner's message

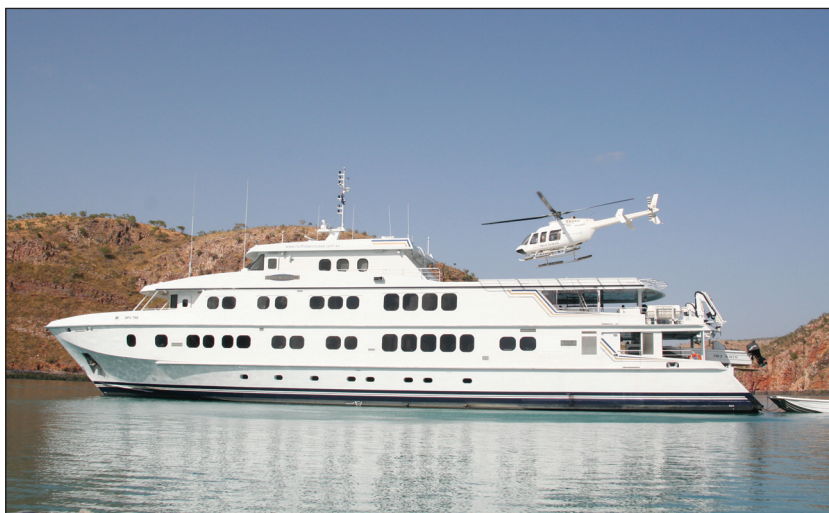
The investigation found that there had been a 'burst' failure of the Rolls Royce

Corp model 250-C47B engine's outer combustion case as a result of pre-existing, high cycle, fatigue cracking in the case's 'armpit' area. That cracking grew slowly and undetected, over a considerable period of time and was a consequence of the cumulative effect of normal engine pressure cycles.

The engine manufacturer had previously strengthened the 'armpit' areas of the outer combustion cases on the Worldwide fleet of RR250 engines in the early 1970's by the addition of brazed wire mesh patches following a number of in-service failures. Subsequently, in 1984, that strengthening was extended to the later series of RR250 engines, such as was installed in the occurrence helicopter. The cracks in this occurrence had developed adjacent to those brazed wire mesh patches and had propagated through them.

The investigation found that the regular crack inspections that were required by the engine manufacturer to be carried out on the outer combustion case had

been done. However, the approved dye-penetrant detection methods used had been ineffective in discovering the cracks prior to failure.

As a result of this occurrence, the engine manufacturer conducted a computerised analysis of the design of the combustion case in an effort to address the relevant

areas of high stress more effectively. That analysis resulted in an on-going re-design of the brazed wire mesh patch to more effectively cover the areas of concern. The engine manufacturer is also re-evaluating the method of inspection used for detecting outer combustion case cracks during maintenance.

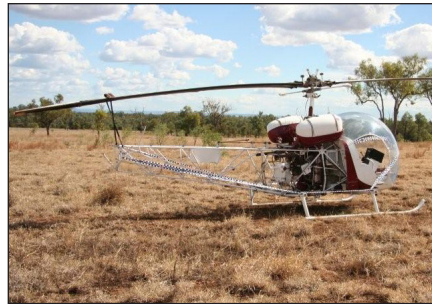
Examination of the helicopter revealed that two blades had separated from the engine cooling fan as a result of fatigue fracture. The fan cowling had fractured and separated from the engine and there was impact damage to the flight control linkages located adjacent to the fan assembly. The ATSB examination determined that the fan unit had not been correctly assembled, and that this probably had an effect on the vibration and resonance characteristics of the fan, which in turn may have increased the susceptibility of the fan to fatigue failure.

As a result of this occurrence, the CASA released Airworthiness Bulletin AWB 63-007, reminding operators and maintainers of the importance of adhering to all current manufacturer's approved data for sheet metal cooling fans and their drive assemblies, and detailing some potential contributing factors to structural fatigue fan failure. ■

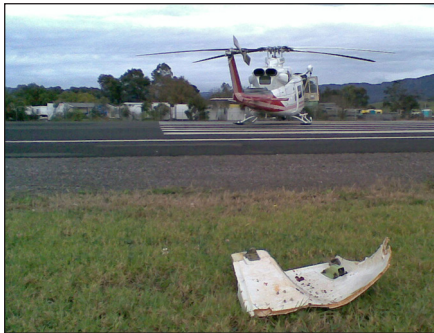
Examination of the helicopter's flight control system revealed an anomaly with the collective hydraulic actuator. Excessive free play had developed between the collective actuator's pivot bolt and the pilot input linkage. It was probable that the free play within the helicopter's flight control system brought about the onset of divergent vibrations and allowed subsequent controllability issues to develop. It is likely that free play at the bolted joint was introduced when the collective actuator was last overhauled.

As a result of this occurrence, the collective actuator manufacturer revised the tensioning procedures and requirements for the pivot bolt assembly during the overhaul process. In addition, the helicopter operator changed its inspection regime of the collective servo-hydraulic actuator units in its fleet of Bell 412 helicopters and issued a 'flight staff instruction' to provide guidance to pilots on what actions to take if they experienced unusual or excessive vibrations during flight. ■

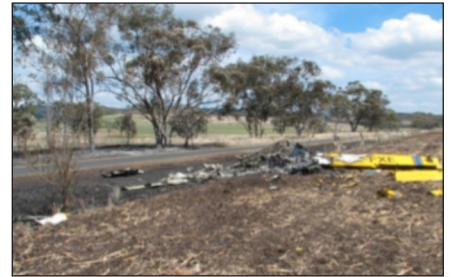
At about 1440 EST on 29 September 2008, the pilot of a Piper Aircraft PA36-375 Pawnee Brave, registered VH FXE, was conducting aerial baiting operations in the Pilton Valley, Queensland when the aircraft collided with terrain. The aircraft was seriously damaged by impact forces and a post-impact, fuel and magnesium-fed fire. The pilot was killed.

The investigation found that the topography of the area in which the pilot was operating, and the strong, gusty, wind conditions at the time, probably resulted in turbulence that increased the hazardous nature of the low-level application task.

It is likely that the pilot lost control of the aircraft as a result of that turbulence, at a height from which recovery was not possible before the aircraft struck the ground. ■
