ATSB TRANSPORT SAFETY REPORT
Marine Occurrence Investigation No. 262
MO-2009-001
Final

Independent investigation into the grounding of the
Hong Kong registered products tanker

Atlantic Blue

at Kirkcaldie Reef, Torres Strait

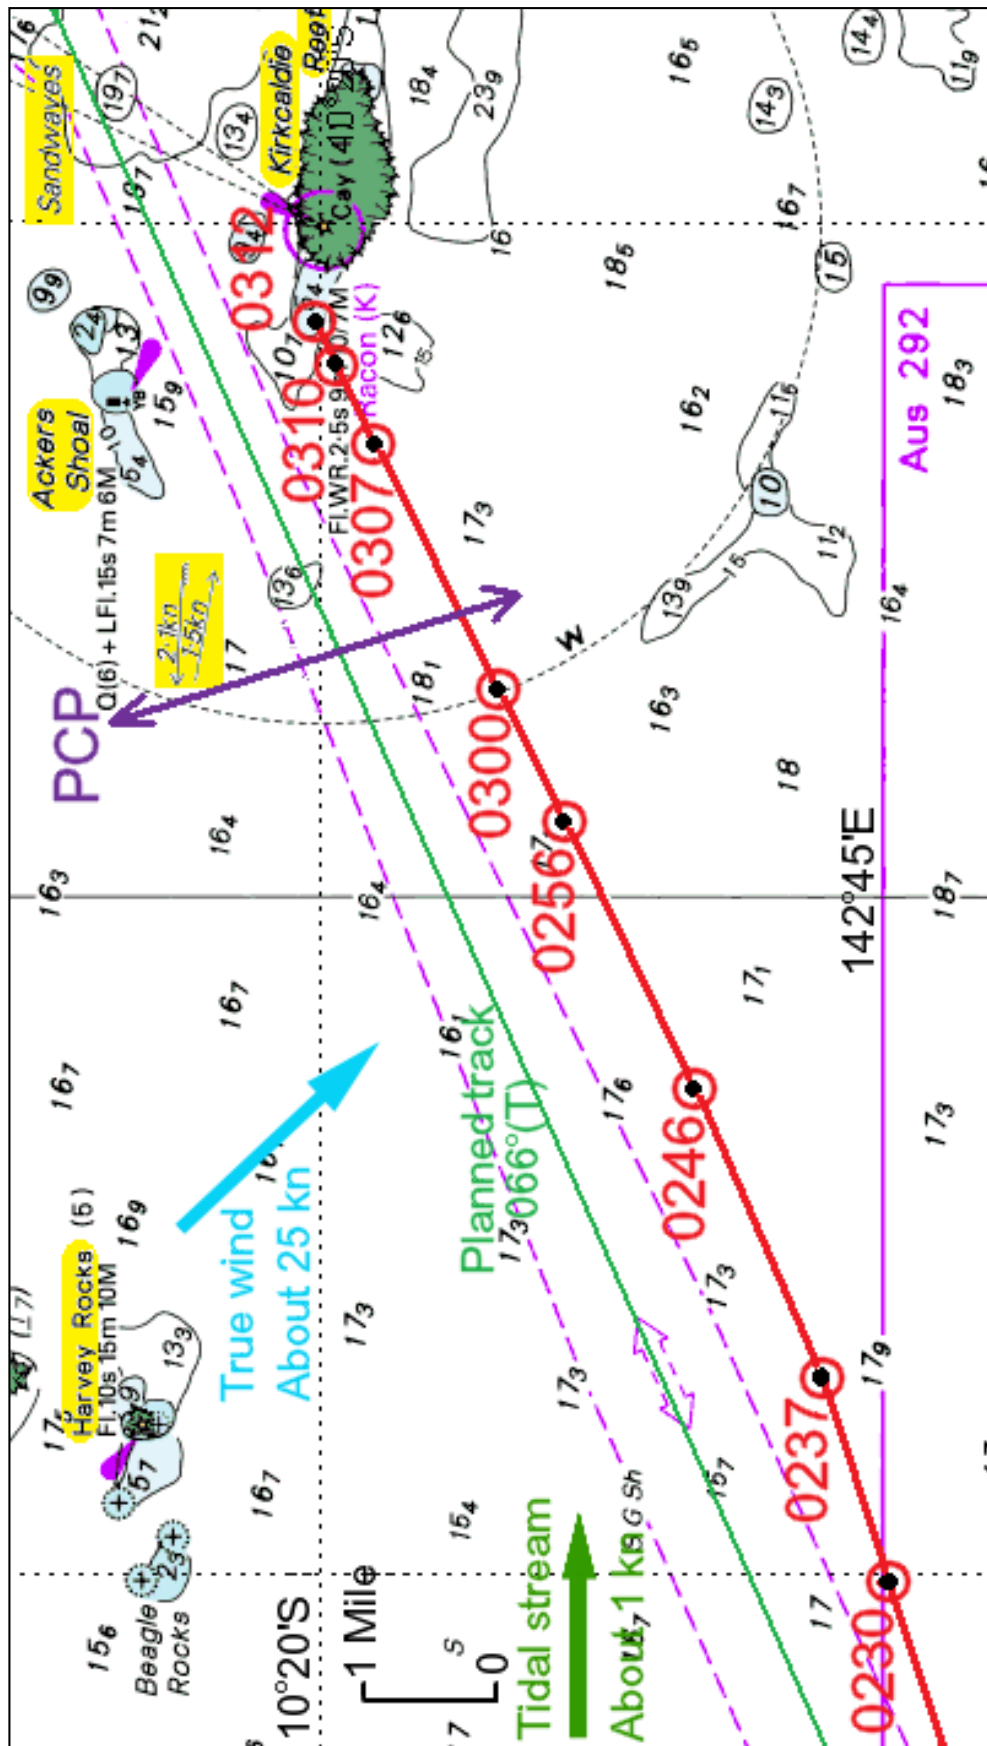
Figure 6: *Atlantic Blue's* track in the period immediately before grounding

At 0312 on 7 February, *Atlantic Blue* grounded in position 10°20.0'S 142°49.2'E, on a shoal at Kirkcaldie Reef, nearly 1 mile south of its planned track (Figure 6). For at least the previous 1½ hours, the ship had been steered on headings that, in the prevailing wind and tide conditions, were inappropriate to follow the planned track.

Atlantic Blue grounded as a result of deviating from its planned track in the prevailing wind and tide conditions. Between 0237, when the ship was 1 mile off-track, and when it grounded at 0312, the series of small heading changes only resulted in a course made good of 065° (T), nearly parallel to the planned track. Had available bridge resources been effectively used to follow the passage plan or adequate action taken to return to the track, the grounding could have been avoided.

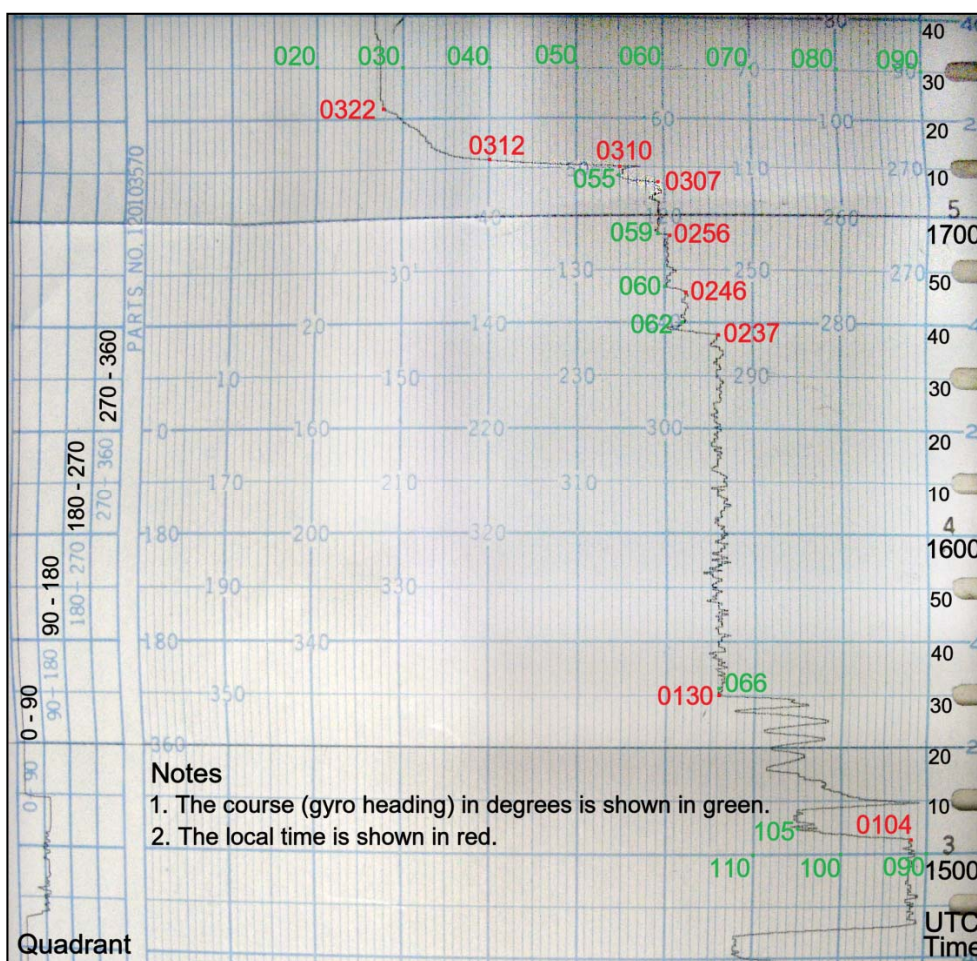
Figure 7: Annotated copy of *Atlantic Blue*'s course recorder chart

Although VDR data was not saved, other automatically recorded data allowed an accurate reconstruction of *Atlantic Blue*'s track and of the sequence of events. The ship's course recorder chart provided an accurate, clear and continuous record of its heading and the times that it was altered (Figure 7). This information was consistent with the ship's AIS/GPS data recorded by REEFVTS which, together with recorded VHF communications, was particularly useful.

Evidence from the course recorder was consistent with REEFVTS data and manually recorded information on the navigational charts and various log books. This information was supported by accounts of the incident. Any discrepancies in those accounts, particularly in the timing of events leading up to the grounding, were resolved by comparing them with the automatically recorded data.

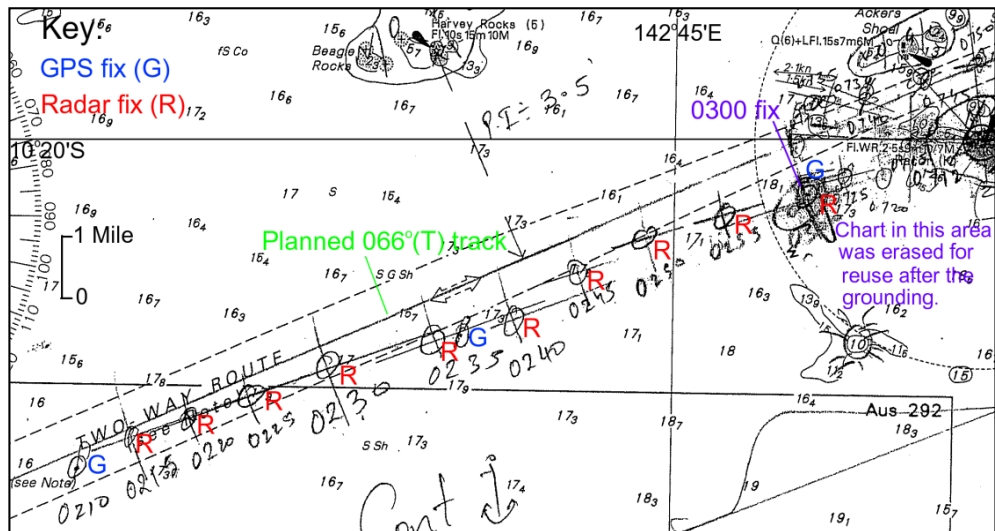
Figure 8: Annotated copy of the navigational chart used

At this stage, the second mate took out the next chart and plotted the 0210 fix on it (Figure 8). He identified Kirkcaldie racon and decided to use it for fixes since it was conspicuous. At 0215, he found the racon's bearing and range to be 070° (T) x 14.5 miles and the fix indicated the ship was about 1 cable south of the planned track. This off-track distance was not consistent with the last two fixes but the second mate did not resolve this inconsistency by cross checking the GPS position or using other radar targets. The GPS position would have indicated that the racon's bearing at the time was actually 068.5° (T) and that there was a 1.5° (west) error in the bearing that had been used.

Atlantic Blue's gyro error had been verified as less than 0.5°. Hence, the most likely reason for the bearing error was the racon signal's arc width on the radar display. The arc, 14.5 miles distant, may have been a couple of degrees wide and, as a result, the bearing taken was probably inaccurate. Despite a bearing error, using at least three position lines from objects well separated in azimuth³⁴ would have resulted in more accurate fixes and parallel indexing could also have been used. Moreover, the GPS provided an independent and reliable position fixing and verification method.

A radar target off the ship's beam is recognised as being more effective for off-track distance monitoring than one fine that is on its bow or quarter. A bearing error for a target fine on the bow or quarter can translate, particularly at long ranges, to a large distance error across the track. Furthermore, radar ranges are generally more accurate than radar bearings. Using only Kirkcaldie racon, then about 4° on *Atlantic Blue*'s starboard bow was, therefore, an unreliable off-track distance monitoring method.

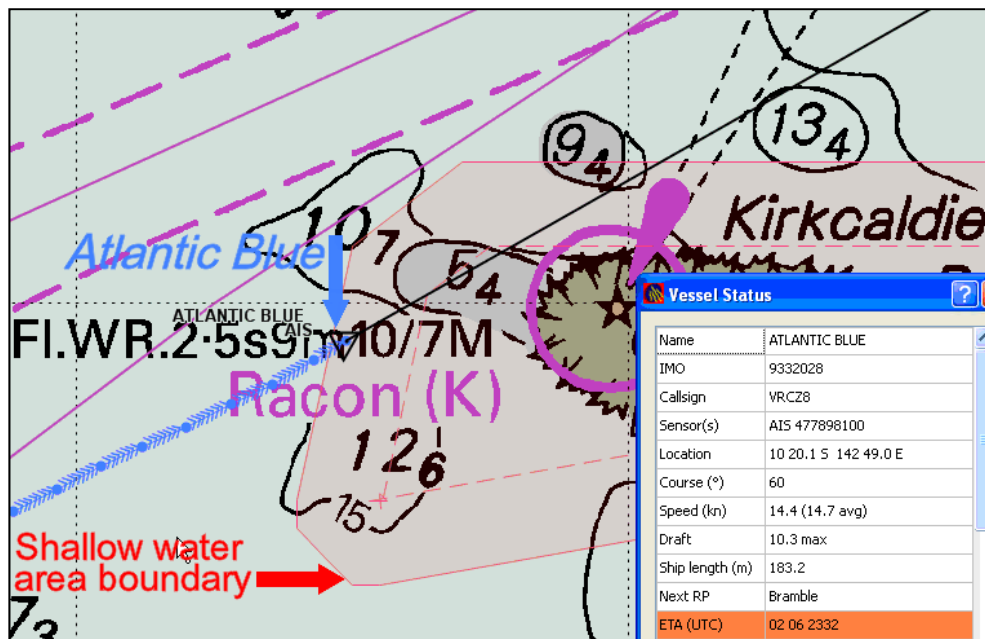
Figure 9: Section of the TIM display at 0310 on 7 February

At 0310 on 7 February, the shallow water alert was triggered when *Atlantic Blue* crossed the shallow water area boundary defined in the TIM (Figure 9). Despite the duty VTSO taking immediate action in accordance with REEFVTS procedures, the ship grounded 2 minutes later. The shallow water alert, the first and only automatic alarm generated for the ship, was ineffective because the boundary of the shallow water area was too close to the danger.

According to REEFVTS procedures⁵², automatic alarms are intended to enhance the duty VTSOs situational awareness and enable interaction with a ship if necessary. Therefore, it is important that the alarms, where possible, provide an early warning to allow timely action to be initiated. Only then can such alarms enhance situational awareness and form effective defences against serious incidents. It is also recognised that where some reliance is placed on automatic alarms, the absence of an alarm suggests a safe or normal condition and an overall perception of safety. It is important to consider this known risk when developing such automated systems.
