ATSB TRANSPORT SAFETY INVESTIGATION REPORT
Marine Occurrence Investigation No. 207
Final

Independent investigation into the grounding of the
Liberian registered general cargo ship

Mellum

28 September 2004

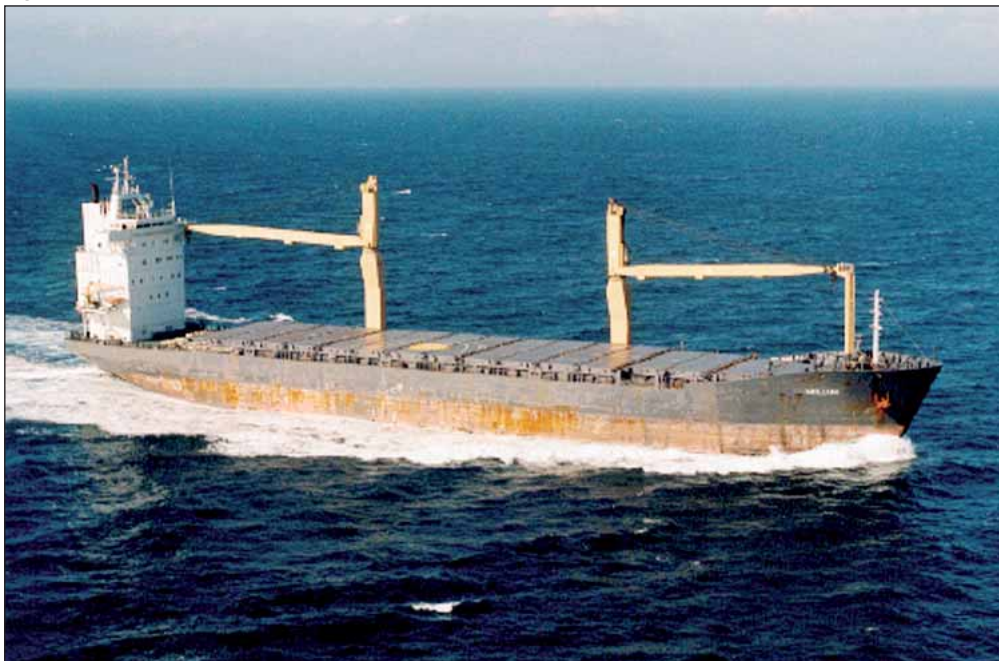
Figure 1: *Mellum*

Mellum is a general cargo ship (Figure 1) registered in Monrovia, Liberia. At the time of the incident the ship was managed by Briese Schiffahrts GmbH & Company KG of Leer, Germany and was classed with Germanischer Lloyd.

The ship was built in 1997 as *Libra Peru* and was renamed *Mellum* in 2002. It has an overall length of 153.2 m, a breadth of 23.6 m and a deadweight of 20 406 tonnes at a draught of 9.727 m.

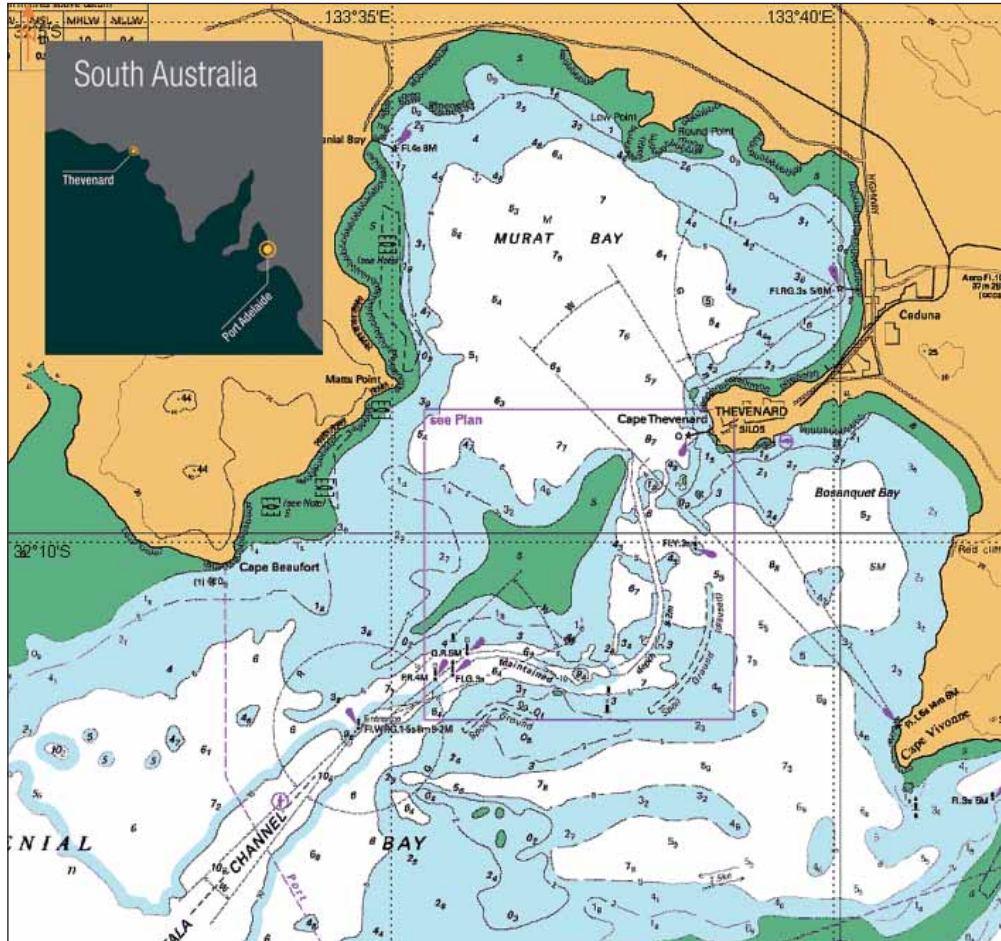
Figure 2: Section of navigation chart Aus 120 showing Yatala Channel and Thevenard

The port of Thevenard (Figure 2) is located on Cape Thevenard at the entrance to Murat Bay, South Australia. The port is managed by Flinders Ports. In 2003, 106 commercial ships visited the port, including 98 bulk carriers and four general cargo ships.

Pilotage for the port of Thevenard is compulsory for ships over 35 m in length and the pilot boarding ground is about a mile² to the south-west of the entrance beacon. The approach to the port is through Yatala Channel, which has a minimum charted depth of 8.2 m. The channel, marked throughout its length by beacons, is about 108 metres wide at its narrowest part. The distance from the entrance beacon, at the seaward end of the channel, to the berth is about five miles.

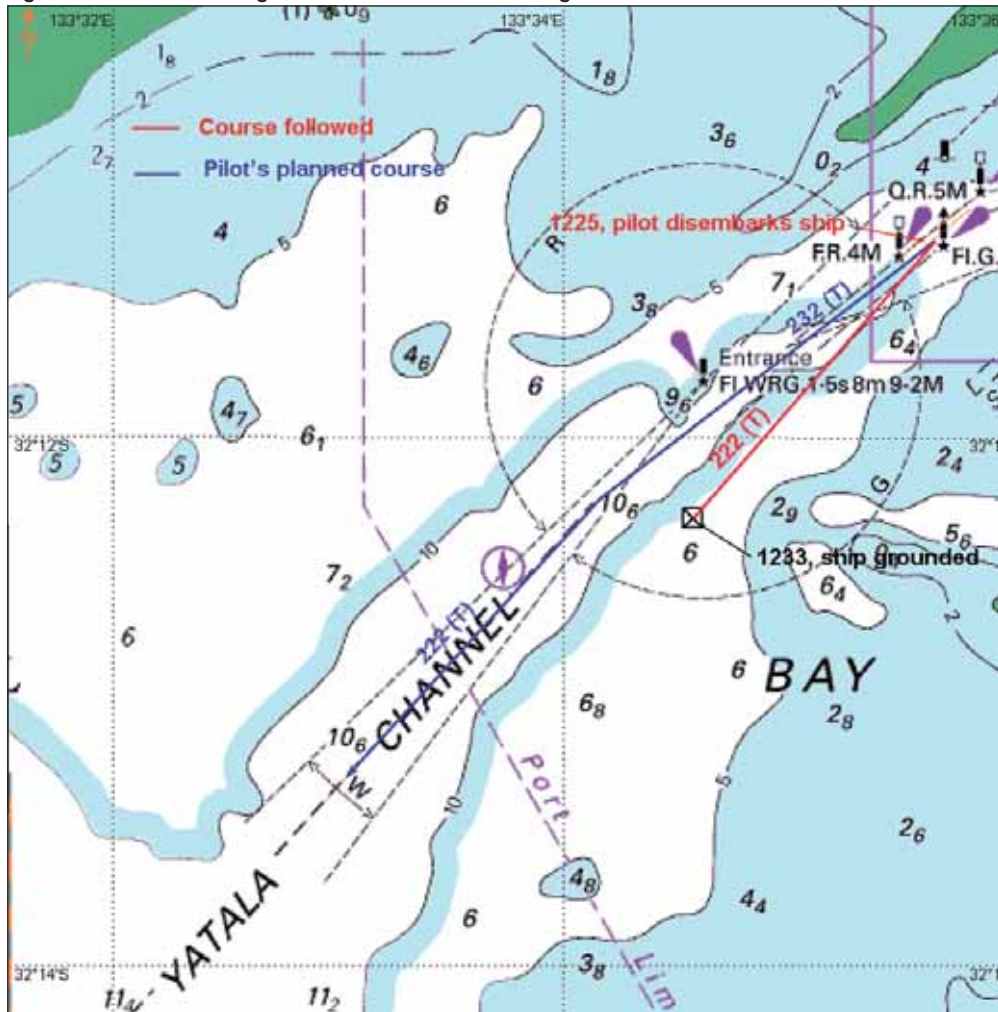
Figure 3: Extract of navigation chart Aus 120 showing *Mellum's* track

At about 1217, on a course, according to the pilot, of 232° (T), and a speed of about seven knots, *Mellum* cleared beacons one and two (Figure 3). The entrance beacon was about one point (11.25°) on the starboard bow and, shortly thereafter, the pilot informed the master that he intended to disembark as agreed.

While the second mate was setting the 'route line', the master noticed that the ship was south of its track and he instructed the helmsman to steer 225° (G). At 1233, before this order could be executed, the ship grounded with the entrance beacon bearing 005½°, at a range of 0.52 miles.

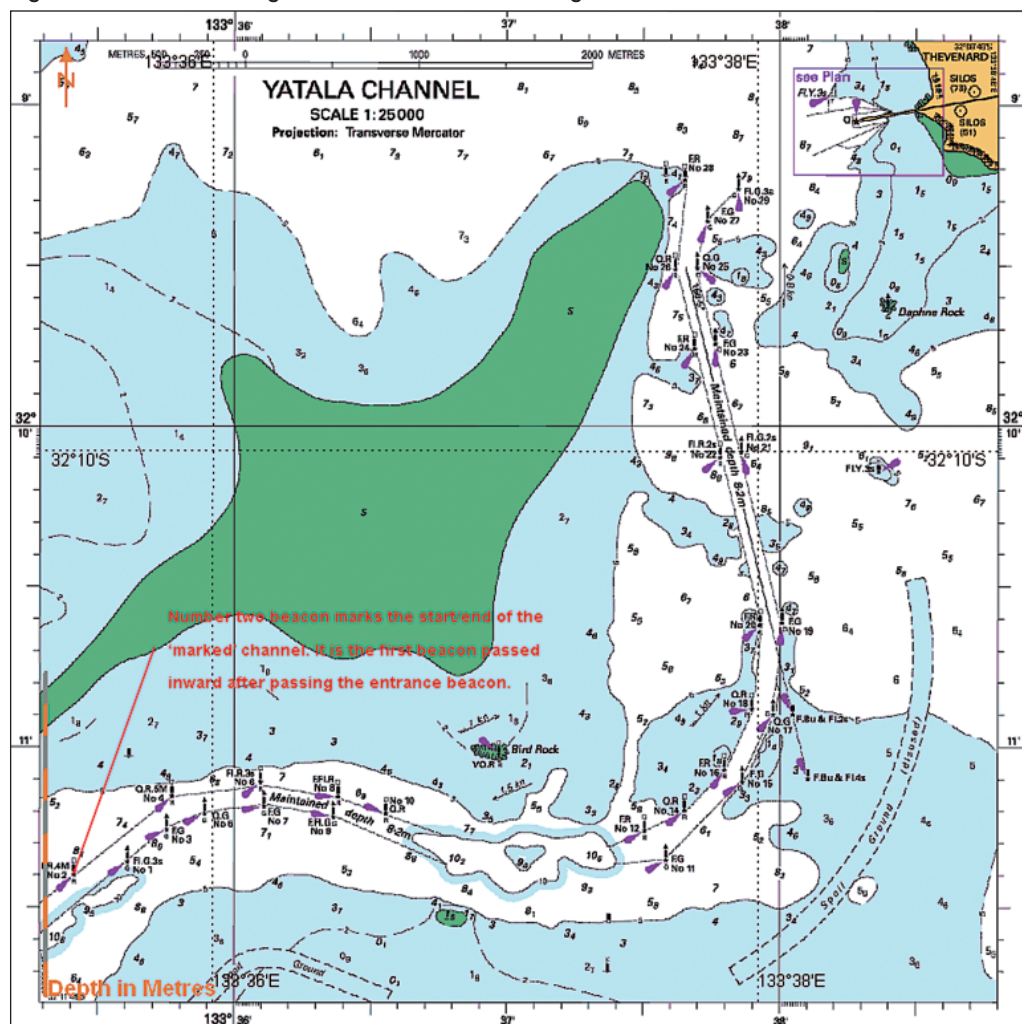
Figure 4: Inset from navigation chart Aus 120 showing Yatala Channel

Navigation chart Aus 120, 'Approaches to Thevenard' is on a scale of 1:75 000. There are two insets on the chart, 'Yatala Channel' on a scale of 1:25 000 (Figure 4) and 'Thevenard Wharf' on a scale of 1:5000.

The limited area of coverage of the channel inset and the differing scales of the inset and main chart means the navigator must switch from a larger scale chart, to one three times smaller, at a critical phase of the pilotage. These deficiencies in the navigation chart Aus 120 may also have contributed to the grounding.
