Australian Transport Safety Bureau

**RAIL SAFETY INVESTIGATION
2004/003**

**Signal MR5 Passed at
Danger, Freight Train Y245
Murarrie, Queensland
28 June 2004**

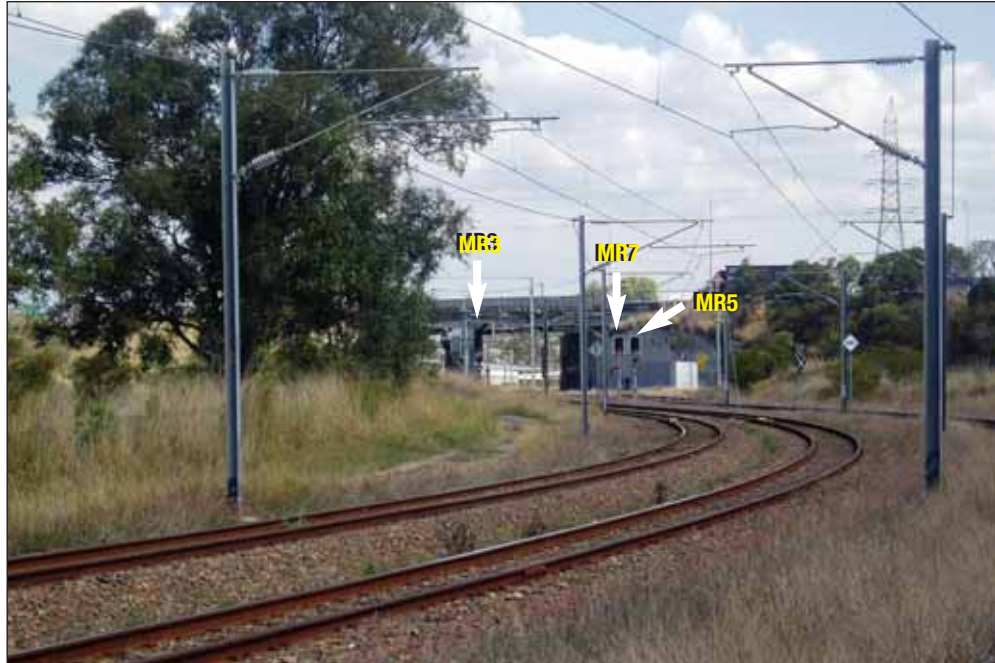
FIGURE 7: Aspect being displayed in signal MR5 visible 257.9 metres (daylight conditions)

- MR1 restricted⁸ – 774.5 metres
- MR1 clear – 679.5 metres
- MR3 restricted – 538.8 metres (momentarily between trees)
- MR3 clear 386 metres
- MR7 clear 257.9 metres
- MR5 clear 257.9 metres.

He said that signal MR5 cannot be seen clearly until it is about 200 metres away because of the curve and, if anything, the signal for the suburban line (MR3) is sighted first. Also, because of loading gauge restrictions that prevent travel on the adjacent suburban line, it had been his experience that trains hauled by a 2800 class

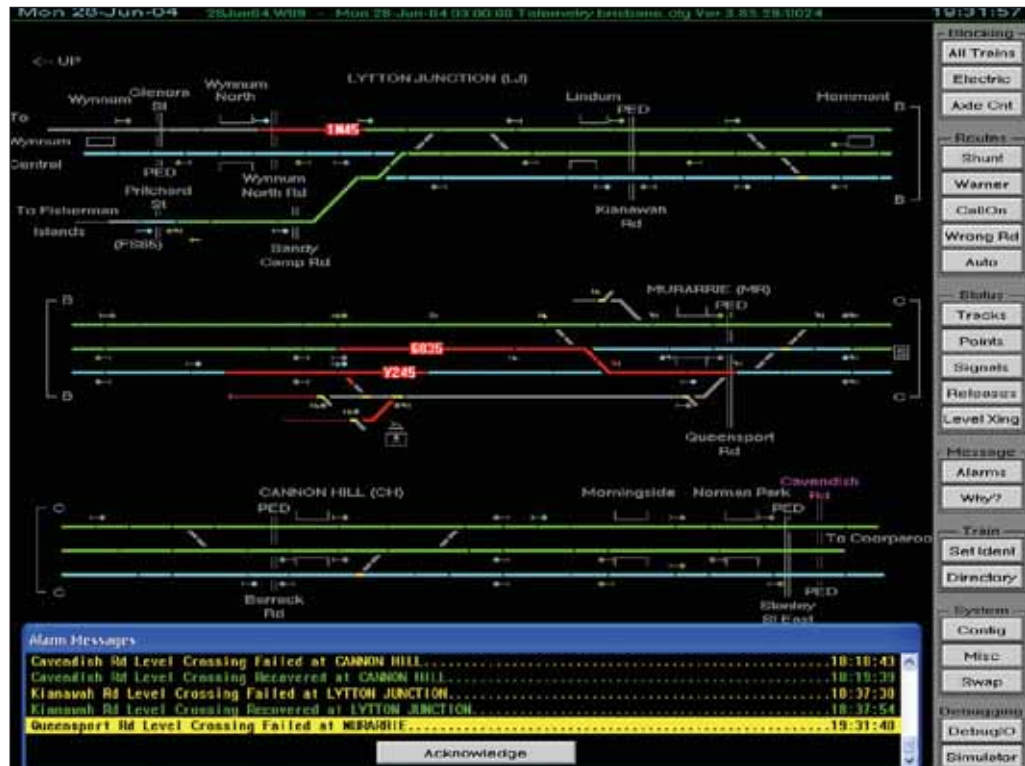
FIGURE 8: Computer monitor 9 of UTC2 workstation at time of the SPAD (1931:57). While the audible SPAD alarm was heard, the SPAD alarm text was still awaiting display

The audible SPAD alarm caused by train Y245 occupying track 24GT immediately beyond signal MR5 activated at the Mayne Control Centre at 1931:57. When a SPAD occurs an audible alarm sounds continuously until it is acknowledged. In addition, a text SPAD alarm is generated that gives details of the SPAD. This alarm will 'jump the queue' over lower priority alarms that are being held awaiting display. This means that, if there is an existing alarm being displayed on the workstation visual display unit (VDU) screen, it must be acknowledged before the SPAD alarm can be displayed as a text message. This feature and distinctive audible warning and visual display on the workstation VDU sets this type of alarm apart from the other alarms.

Interviews with the train controllers confirmed that the controller was absent from the UTC workstation that controls this section of track (UTC2) when the SPAD at MR5 occurred. The initial response to this alarm was initiated by the train controller at the adjacent UTC1 workstation. This controller had to stop what he was doing, move to the UTC2 workstation and cancel an alarm that read 'ALM Queensport Rd Level Crossing Failed at MURARRIE'¹⁰ that was already displayed in order to bring up the SPAD alarm details on the UTC2 workstation VDU. The emergency call for train Y245 to stop was subsequently made 16 seconds after the SPAD alarm first sounded.

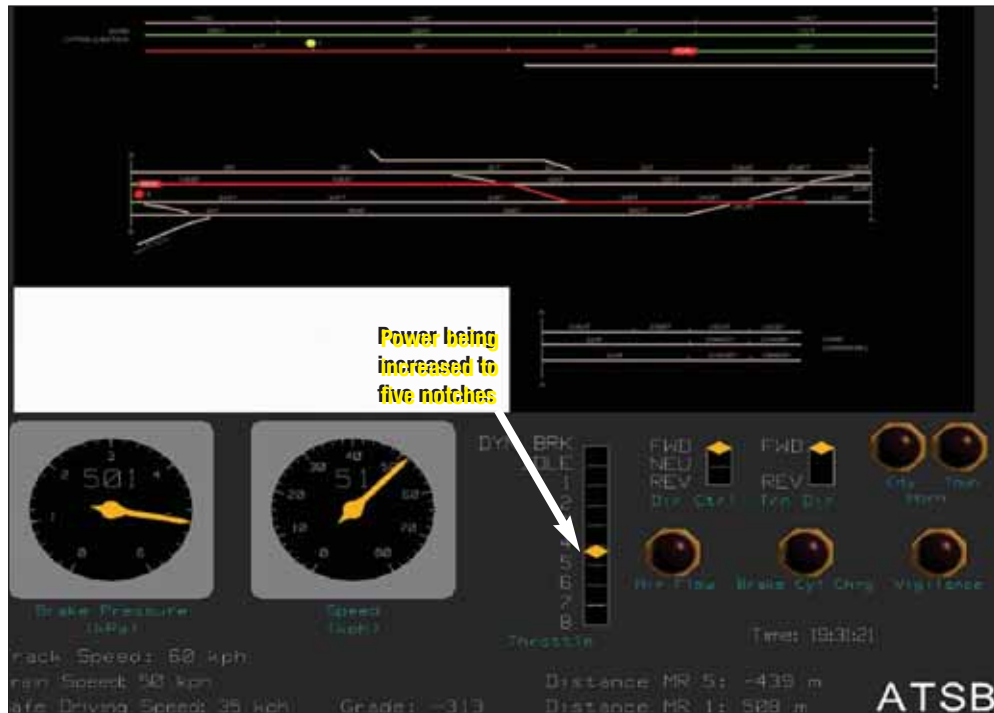
FIGURE 9: 1931:21 train Y245 439 metres from signal MR5, power being increased to five notches

At 1931:21, when 439 metres from signal MR5, the driver advanced the throttle from three notches to five notches.

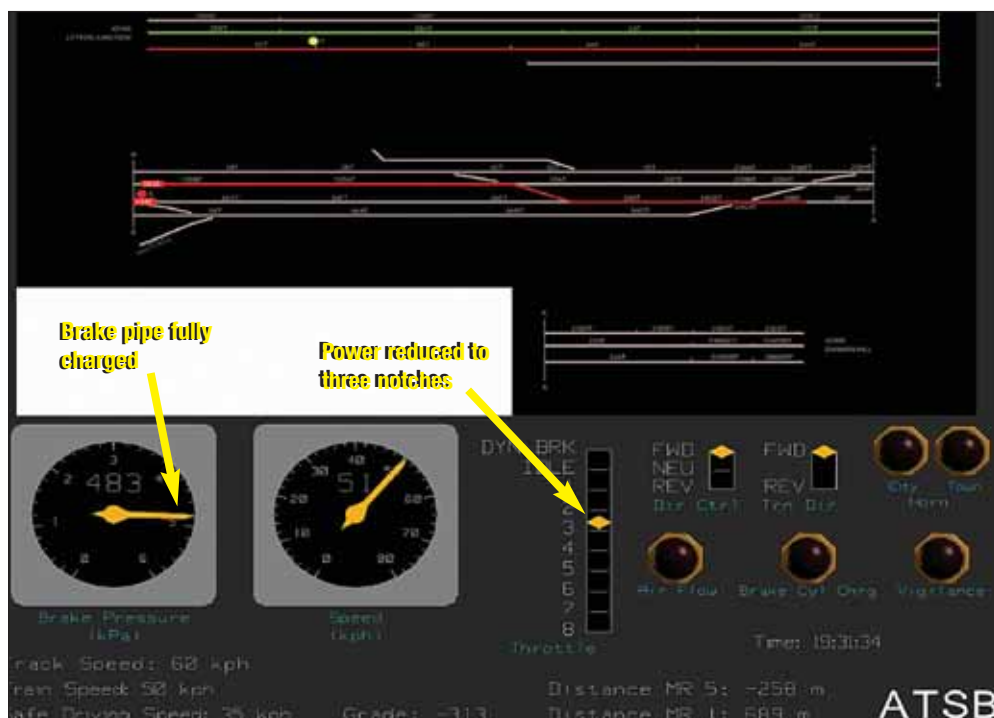
FIGURE 10: 1931:34, train Y245 at sighting distance (258 metres) from signal MR5

Thirteen seconds later at 1931:34 the throttle setting was lowered and one second later was in notch two. The speed of Y245 was 51kph and slowly decreasing; the brake pipe was fully charged and independent brake released. At 1931:34 train Y245 was 258 metres from signal MR5, which is the unrestricted sighting distance of signal MR5 as measured during this investigation.

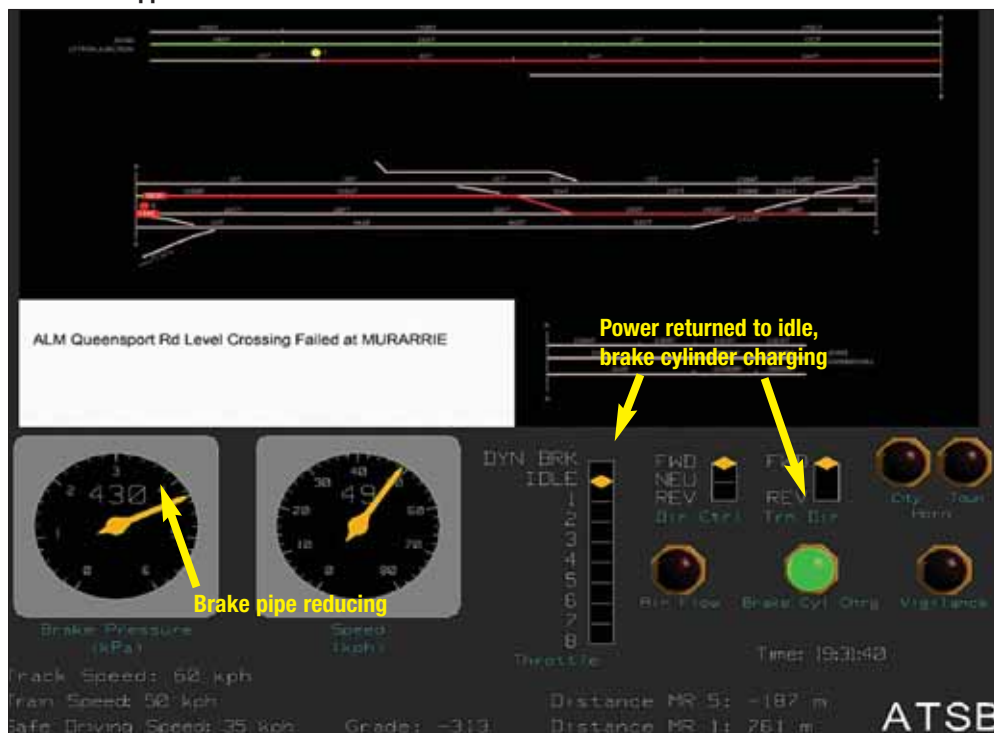
FIGURE 11: 1931:40, brake application initiated, UTC Queensport Road level crossing alarm first appears

Five seconds later at 1931:39 the brake pipe pressure was recorded at 465 kpa in lieu of 501 kpa. This is the first recorded indication of a brake pipe pressure reduction during this analysis. However, as the ATP data logger only records any change greater than 20 kpa, the initiation of this brake application occurred in the moments prior to 1931:39. By this time train Y245 was 201 metres from signal MR5.

One second later, at 1931:40, the throttle was moved from notch two to idle and the locomotive brake cylinder was recorded as 'on' indicating at least a partial application. It appears that this driver-initiated brake application was, momentarily, a service application followed quickly by an emergency brake application. This is indicated by a gradual, then rapid drop in brake pipe pressure. At the same time, a UTC alarm shown as 'ALM Queensport Rd Level Crossing Failed at MURARRIE' appeared at the UTC2 train controller workstation. By this time train Y245 was 187 metres from signal MR5.

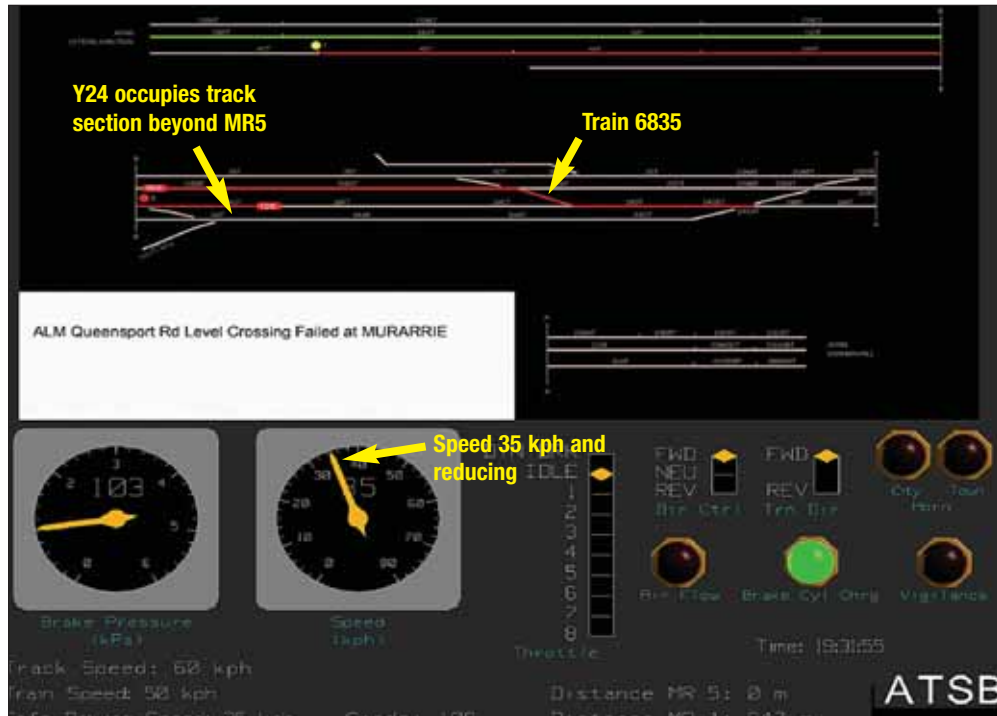
FIGURE 12: 1931:55, train Y245 occupies 'track 24G' beyond signal MR5

At 1931:55 train Y245 occupied 'track 24GT' that is immediately beyond signal MR5, passing this signal at stop in the process. The speed of Y245 was now 35 kph and decelerating, the throttle was in idle and the brake pipe pressure 103 kpa and locomotive brake cylinder charged. The UTC alarm 'ALM Queensport Rd Level Crossing Failed at MURARRIE' at the UTC2 workstation had yet to be acknowledged. At 1931:57 the audible SPAD alarm at the Mayne Control Centre activated.

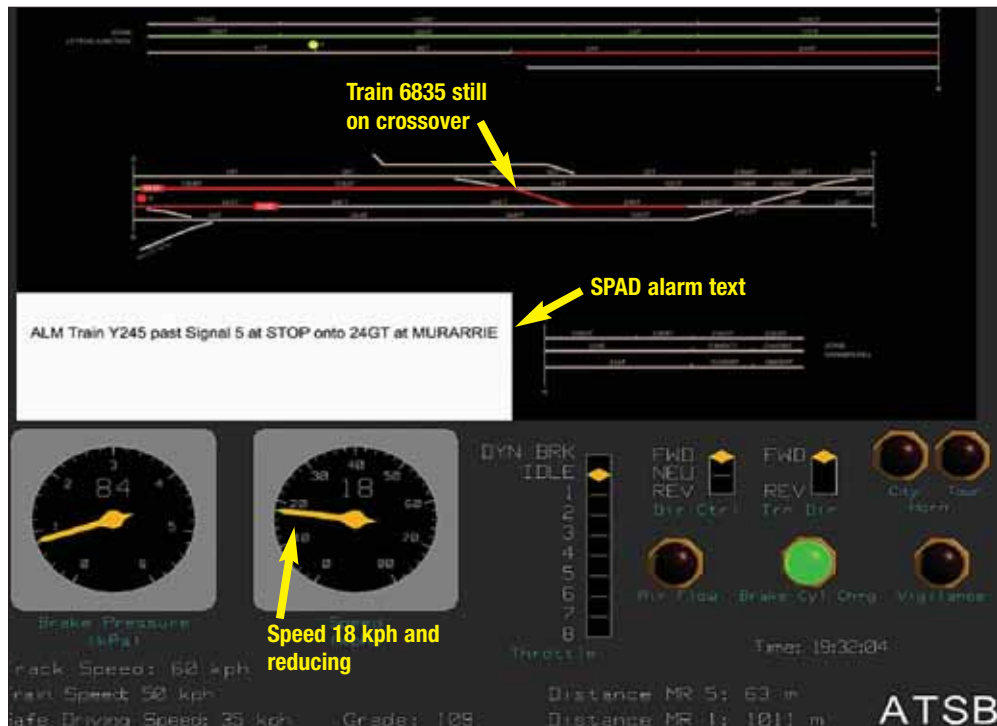
FIGURE 13: 1932:04 SPAD Alarm appears at the UTC2 workstation

At 1932:04 'ALM Queensport Rd Level Crossing Failed at MURARRIE' was acknowledged and a message reading 'ALM Train Y245 past Signal 5 at STOP onto 24GT at MURARRIE' appears on the VDU at the UTC2 workstation.

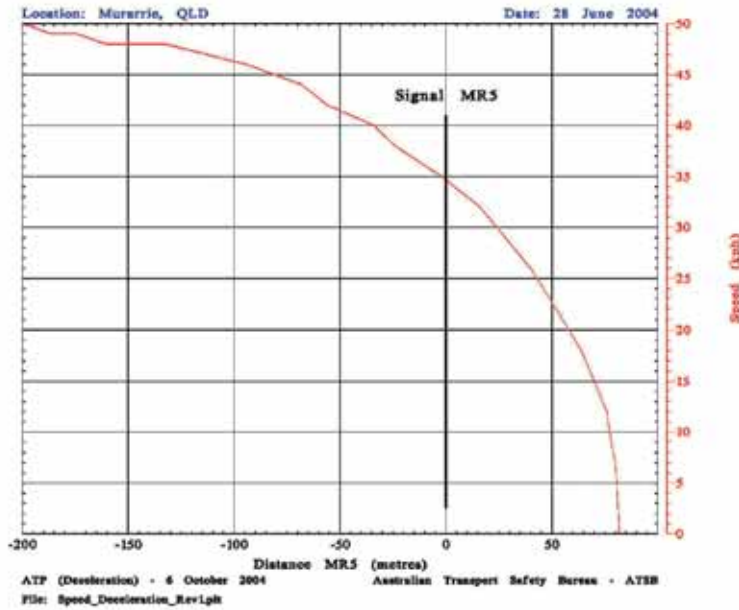
FIGURE 15: Theoretical braking curve, train Y245

Scenario	Explanation/Question	Outcome
No further acknowledgement of the VCS after passing and acknowledging the station protection magnet and driver has not acted on red signal.	The station protection magnet is 2034 metres from signal MR5. If train Y245 maintained the speed of 61kph as recorded at the station protection magnet where would it stop after the VCS timed out 93 seconds later?	Train Y245 would have stopped approximately 23 metres prior to signal MR5.
Driver has not acted on red signal. Train controller is at workstation and transmits emergency radio message at 1931:59.	1931:59 is two seconds after the SPAD alarm sounded. Two seconds has been allowed to acknowledge the alarm and comprehend what is being displayed. The original transmission lasted 14 seconds and the driver has been allowed two seconds to make an emergency application at the conclusion of this transmission (1932:15) Train speed is 50kph.	Train Y245 would have stopped approximately 544 metres past signal MR5. This is about 42 metres prior to the potential collision point.

Driver has not acted on red signal. Train controller is not at workstation, emergency radio transmission sent at 1932:13.	1932:13 is the actual time the radio transmission was sent to train Y245. The original transmission lasted 14 seconds, the driver makes an emergency application two seconds later at 1932:29 and the train speed was 50kph.	Train 245 would have stopped approximately 738 metres past signal MR5. Train 6835 would have cleared these points by this time (within seconds).
Driver has not acted on red signal. Emergency radio transmission is not sent or acknowledged.	If train Y245 retained a constant speed of 50kph from 201 metres from signal MR5 would a collision have occurred with train 6835?	Train Y245 would have arrived at the potential collision point at about 1932:36. Train 6835 cleared track MR 24E at 1932:37. A collision could have occurred.
Train Y245 was travelling at the 'safe driving speed' ¹³ (after having passed signal MR1 at yellow) and the driver saw signal MR5 at stop when about 200 metres from it.	Train Y245 was 614.30 metres long. Because the rear of this train was still on the 50kph curve the safe driving speed is 35kph. If the driver made an emergency application in the moments after sighting signal MR5 at stop at about 200 metres away where would train Y245 have stopped?	Train Y245 would have stopped in about 151 metres, some 49 metres prior to signal MR5.

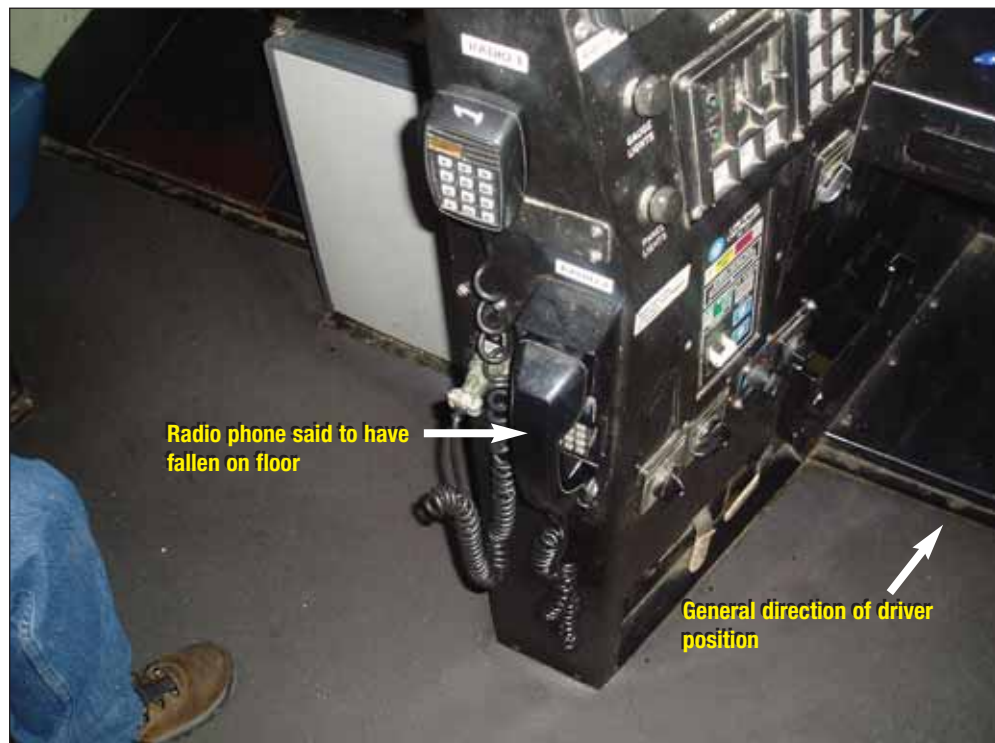
FIGURE 16: 2800 locomotive radio

In this instance, although neither the signal sighting nor the dislodging of the radio hand-set are considered directly causal to the SPAD, the falling radio hand-set may well have contributed to the aspect of signal MR1 being forgotten. This memory lapse could have led to the reversion back to normal ‘clear signal’ driving and, ultimately, to the SPAD.

There is recorded and anecdotal evidence of other drivers reporting radio hand-sets falling from their cradles on the 2800 class locomotives. Modifications to the phone hand-sets are currently being considered and implemented by Queensland Rail.

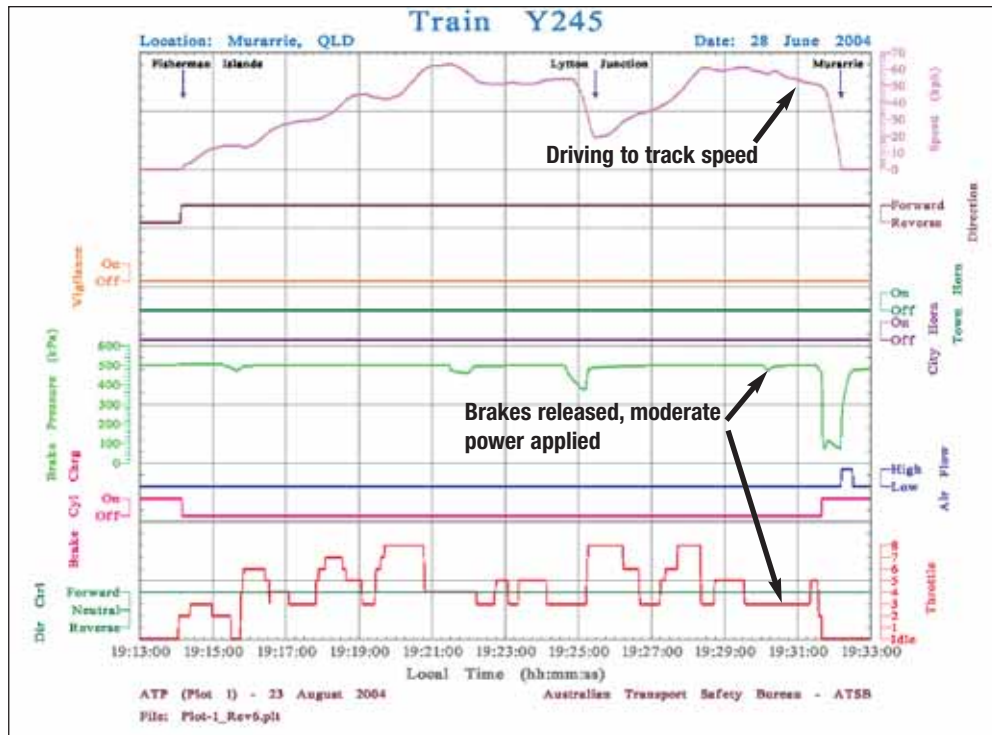
FIGURE 18: Data logger readout, Fisherman Islands to Murarrie, 'clear signal' driving

The driver was fully qualified and very experienced. On 28 June 2005 he was apparently anticipating a run with Y245 through Murarrie without stopping. For a driver of his experience the task was primarily ‘skills based’ – essentially routine, requiring limited cognitive processes such as driving to the road and monitoring the signals and track ahead. Routine tasks involving ‘automatic’ responses can lead to inattention or distraction, a state of mind ‘in neutral’, where past experience influences a persons actions or inactions.

The driver, to the best of his recollection, had never stopped at signal MR5 on any previous occasion and his perception was that train control liked to ‘keep you moving’ when driving a 2800 class locomotive on the dual gauge. This perception is supported by the low frequency of red aspects presented to trains at MR5 from 01 March to 25 July 2004. It is possible, or even probable, that the driver was not appropriately concentrating on the task at hand. In this state an unexpected ‘out of course event’, such as the radio hand-set becoming dislodged to the floor, could distract the driver such that he forgot an intended action formulated only moments before.
