ATSB TRANSPORT SAFETY INVESTIGATION REPORT
Rail Occurrence Investigation 2006/011
Final

Collision between
freight train 4AM3
and an
elevated platform vehicle
at North Geelong in Victoria

26 October 2006

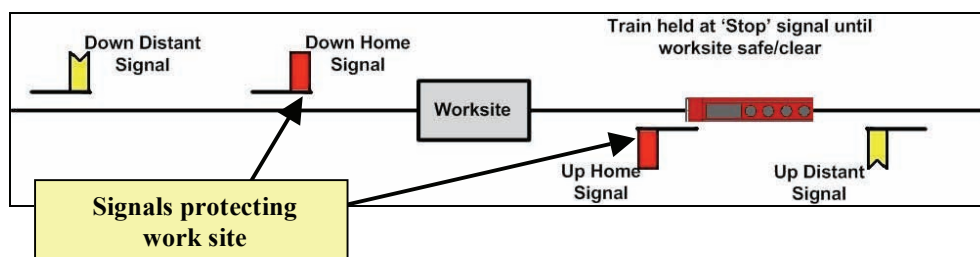
Figure 9: Diagrammatic representation of ‘section 15, rule 5’

would be more productive to use an alternative method of safeworking for protecting the site instead of ‘track warrant’ access. This alternative method of safeworking (section 15, rule 5 of the network rules) required that the North Geelong ‘C’ signal box was switched-in. Under section 15, rule 5 the two men understood that only verbal authority (that of the track protector to the signaller) was required before clearing the protecting signals (see Figure 9) either side of the work site. Once the protecting signals had been cleared, a train had authority to proceed through the work site.

4. Section 15, rule 5 of the network rules is only applicable for ‘Two Position Lower Quadrant Signalling’ areas and should not have been used at the Separation Street overpass work site which had ‘Three Position Signalling’. Further, section 15, rule 5 stipulates additional but unspecified levels of site protection by the ‘Ganger’. The level of protection needs to be qualified to ensure the correct intent of the rule is observed. Neither of these important qualifications is apparent when reading section 15, rule 5 of the network rules.
[Safety Issue]

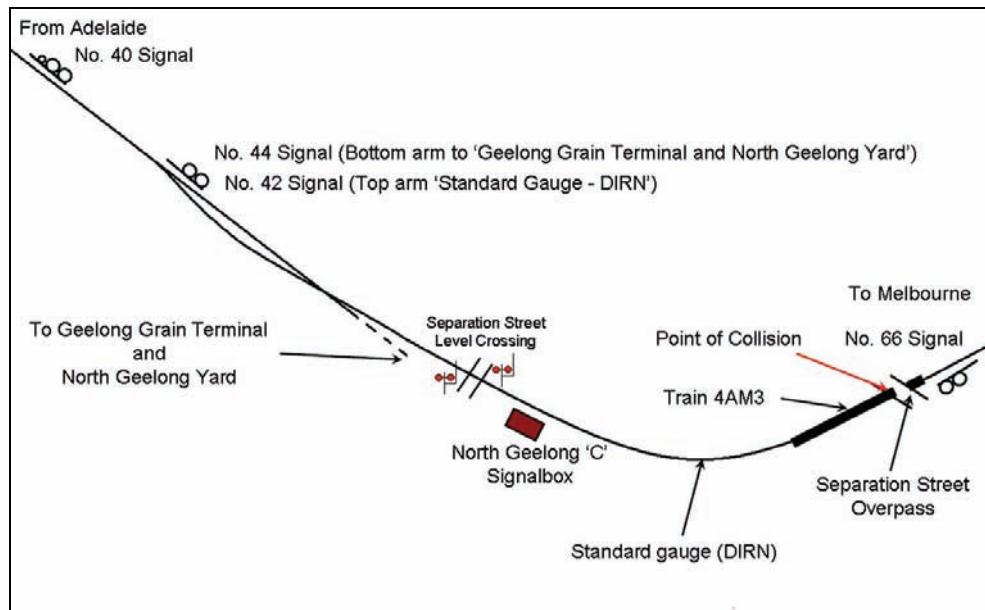
Figure 10: Approaches to Nth Geelong 'C' Signalbox. Work site at Separation Street overpass located on the DIRN

The EM80 was recorded as passing the Nth Geelong 'C' signalbox at about 0802. Phone records show that the track protector then rang and spoke to the signaller at 0801:54. Following this telephone call the track protector authorised work to commence on the overpass structure. The employee who was later injured in the collision with 4AM3, climbed into the basket of the elevated platform vehicle and manoeuvred it until it was directly beneath the bridge structure. He started cleaning the support beams using a high speed grinder. The basket of the elevated platform vehicle, with the worker in it, was now foul of the standard gauge main line.

At this time train 4AM3 was approaching the North Geelong 'C' signalbox with No. 40 Signal displaying a proceed indication and No. 42 Signal, the signal in advance of the work site, also displaying a proceed signal (having been previously cleared by the North Geelong 'C' signaller). The train driver observed the signals to be at clear signifying authority to pass through North Geelong unhindered. He slowed the train to a speed of approximately 17 km/hr for a temporary speed restriction and then increased the train speed to about 30 km/h in advance of a curve speed restriction of 50 km/h near the North Geelong 'C' signalbox. A short time later train 4AM3 passed over the Separation Street level crossing. The train was now entering the sweeping left hand curve leading to the Separation Street overpass, with buildings and vegetation obscuring the driver's view of the work site ahead. When the locomotive cleared the buildings and vegetation the train was travelling at a speed of 32 km/h. At this point the train driver saw the elevated platform vehicle at the overpass and realised that it was fouling the track. He made an immediate emergency brake application and sounded the locomotive horn.

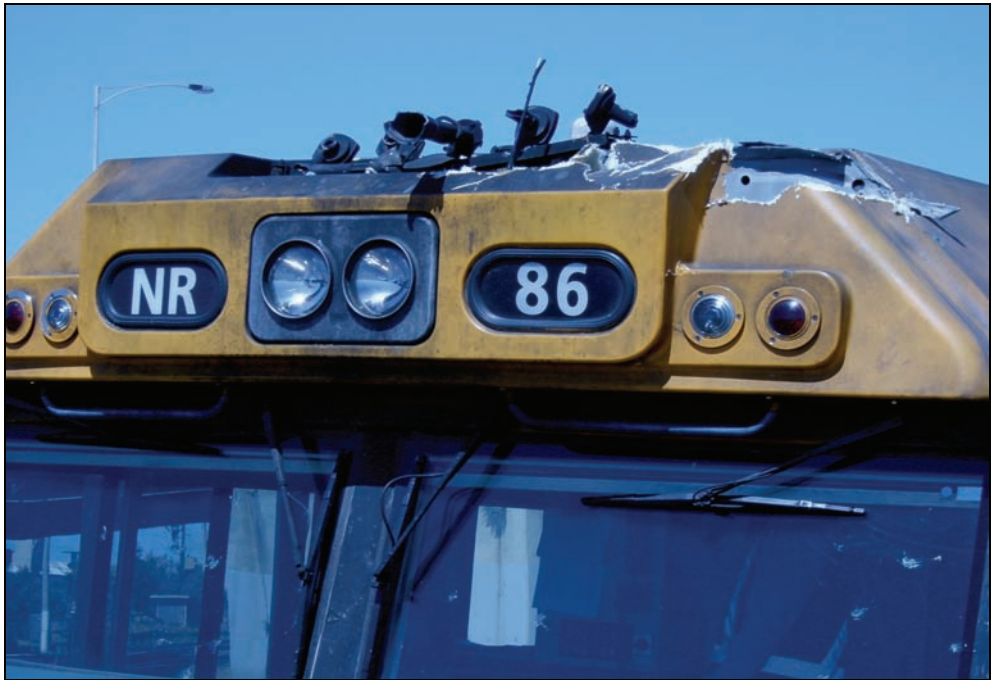
Figure 11: View of damage to cowling on locomotive NR86

Locomotive NR86 sustained only minor damage to the cowling and horn cluster above the driver's cab (Figure 11), there was no damage to the trailing locomotives and wagons. There was no observed damage to the elevated platform vehicle (Figure 12).
