ATSB TRANSPORT SAFETY INVESTIGATION REPORT

Technical Analysis Investigation – 200700054

Crankshaft Failure Analysis - Rotax 912 Engine

TL Ultralight TL-2000 Sting Sport

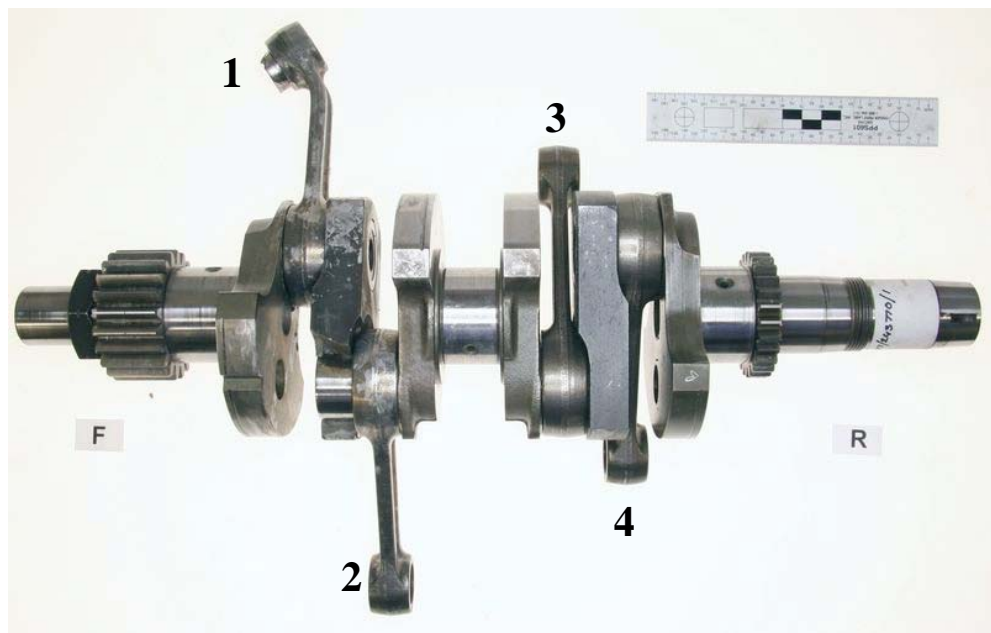
The crankshaft from the Rotax 912 ULS engine was received as shown in Figure 1, with the connecting rod journals numbered one through four. The crankshaft used in the Rotax 912 engine was of a composite construction. Each of the forged connecting rod journal sections had been press-fit¹ into two web sections between journals one and two, and also between journals three and four. The crank web between the number one and number two connecting rod journals was found fractured in two locations, shown more clearly in Figure 2.

Figure 1: Rotax 912 crankshaft, as-received, with cylinders numbered.

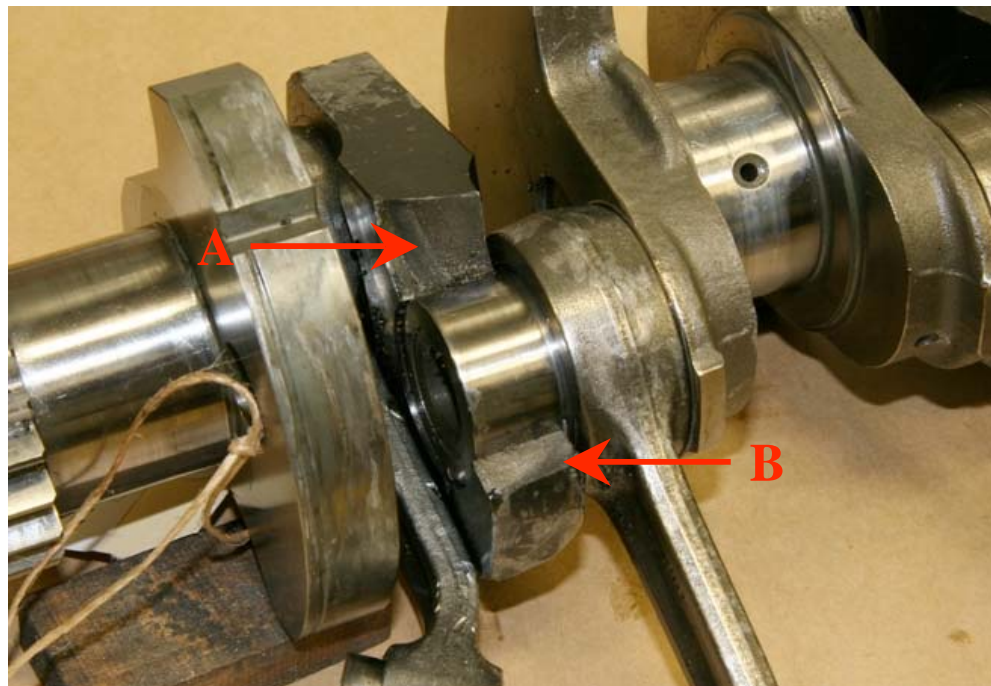
The liberated section of crank web was also recovered with considerable impact damage consistent with being loose in the rotating engine. The failed crank web and the surrounding connecting rods all exhibited impact damage from the liberated section of web.

Figure 2: Section of crank web failed in two locations (labelled 'A' and 'B') at the number two journal.

The crank web failed in two locations, marked 'A' and 'B' as shown in Figure 2.

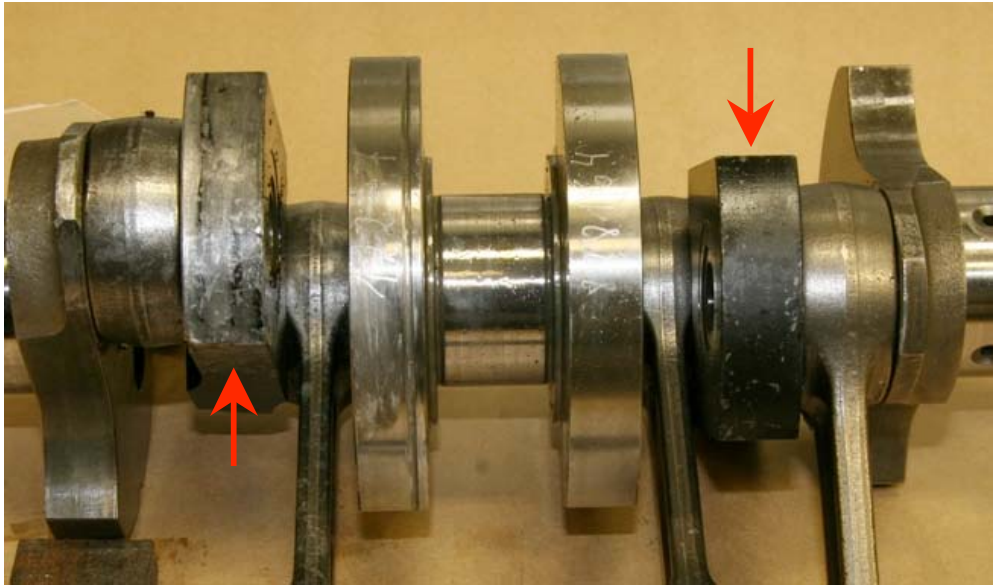
There was misalignment evident along the crankshaft due to twisting of the connecting rod journals within the crank web sections (Figure 3). Twisting was evident at all four journals, but particularly noticeable when comparing the positions of the counterweights adjacent to the number one and four journals. The movement was consistent with the direction of engine rotation.

Figure 3: Twist evident in the crankshaft.

While there was misalignment evident in the crankshaft, the investigation could not establish if it had been pre-existing or if it developed as a result of forces sustained during the final mechanical breakdown of the engine.

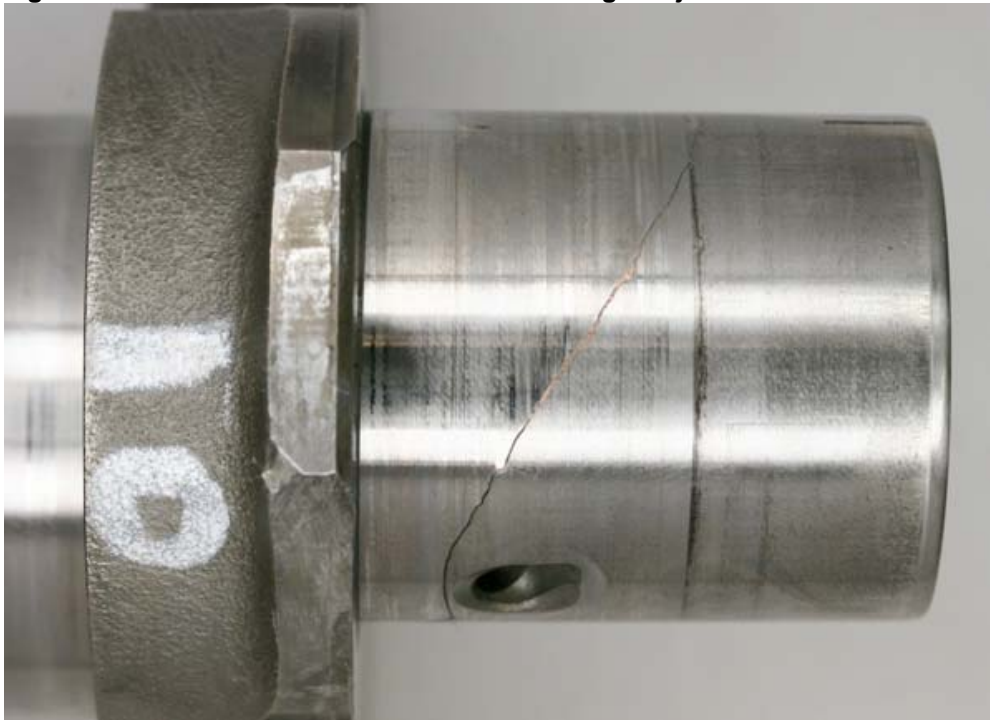
The web section was removed from the number one and two connecting rod journals. The journal was found to have an extensive crack running from the web, approximately 270 degrees around the journal on a 45 degree angle (Figure 4).

Figure 4: Crack in the number one connecting rod journal.

The number one journal fatigue crack, as shown in Figure 4, had progressed approximately 270 degrees around the journal, but had not completely separated the journal at the time of disassembly. The journal was sectioned so that the fracture surface could be examined. Both halves of the journal are shown in Figure 11. Visual examination of the fracture surface showed beach marks radiating out from a point in the relief radius between the web and journal, in close proximity to the oil galley (Figure 12).

The loss of the interference fit in the number two journal to crank web section, may have contributed to a higher loading condition which resulted in the fatigue crack observed in the number one journal. The appearance and 45 degree angled progression of the crack in the number one connecting rod journal was consistent with fatigue through cyclic torsional loading.

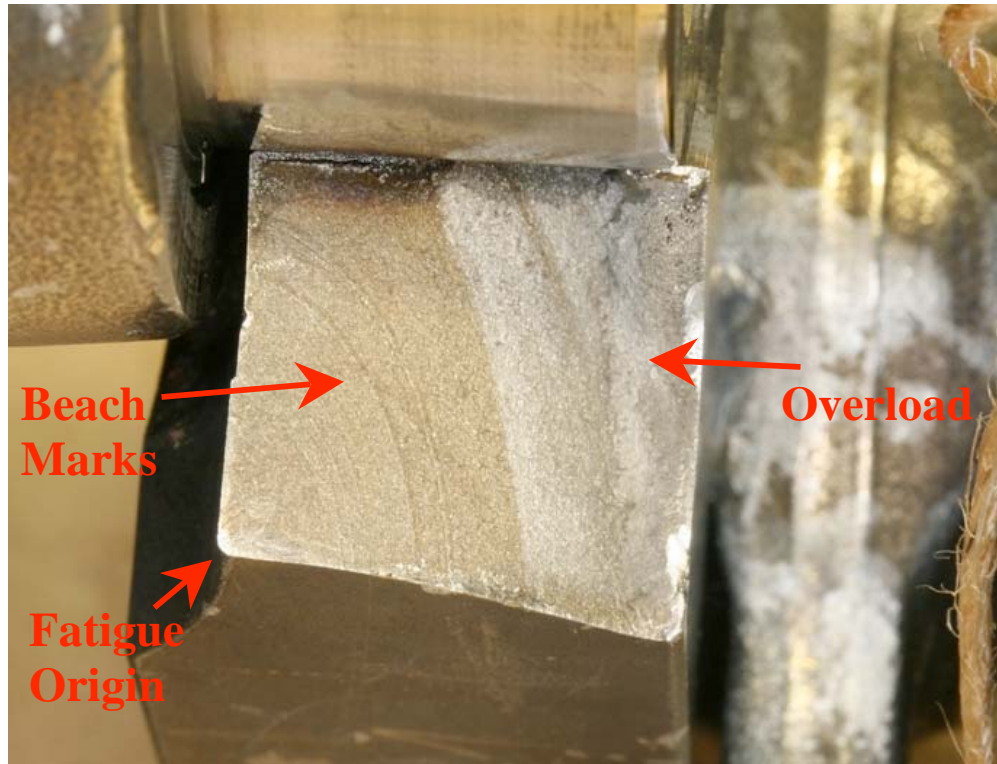
Visible on fracture surface at 'A' was a series of beach marks originating at one corner on the outside of the crank web and progressing through the section to a final overload region, where the part failed catastrophically. Beach marks are associated with fatigue failures and indicate the location of the advancing crack front. Beach marks radiated outward from the crack origin which was one of the outside corners of the web as indicated in Figure 5.

Figure 5: Failure 'A' in crank web.

- The crankshaft from the Rotax 912 ULS engine (serial number 4.427.607) failed as a result of the initiation and propagation of fatigue cracking in the web section that spanned the number one and number two connecting rod journals.

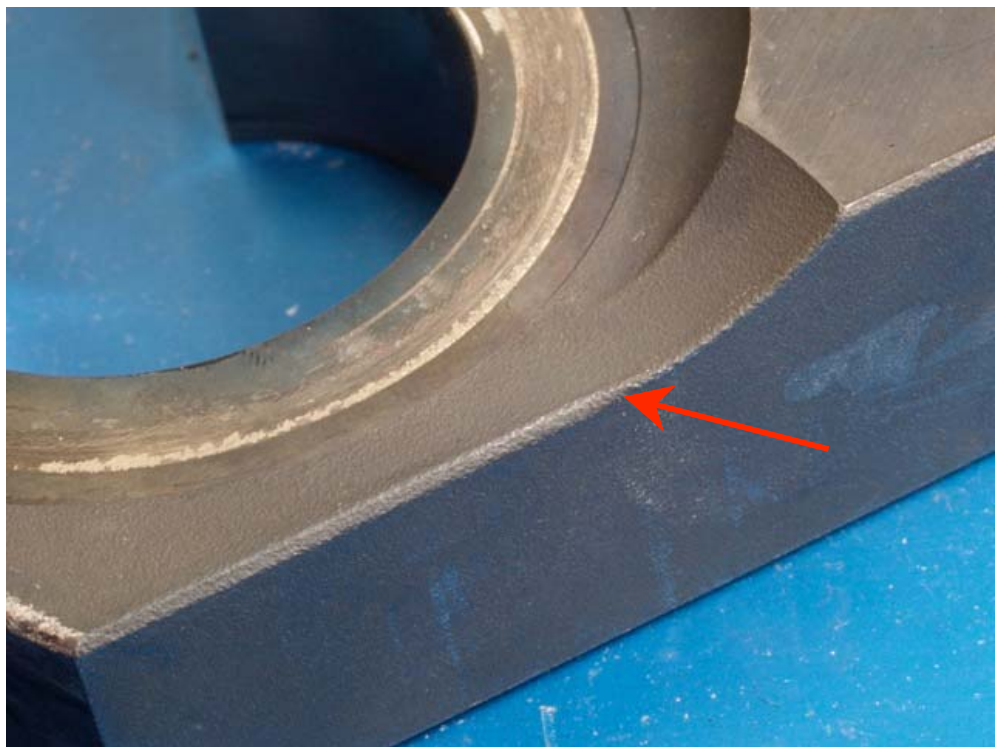
The fracture at 'A' occurred at a reduction in the crank web cross-sectional thickness and originated at the end of the edge chamfer, at a point equivalent to that indicated in Figure 6. The surface of the web section exhibited a textured, dimpled appearance consistent with shot-peening. Peening is surface treatment mechanically applied to fatigue-critical parts to improve the fatigue life.

Figure 6: Web section opposite failure site showing change in section thickness and similar location of crack initiation.

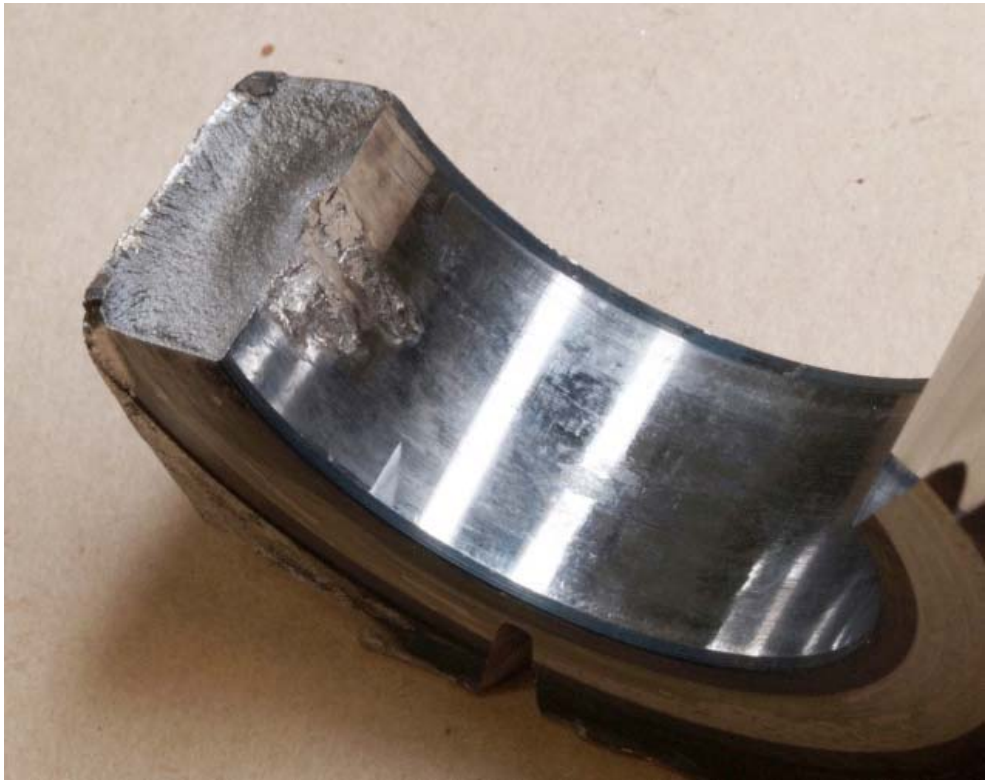
Fracture 'B' occurred through the crank web where the cross sectional area was at a minimum. Visual examination showed galling wear adjacent to the fracture, on the surface in contact with the number two journal (Figure 7) and also on the number two journal (Figure 8). Galling is the result of microscopic welding caused by high-friction sliding contact between mating parts.

Growth of the web cracks would have reduced the interference loads on the journal-web joint, allowing for some high-friction movement, as evidenced by the adhesive wear between the web and journal prior to the liberation of the web section.

Beach marks were also readily visible on the fracture surface at 'B'. The marks appeared to originate from one of the areas of galling.

Figure 7: Failure 'B' in crank web with adhesive wear on journal contact surface.

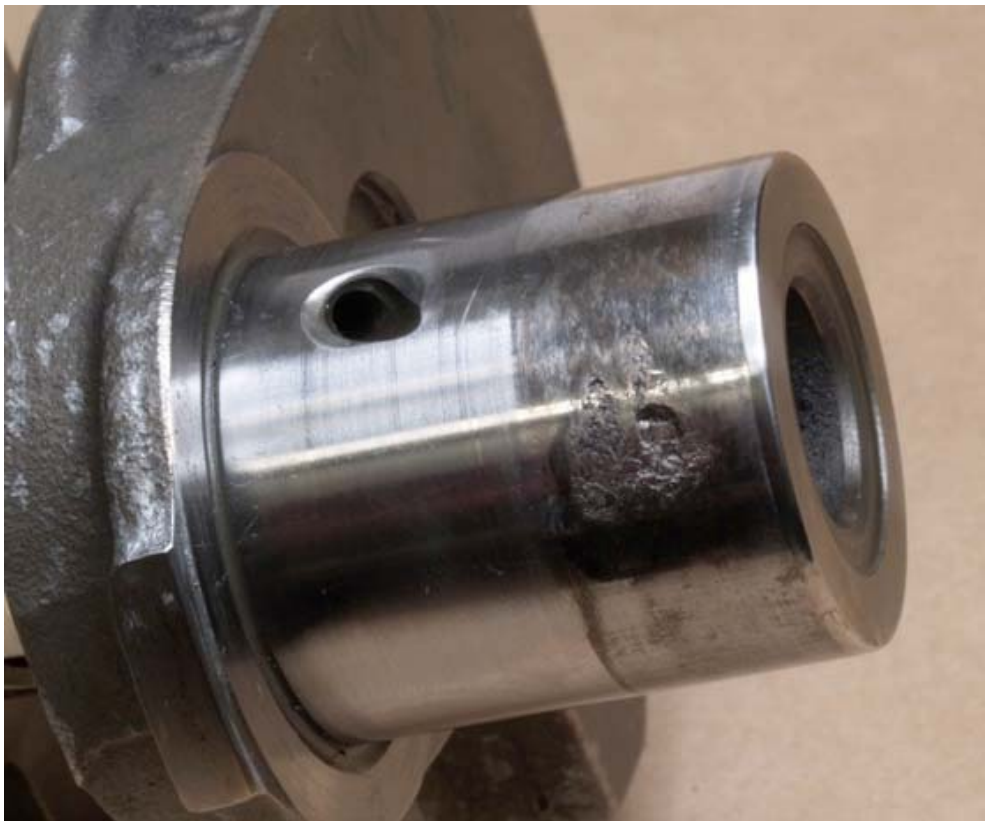
Figure 8: Adhesive wear on number two connecting rod journal.

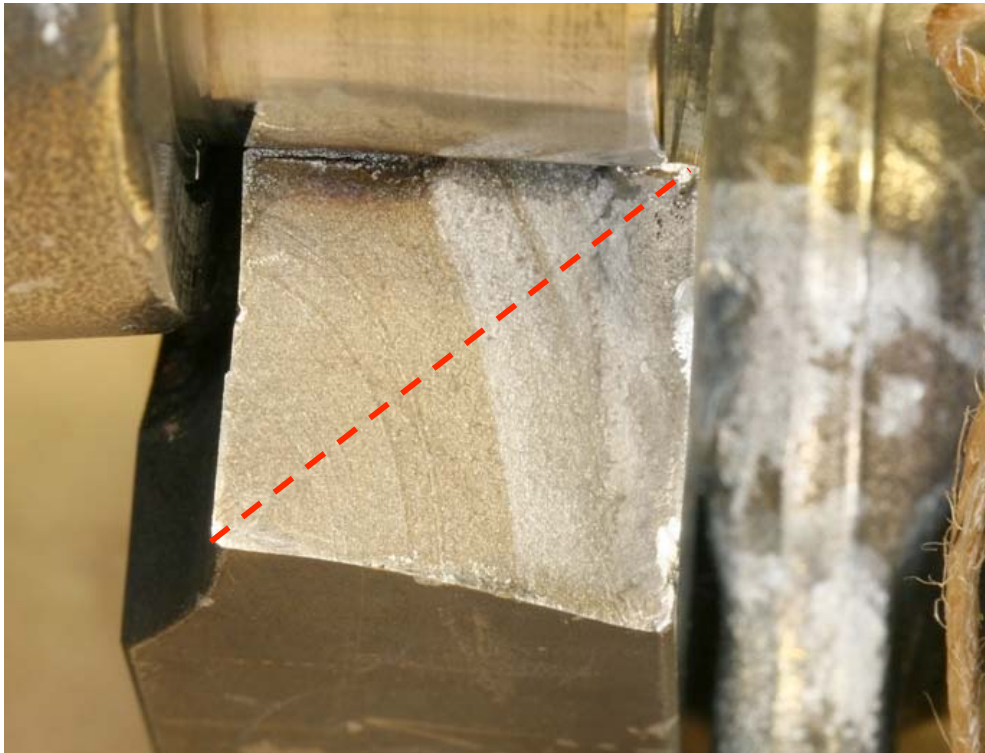
A metallographic section was prepared through the fracture at 'A' (Figure 9). The section was taken perpendicular to the fracture surface, diagonally through the crack origin and the opposite corner. There were no indications of inclusions or defects. When examined in the etched condition (Figure 10), the section appeared to have a predominantly martensitic structure. There was a change in microstructure approximately 200-300 microns below the surface of the web and an unetched, white layer on the surface. Neither of these features were considered to be related to the fracture, but were consistent with the part being case-hardened by nitriding.

Figure 9: Orientation of metallographic section taken perpendicular to fracture surface 'A'.

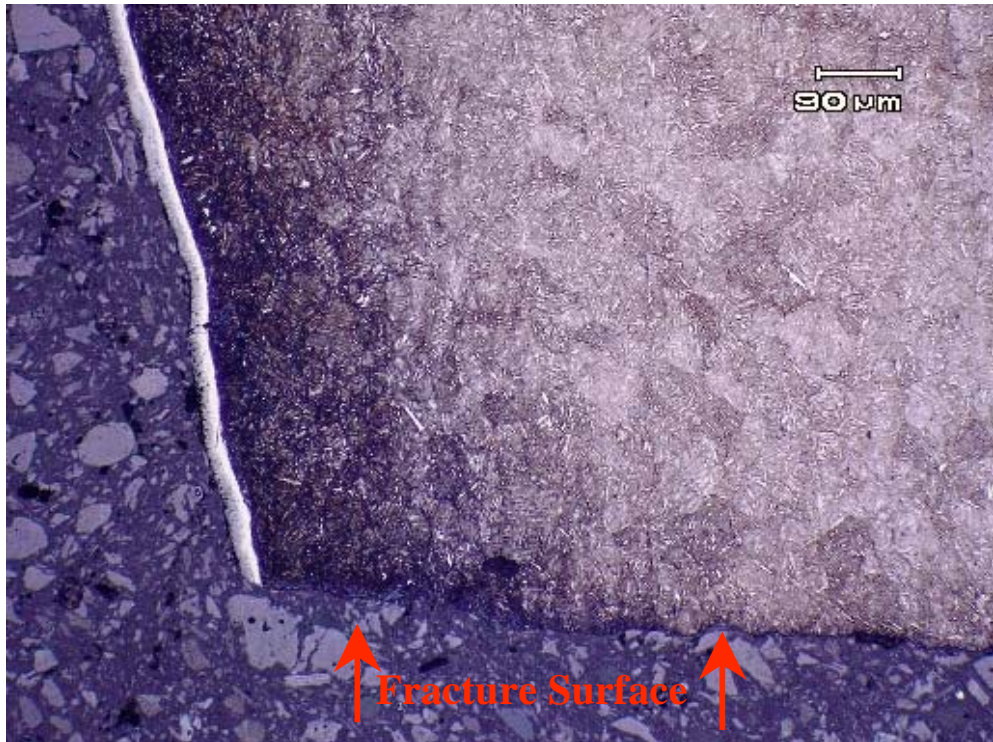
Figure 10: Metallographic section through fatigue origin at 'A'.

These results confirmed that both parts had been subjected to a surface hardening treatment. The presence of the white layer on the surface of the web section (Figure 10) was consistent with that which is typically formed during the nitriding process. The absence of the white layer and the greater case depth observed in the journal section was more consistent with a carburising process.

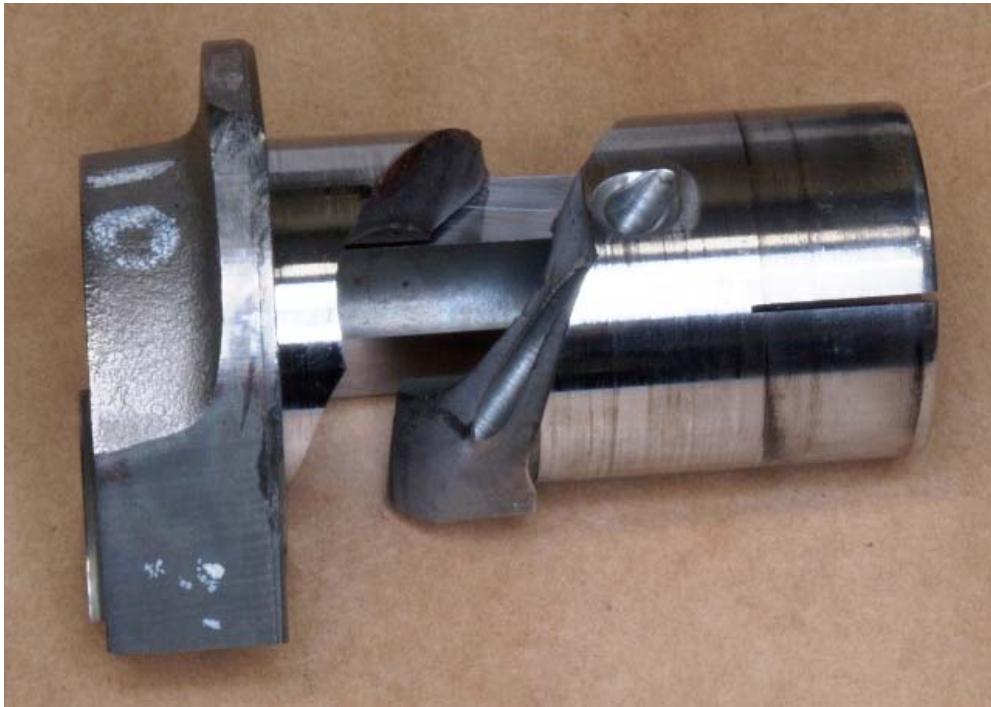
Figure 11: Failed number one connecting rod journal.

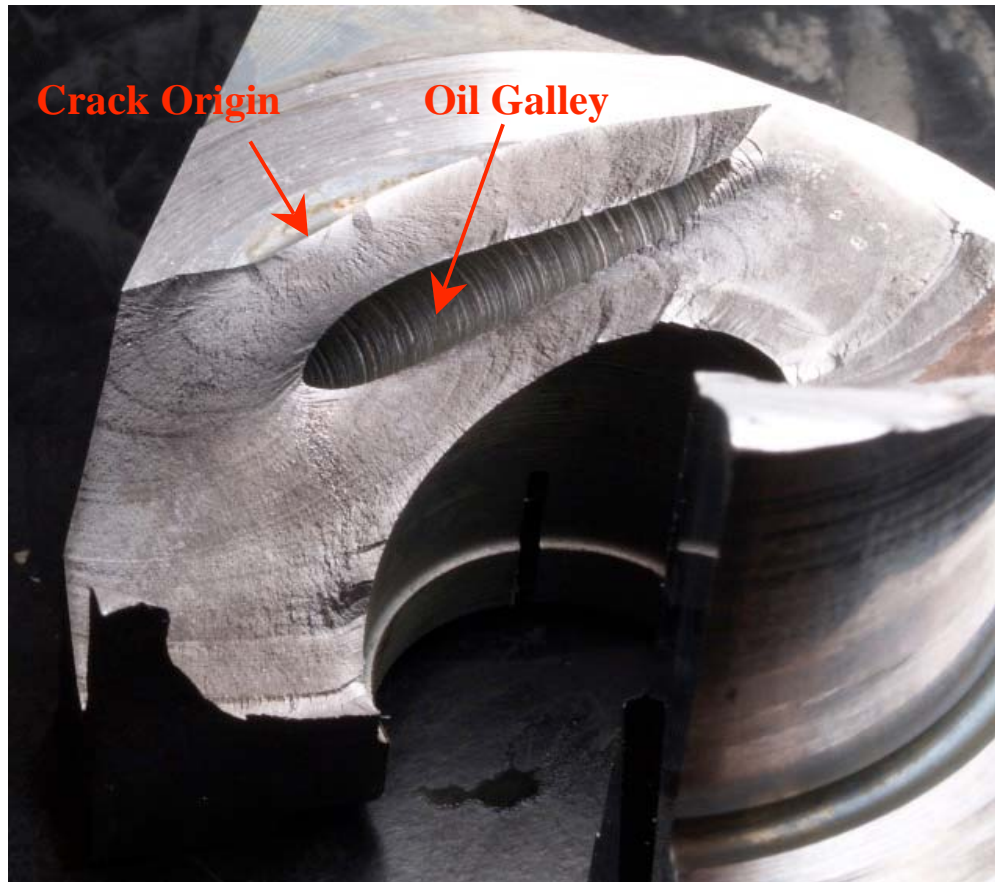
Figure 12: Number one connecting rod journal fatigue surface. Arrow indicates fatigue initiation site.

Optical and scanning electron microscopy of the fracture surface site did not reveal any anomalies. As with the web failure, a metallographic section was taken through the crack origin indicated in Figure 12, perpendicular to the fracture surface.

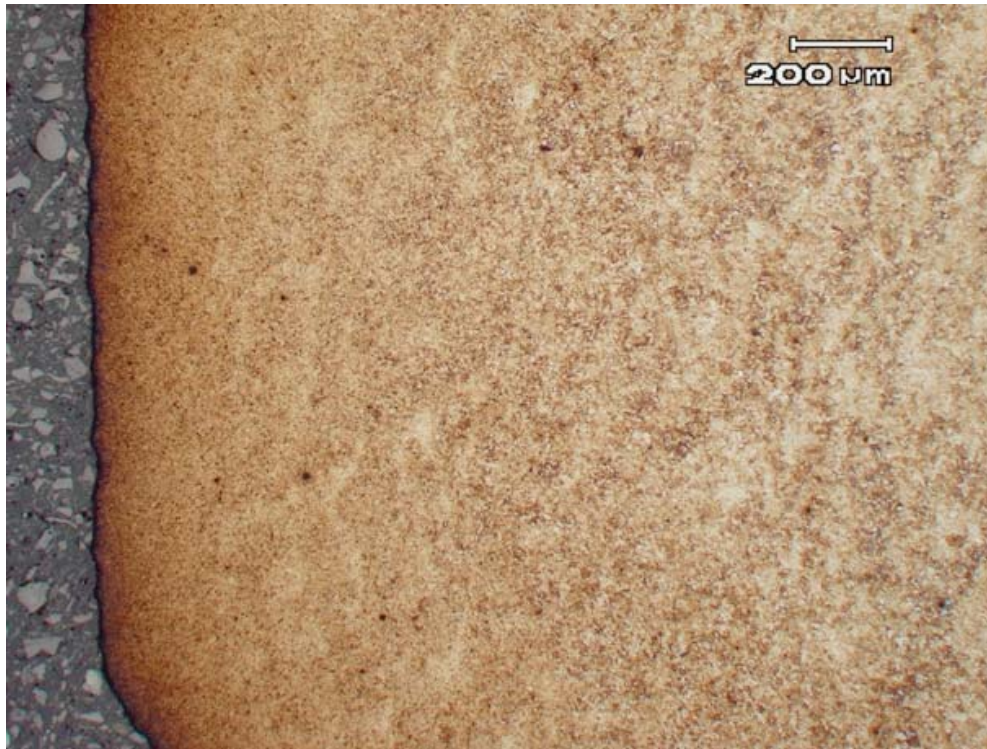
Figure 13 shows a micrograph through the journal surface. There was a visible difference in the microstructure between the journal surface and the core of the material. The microstructure was also visibly different from that observed in the web section and was consistent with a surface hardening treatment.

Figure 13: Microstructure of the number one journal cross section.
