RAIL SAFETY INVESTIGATION
2004/002

Derailment of Freight Train 6SM9V

Alumatta, Victoria
15 March 2004

Rail Safety Investigation into the Derailment of Train 6SM9V

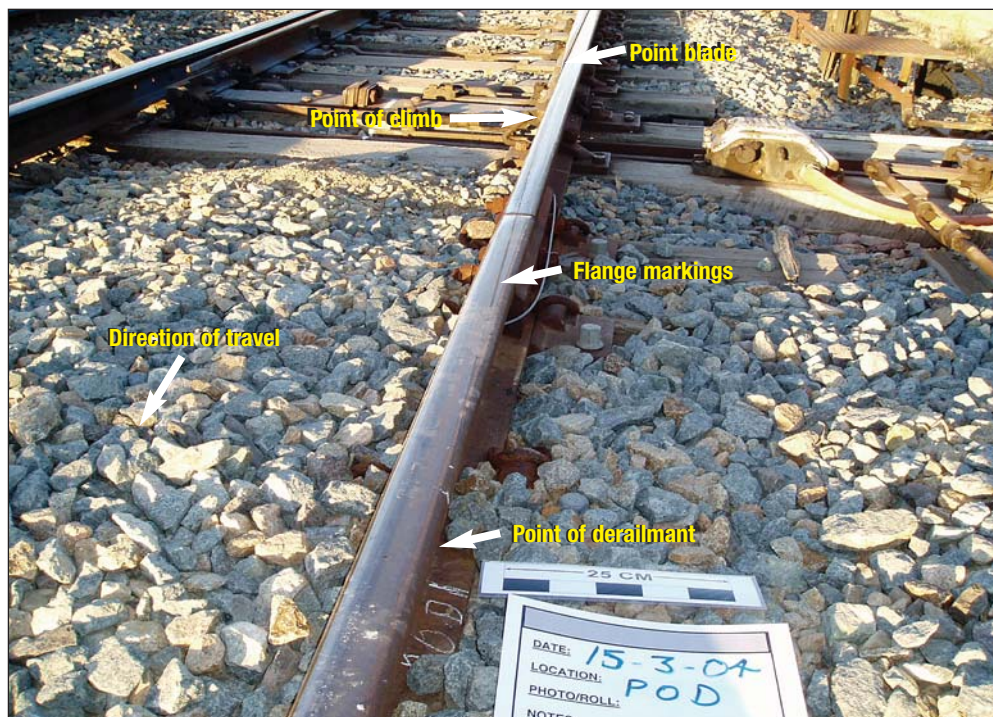
FIGURE 3: Point of derailment, Alumatta

Both wheels of the fourth axle of VQCY 850X remained on the rails for 10.8 metres from the point of climb whereupon the left wheel derailed to the eastern side of the left rail. The right wheel of the fourth axle then travelled through the 'frog' of the crossing loop/main line points and derailed immediately after. At this time the trailing bogie of wagon VQCY 850X was completely derailed. The derailed wheels then struck the eastern point blade of the Alumatta crossing loop points and points machine causing damage to both components. A small metal object was propelled through the window of an adjacent residence as a result of the derailed wheels striking and deflecting track fasteners and other debris. No injuries resulted. The initial point of climb was at the 231.860 kilometre mark and the point of derailment was at the 231.85745 kilometre mark.

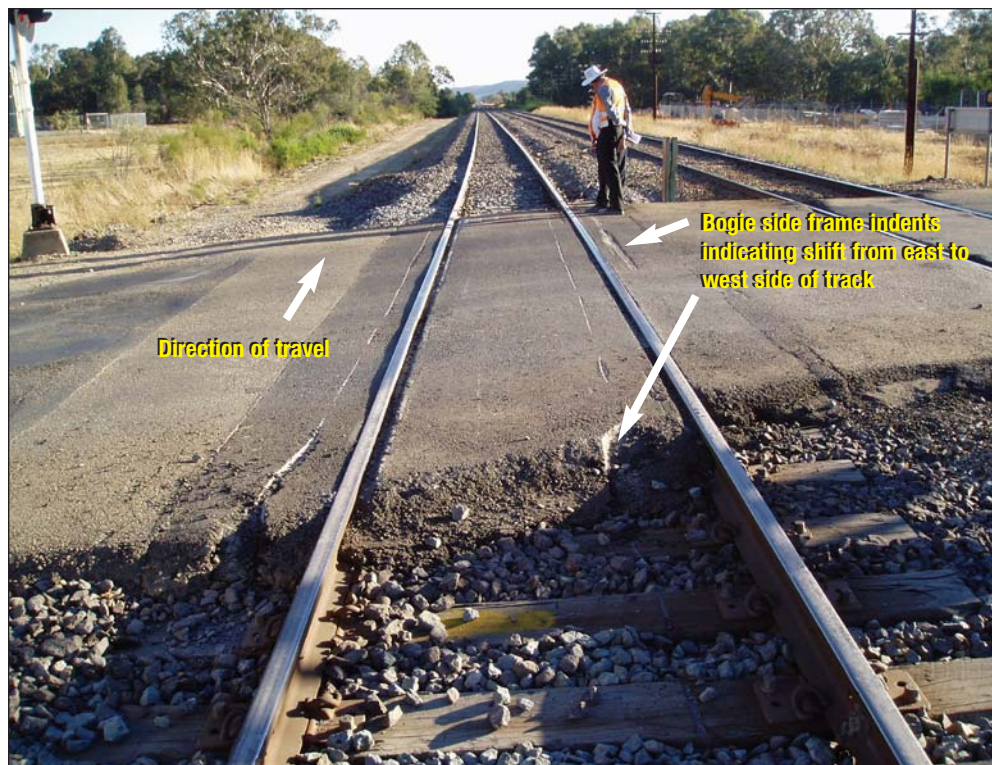
FIGURE 4: Shanley Street level crossing, looking south

At the Shanley Street level crossing (230.352 kilometre mark) flange marks were again evident on the eastern side of both rails on the asphalt surface. There was also a significant indent consistent with the initial impact of the right bogie side frame as the level crossing was encountered. This indent was on the eastern side of the right rail. Then, about half way along this crossing, gouge marks of similar width and characteristics appeared on the crossing surface. Immediately beyond this level crossing, commencing at the fourth sleeper, there were marks on the western side of the right rail that were consistent with the heavy impact of the right bogie side frame 'bottoming out' after the level crossing had been traversed. It would seem that the right side bogie side frame crossed from the east to the west side of the right rail as it traversed this crossing (see figure 4).

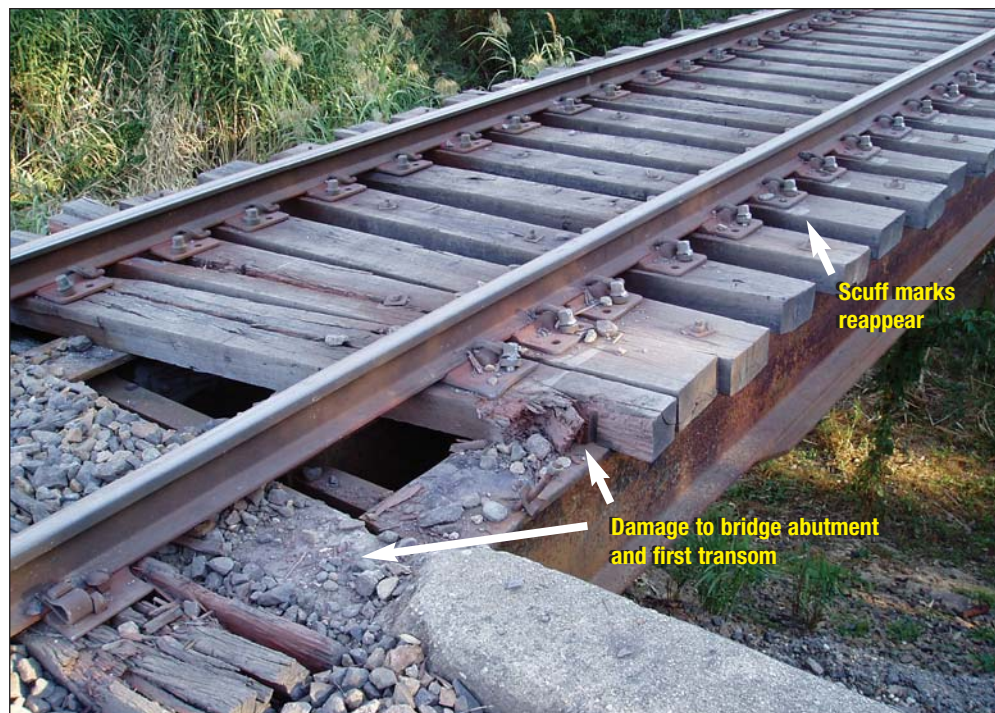
FIGURE 5: Damage to concrete abutment and transom

The standard gauge infrastructure was damaged to a varying extent along the derailed route. There was no damage to the adjacent broad gauge infrastructure. Damage to the standard gauge infrastructure was confined to track fastenings, sleeper displacement and severing of track circuit cabling. There was no significant rail damage except at the turnout at Alumatta and in the immediate vicinity of Dellaro Road level crossing. Some transoms and rail fastenings on the bridge over Fifteen Mile Creek were damaged but no structural damage to the bridge itself was incurred.

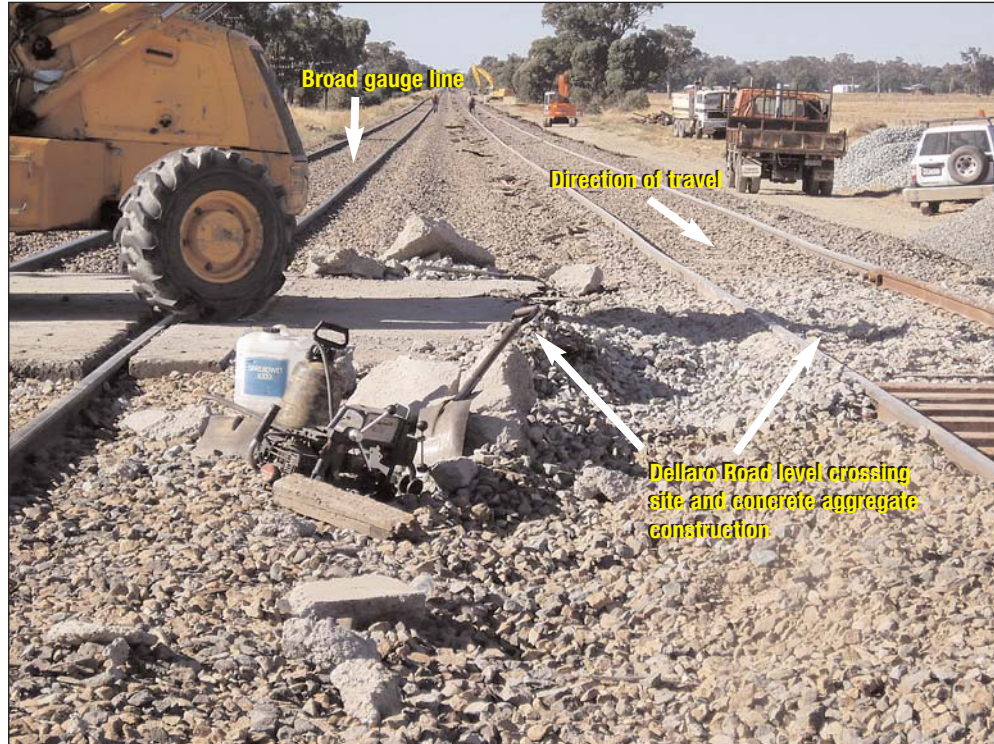
FIGURE 7: Dellaro Road level crossing under repair

The Dellaro Road level crossing is constructed of concrete aggregate. Severe damage was caused to this crossing when the derailed bogie struck it. In the aftermath, large portions of concrete aggregate were spread over the immediate vicinity of this level crossing.

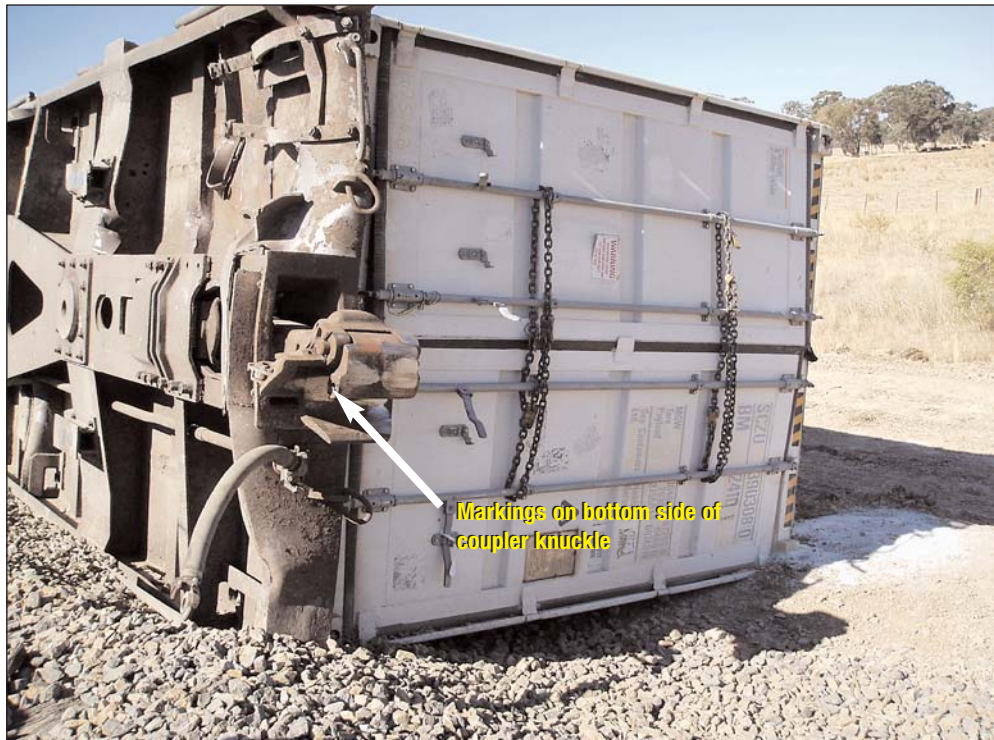
FIGURE 8: Trailing wagon at the recovery site

Markings and the position of the bogies and wagon VQCY 952K at the recovery site indicate this wagon had derailed and separated from train 6SM9V due to the bogie of the adjacent wagon, VQCY 850X, becoming dislodged at the Dellaro Road level crossing. The trailing wagon, VQCY 952K, then travelled over the dislodged bogie, dislodging both of its bogies. Markings on the coupler knuckles between these two wagons also indicate that the deck of VQCY 850X dropped while the deck of the trailing wagon, VQCY 952K, lifted as the dislodged bogie fouled the trailing wagon.

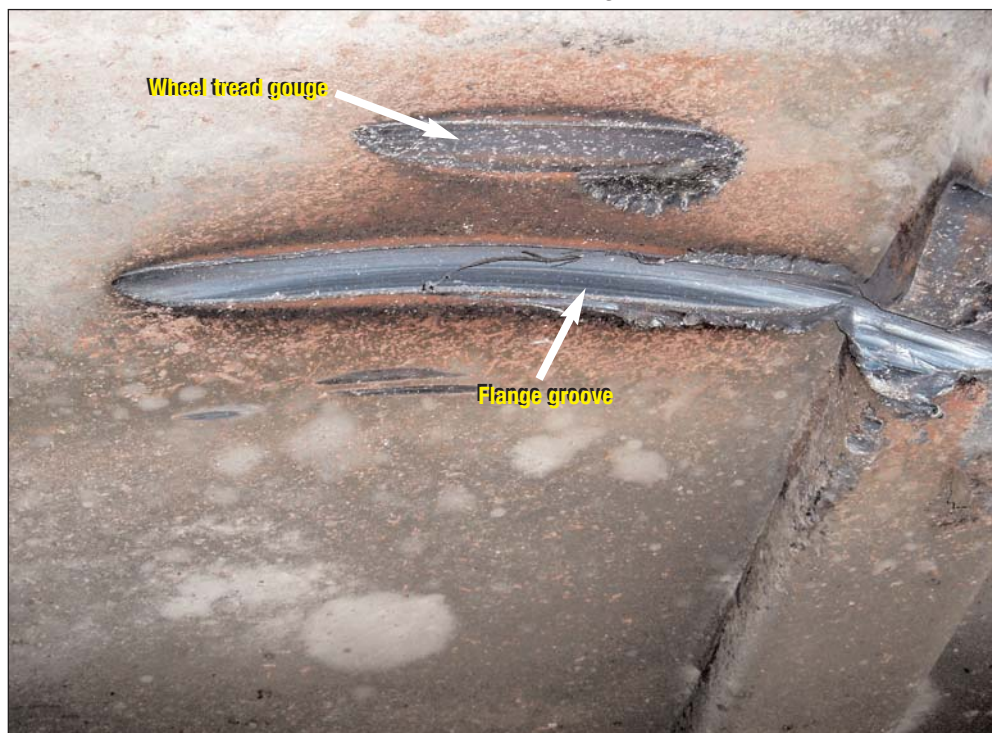
FIGURE 9: Indent marks underside of VQCY from wheel flange

The wheel flange and tread grooves under the right side of the wagon body could have only been made as a result of either the dislodgement of bogie spring nests and/or the disengagement of the bogie side frame from the axle box keeps. While the investigation has not been able to detail conclusively the exact sequence in this regard, the right wheels of the derailed bogie had assumed a raised position under the wagon to allow these grooves to be made. Because the wheel flange and tread groove were almost directly above and slightly inwards from the normal projected position of the wheels of this bogie, it is considered that this contact occurred prior to the rearward and angular displacement of the bogie bolster that caused contact between the bolster and swage lock bolts. This contention is supported by the location of an outer spring on the east side of the standard gauge track 52.4 metres from the point of derailment and the later location of the right side bogie side frame scuff marks along the west side of the track between Sandford and Shanley Street level crossings. To further support the contention that this displacement was the result of the derailment and subsequent dynamic trauma, metallurgical testing indicated that the metal hardness of the swage lock bolt collars was less than the bogie material. This indicated the wear observed to the swage lock bolt collars was sacrificial to that of the bogie bolster material. This leads to an indication that the

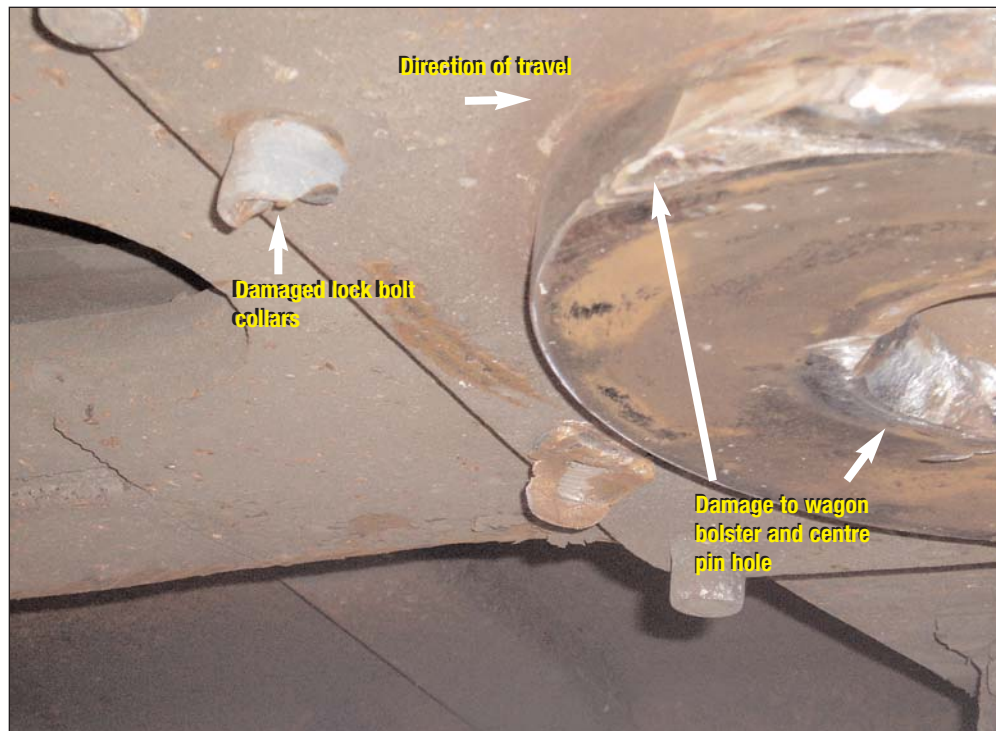
FIGURE 10: Damage to lock bolt collars and wagon bolster

The wagon showed damage to the two rear bolster plate swage lock bolt collars and localised deformation at the sides of the wagon bolster matching the deformation evident on the bogie centre plate. The damage to the swage lock bolt collars and the localised deformation to the wagon bolster indicated that the bolster had experienced angular and linear displacement during operation.

The bent centre pin and damage caused to the wagon bolster bowl and swage lock bolt led to some conjecture that the wagon and bogie may have been disengaged prior to the derailment at Alumatta. During testing the wagon body was lifted from the replacement bogie to see if sufficient displacement could be attained to allow contact between these components with the centre pin engaged and the bogie bolster horizontal. Contact could not be made. The only way in which such contact could occur would be by angular displacement of the bogie bolster combined with a bent centre pin. Extreme forces would be necessary for this to occur, such as a bogie being dragged beneath the wagon at speed.

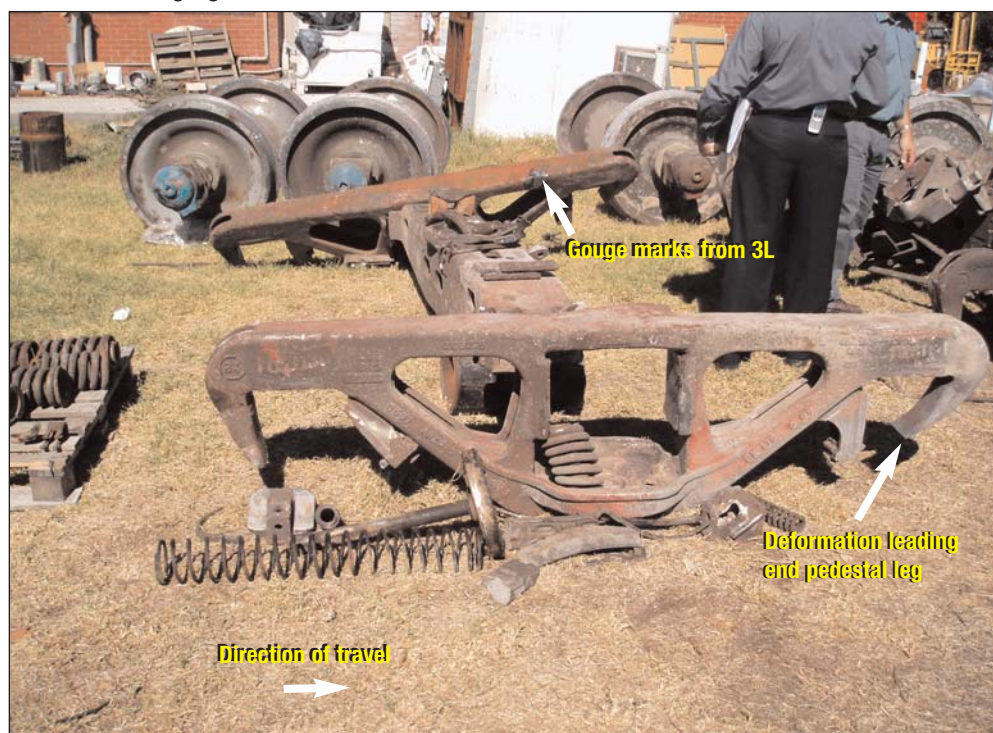
FIGURE 11: Recovered components of bogie VXSC 15611 showing deformation of leading pedestal leg and gouge marks from wheel 3L

The independent examination commissioned by the ATSB identified damage to the pedestal frame. The examination concluded that some of the damage had occurred as a result of contact with the ballast/track work. The report determined that the damage to the pedestal was caused by instantaneous overload as a result of the derailment.

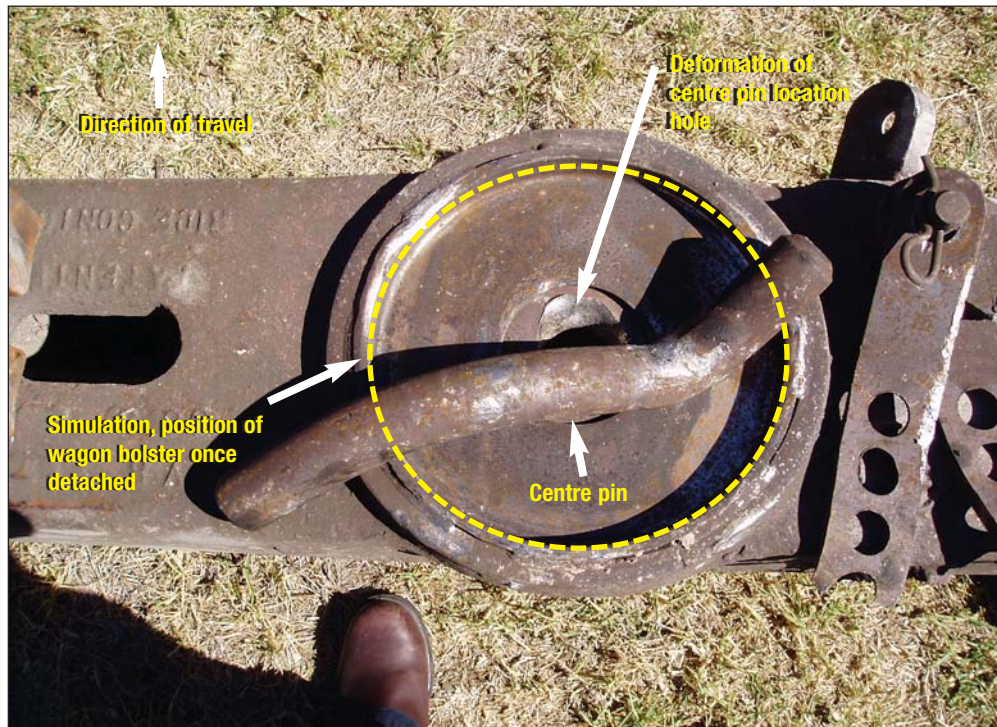
FIGURE 12: View of bogie bolster centre plate bowl area and centre pin deformation

Similarly, deformation of the bolster in the gib clearance region and the absence of excessive wear make it probable that the dislodgement of the right side frame from the bogie resulted from the initial derailment and subsequently being dragged in a derailed state. There was no sign of pre existing cracking that would suggest failure of the side frame.

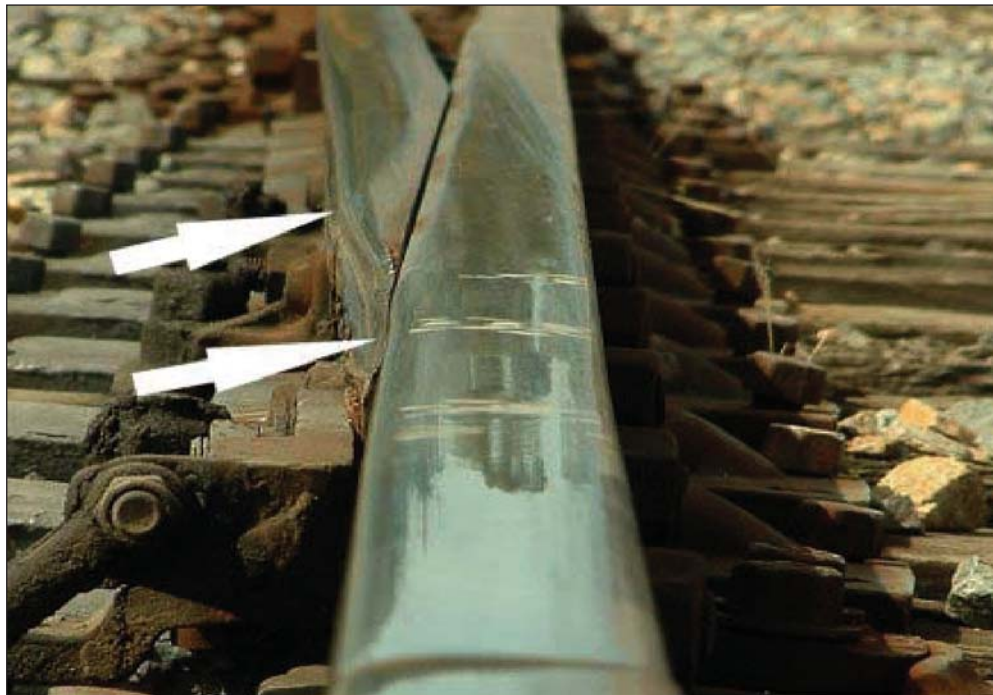
FIGURE 22: Alignment and flared nature of last 500mm of east point blade

At figure 22 a photo of the east point blade can be seen. The last 500 mm of the east point blade was hollowed out. Indications are that some wheels followed a projected line of this point blade (not contacting the hollowed portion) and some followed the actual point blade profile.

Should the latter path be taken, the stock rail is impacted immediately beyond the toe of the point blade. If this were not so, the gauge corner would not be crushed down at the tip of the switch point. Figure 23 shows these two paths, the black dotted line is the path that the majority of wheels take. The red solid line indicates the approximate path of the wheels that follow the point blade alignment. The evidence indicates that the wheel that derailed did not curve back onto the straight stock rail but carried on across the stock rail head in the direction indicated by the blue arrow.

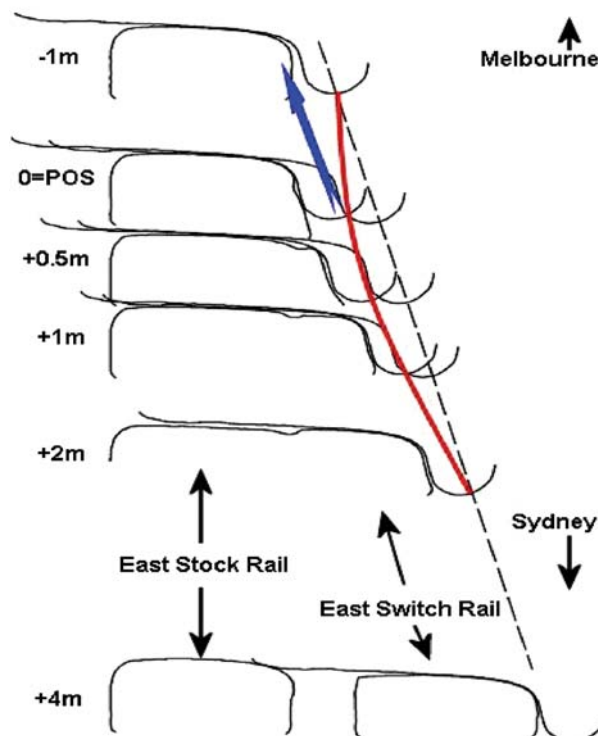
FIGURE 23: Wheel paths over east point blade

Observation of southbound trains travelling via the crossing loop at Alumatta showed that most wheels followed the projection of the point blade rather than closely conforming to the actual alignment. This meant that the wheel flange met the stock rail somewhere along the stock rail beyond the toe of the point blade. In observing the point of climb at the very end of the point blade point though, it is apparent that the first wheel to derail followed a path closely conforming to the actual alignment of the last portion of the point blade. If such an alignment is followed, the wheel tread is well over the head of the stock rail and the flange would be very close to, or in contact with, the point blade gauge face. There are two issues to be considered. Firstly, the wheel will contact the stock rail immediately beyond the toe of the point at an acute angle and secondly, this tracking will lead the outer side of the wheel tread into contact with the outer or field side of the closure and stock rails.

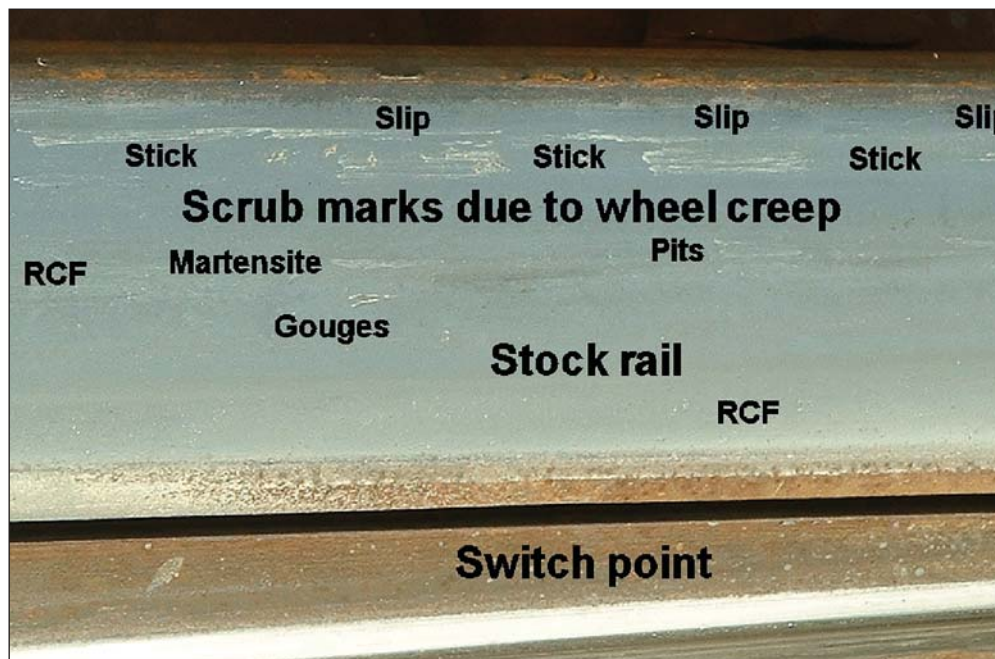
FIGURE 26: Rail wear pattern

However, the fact remains that in order for the wheel to climb there must be a lateral force that is significant enough to overcome the vertical wheel load. In addition, draft or buff forces¹⁹ should not have been excessive given that by the time this portion of the train exited the turnout power had been applied for about 126 metres.

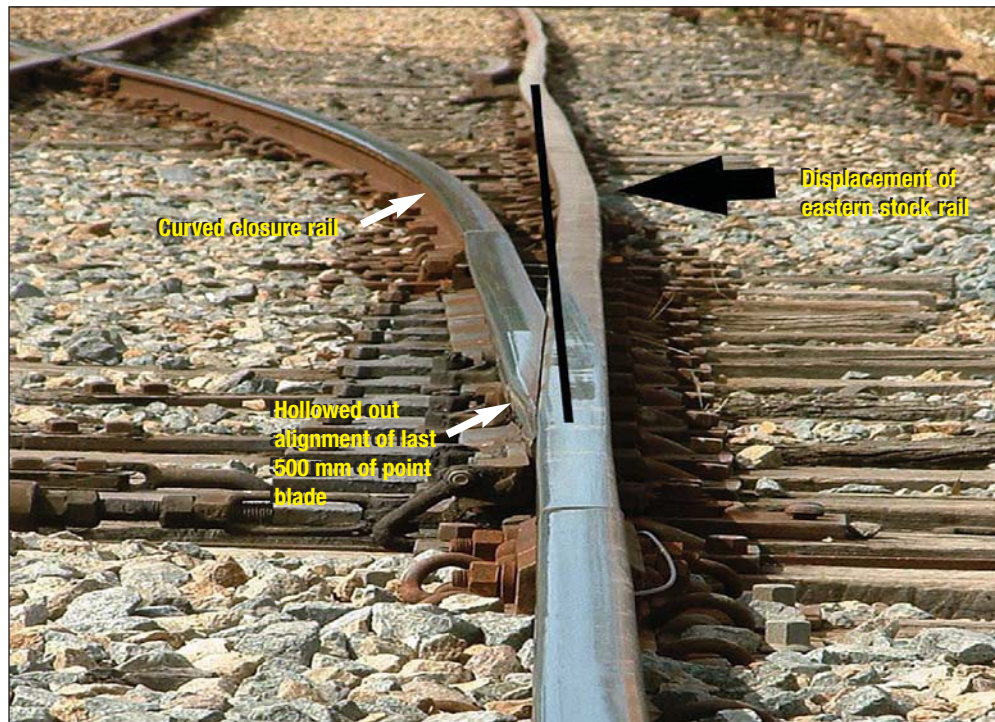
FIGURE 28: Alignment of eastern stock rail

The horizontal alignment and vertical profile of the turnout was observed to be such that considerable wagon body and suspension activity would be experienced by passing rail traffic. This movement was seen by ATSB investigators when observing a train negotiating the turnout. At a reduced speed of 20 kph wagons were observed to change direction with noticeable lateral movement

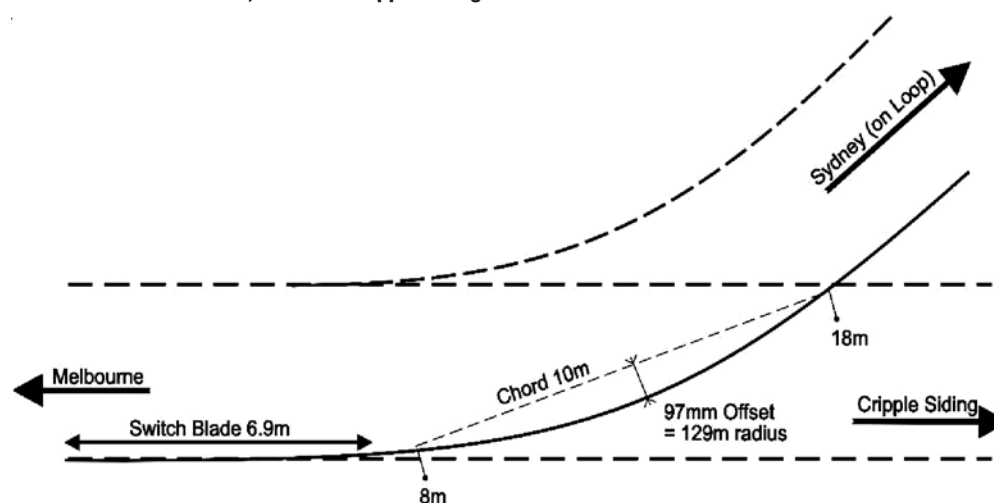
FIGURE 30: Curve radius, Alumatta cripple siding southern end

The design radius of this turnout as defined by plan number 426.61 was 219 metres. After a derailment at almost the exact same location in November 2002, the radius of this turnout was measured at 154 metres. These measurements represent a steady deterioration of the design radius. The comparative examinations undertaken of the turnouts at the northern end of Alumatta and southern end of Glenrowan also revealed non compliance in terms of design radius. The design radius of the Glenrowan turnout is 227 metres but was measured as 169 metres. The design radius of the Alumatta turnout (northern end) is 219 metres but was measured as 185 metres.
