RAIL SAFETY INVESTIGATION
2003/004

Derailment of Train 6WP2

Bates, South Australia
9 November 2003

Rail Safety Investigation into the Derailment of Train 6WP2

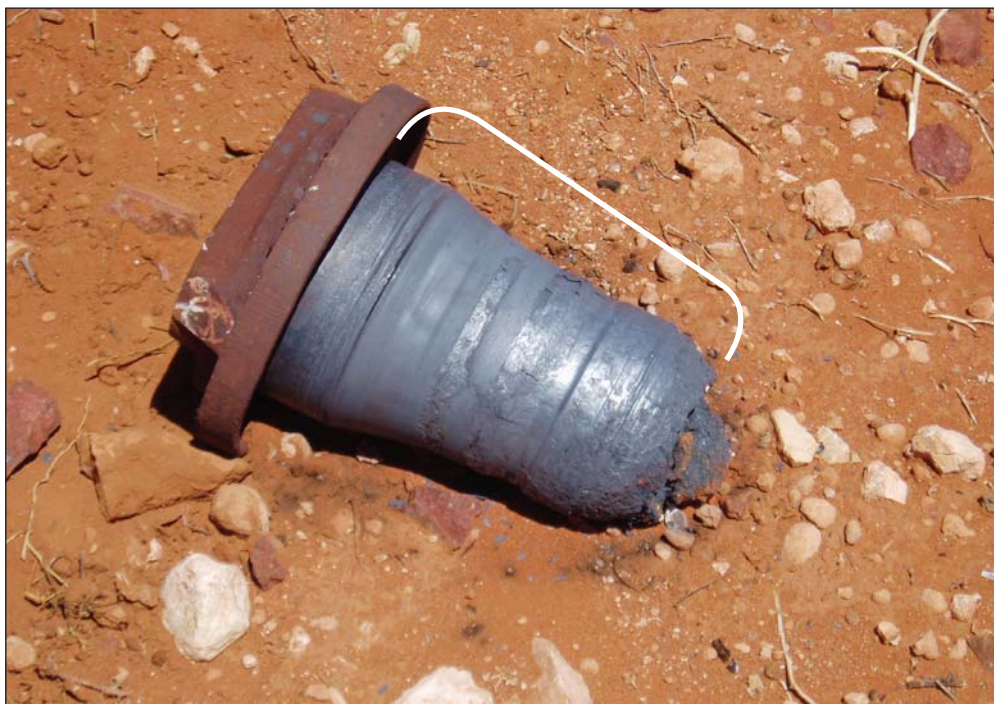
FIGURE 3: The remains of the journal after 'screwing' from the axle with the heat affected area of the surface marked as shown

Somewhere between Ferguson and Bates the RBU, on the right-hand side (in the direction of travel) leading axle of the trailing bogie of wagon number RKCX24, deteriorated to a serious level.

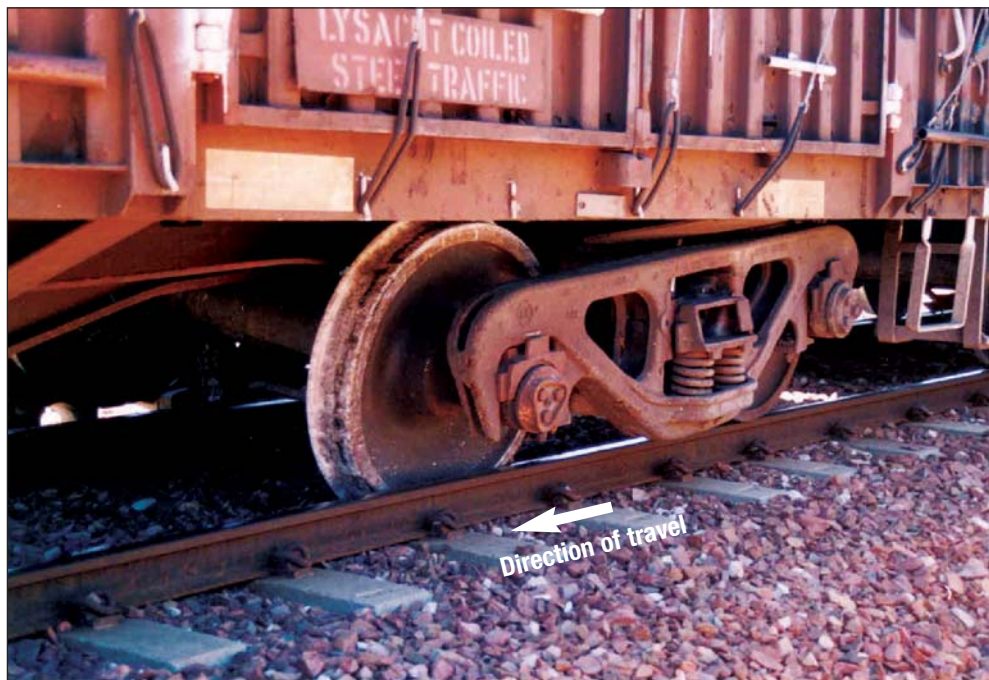
FIGURE 5: A view of bogie from the opposite side. Evidence of the damaging effect on the sleepers can be seen on the wheel flange and tread

As the left-hand wheel continued to rotate it caused severe damage to approximately 2,100 concrete sleepers as well as left-hand rail fixings up to the final stopping location of the wagon. At some point, the dragging right-hand bogie frame had also collected a loose short piece of rail situated beside the track.

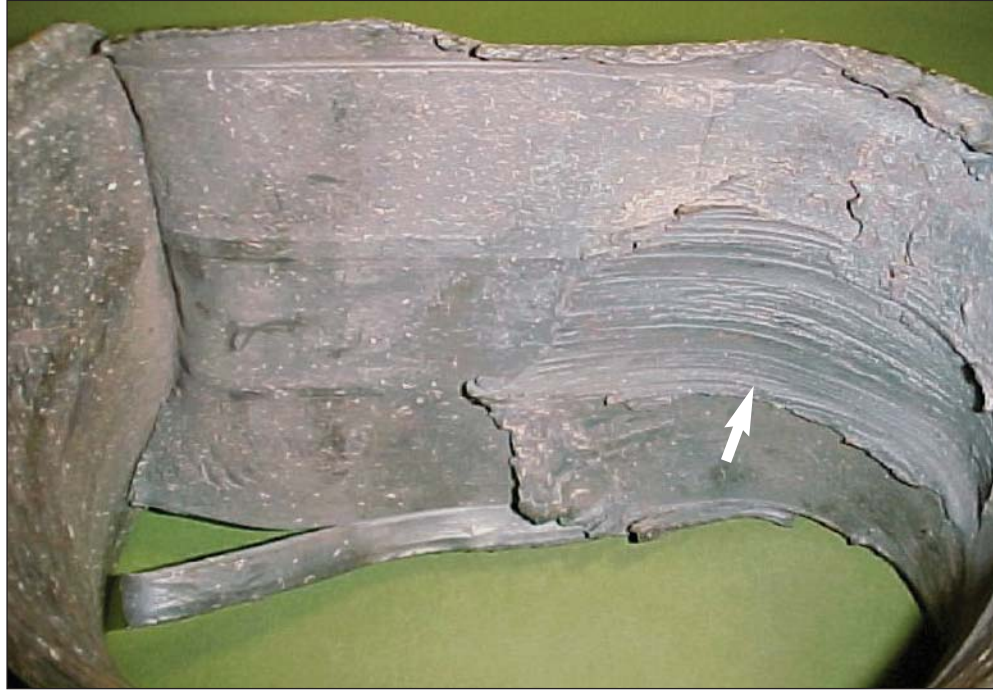
RBU 305809 was destroyed in the occurrence with the majority of the components including rollers and a cage missing. One cage from the RBU, which was present, had the roller separators flattened in the failure. Details of the internal components of the RBU from the broken journal were limited due to the amount of damage sustained and the number of components missing.

The pattern of damage to the RBU components was considered to be consistent with one roller assembly being damaged more than the other.

Indications were that seal wear ring damage appeared at the inboard roller assembly and that this roller assembly was the first to have failed.

FIGURE 9: View of the failed RBU outer ring raceways in the overheated zone

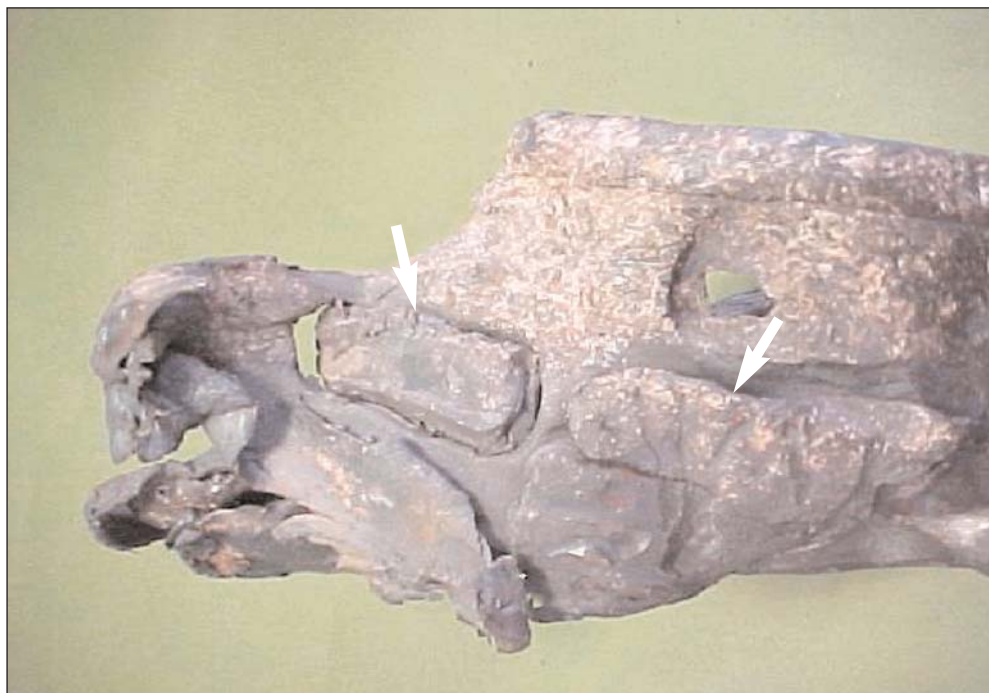
FIGURE 10: Detail view of rollers embedded transversely in the inner ring raceway

The outer cage had broken and released the rollers. The broken cage was present but had been severely damaged in the failure and as a result of this, the cause of the broken cage could not be established. Some roller separators were missing and the remaining cage rolling separators had been flattened but were still attached to the cage. The flattening of the cage appeared to be a result of the RBU collapse rather than the cage elements rolling through the bearing. There was no evidence of rollers embedded in the intact inner ring. This indicated that the rollers had been displaced from the roller assembly prior to the softening of the inner ring from heat produced after loss of interference fit of the roller assembly inner ring.

The pattern of damage suggested that the cage failure had contributed to the loss of interference fit that was evident in the RBU inner rings. It was not possible to establish the cause of the inboard cage failure as the cage and most of the rollers were missing. There was also no clear indication of the cause of the cage failure evident on the remaining components of the failed RBU.

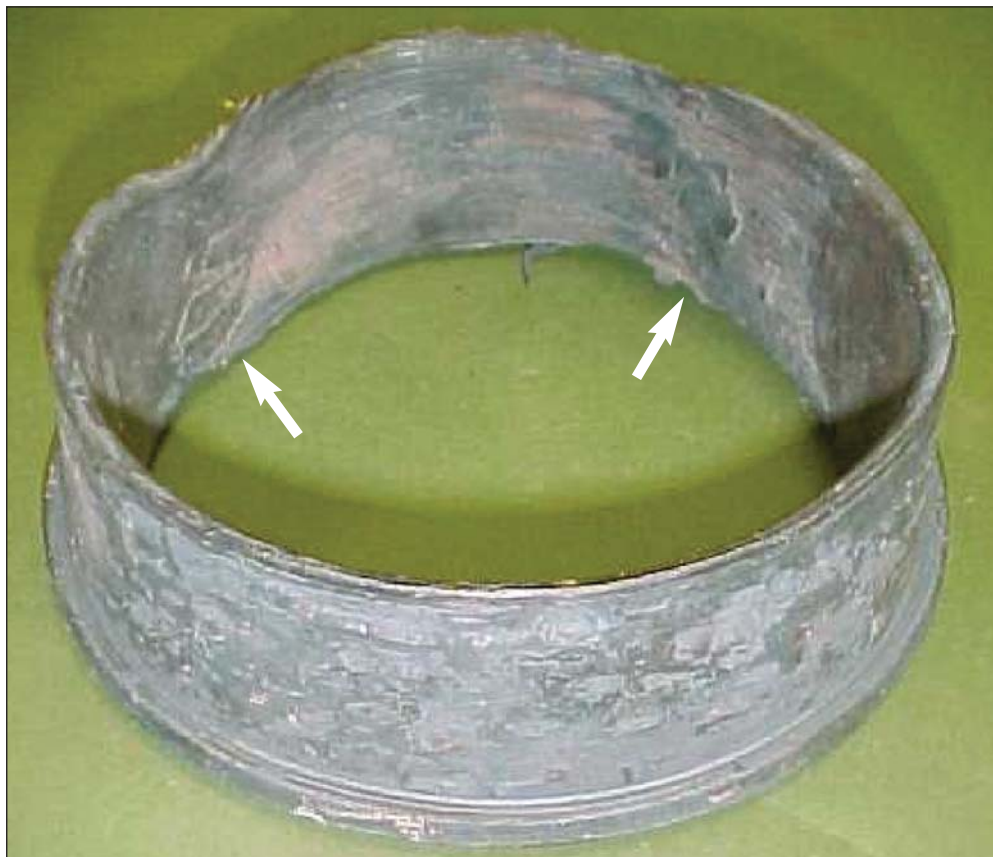
There was evidence that the failed RBU had experienced a loss of interference fit¹⁰ on the axle journal. This loss of interference fit led to the failure of the axle journal. A number of potential contributing factors to the loss of interference fit were determined by the investigation.

The evidence established by the examination found that failure of the roller assembly cage of the failed RBU led to the inner ring loss of interference fit on the axle journal. The cause of the cage failure could not be positively identified by NDT although it was determined that assembly of the RBU could have led to this failure. This was based on the failure early in the life of the RBU. The in service damage of the seals or seal failure was also considered to be possible contributing factors to cage failure.

FIGURE 11: View of loss of interference fit on an inner ring bore

- PN undertake a review and implementation of remedial action as required of workshop processes for the care and fitment of bearings to make sure that appropriate measures are in place to reduce the risk of subsequent cage related failure.

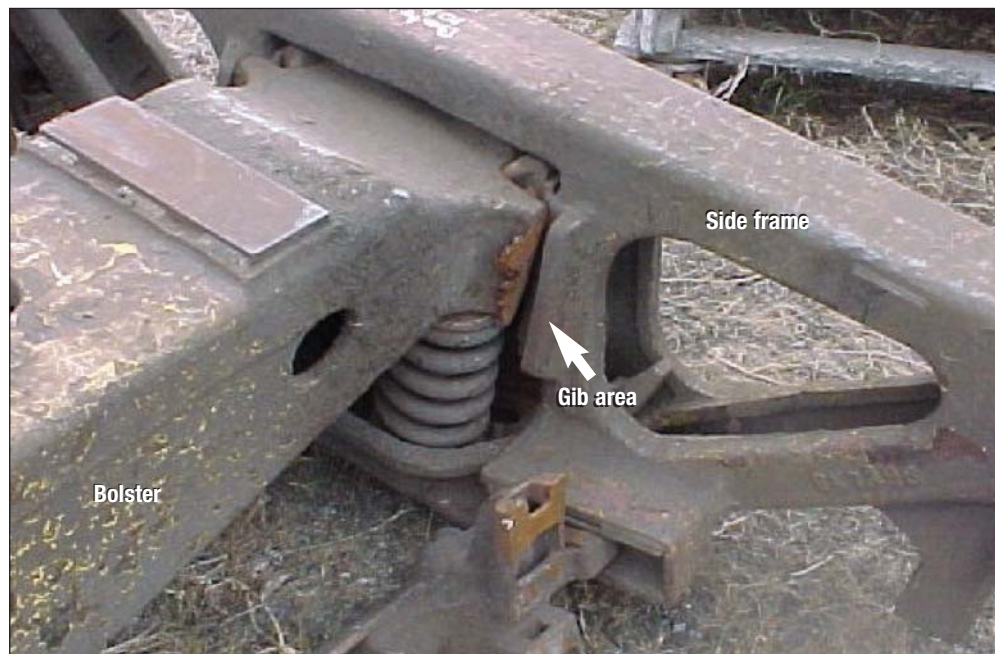
There was wear evident on the side frames and bolster when the bogie was inspected. Heavy wear was evident in the gib clearance area opposite the RBU failure but there were no signs of similar wear at other gib clearance areas. Measurements were taken at the top position at each side frame and the bolster gib clearances measured 25 mm. The wear limit for this type of bogie (50 ton SG Class C) at overhaul is 28 mm¹³.

FIGURE 12: General inboard view of the bogie gib area at opposite end to the failed RBU

As there were no signs of similar wear elsewhere on the bogie, the wear can be considered to be a result of the journal failure at the opposite end of the wheel set. It was considered that the condition of the bogie had not contributed to the derailment.

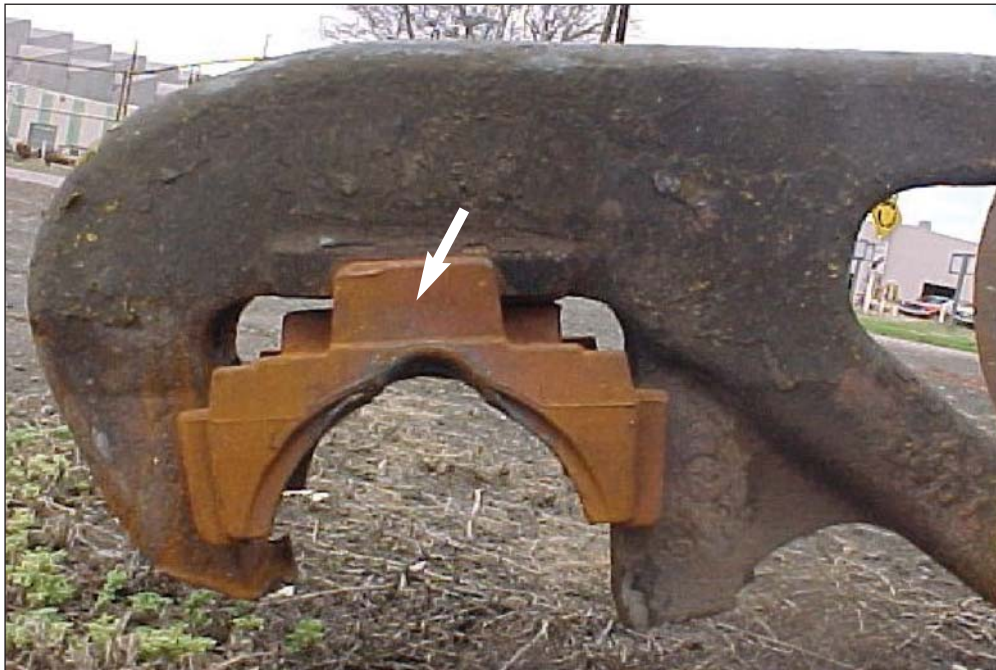
FIGURE 13: Detail inboard view of the adaptor casting at the failed RBU

The adapter from the failed end of the axle showed no signs of angular misalignment on the crown. The adapter seat showed predominantly even wear indicating that it had been fitted properly prior to the failure. While there was internal mechanical damage to the outer seat in the loaded zone of the adapter, the cause of this damage was not apparent as the seat and the RBU outer ring would normally be mated together at this point which should prevent damage at this location. The adapter seat was considered unlikely to have contributed to the failure of the RBU.

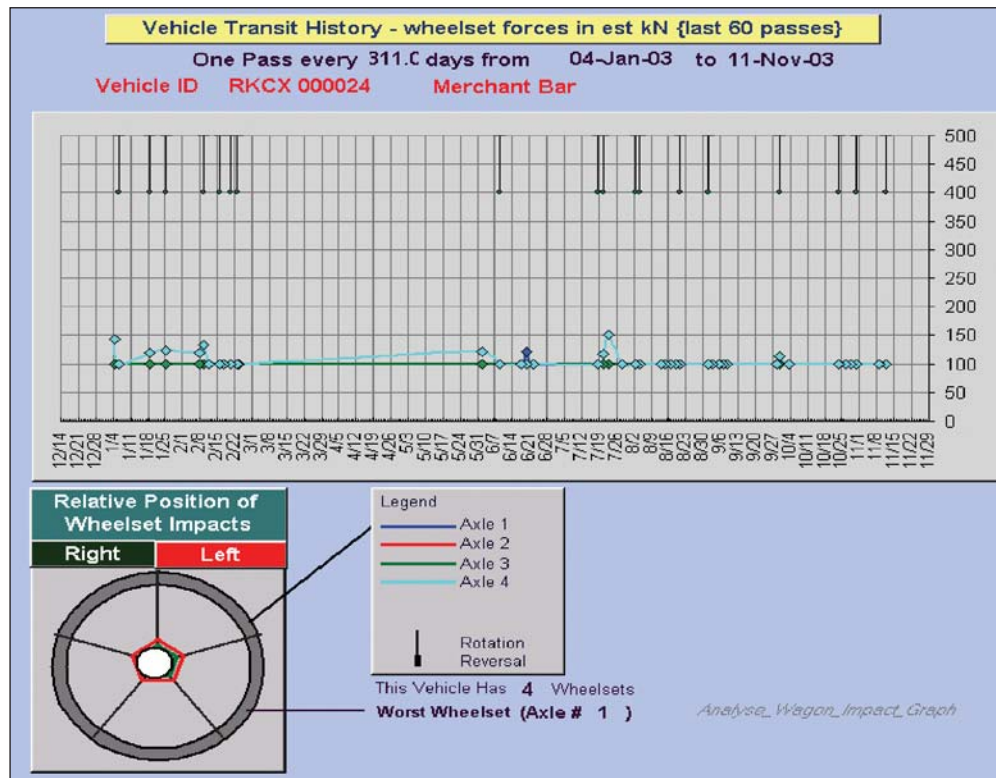
FIGURE 14: WCM Fault Vehicle transit history graph for wagon RKCX24

This histogram plot of the force generated by the wheel tread defect at the wheel rail interface has been normalised to a fully loaded wagon against a clean new wheel tread. The polar plot in the bottom left is the relative position of the wheel set impacts, a comparison of the wheel defect for both the left and right wheel for that wheel set (Graph by the ARTC).

There was no indication of any wheel tread irregularities or tread defects in the period leading up to the derailment.

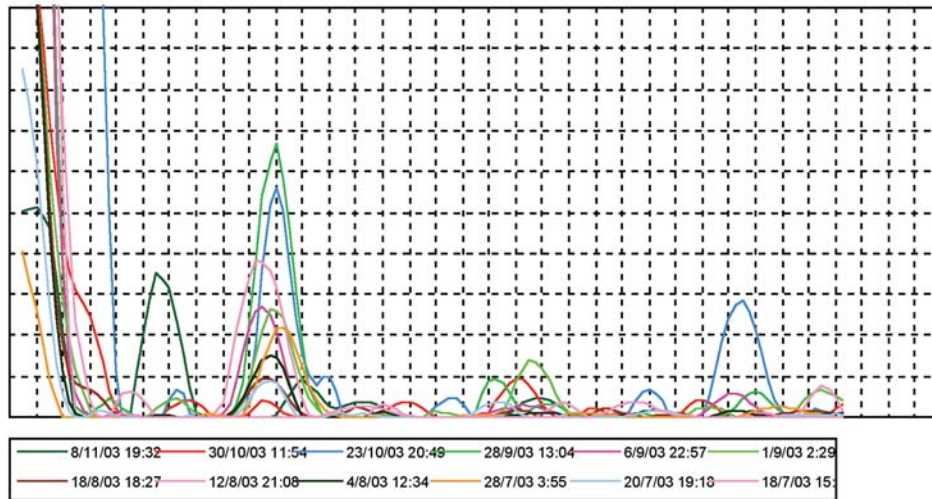
FIGURE 16: The Spectral plot for RKCX24 – RBU location 3A. Shown is the growth in RBU fault type as time progressed against decibel strength. As fault strength is a function of the speed of the RBU, the fault level is normalised against a wagon travelling at 82km/hr (500rpm) and an average wheel diameter of 870mm.

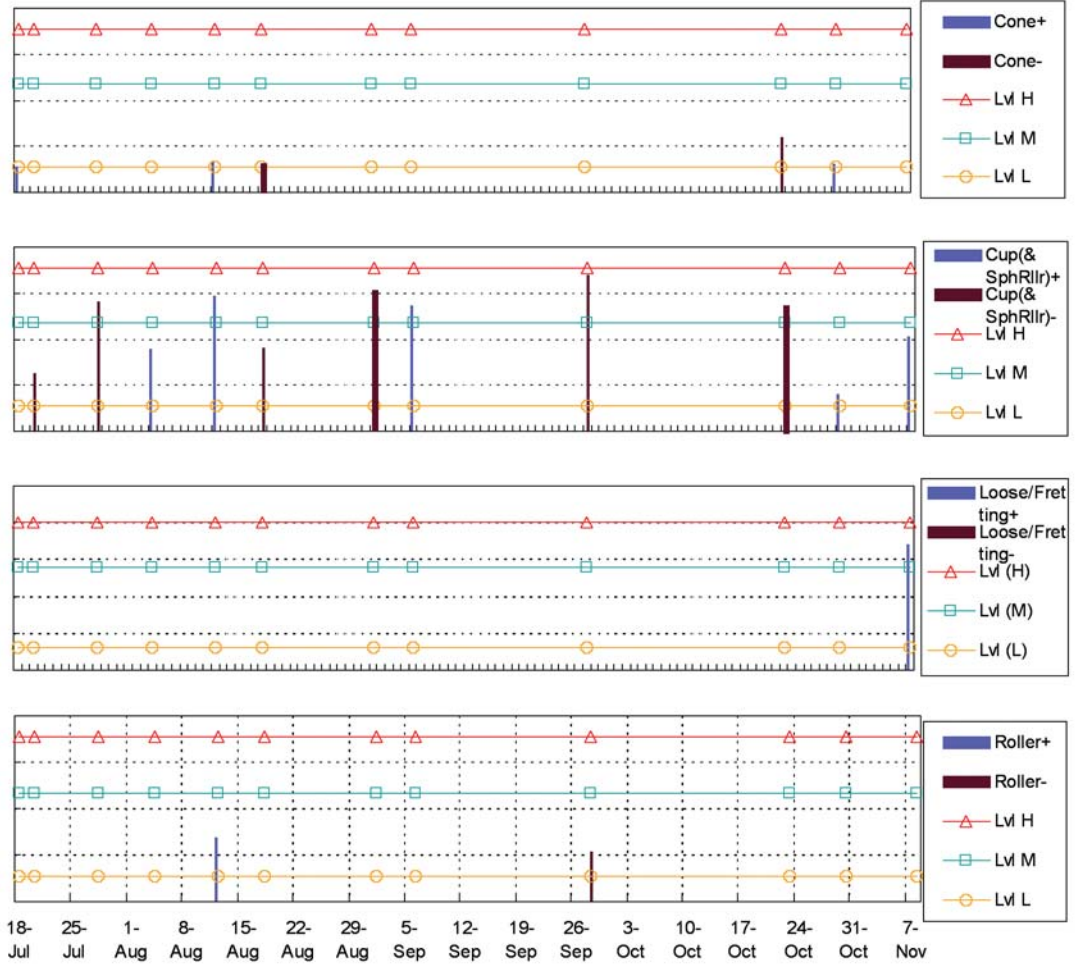
FIGURE 17: Fault level readings for RKCX24 – RBU location 3A. Fault levels for CONE, CUP, LOOSENESS, and ROLLERS have been shown as this RBU had elements of the faults in both the RBU which failed and that of the opposite side of wagon RBU in position 3B
