Australian Transport Safety Bureau

# Derailment of Pacific National Train 2PW4-N – 28 November 2003

January 2005

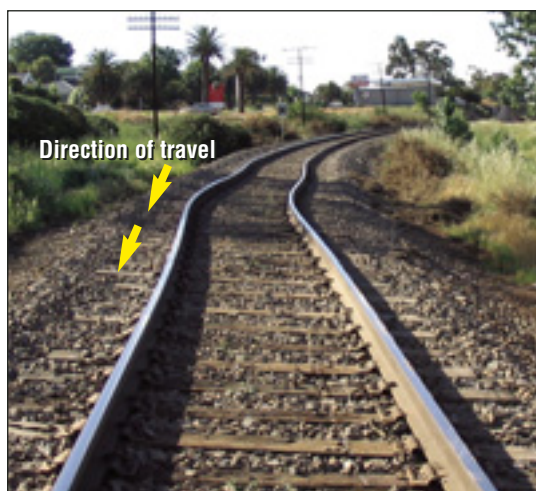
**FIGURE 1:**  
The buckled rail at Ararat looking towards Adelaide

Some external factor, probably the tamping operation of 20 November, altered the geometry of the track lowering the stress free temperature to below 38° C. The tamping would have also reduced the ability of the ballast to hold the track in place.

1. The track was not stress tested after the tamping operation on 20 November 2003 up to the time of the accident and it is likely that the stress free temperature of the rail had changed from that before tamping.
2. Excess rail cut out after the derailment indicated that the stress free temperature of the rail at the time of the derailment would have been lower than the Public Transport Corporation Infrastructure design standard used by ARTC.
3. A lower stress free temperature would mean that the track was more susceptible to rail buckle during higher ambient temperatures.
4. No action was taken after Track and Rail Conditioning Monitoring found rough riding on the tamped piece of track on 24 November.

The ATSB recommends that the ARTC review track maintenance procedures to ensure that track geometry and stress free temperature are within the specified standards.

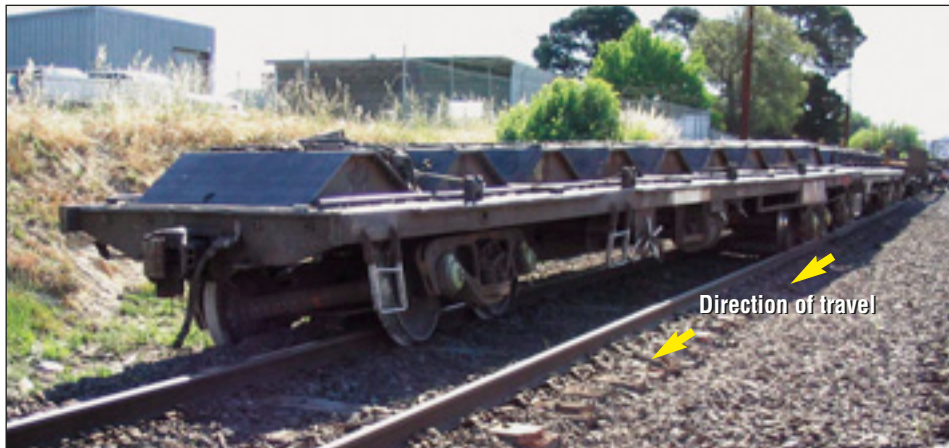
Two wagons had derailed at 265.745 km (Point of Derailment). The first derailed wagon was RQKY2716J located in the 45th position in the train. The following wagon (46th position) RCRX23141U was also derailed. Wagon RQCXO902X at the 44th position received minimal damage and remained on track. Empty containers RVO01 and RVO17 dislodged from wagon RQKY2716J (45th) during the course of the derailment and were substantially damaged.

**FIGURE 2:**  
**Derailed Wagon RCRX23141U (46th position)**

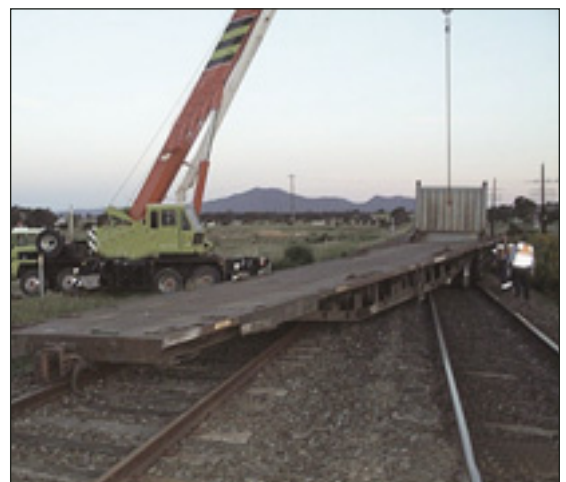
**FIGURE 3:**  
Recovery operation at derailment site

Both rails were restressed in the week after the derailment with the following results:

Following the derailment, the rail was cut out to restore it to a stress free state at its neutral temperature.
