Aviation Occurrence Investigation – AO-2007-052

Uncontained Engine Starter Failure

General Electric CF6-80E1-A3

Airbus A330-300

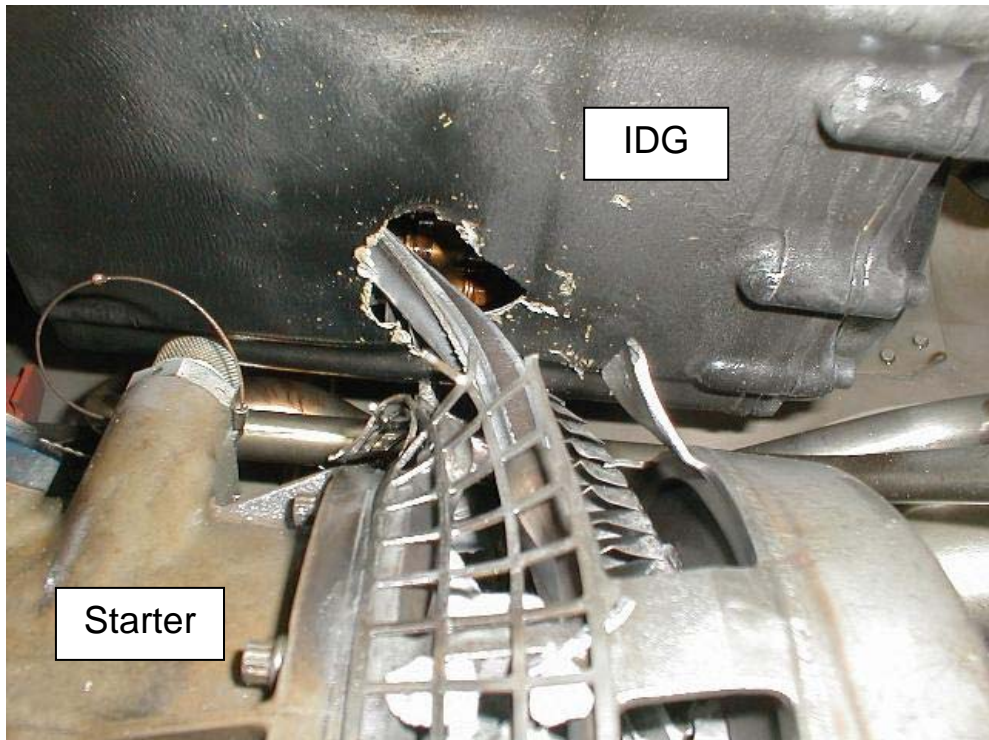
The second attempt was a manual start lasting 6 minutes, at which time smoke and sparks were observed from under the engine cowls. Subsequent inspection of the engine revealed an uncontained failure of the starter turbine and secondary damage to the integrated drive generator (IDG) (Figure 1).

Figure 1. Uncontained starter failure and associated IDG damage

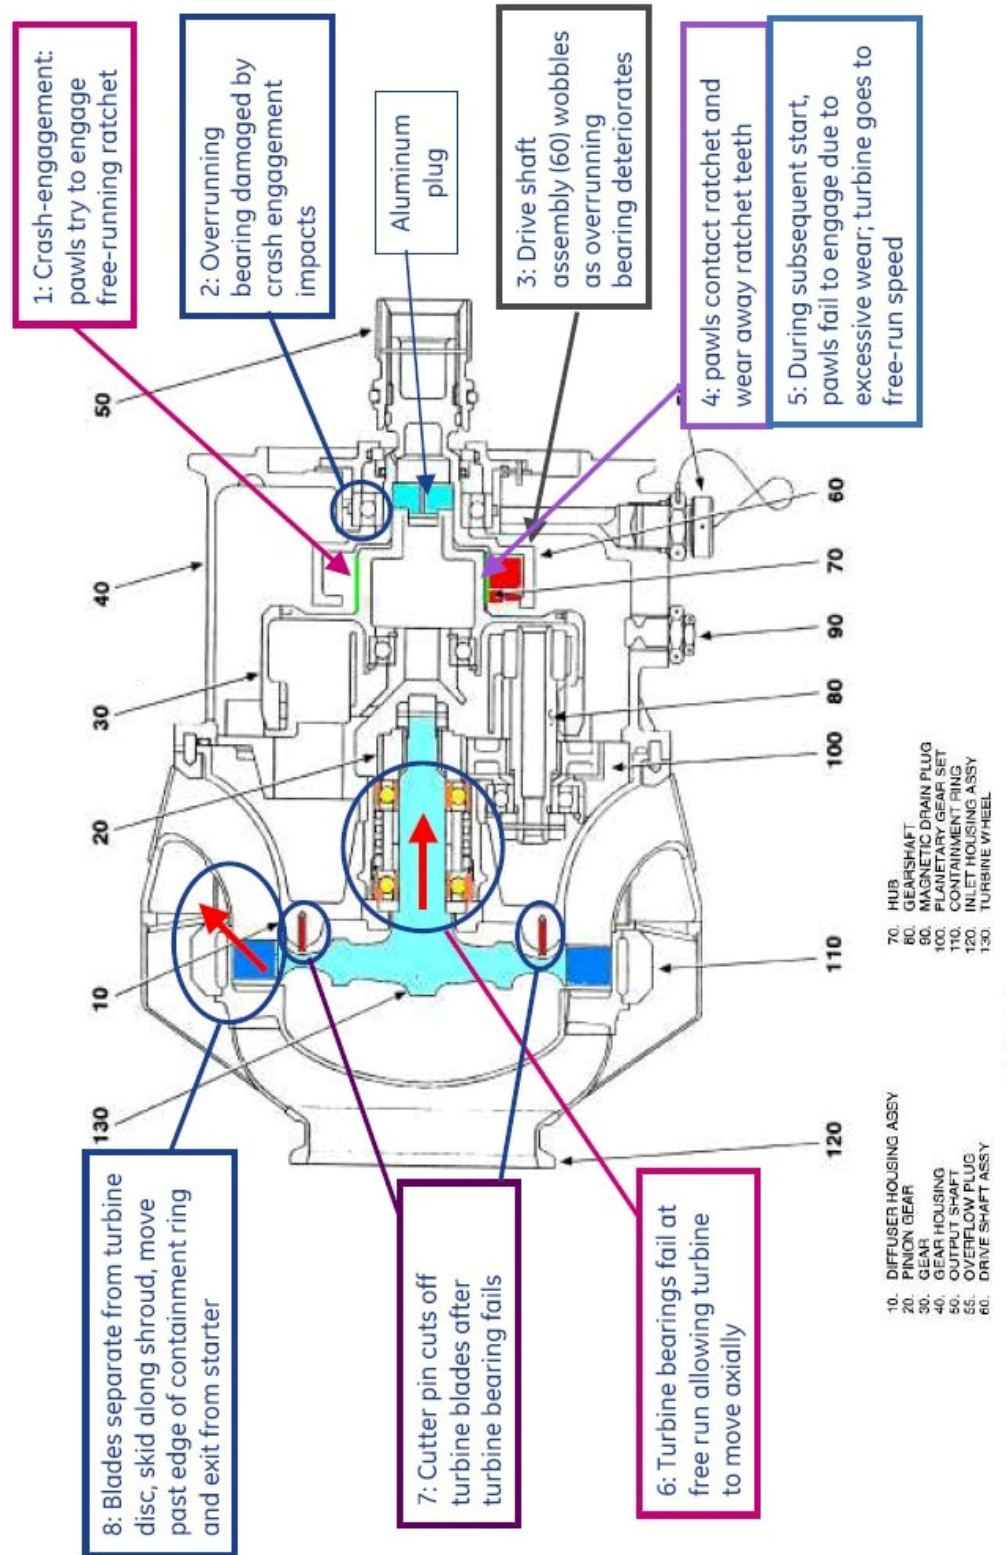
Crash engagements result in significant damage to the clutch and can also damage the overrunning bearing and lead to further starter damage. The likely failure scenario proposed by the manufacturer is described below and illustrated by Figure 5:

At some time the starter was subjected to a crash engagement. The impact may have forced skidding in the overrunning bearing as well as a large over turning moment. As more starts were being performed, and during each subsequent engine run, the overrunning bearing further deteriorated. The clutch shaft begins to wobble. The bearing eventually fails completely, allowing the output shaft to move further out of position. The pawls can now contact the ratchet, eventually wearing away most of the ratchet teeth. During a subsequent start attempt the pawls then fail to engage because the ratchet teeth have become too worn. The starter then goes to free-run speed. The turbine bearings fail, allowing the turbine to move axially into the starter. The cutter pins begin to cut off the turbine blades. The blades eventually separate from the turbine disc, hit only the edge of the containment ring, and exit from the starter, causing IDG damage. The starter no longer drives/assists the engine, and a no-start occurs.

Figure 5. Schematic of starter showing probable sequence of events

The failure scenario provided by the starter manufacturer was credible including that the precipitating event was a crash engagement occurring at some time during the life of the starter that resulted in the overrunning bearings being damaged. With continued normal operation cycles contributing to further bearing deterioration.

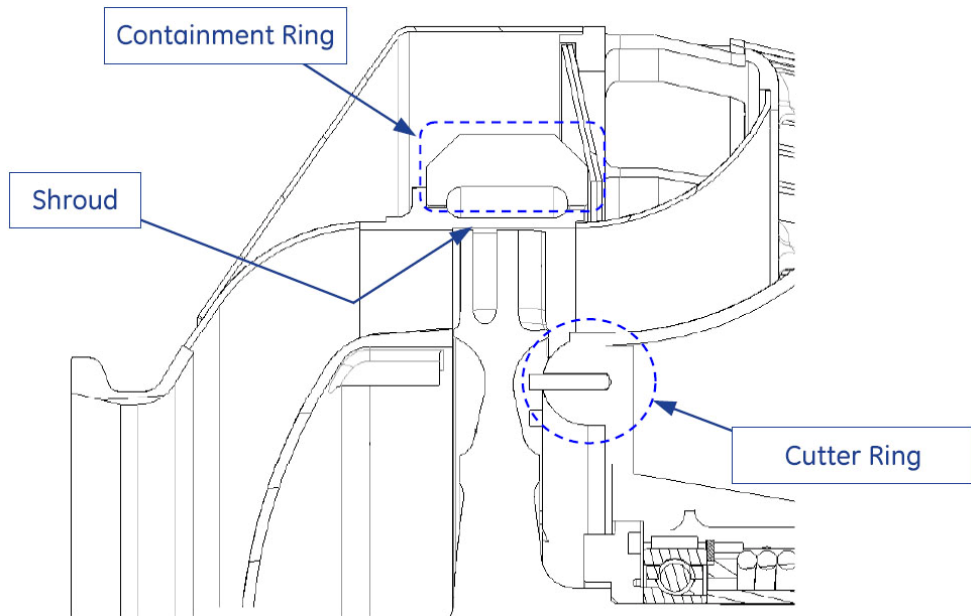
The starter design was not adequate to contain the cut-off blades from the turbine disk in the event of starter failure.

Figure 6. Starter inlet assembly

As a result of this incident, the engine manufacturer undertook corrective actions in the form of a starter containment improvement plan, which proposed design improvements to the starter (Figure 6) and allowed rework of existing starters to prevent further uncontained failures.

- The cutter ring would be redesigned to improve cutting efficiency and minimise axial wheel travel.
- The inlet assembly would incorporate a larger, deeper ring pocket to better capture turbine blades after axial wheel travel.
- The stator shroud would be made thinner to allow easier penetration by blades into the containment ring pocket.
