MARINE SAFETY INVESTIGATION
No. 211

Independent investigation into the collision between the

Greek registered bulk carrier
Spartia
and the Australian fishing vessel
Hannah Lee

off the south-west coast of Western Australia
15 April 2005

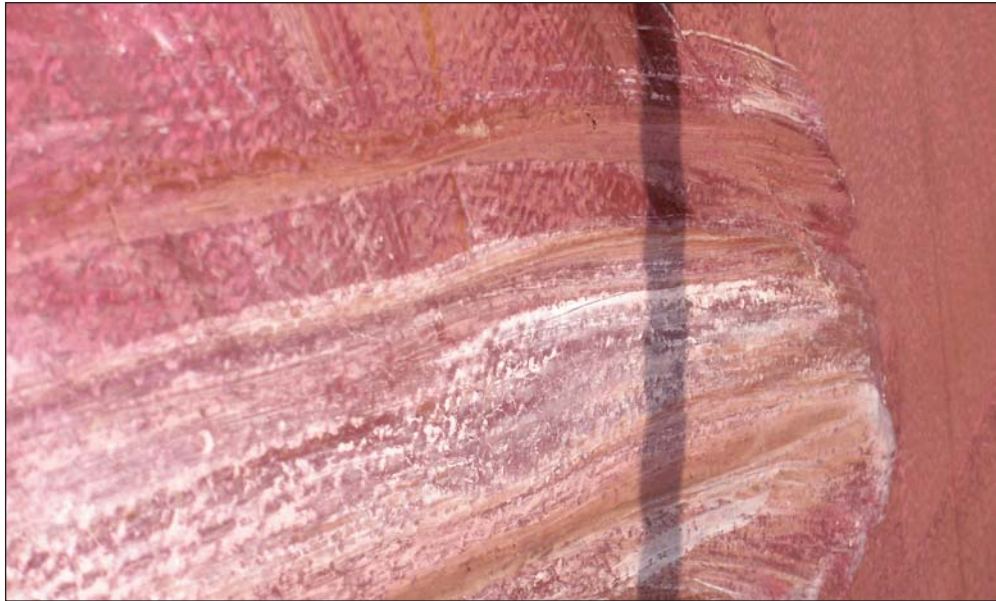
At 0535, the two vessels collided in position 32° 43.8'S, 115° 16.9'E, with the fishing vessel impacting on *Spartia's* hull in way of number six hold.

FIGURE 3: Paint scrapings on *Spartia's* hull

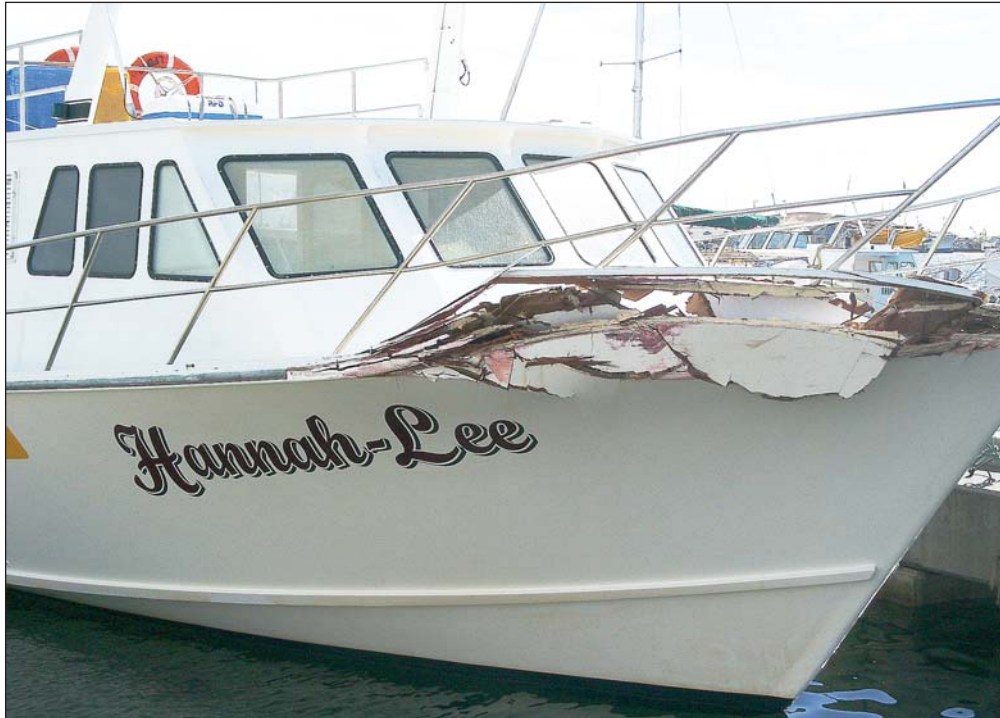
FIGURE 4: *Hannah Lee* damage to starboard bow

The location and the extent of damage to *Hannah Lee's* starboard bow indicates that the fishing vessel and *Spartia* were at an oblique angle at the point of impact and supports the skipper's assertion that he was turning to port when the collision occurred. The damage to *Hannah Lee* would have been significantly worse if its angle of attack with respect to the ship had been greater, given the speed of the fishing vessel at the time.

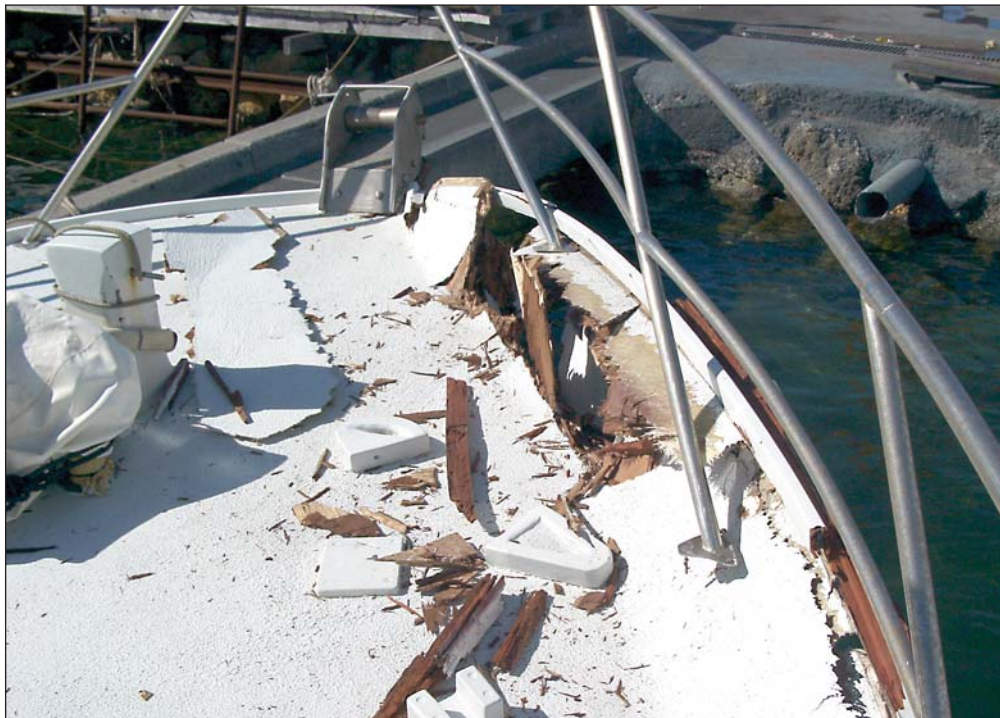
FIGURE 5: *Hannah Lee* damage

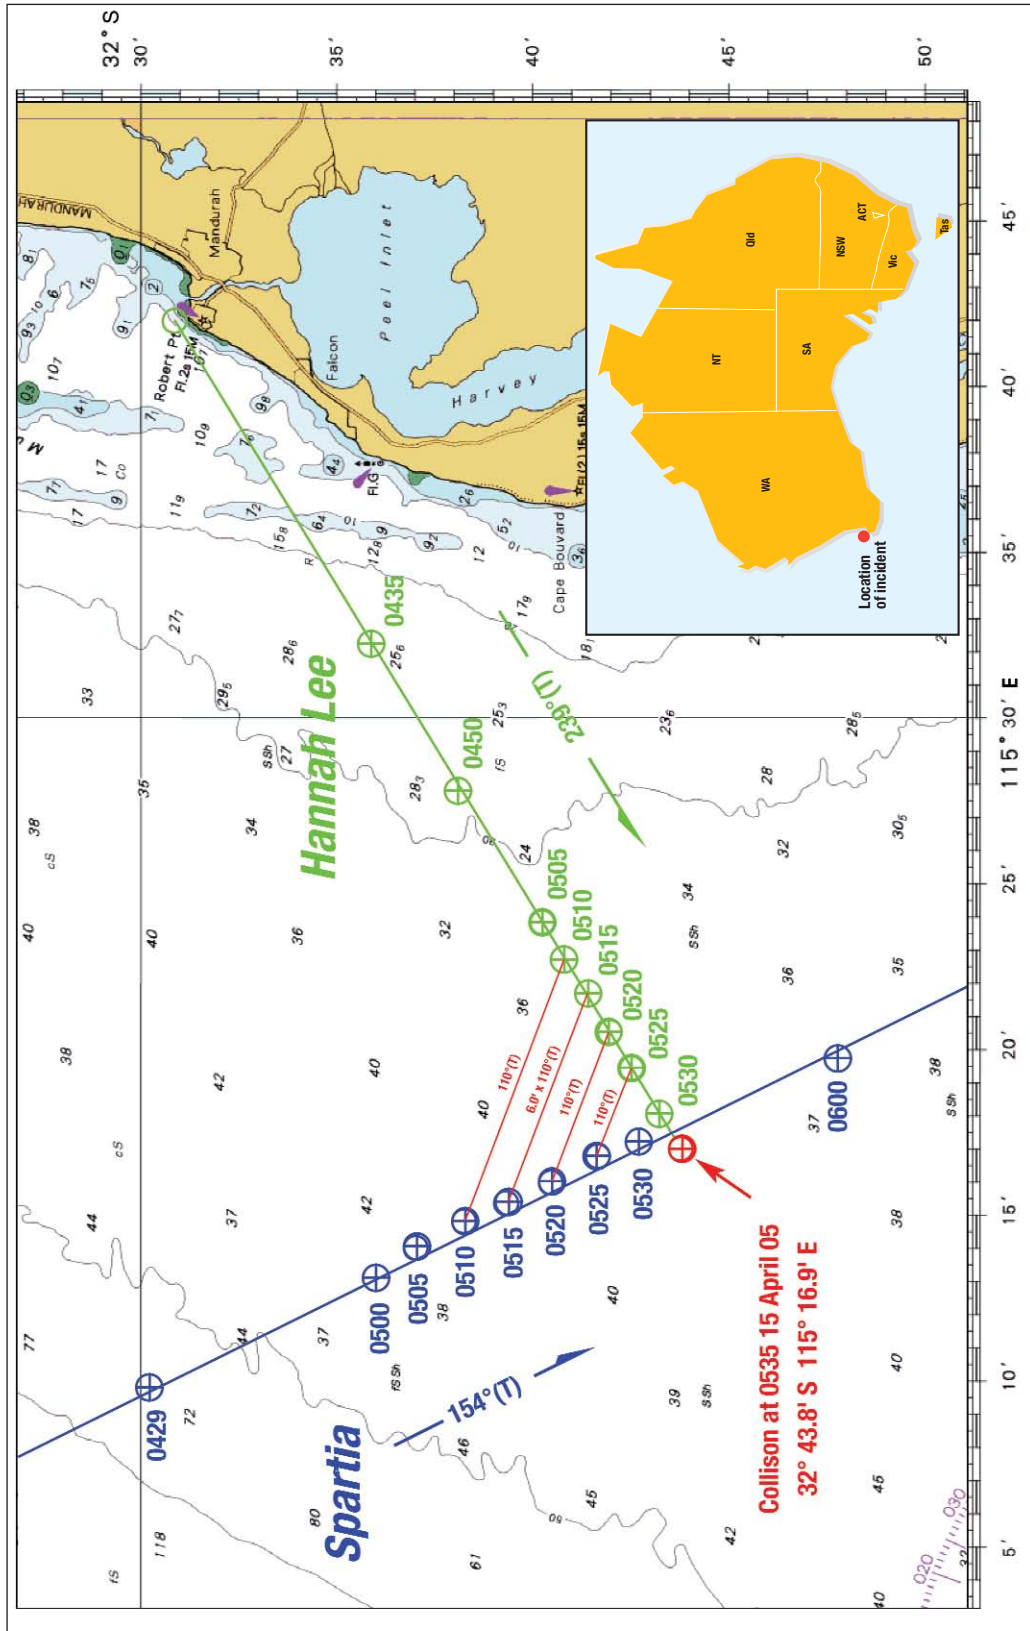
FIGURE 6: Portion of chart AUS 334 showing tracks of each vessel leading up to the collision

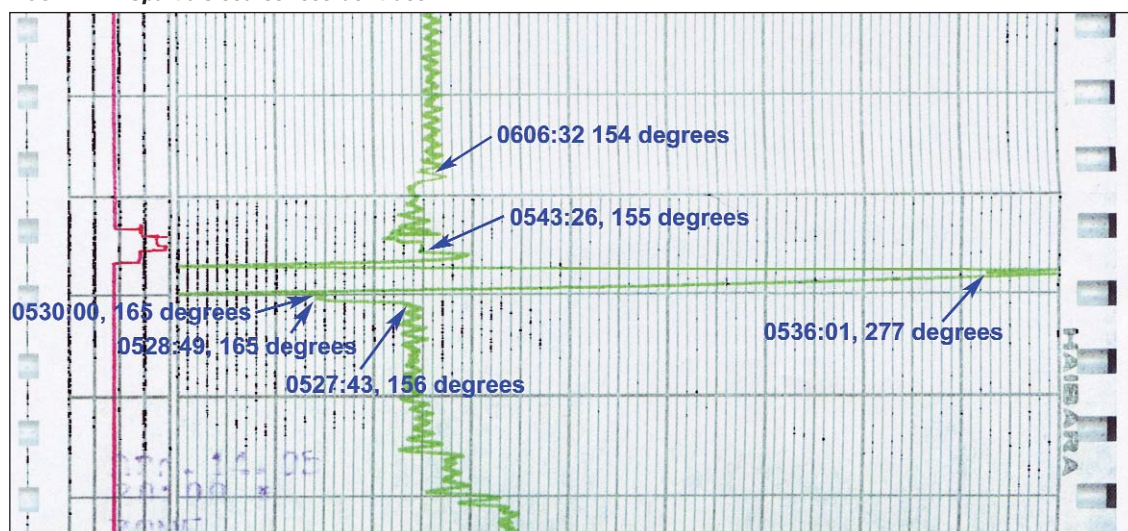
At 0530:00, a turn was initiated by the application of starboard rudder which brought the ship to a heading to 277°(T). This heading was reached at 0536:01, shortly after the collision. The rate of turn of *Spartia* from 165°(T) to 277°(T) was calculated to be 19 degrees per minute. Information obtained from the ship's manoeuvring diagram indicated that the ship can achieve a rate of turn in the vicinity of 50 degrees per minute (in ballast, on full sea speed in winds of less than 10 knots) with full starboard helm on. Considering the circumstances of this case, a rate of turn of 19 degrees per minute is relatively slow.

FIGURE 7: *Spartia's* course recorder trace

At a rate of turn of 19 degrees per minute, the radius of the ship's turning circle would be approximately 0.7 nautical miles. This means that *Spartia's* advance⁶ would have been in excess of this amount, possibly up to the same distance the two vessels were apart when the master states he ordered the course alteration. Had the helm be put hard over to starboard when the master claims it was, at 0527:43, *Spartia's* advance would have been less than 0.7 nautical miles, possibly as low as 0.3 nautical miles and probably enough to avoid contact with *Hannah Lee*.

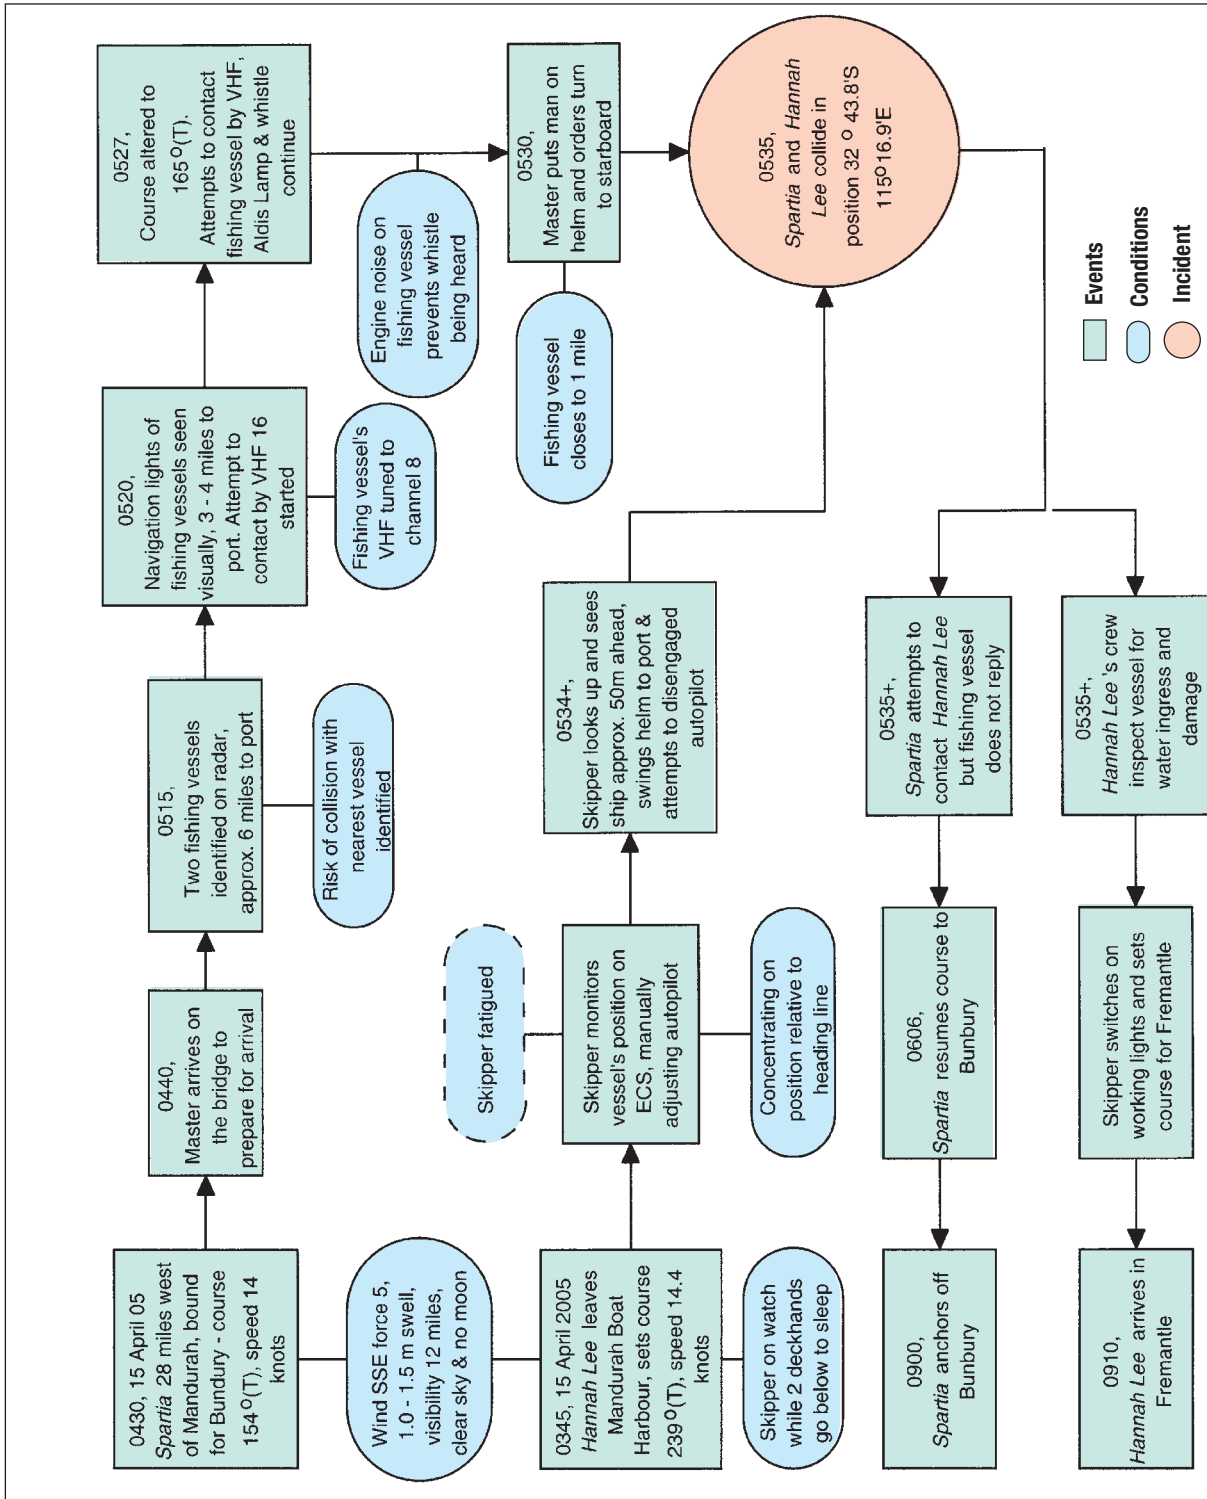
FIGURE 8: Spartia/Hannah Lee: Events and causal factor chart.
