ATSB TRANSPORT SAFETY INVESTIGATION REPORT

Aviation Occurrence Report – 200503722

**In-flight upset event
240 km north-west of Perth, WA
Boeing Company 777-200, 9M-MRG
1 August 2005**

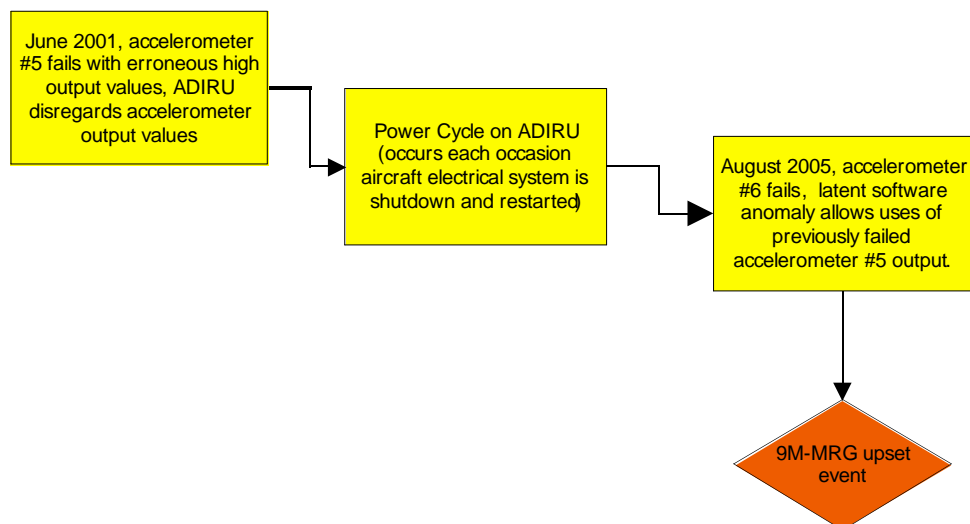
Figure 1: Component event flow chart

Further investigation revealed that the conditions necessary for the occurrence were (figure 1):

- an accelerometer failure producing high value/voltage output
- the ADIRU excluding that failed accelerometer from use in its acceleration computations
- power to the ADIRU cycled (system reset)
- a second accelerometer then failing and the latent software anomaly allowing the ADIRU to once more utilise the previously failed accelerometer information with its high output values in its computations, resulting in erroneous acceleration outputs into the flight control outputs but not the navigation (ground speed, velocity, position, etc.) outputs.

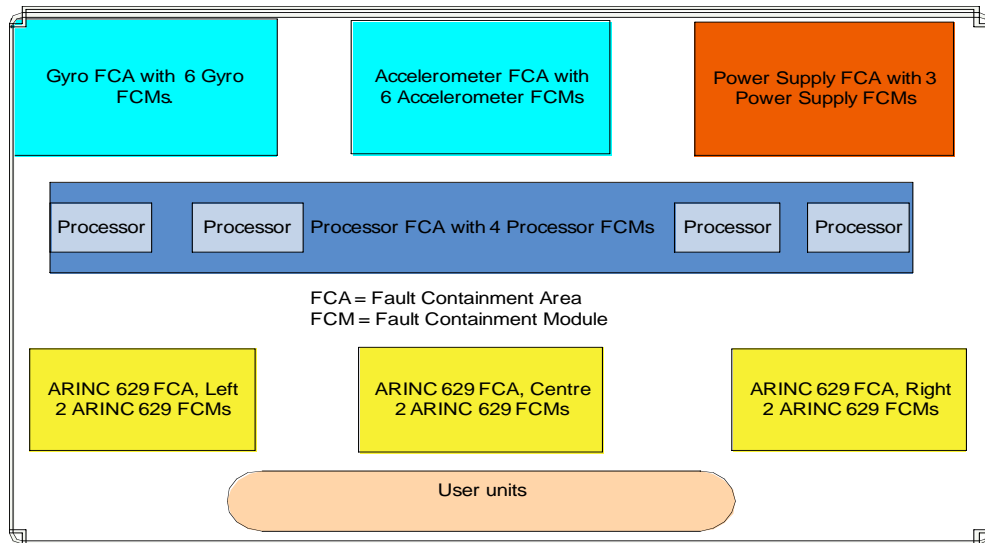
Figure 3: ADIRU diagram

Data from the accelerometers and gyros was sent to the processor FCA which produced navigation and flight control inputs. The processor FCA performed redundancy management on the gyro and accelerometer data by using fault detection and isolation software. The data was then checked by the software before it was sent to the ARINC 629 units for distribution to the aircraft user units. That design feature was to ensure that only data from serviceable sensors would be used in the ADIRU outputs.

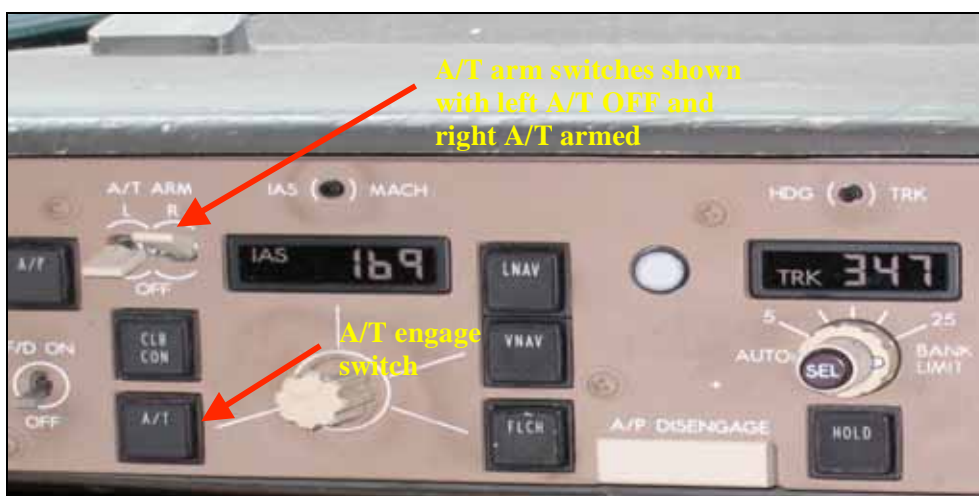
Figure 4: MCP autothrottle arm and engage switches

The aircraft mode control panel (MCP) had three distinct switches which operated the engine autothrottle (A/T). The autothrottle arm switches were located on the MCP and consisted of two toggle switches that armed the selected autothrottle for mode engagement. The autothrottle engage switch was a push-button type switch that was used to engage an autothrottle mode for various aircraft pitch modes, or if no pitch mode was selected, in the speed mode. The autothrottle could be disconnected at the MCP by moving the relevant autothrottle arm switch to OFF (figure 4).

During the occurrence, the autothrottle system remained active or armed, even though the pilot in command attempted to disconnect it by pressing the thrust lever disconnect switch and pushing the autothrottle engage switch. The reason it remained active was because the flight crew did not deselect the autothrottle arm switches from the ARMED position to the OFF position. As a consequence, the autothrottle activated and automatically advanced the thrust levers when it sensed a low-speed condition as a result of erroneous data being provided by the ADIRU.

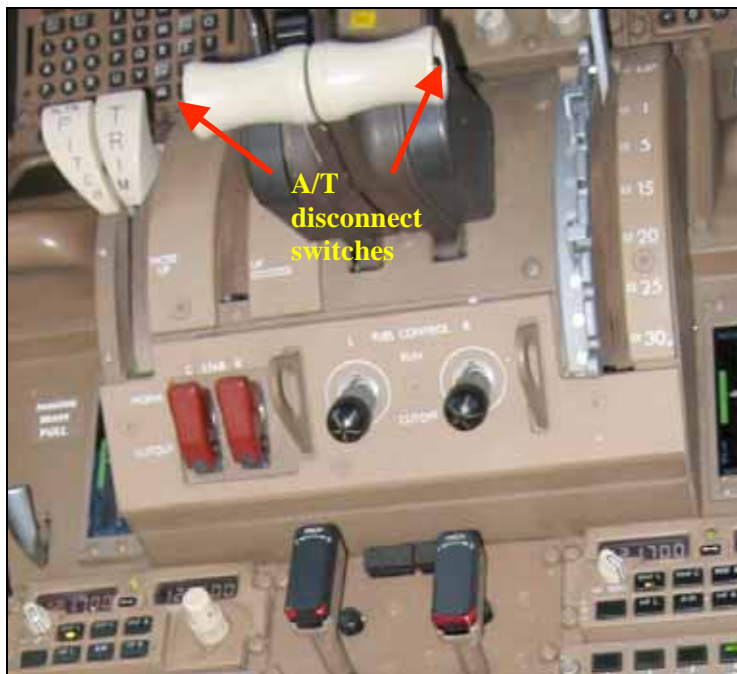
Figure 5: Engine thrust lever autothrottle disconnect switches

In addition, the autothrottle could be disconnected by pushing either of the autothrottle disconnect push-button type switches on the engine thrust levers located on the pilots centre console (figure 5).
