INCIDENT INVESTIGATION REPORT

Pan American World Airways Inc. Boeing 747 Aircraft N652 PA at Sydney (Kingsford-Smith) Airport New South Wales on 18 July 1971

July, 1972

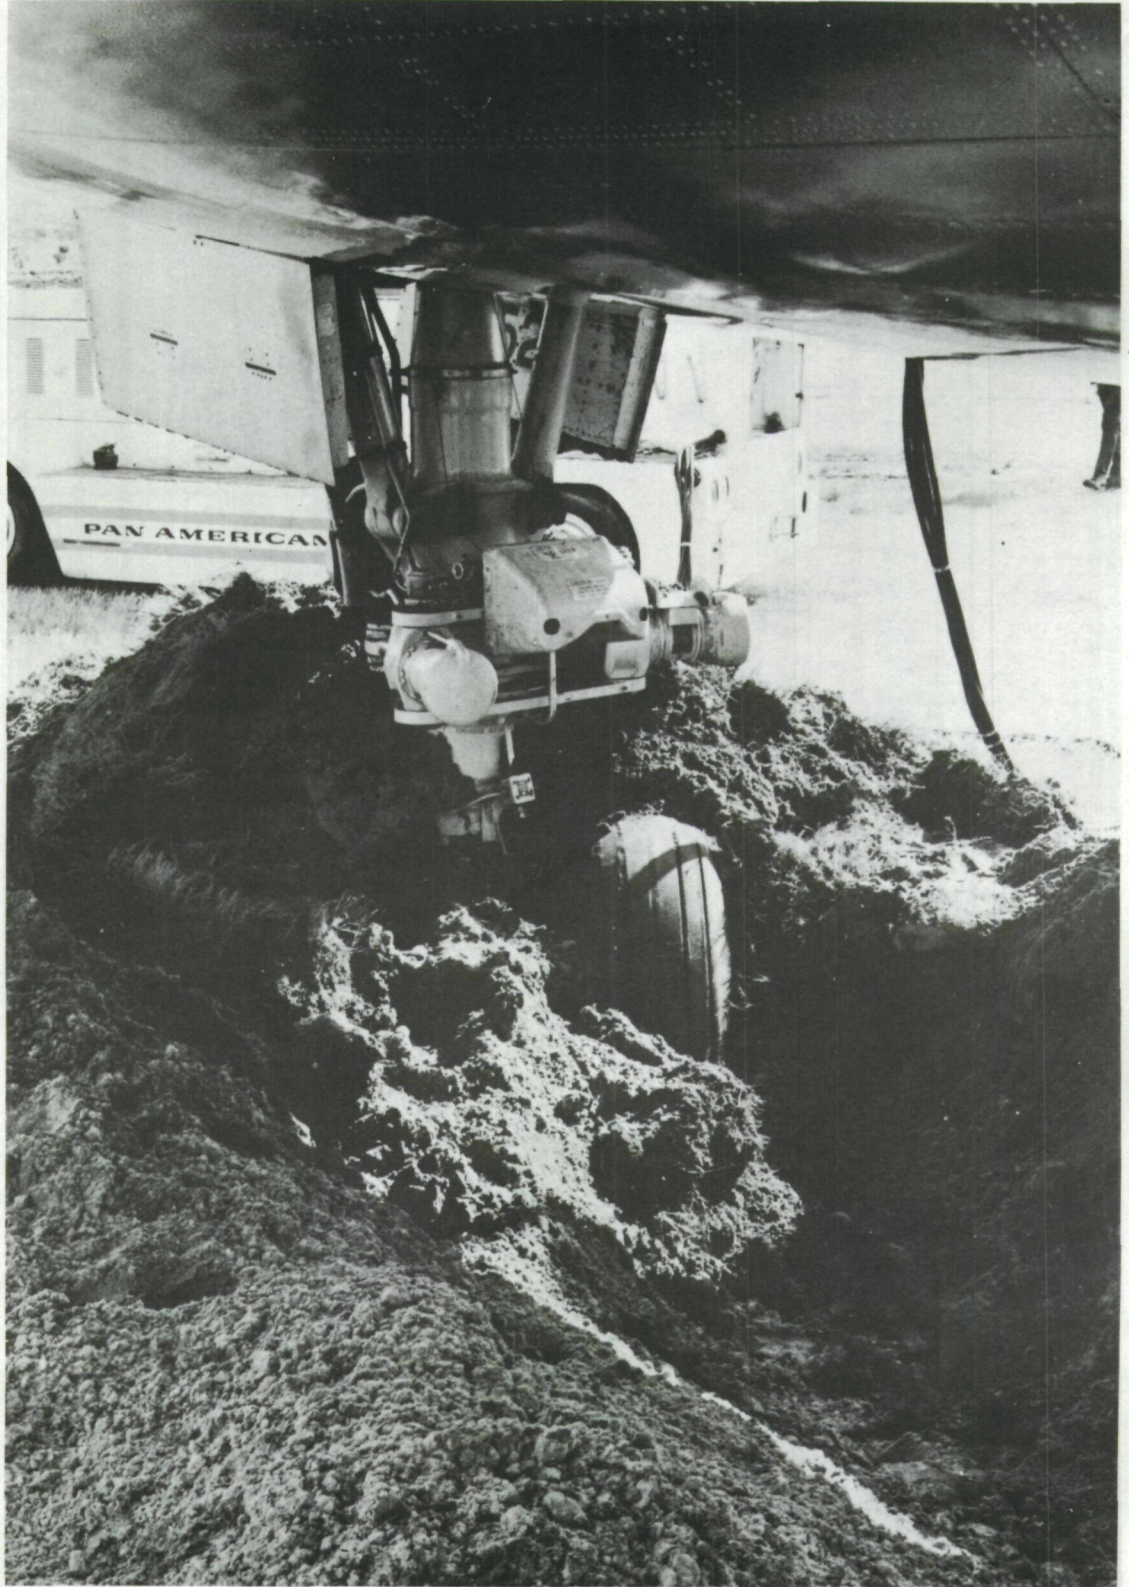
Appendix A

There was no damage to the aircraft, but both nosewheels were changed as a precaution against possible contamination by the sand in which they were buried.

The nose undercarriage of N652PA showing the depth to which the wheels penetrated the soft earth.

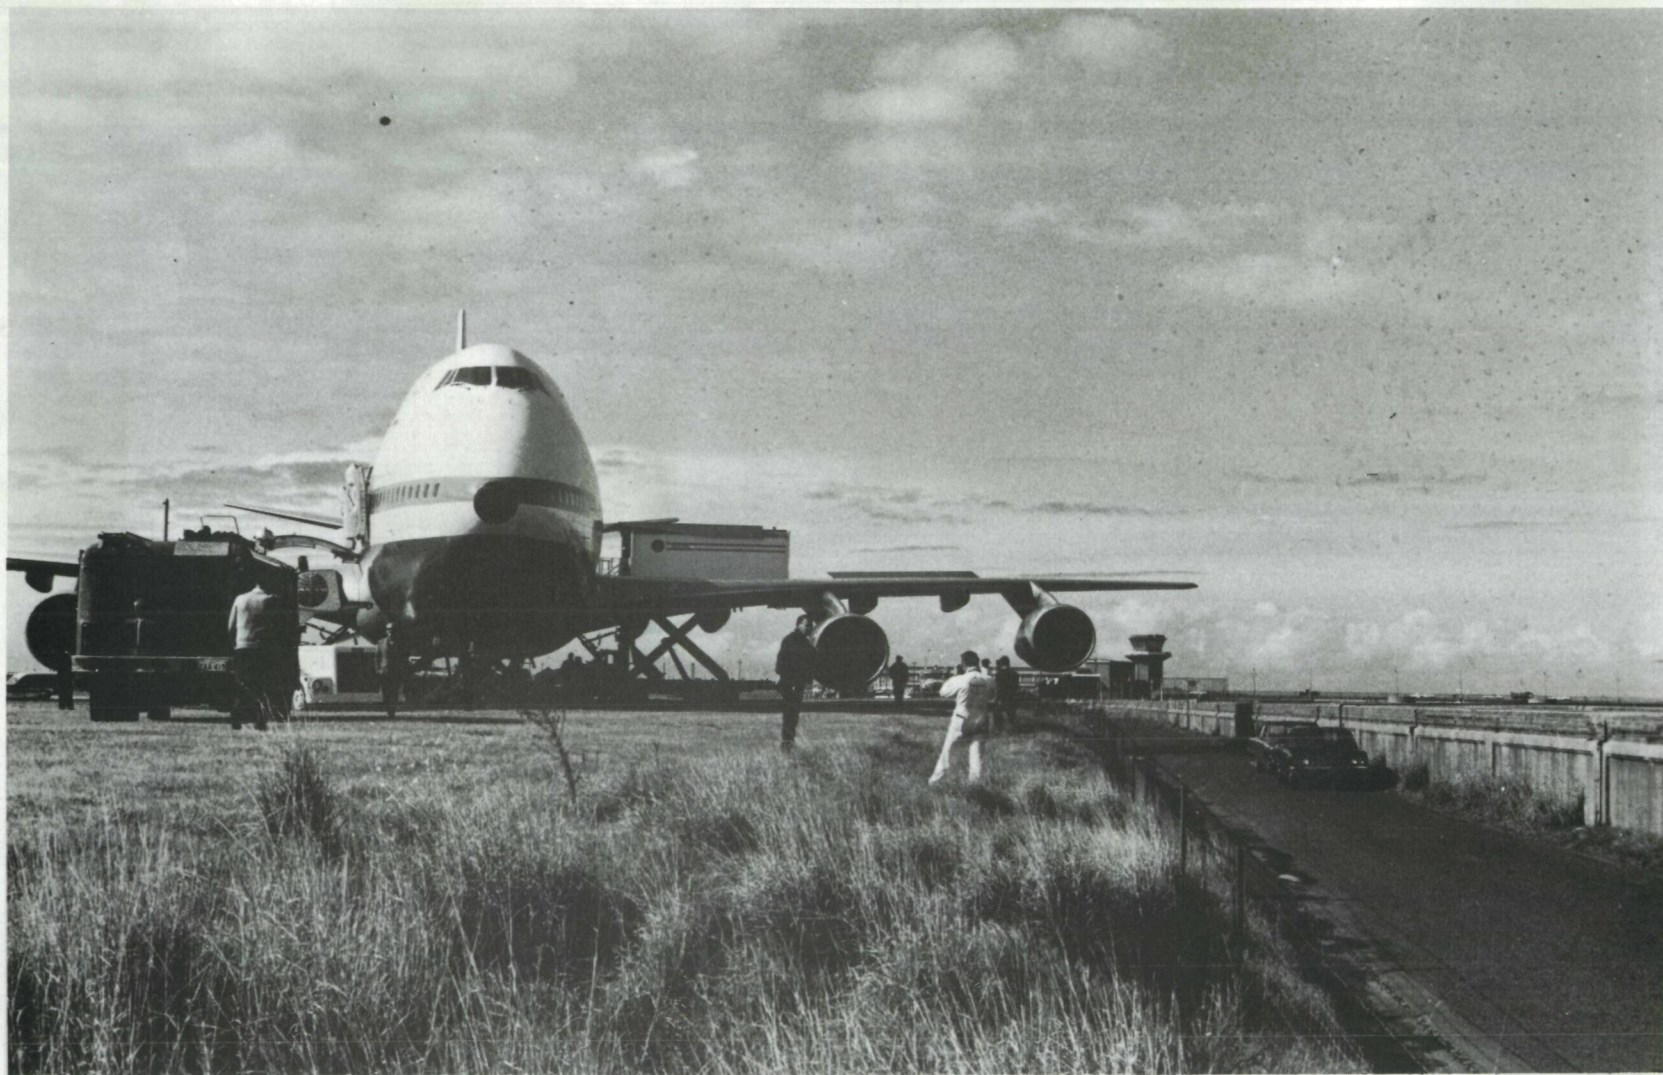
The captain has said that there was not any malfunction of the braking system and he believes that the anti-skid system operated normally. He has stated that he did not get normal deceleration, that he felt frequent brake releases and that he believed that this was due to the wet and slippery condition of the runway. As the aircraft neared the end of the runway, it was steered to the right off the end of the sealed surface to avoid running into a large concrete sewage outfall and a sunken perimeter road just off the end of the runway.

The aircraft as it came to rest a short distance beyond the end of the runway.
Note the sunken perimeter road and the sewage outfall.

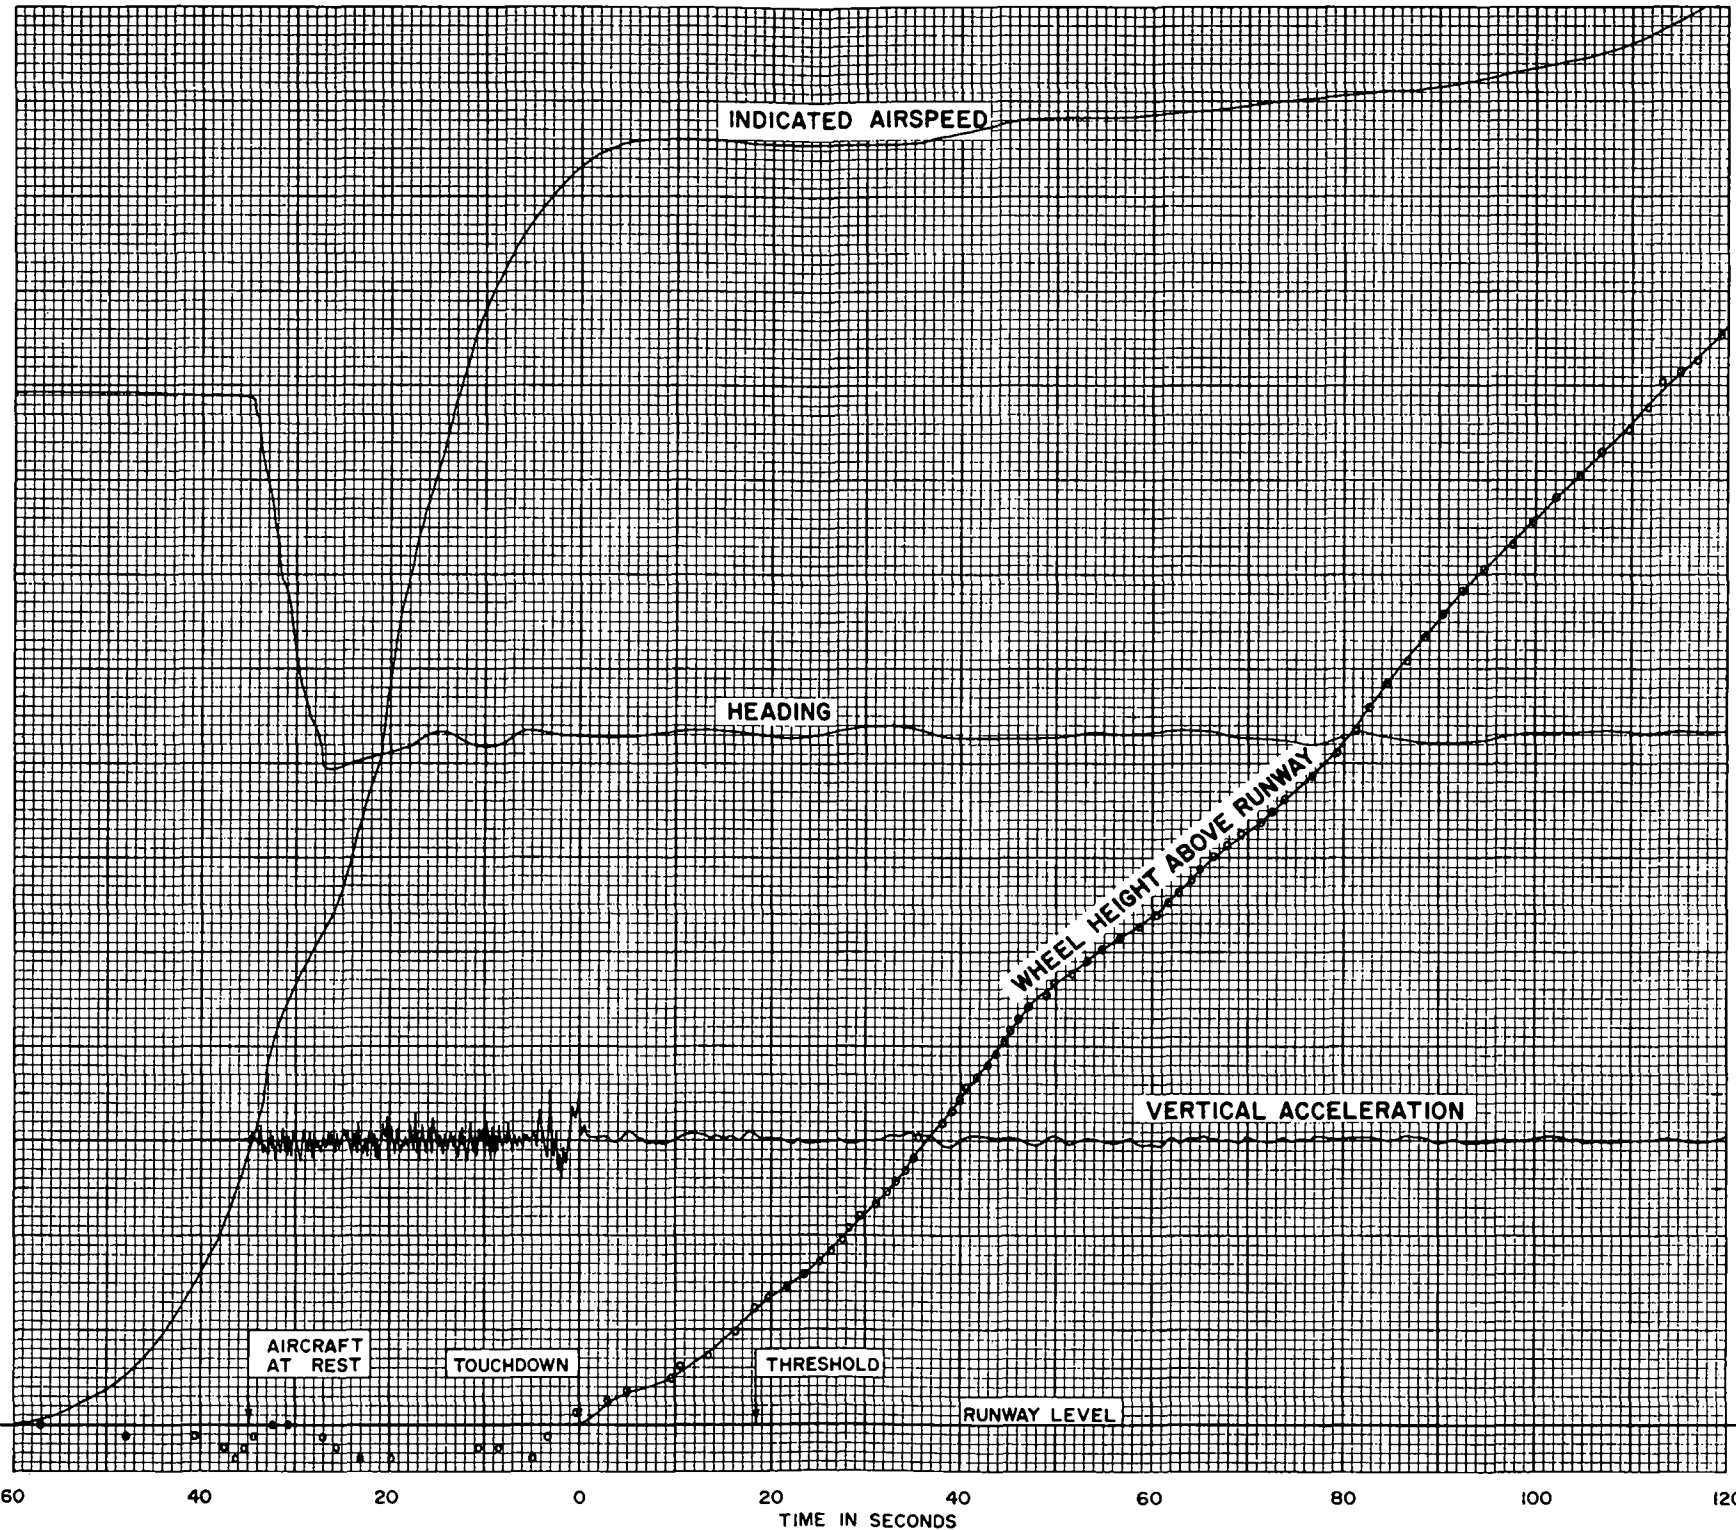
Below a height of about 50 feet above the runway the aircraft's static system is subject to pressure changes arising from ground effect and, consequently, the shape of the altitude graph and absolute height values depicted in Appendix D are unreliable in this area. Similarly, during deceleration the airspeed record is subject to a rapid dynamic change and the graph suffers from the lag characteristic which the recorder is subject to under such conditions.

Recorded flight data during approach and landing.

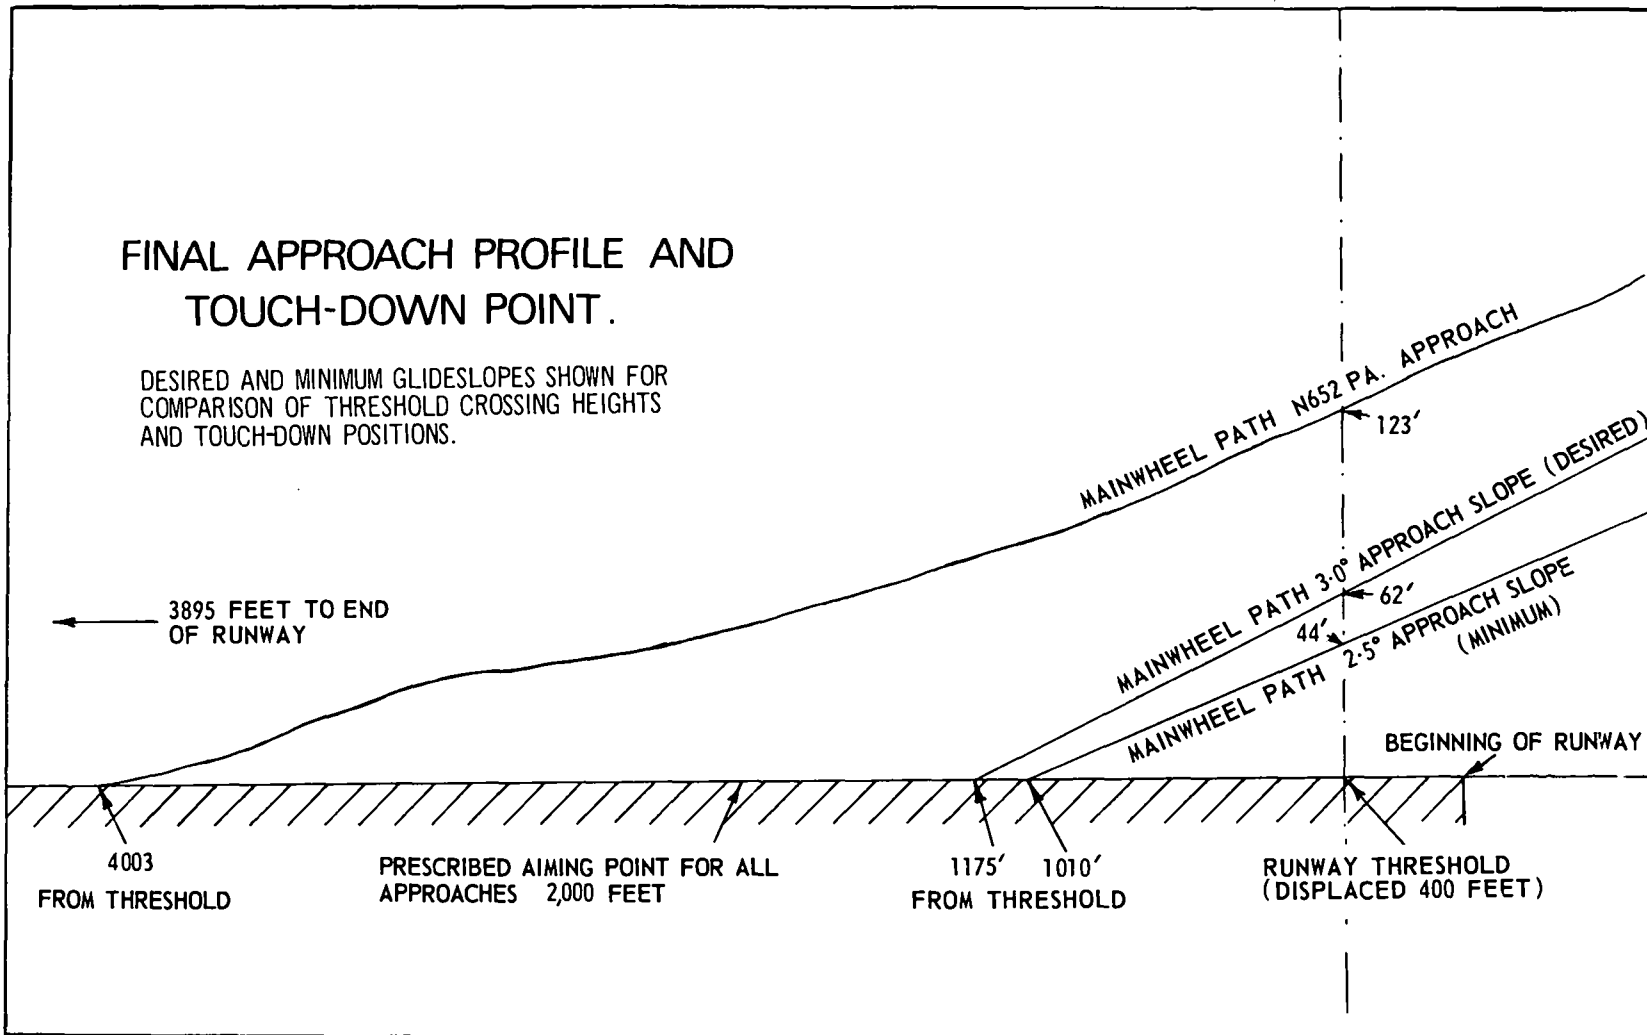
The reasons for this delayed touchdown may be found in an examination of Appendices E and F. The approach profile at Appendix E shows that the aircraft crossed the threshold with a wheel height of 123 feet and with an approach slope angle of 24 degrees. Appendix F, a graph supplied by The Boeing Company, indicates that this combination of excessive threshold height and shallow approach slope will result in overshooting the normal touchdown point by some 2,200 feet. Since the normal touchdown point from a 3 degree approach slope in this type of aircraft, with due allowance for 500 feet consumed during the landing flare, is specified by the manufacturer as being 1,675 feet beyond the threshold, a touchdown in this case at about 4,000 feet beyond the threshold is not a surprising result.

FINAL APPROACH PROFILE AND TOUCH-DOWN POINT.

DESIRED AND MINIMUM GLIDESLOPES SHOWN FOR COMPARISON OF THRESHOLD CROSSING HEIGHTS AND TOUCH-DOWN POSITIONS.

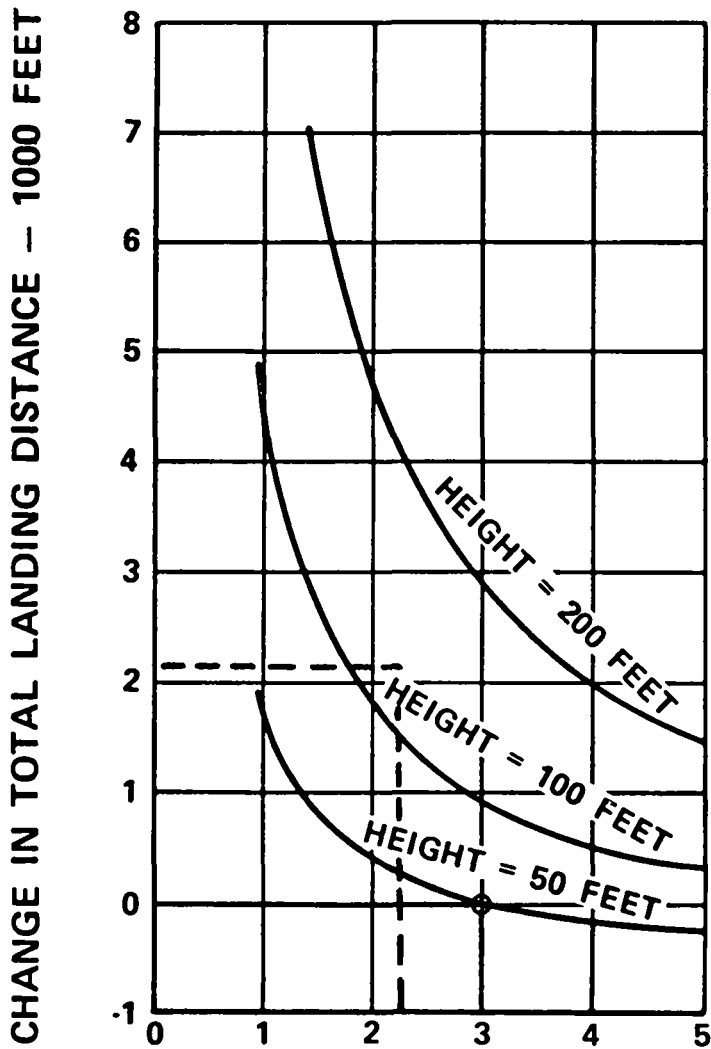
GLIDE PATH ANGLE – DEGREES

FLAT GLIDE SLOPE PATH AND EXCESSIVE HEIGHT OVER END OF RUNWAY COMBINE TO EXTEND LANDING DISTANCE REQUIRED DUE TO RUNWAY USED BEFORE TOUCH DOWN.

BROKEN LINE INDICATES SITUATION OF N652PA DURING THE LATER STAGES OF THIS APPROACH.
