SPECIAL INVESTIGATION REPORT

BUREAU OF AIR SAFETY INVESTIGATION

BASI REPORT B/902/3110

**Flap limit speed exceedence
on departure from London Heathrow
on Monday 26 March 1990**

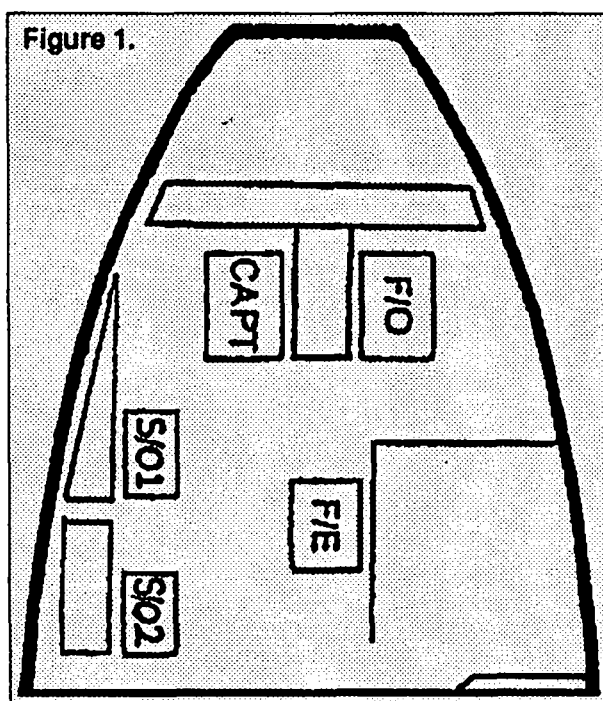
The seating configuration on the flight deck for departure is shown at Figure 1. The First Officer was flying this sector from the right hand pilot's seat.

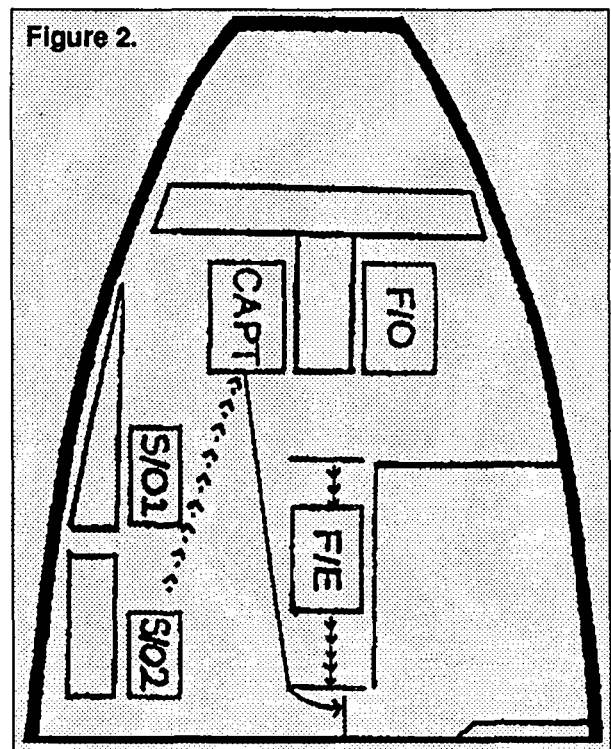
At about this point the Captain called for a seat change which involved removing himself from the left pilot seat and replacing himself with S/O 2. The F/E moved his seat aft, and the Captain then moved to the rear of the flight deck. The seat change sequence is shown at Figure 2.
