BASI Report B/885/1005

**Bell 214ST Helicopter VH-LAO
100 km north-west of
Troughton Island WA
28 March 1988**

ACCIDENT INVESTIGATION REPORT
B/885/1005

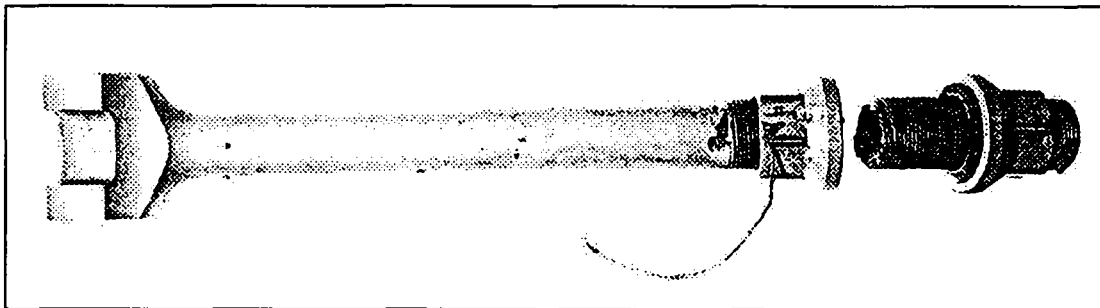
Figure 4. Drag brace barrel failure location

The location of the failure within the inboard clevis retaining nut is shown in figure 4.

commenced within the inner drag brace nut in the root of the third thread from the bearing face of the nut. The primary crack initiated on the outboard side (normally unloaded) of the root radius of the thread. It was located in the lower leading quadrant of the barrel at about the five o'clock position. There was no evidence of corrosion or material defect at the fracture location.

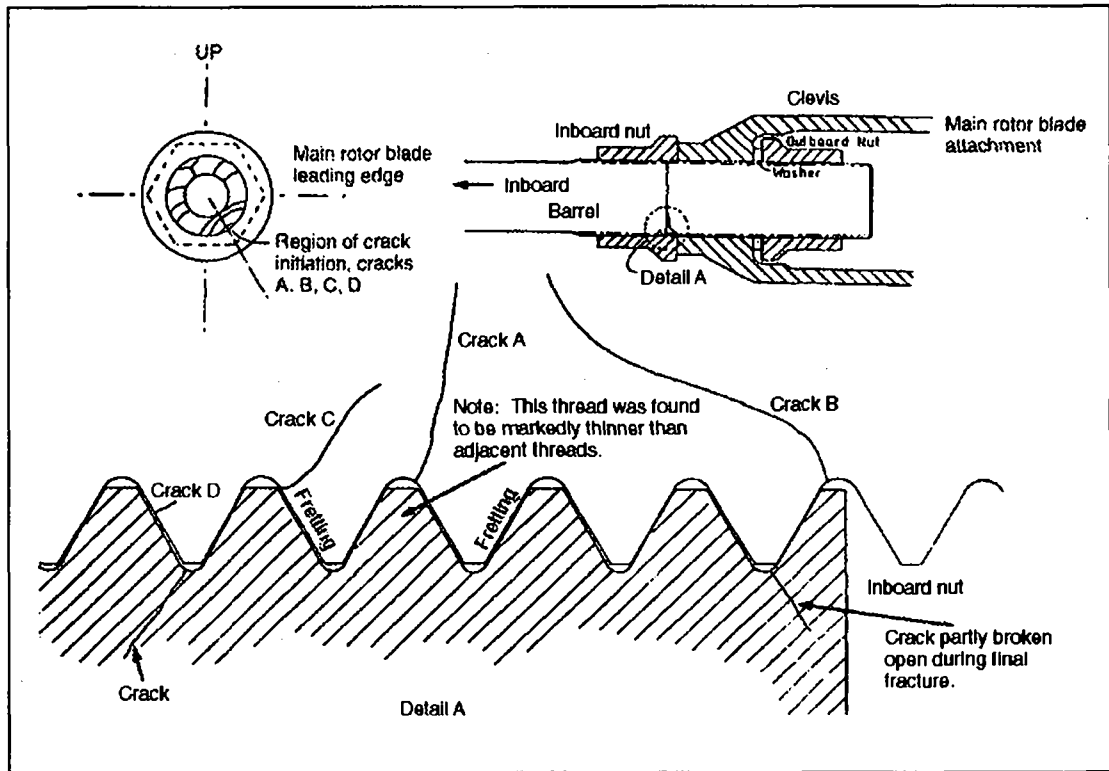
Figure 5. Detail of fracture and cracks

The fracture surface of the barrel is shown in figure 5. The fracture surface was relatively flat and contained a number of clearly visible progress lines typical of a fatigue-induced fracture.

It was apparent that crack initiation had occurred under high stress yet the rate of crack growth was slow. The crack grew symmetrically across the barrel with final overload failure occurring when about 2% of the sectional area remained. This indicated that loads progressively reduced as the crack grew.

Microscopic examination revealed 343 evenly spaced bands of fatigue striations on the fracture surface, each consisting of about 60–80 individual striations.

From previous experience and data concerning fatigue crack growth in aircraft components, it was deduced that each band of striations on the fracture surface of the barrel represented one flight cycle (takeoff to landing). Thus, the fracture had been growing for at least 343 flights.
