A U S T R A L I A N T R A N S P O R T S A F E T Y B U R E A U

MARINE SAFETY INVESTIGATION

REPORT 165

Independent investigation into the fire and
muster of the passengers aboard the
Australian flag passenger ferry

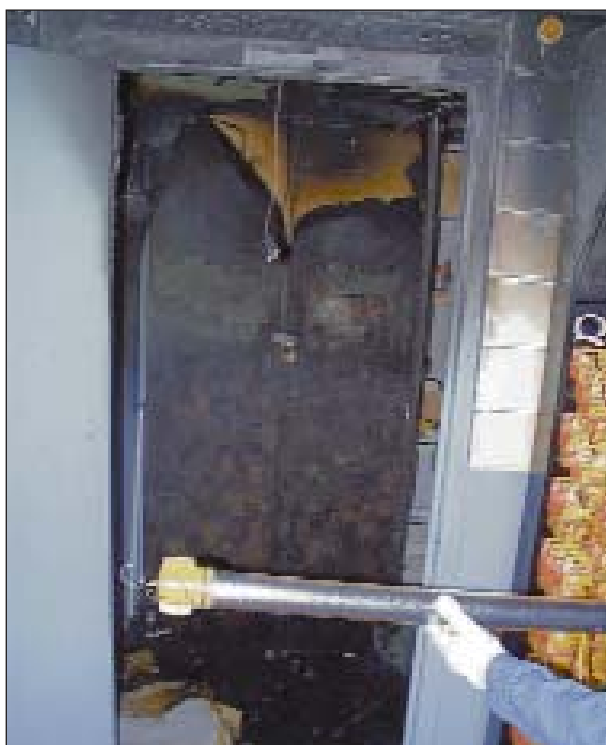
FIGURE 4:
Doorway to store area

The retail/display area of the shop showed extensive smoke and water damage throughout with some heat damage in the upper part of the shop, particularly the deckhead adjacent to the door into the store area where some mounted plastic fittings had melted. There was no evidence of flame damage within the display area apart from in the doorway leading into the store area at the rear (figure 4).

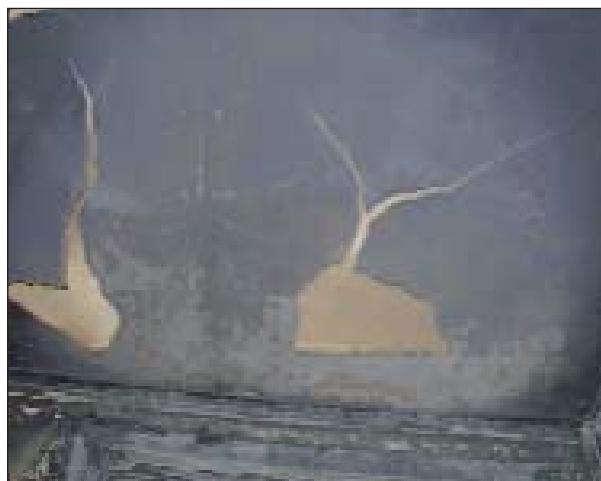
FIGURE 5:
Heat damage to deckhead panelling

Inside the store area, all the bulkheads and deckhead panels showed extensive fire and smoke damage. The examination revealed that the fire had started in the forward end of the store/office area and had been mainly confined to this area. In many areas plastic laminate facing of the bulkhead and deckhead panels had either been burnt away or delaminated from the backing particle board. In all of these areas the fire resistant particle board had remained wholly intact (figure 5).

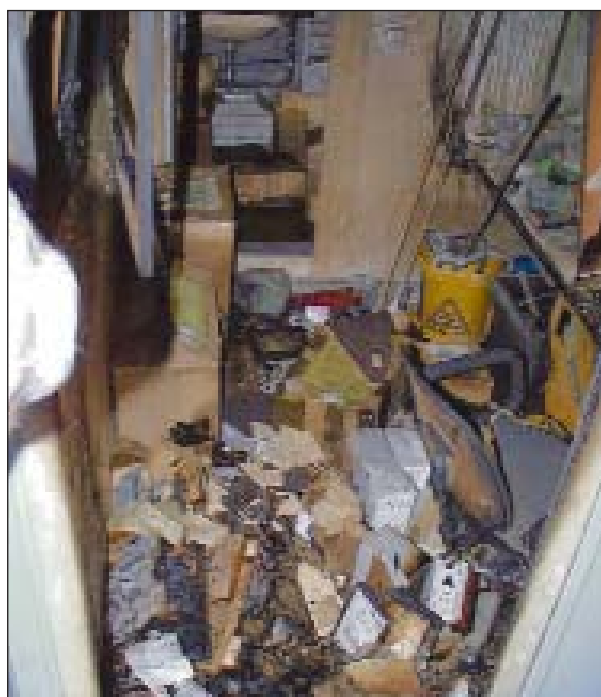
FIGURE 6:
Fire debris in the forward section of the store

In the forward section of the store, the deck was covered in fire debris (figure 6). The debris consisted mainly of charred paper, broken glass and melted plastic. Most of the debris was lying in the area of the computer desk and adjacent to

the opposite bulkhead. Among the debris were the remnants of the electrical power-board, which had been fixed to the bulkhead adjacent to the computer work-station. Examination of the remnants of the power board showed that the plastic components of the board and of the plugs to the extension lead supplying the fridge, CD writer, printer and battery chargers had been destroyed, to leave only the conductors within the board relatively intact. Of the electrical leads plugged into the power board only the copper conductors remained. The position and condition of the power board presented one possible source of ignition for the fire.

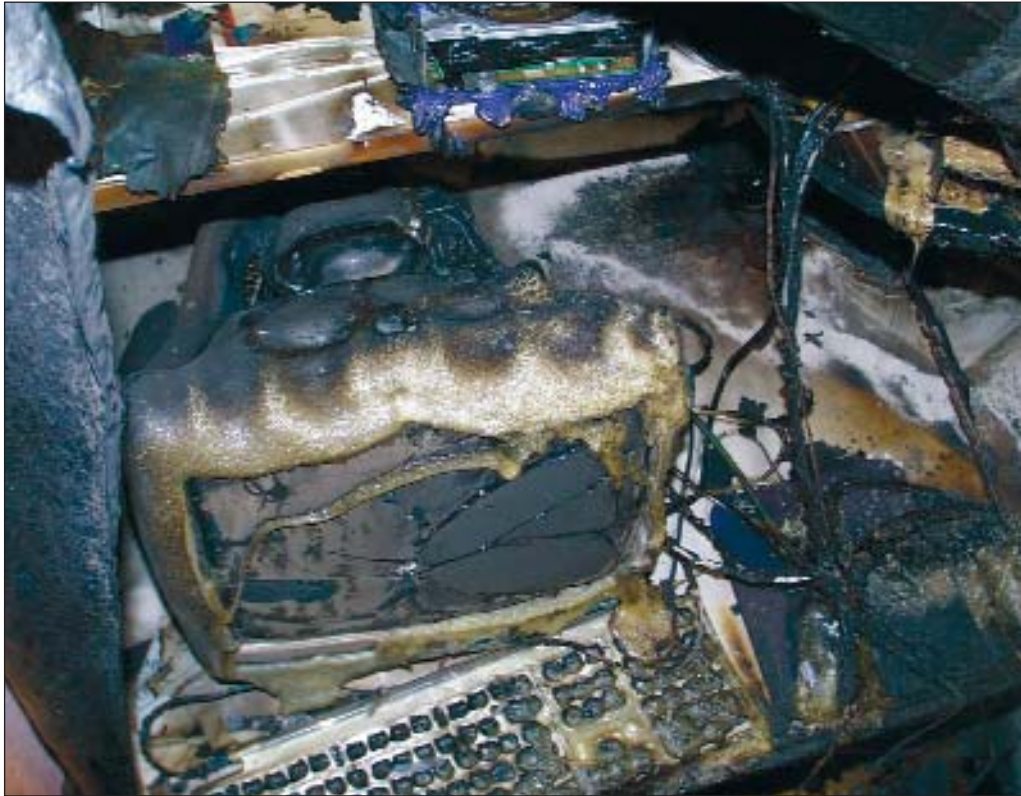
FIGURE 7:
Fire damage to computer workstation

On closer inspection, the seat of the fire appeared to be centred low in the area around the bench where the computer was located. The computer monitor and keyboard both showed extensive fire damage (figure 7). The compact disc writer and printer on the shelf above the computer, and a stock of manuals on the shelf above that, had been destroyed. Systematic clearance of the debris from the deck under the computer work-station (mostly partially burned cardboard boxes containing photograph envelopes), revealed a characteristic fire ‘V’ pattern low in the corner between the engine casing bulkhead and the part bulkhead between the forward and after sections of the store (figure 8). The pattern of the burn damage in the surrounding boxes of photograph envelopes indicated that the flame had travelled from a point close to the deck in an upwards direction, partially consuming the boxes of envelopes in its path.

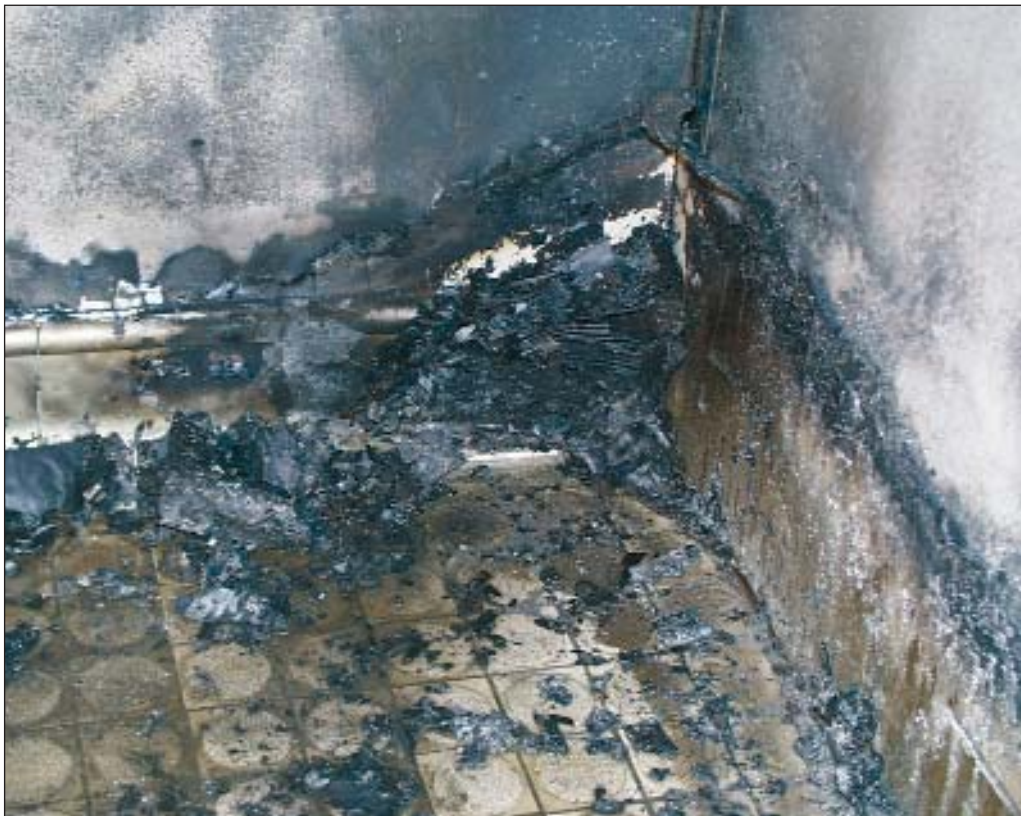
FIGURE 8:
Fire damage under computer workstation showing 'V' pattern in corner

Adjacent to the burn pattern under the computer work-station lay a section of a short extension lead, which had connected the power board to the power lead from the fridge (figure 9). The plastic hose used to drain chemical from the silver recovery unit in the shop to the sink in the store lay alongside the connection between the extension lead and the fridge lead. This hose had been partially damaged by the fire and had a charred hole in it adjacent to the extension lead connection.

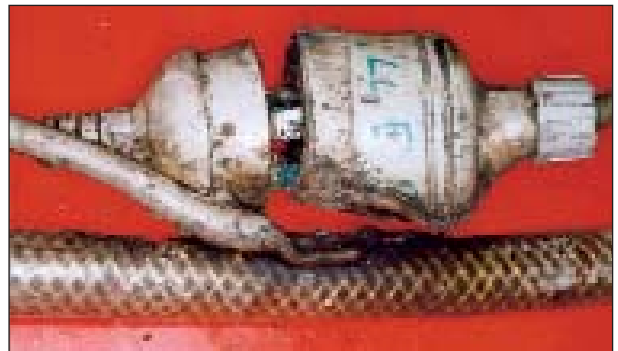
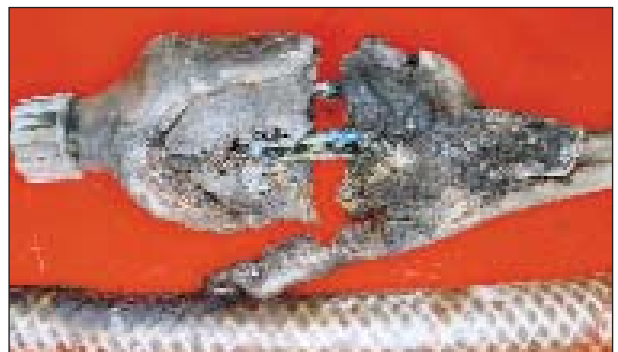
The plastic drain hose had also been affected by localised melting and charring to a degree that created leaks. The blue coloured compounds on the plug pins are consistent with a reaction between the copper alloy of the pins and waste photographic processing chemicals.

It is likely that the complete destruction of the copper conductor wires in the section of the electrical lead trapped between the plug fitting and drain hose was caused by electrical arcing between the conductor wires.

Based on the technical analysis unit's findings, it is probable that the fire in the photography shop was caused by arcing/heating as a result of the breakdown of the insulation between the conductors in the section of extension lead trapped between the chemical drain hose and the plug. It is likely that the poly vinyl chloride insulation in the lead had 'flowed' until thin enough to allow heating/arcing (a short circuit) between the conductors after being subjected to the weight of the boxes of photograph envelopes. These boxes had been stored under the computer work-station, resting on the plug/lead/hose, for a considerable period of time (approximately three months according to the shop manager).

FIGURE 9:
The features of the recovered section of the electrical lead and drain hose (two views)

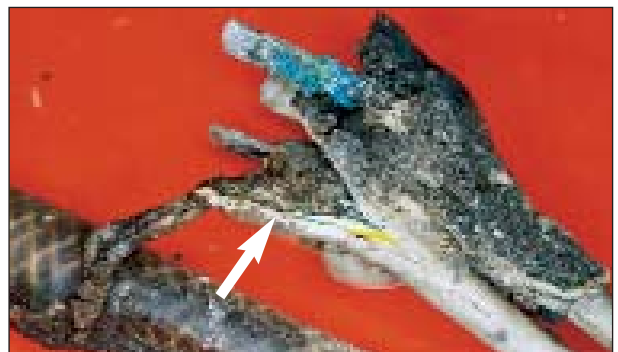
FIGURE 10:
A remnant of a copper conductor wire (arrowed) exposed by cutting the remaining intact insulation
