MARINE SAFETY INVESTIGATION
REPORT 169

Independent investigation into the grounding of
the Kerguelen Islands (French) registered

Mirande

in Port Phillip Bay, Victoria
on 28 June 2001

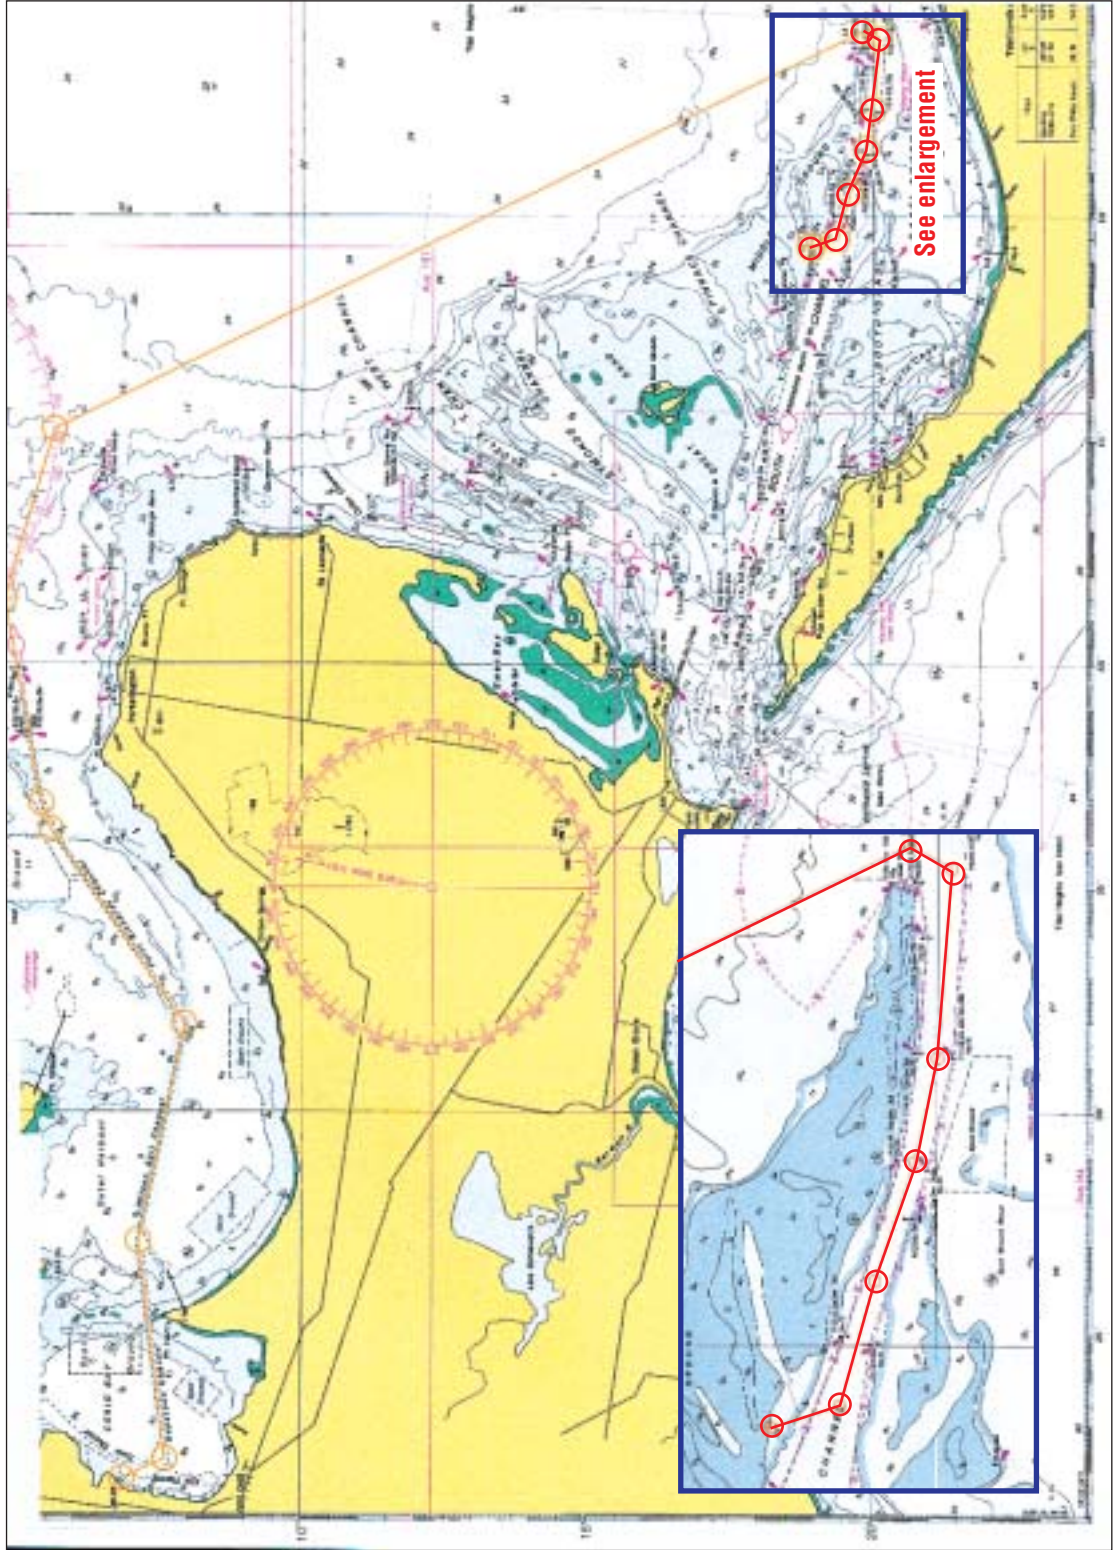
FIGURE 2:
Portion of chart Aus 143 showing track of *Mirande*

The departure pilotage from Geelong and across Port Phillip proceeded without problem and, at about 2115, the ship rounded the Hovell Pile and commenced its passage through the South Channel to sea. The ship was, at this time, on full sea speed at about 12.8 knots with the helm on 'hand' steering. As the ship passed to the south of beacon 12, the ship's steering gear suffered a telemotor system failure and the alarm started ringing. The port steering system had failed.

Shortly afterwards, at about 2135 it was confirmed to the pilot that there was a steering failure and, as the ship continued sheering toward the northern side of the channel, he requested 'full astern'. The ship's momentum, however, and the proximity of the shallows near the channel edge meant the ship was very soon aground. The grounding, according to the pilot, occurred at 2137.

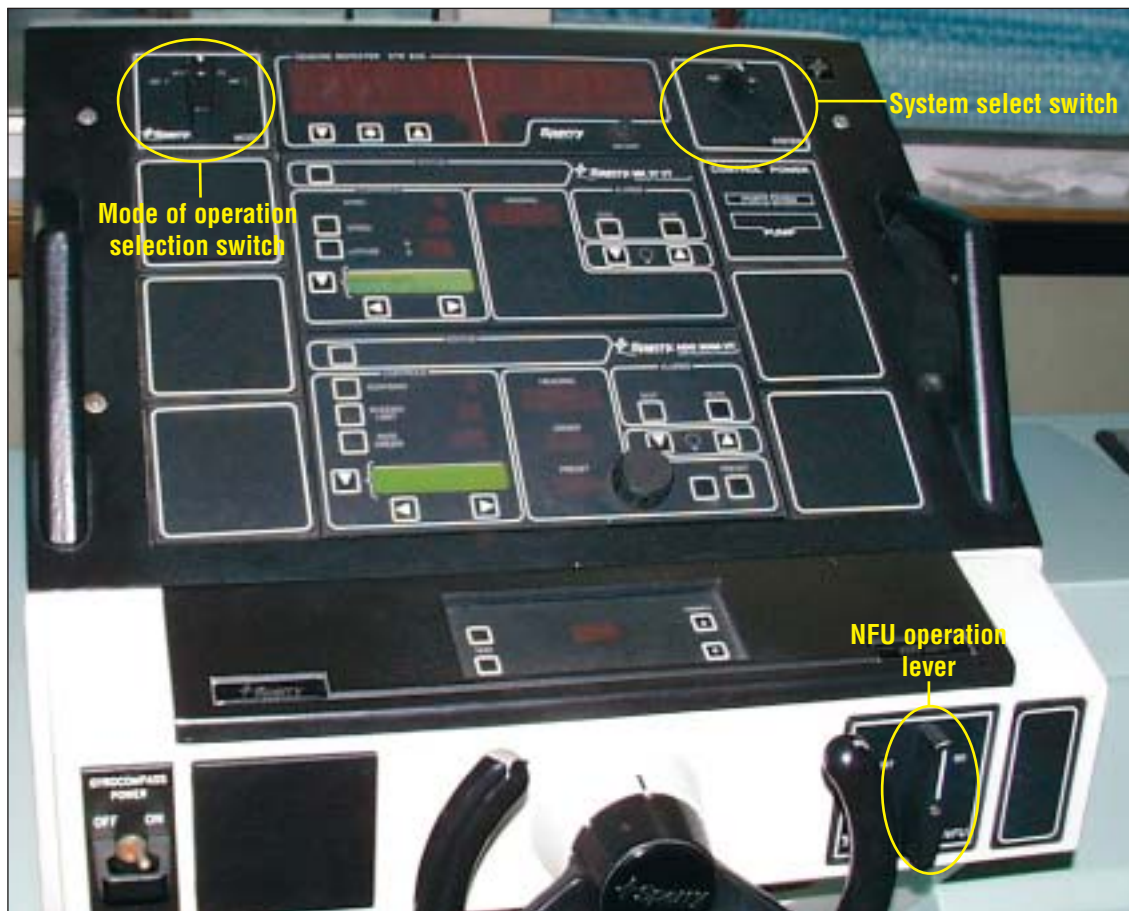
FIGURE 3:
Steering motor control panel

The bridge steering pedestal (see fig 3) has easily accessible and well-marked controls both for NFU control as well as for changing over systems and modes of operation.

The examination of the Sperry Gyropilot unit and its electrical supplies, which are fed to the wheelhouse from the steering flat, revealed that the two 2-amp fuses, fitted at the primary side of the 450/110 volt transformer in the port telemotor system, had blown, causing the failure of the steering at the time of the incident.

apparent reason for the fuses to have blown. They did, however, identify that these fuses should have been of the 'slow blow' type and not of the 'instantaneous' type which had, at some time, been fitted.

The drawings issued by Porsgrunn Steering Gear A/S, the manufacturers of the rotary-vane steering gear, however, show the fuses fitted on the primary side of the transformers. The Inspector finds it difficult to see how fuses fitted in the secondary side of the transformer would provide protection for the power supplies to the steering flat equipment in the case of a transformer failure. For this reason it is customary to fit the fuses on the primary side of the transformer. The remote steering unit (on the secondary side of the transformer) is also fitted with fuses.

The grounding should have been avoided. The ship's staff had three alternative actions to take, each of which would have restored steering. The NFU lever was just to the right hand side of, and next to, the steering wheel. Just operating this lever would have overridden the steering wheel and operated the rudder. Also at the top left of the control panel was a mode selection switch. Had this switch been turned to NFU, the NFU steering lever would have maintained steering in the non-follow-up mode. Finally, the telemotor control selection switch was switched to the port telemotor control. By turning the switch to the starboard telemotor control, full steering would have been restored.

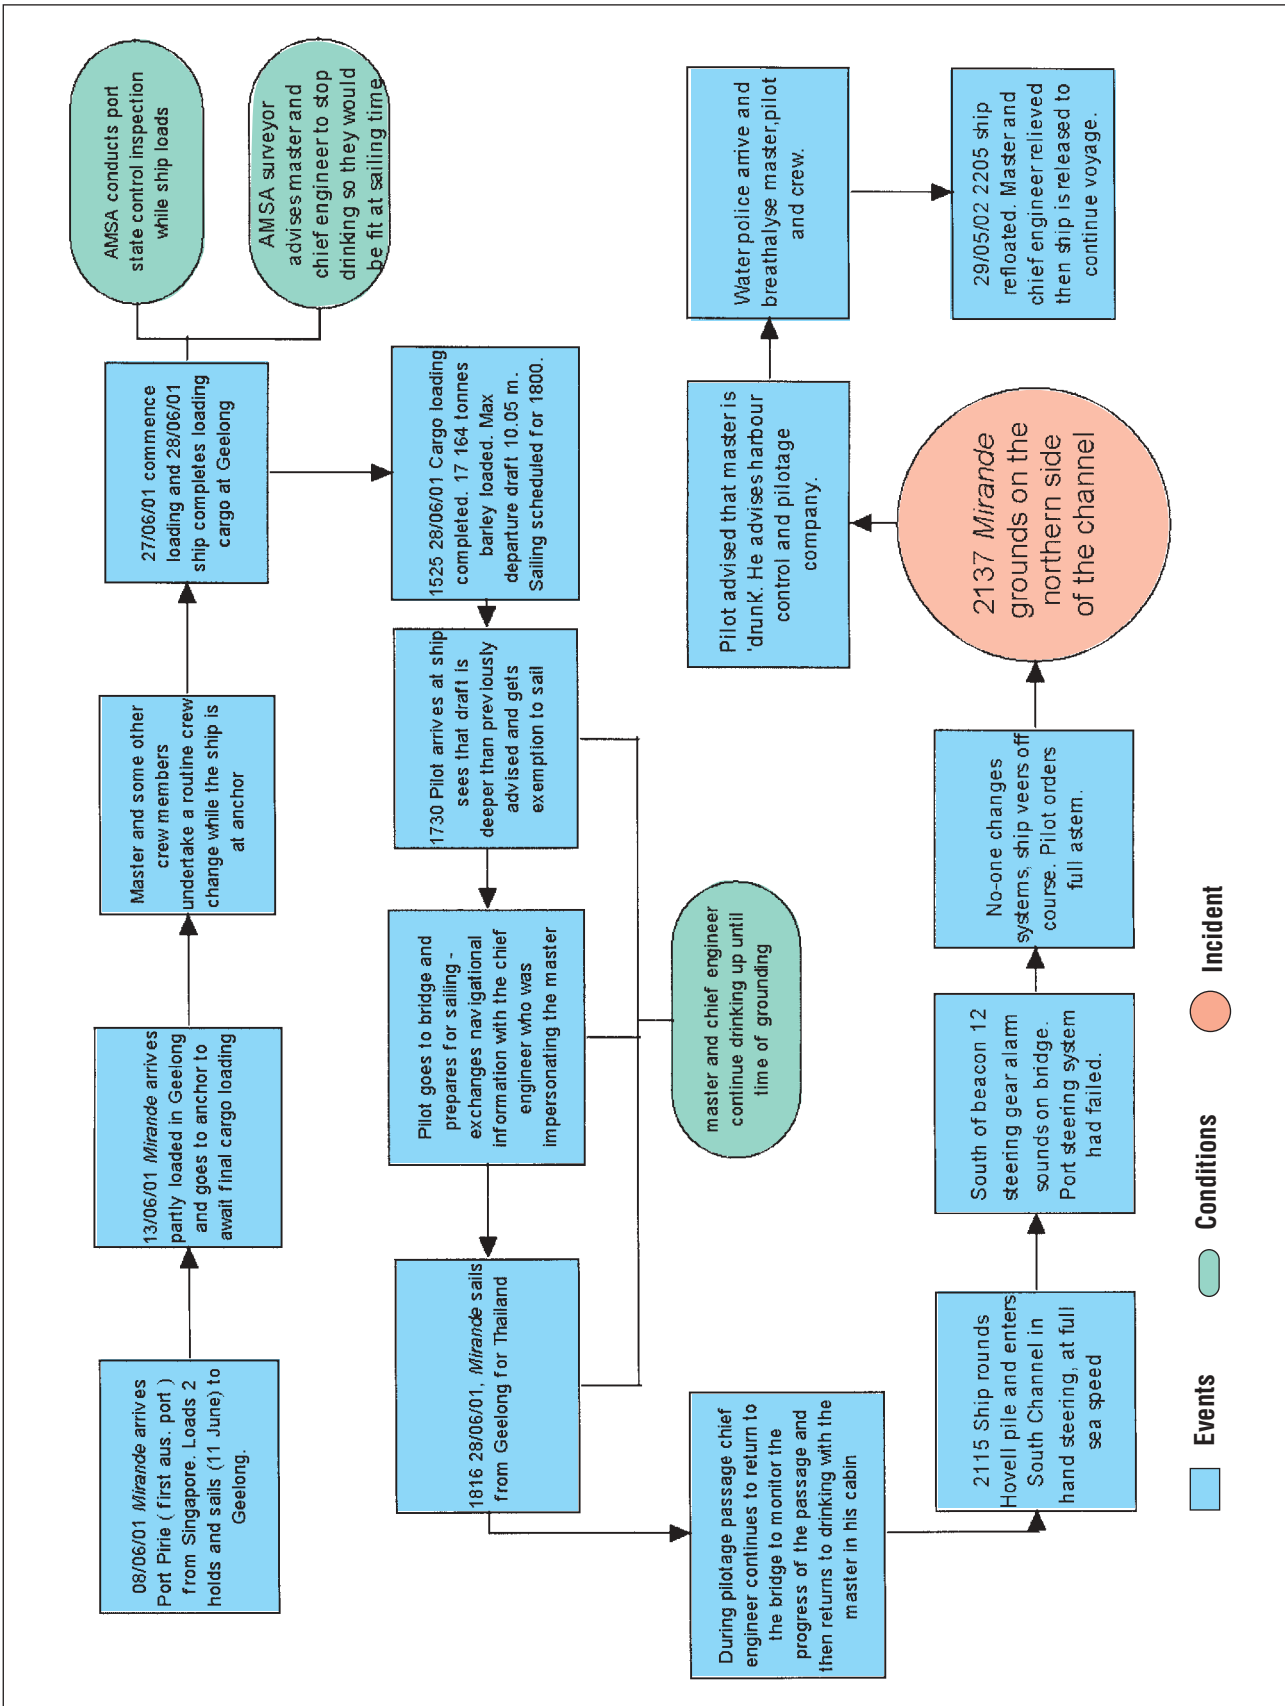
FIGURE 4:
Mirande: Events and causal factors chart

1. For a reason which could not be determined, two fuses in the primary side of the transformer supplying power to the port telemotor system blew, causing failure of the hand steering in use at the time.
2. Fuses of the 'instantaneous' rather than the 'slow blow' type had been fitted.
3. The mate and third mate had inadequate knowledge of the bridge equipment, particularly the emergency steering change-over procedures.
4. The helmsman had received no training in emergency steering procedures.

5. Intoxication of the master resulted in his absence from the bridge at the time of the steering failure and hence in a lack of proper leadership, experience and knowledge at a time when it was particularly needed.
6. The pilot was licensed only to 9.5 m maximum draught, however the draught was 10.05 m and he had obtained a verbal exemption from his managing director to undertake this passage. He had been advised that the sailing draught would be 9.5 m by the ship's agent.
