OUTLINE OF INCIDENT

On 21 April 1987 at approximately 0710 ships time (0810 E.S.T.) the Cypriot registered cargo vessel "RUCA CHALLENGE" of 1587.46 gross tons on passage from Haifa, Israel to Cairns, Australia, via Singapore, with a cargo of potassium nitrate, ran aground on Piper Reef in position 12° 14' 80" S 143° 14' 40" E.

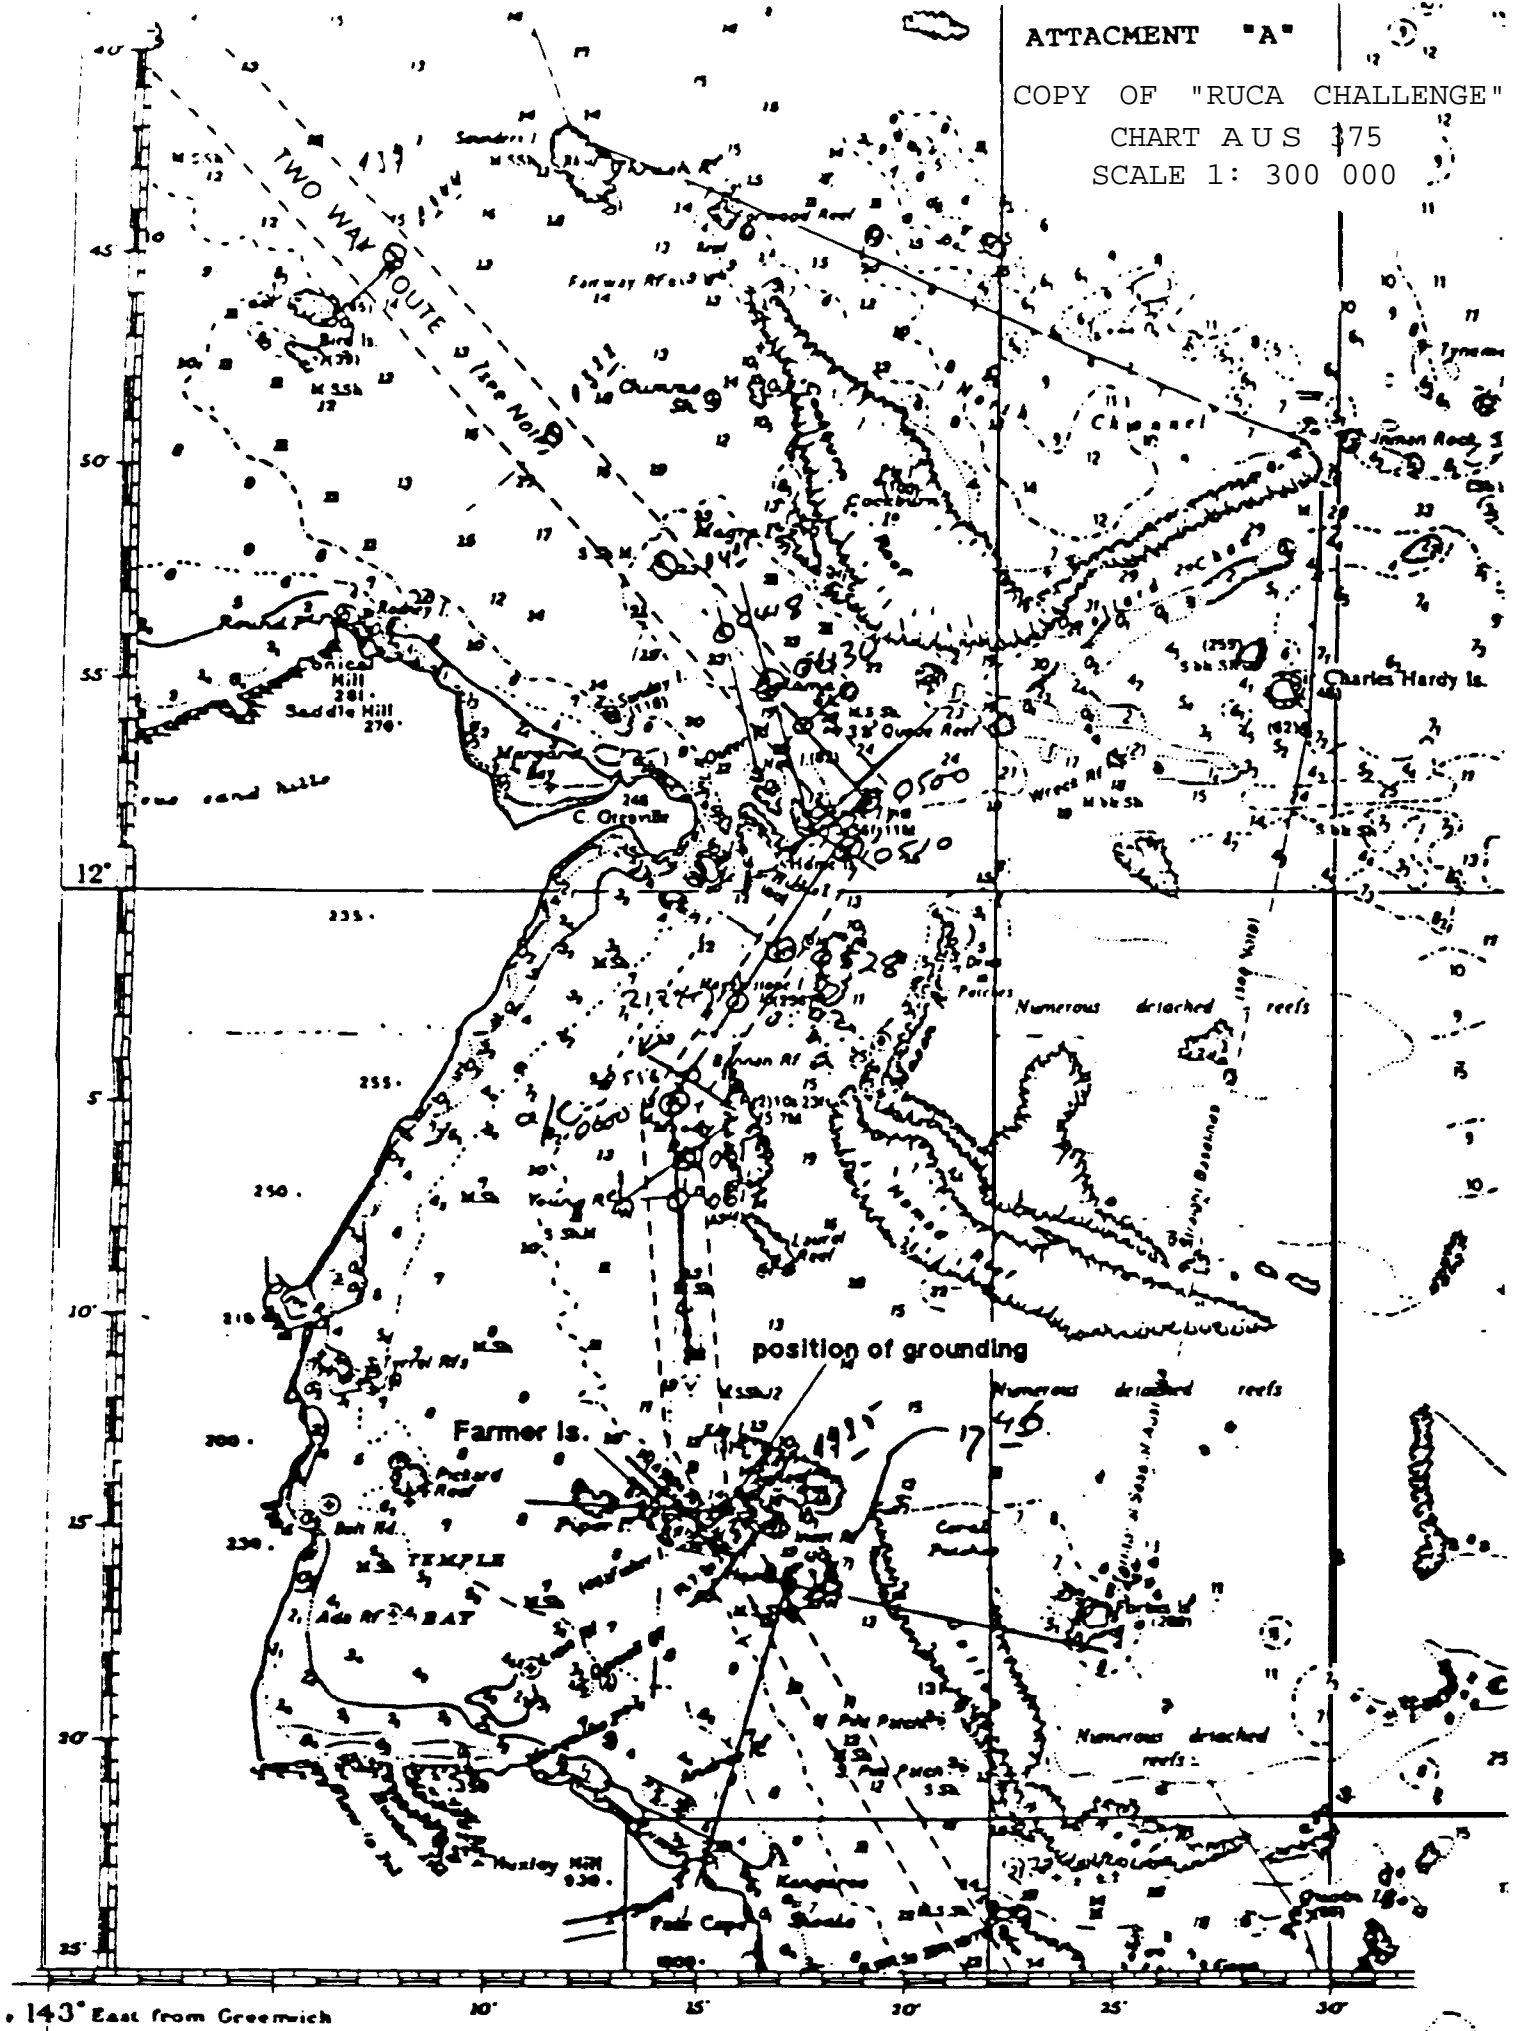
No further positions are shown on Chart AUS 375 and the vessel grounded on Piper Reef sometime around 0705 to 0710. The visibility at 0600 was reported to have been about 8 miles with no rain squalls in the area.

The Chief Mate claimed that he took subsequent positions after 0617, but they were later erased owing to the scale of the chart in use (1-300000). He had set a course to pass 1 mile to the west of Inset Reef Light and 1.5 miles to the east of Farmer Island.

NOTE: This reproduction is a photocopy of the actual chart in use aboard the "Ruca Challenge". The quality of the reproduction has suffered in the copy process.
