Summary

On 19 January 1994, the Australian flag tanker *Oscro Star* was loading a cargo of petroleum products at No.2 Jetty of the BP Refinery at Kwinana, near Fremantle, W.A.

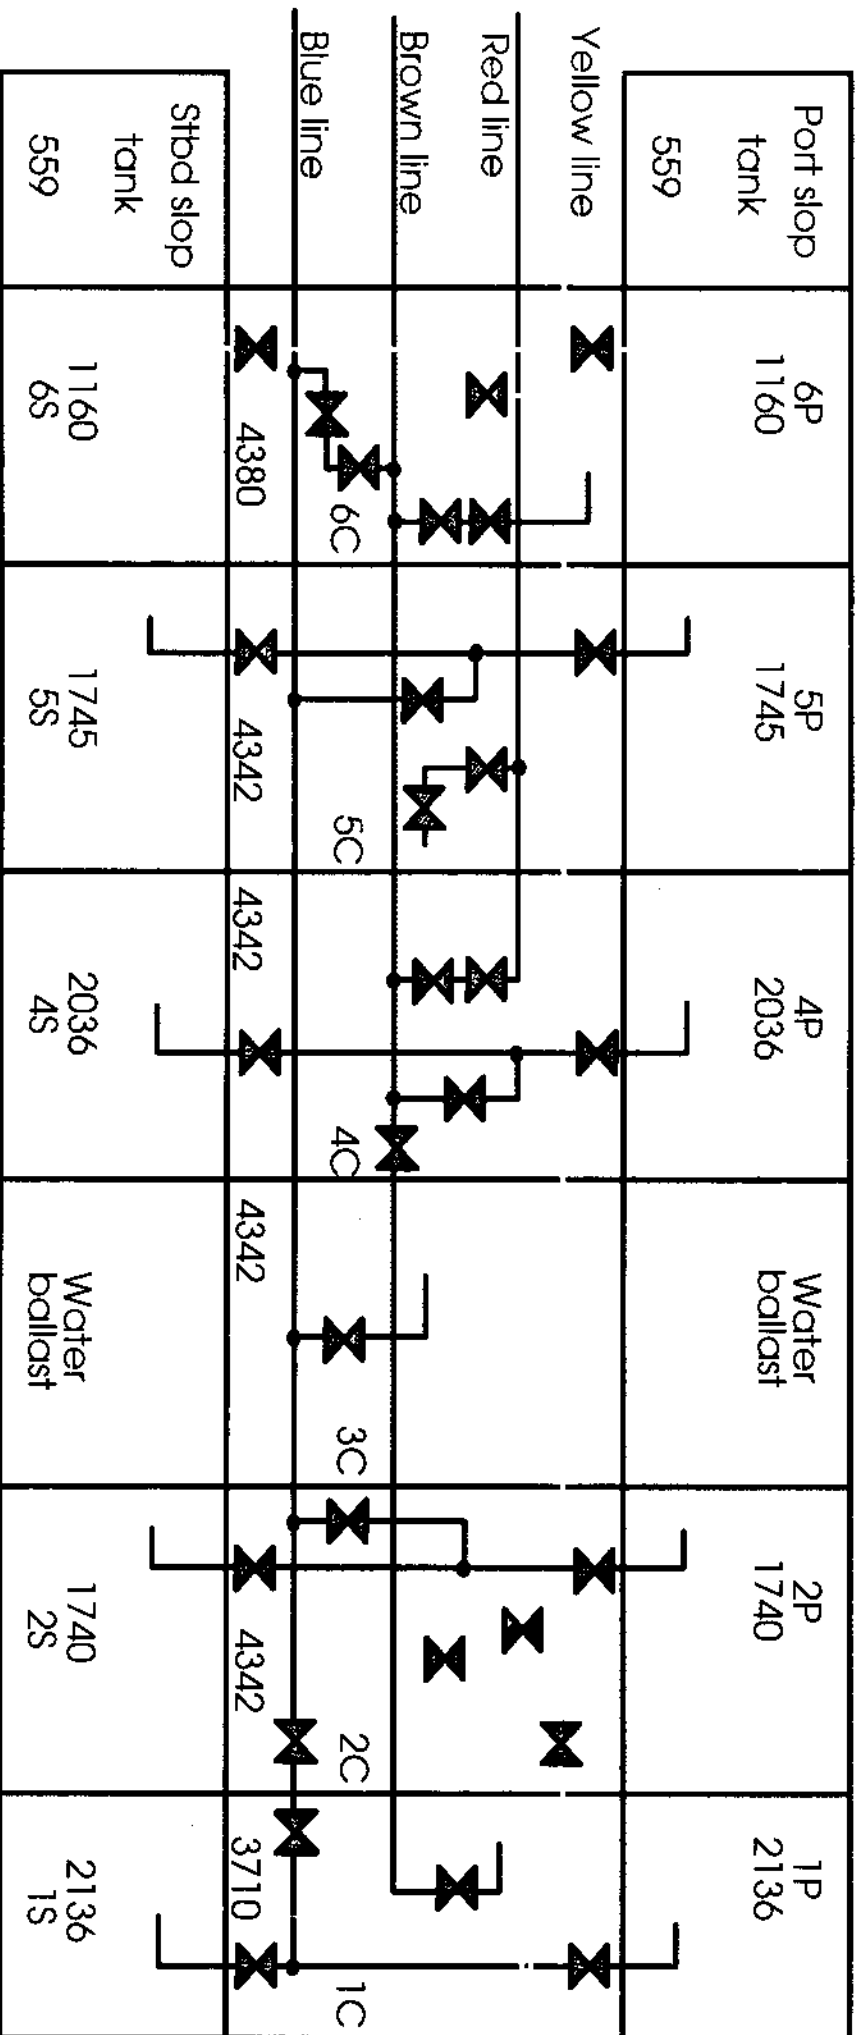
Cargo tank and pipeline diagram

He had previously opened the blue line to brown line cross-over valves and the isolating valve on the brown line, ready to change over the filling from No.5 wing tanks to No.1 centre tank which already contained some product loaded at 1100 for the purposes of sampling and stress reduction. The tank filling valve on No.1 centre tank, however, was still closed. (See pipeline diagram on page 4)
