RAIL INVESTIGATION REPORT

# **Collision between suburban electric passenger train 6369 and the empty express electric train 6371**

**Footscray, Victoria  
5 June 2001**

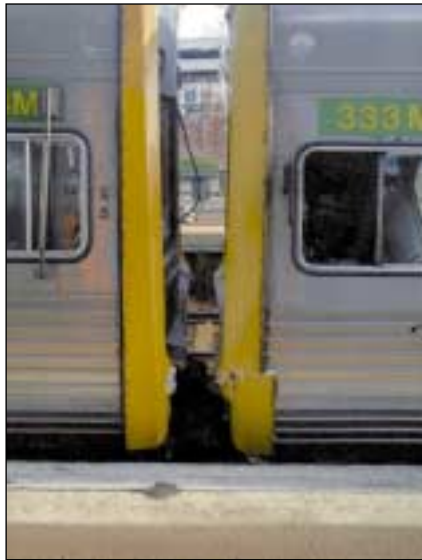
FIGURE 2:  
The collision scene Car 504 M and Car 333 M

point of impact. Train 6369 was propelled forward approximately 15 m and couplings broke between cars 1102T and 504M and between cars 503M and 1102T.

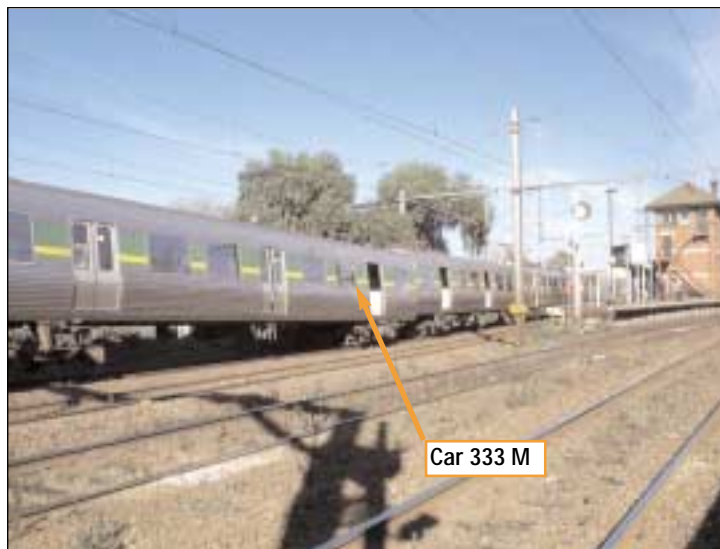
FIGURE 3:  
Collision scene Car 1017T underridden Car 333 M

The lead unit of train 6371 [333 M] sustained the most damage. There was damage at the point of impact of cars 333 M and 504 M. The rear of leading motor car 333 M was lifted into the air about 600 mm causing 1017 T to under-run it, resulting in significant end damage to both cars. The rear of car 1017 T was also underrun by car 334 M causing significant structural damage, including the failure of the anti-collision posts on 334 M at the pantograph end of the car and damage to bogies (eg torsion bars), couplings and associated equipment. During the recovery operation, the chaining together of vehicles that could not be coupled resulted in further damage. At the time of writing this report, that unit remains out of service.

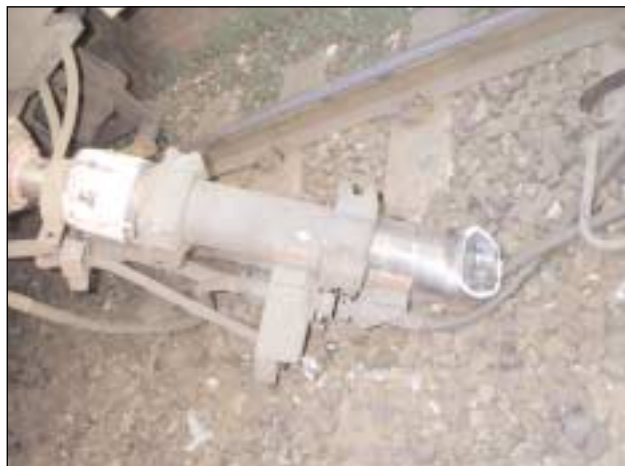
FIGURE 4:  
Collapsed as designed Scharfenberg coupler

The cars are equipped with Scharfenberg couplers. To help protect the carriages from structural damage in abnormal heavy impacts and collisions these couplers include a shock absorption device. That device consists of a preloaded collapsible tube and a drift with a design absorption capacity of 225000 Joules. On both trains the deformation tubes collapsed as designed. After any such accident both the tubes and couplers are replaced.

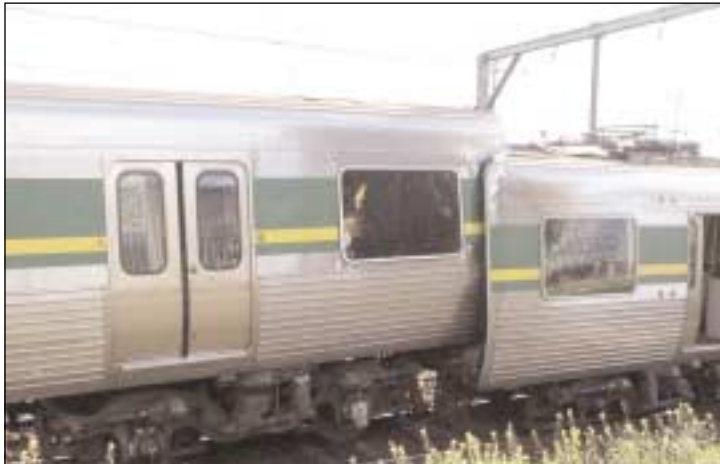
FIGURE 5:  
334 M impacted into 1017T Platform side view

The trailing unit of train 6369 [504 M] sustained significant damage. Apart from damage at the point of impact between cars 333 M and 504 M, the couplings between the cars within the unit broke under tension load. Damage occurred to the bogies and to equipment around the couplers, airlines, cable etc. In addition, some impact damage occurred to the ends of the car. That unit remains out of service awaiting repair.

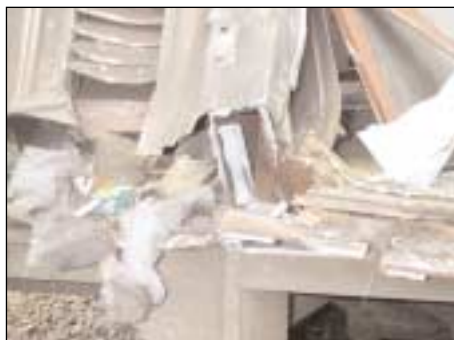
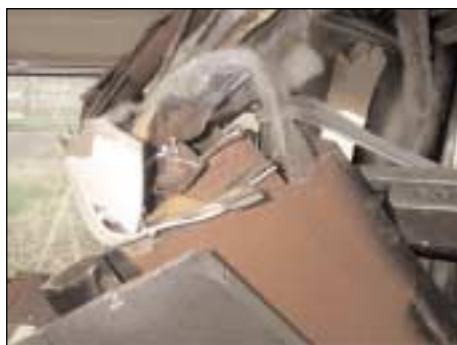
FIGURE 6:  
Left Hand and right hand collision post failures car 334 M

As a result of the failure of the anti-collision posts on 334 M there was significant encroachment into the adjacent passenger space within the car. Collision posts are designed to prevent one carriage telescoping into another and into the passenger space.

5. The anti-collision posts on motor cars on Com Eng trains should be further investigated to identify any deficiency in their design.
6. Rail accident response plans should be reviewed to provide procedures to ensure immediate safety of the track infrastructure, training for station staff at manned stations in immediate response procedures and rapid deployment of staff at unmanned stations.

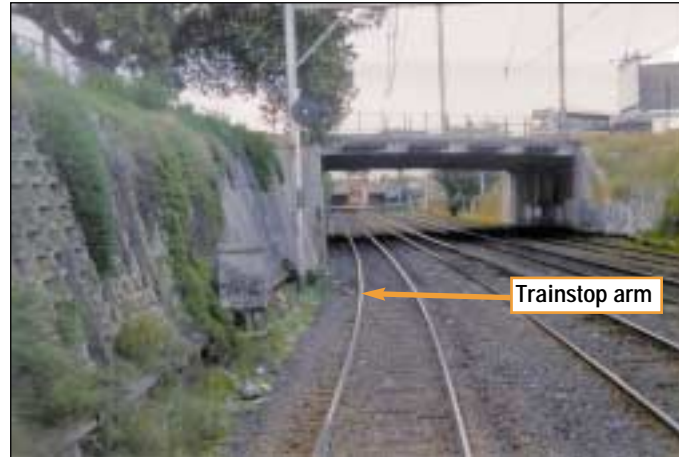
FIGURE 8.  
The cutting approaching signal W 223

track was inspected for accident damage, gauge, alignment and for any track condition that may have contributed to the accident. The track was found to be within the required tolerances. The track infrastructure was not considered to be a contributing factor to the accident.

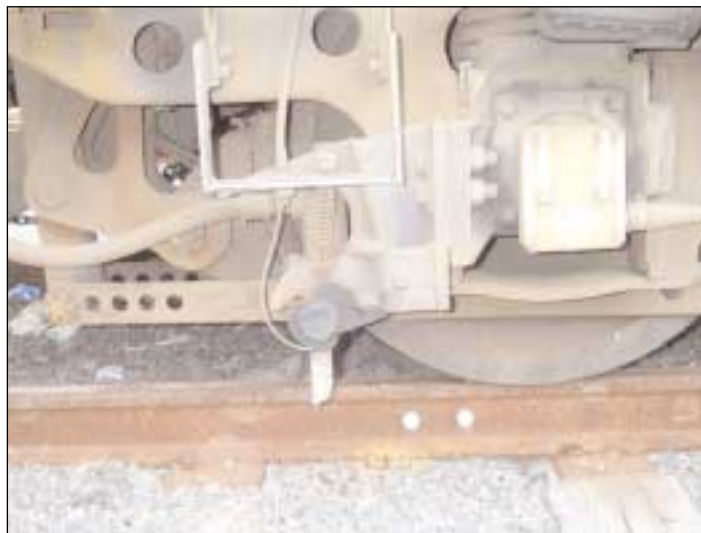
FIGURE 10:  
Trainstop lever on motor car

The distance from signal W223 to the rear of a stationary two-unit train at No. 4 Platform Footscray Station is about 225 m. Therefore, the design distance of the overlap did not equate to a safety margin, a distance that the train stop would bring the train to a halt from line speed, should the driver become incapacitated or otherwise lose control.
