INVESTIGATION REPORT

BUREAU OF AIR SAFETY INVESTIGATION

BASI Report
B/921/3068

**Breakdown in Runway Separation
Standard during Landings on
Runways 16 and 07 Sydney
(Kingsford Smith) Airport
12 March 1992**

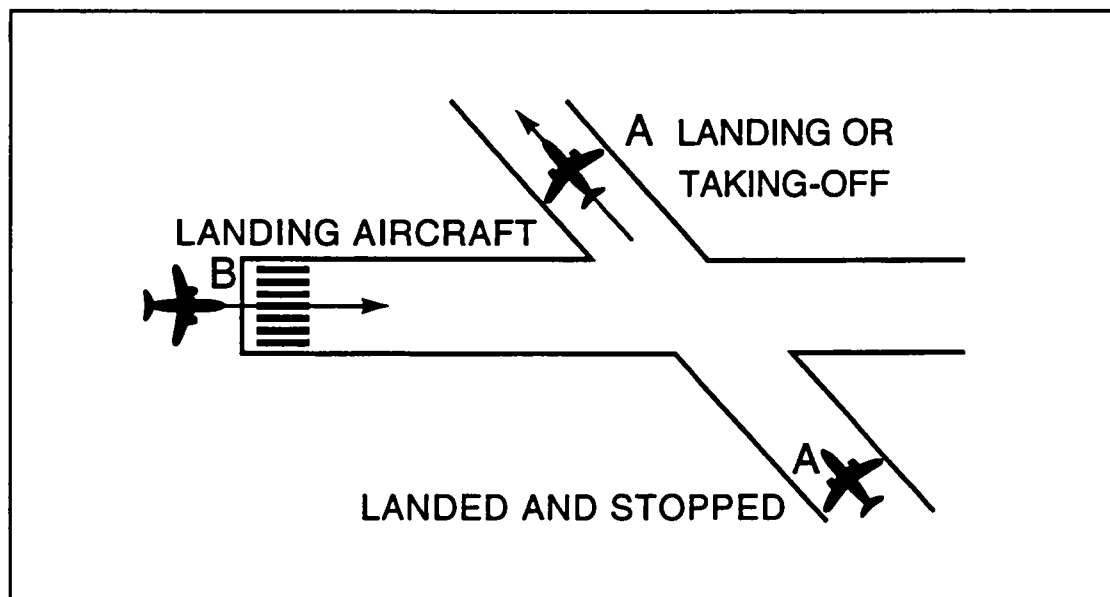
Figure 1

The appropriate standard relating to the circumstances at the time of the incident was documented in MATS 6-3-6, para. 32, case (f) (see fig. 1).

B (the B727) shall not be permitted to cross the runway threshold until the preceding departing or landing aircraft A (the B767) has crossed the relevant runway intersection or has stopped short of the intersection.

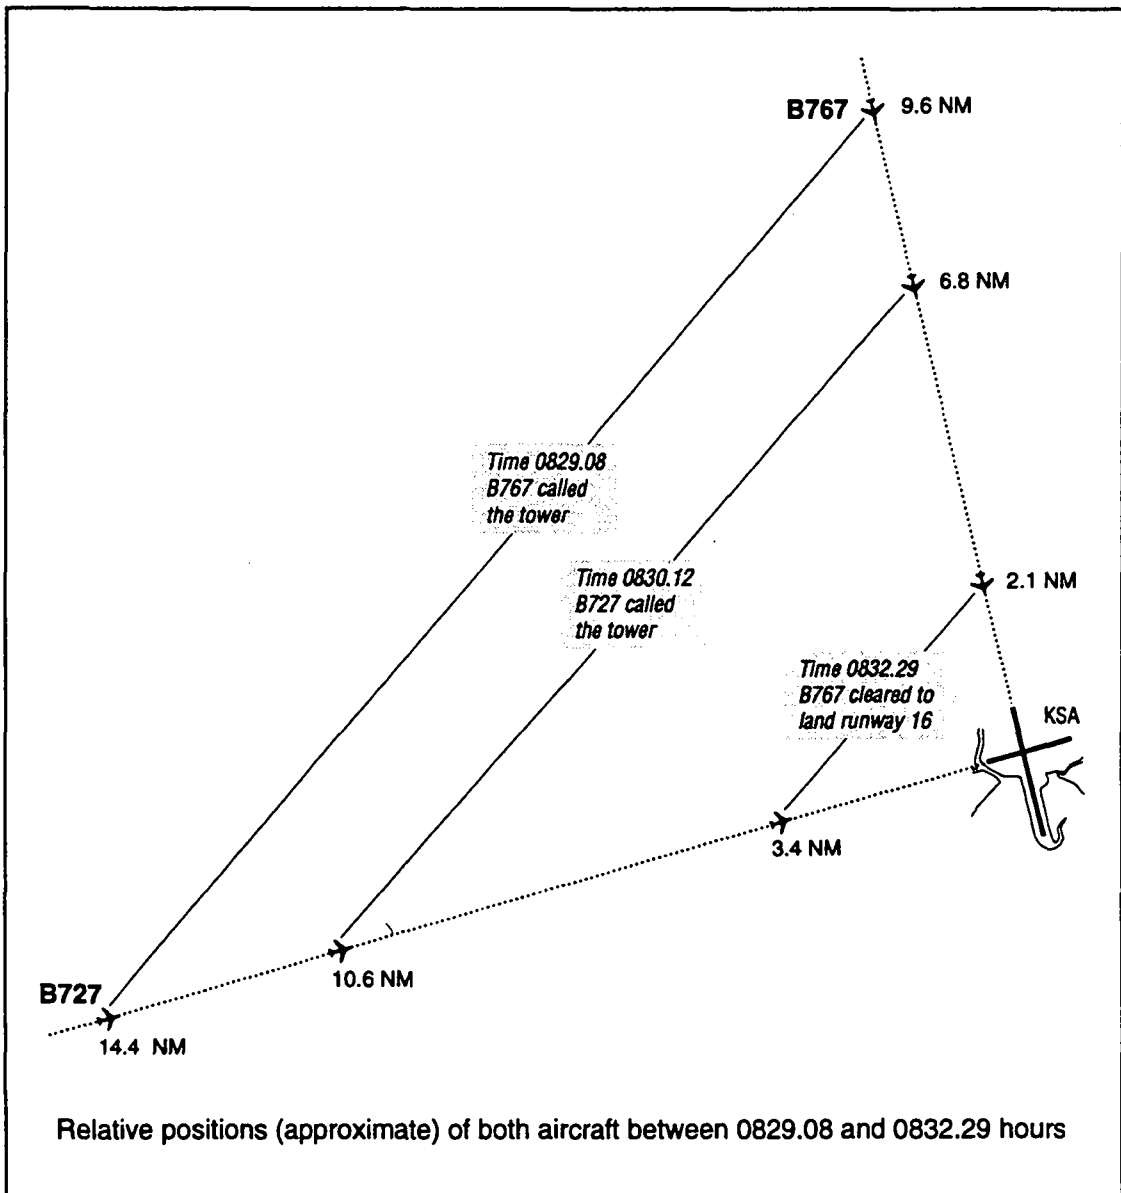
Figure 2

Both aircraft were fitted with a digital flight data recorder. Both recorders were serviceable and a readout of the recorders and recorded radar data indicated the following:

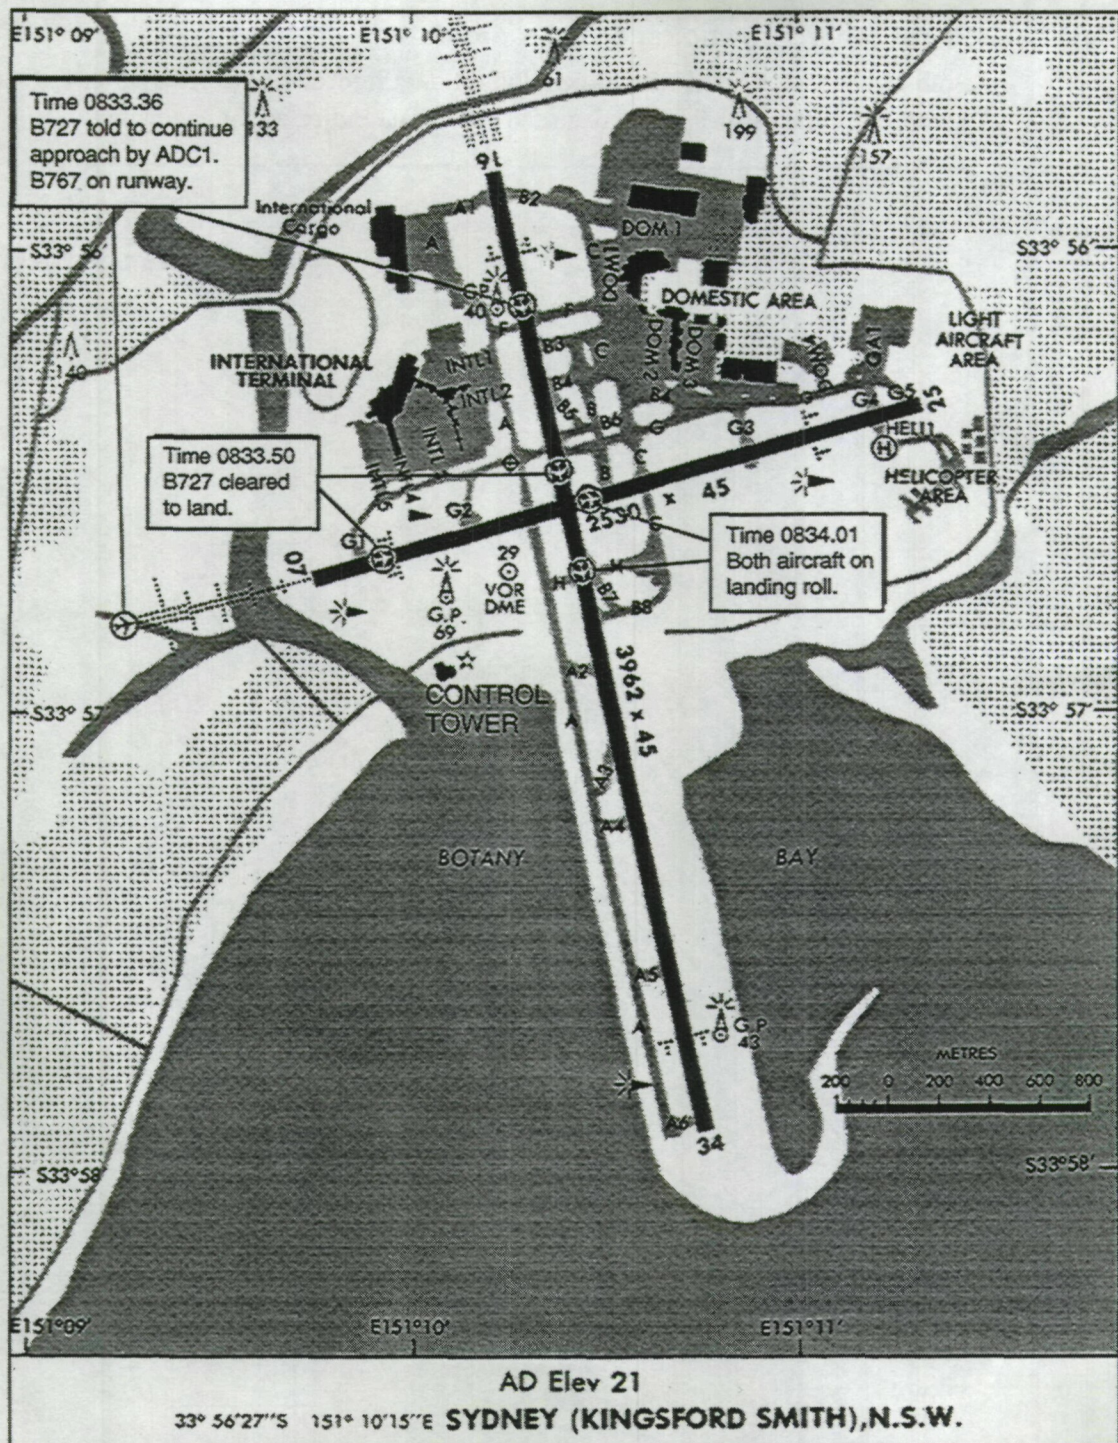
Figure 3 Relative positions (approximate) of both aircraft between 0833.36 and 0834.01 hours

At 0833.36 hours, the ADC1 again told the B727 to continue the approach. He then instructed the B767, which was by this time on the runway and approaching the runway intersection, to expedite its movement through the runway intersection. At 0833.50 hours, the ADC1 cleared the B727 to land. At this time the aircraft was approximately 500 m past the threshold of runway 07. The B767 had cleared the intersection by the time the landing clearance was acknowledged, and the B727 touched down about 100 m beyond the runway 16 centreline.

The B767 had landed approximately 470 m after the threshold of runway 16, and had decelerated to approximately 89 kts ground speed when the pilot was asked to expedite crossing the runway intersection. The pilot had then cancelled reverse thrust at approximately 76 kts ground speed and reapplied power to comply with the request. This brief application of power had resulted in an acceleration to approximately 80 kts ground speed whilst the aircraft was crossing the intersection.
