**ATSB TRANSPORT SAFETY REPORT**

Aviation Occurrence Investigation – AO-2006-006

**Loss of control  
21 km NE Mount Gambier, SA  
20 December 2006  
Kawasaki KH4  
VH-LFK**

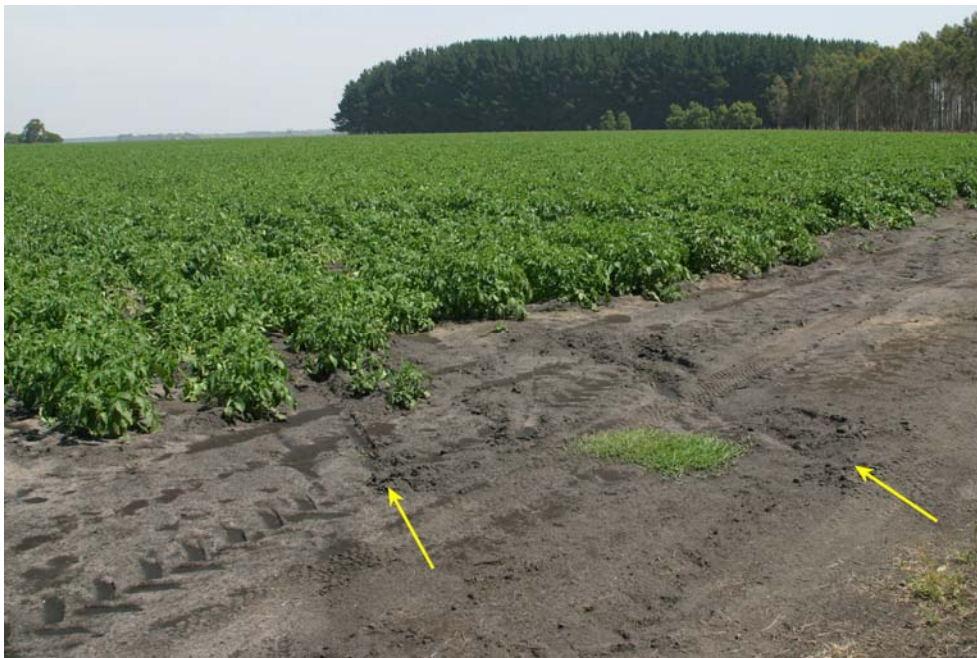
A second set of skid impressions was found within the paddock approximately 4 m forward of the first set. This indicated that the helicopter had bounced after initially impacting the ground, and then travelled a short distance forward before coming to rest in the soft soil.

**Figure 2: The accident site showing skid impressions (arrowed) where LFK first impacted terrain**

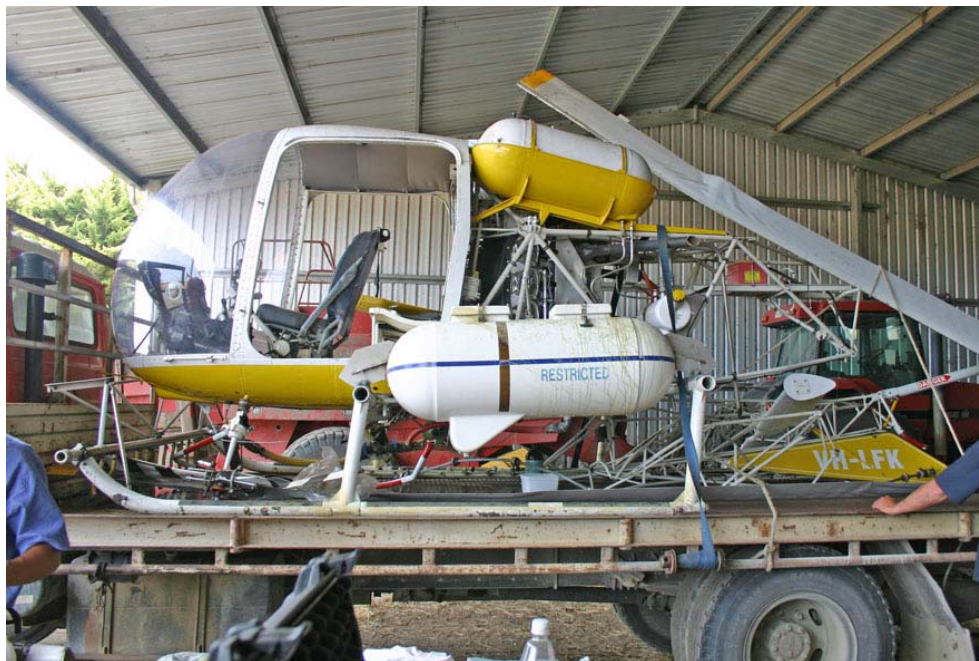
The helicopter's main cabin structure and landing gear was relatively undamaged. Both the left and right skids displayed evidence of minor upward bending. The tail boom frame had completely separated just forward of the centre fuselage frame assembly with buckling of the supporting cross tubes and main tubes evident. All damage to the airframe was characteristic of a moderately hard landing whereby the tail section had impacted the ground first.

**Figure 3: LFK as recovered from the accident site**

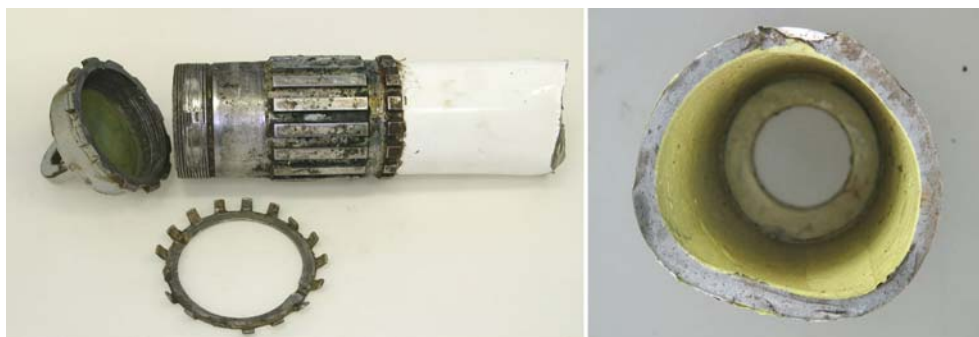
Examination of the main rotor mast showed that it had fractured toward the upper end of the assembly (Figure 4). The mast, which was tubular in section, was deformed out-of-round at the point of fracture. The fracture surfaces were clean and fresh with no visible evidence of pre-existing defects or progressive cracking.

The mast cover nut, which normally clamped the main rotor hub and blades to the main rotor mast, had detached from the upper portion of the broken mast. The internal threads of the cover nut had stripped from shear overload. Corresponding damage to the mating threads on the uppermost end of the fractured mast where the cover nut had been secured was also found. Such thread damage, coupled with the mast deformation at the point of fracture, was indicative that these components had been subject to considerable forces throughout the accident sequence.

**Figure 4: The detached mast cover nut (left) and fractured upper portion of the main rotor mast (right)**

Note the substantial deformation to the tubular mast section at the point of fracture

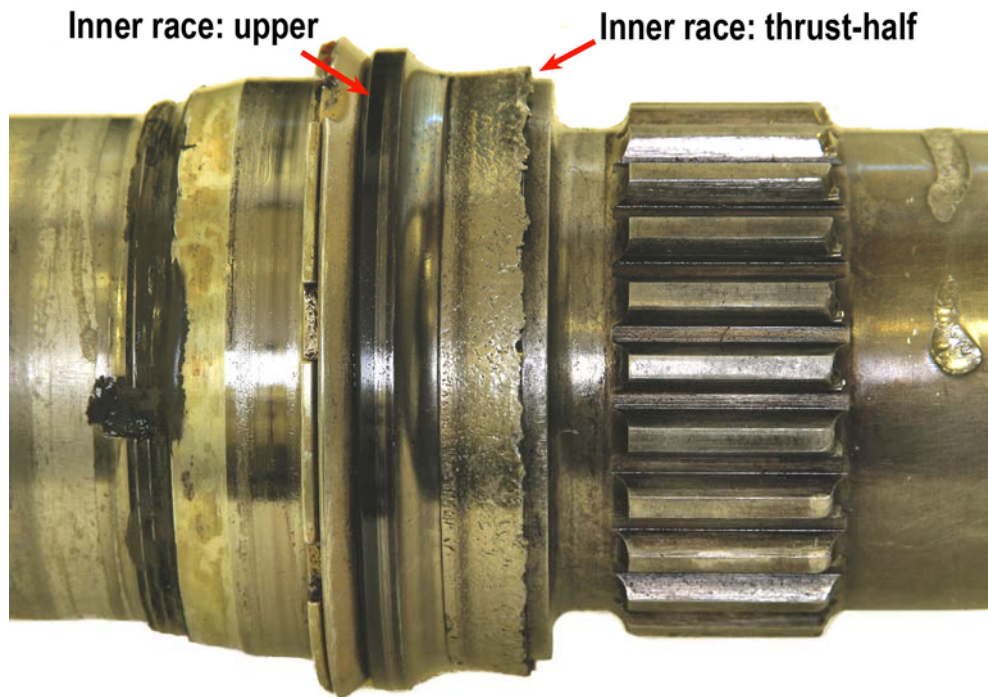
Further examination of the main rotor mast revealed that the mast thrust bearing had catastrophically failed. The bearing outer race, which was still secured within the upper throat of the transmission housing, displayed many contact marks around the running surfaces. The split inner race, which was still secured to the mast, was severely disrupted with gross physical damage to the thrust-half section (Figure 5). Examination of the recovered spherical bearing balls from the mast bearing showed a worn and irregular surface similar in texture to the rolling surfaces observed on the split inner lower race.

The general features of the damaged mast bearing indicated that gross degradation had occurred during main rotor operation.

**Figure 5: Close-up of LFK's mast as-recovered noting the extensive loss of curvature and physical damage to the thrust-half section of the inner race**

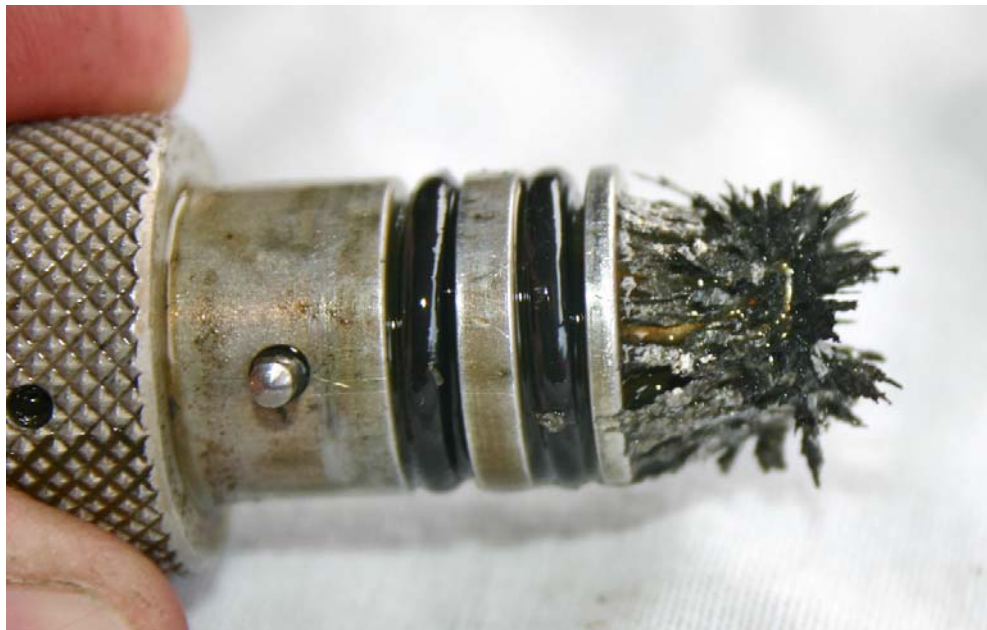
mast thrust bearing. The oil system incorporated a full-flow oil filter. A non-electrified magnetic single-pole chip detector that was designed to remove and collect ferrous particles from the oil supply, had been incorporated into the sump drain plug. A significant quantity of accumulated metallic chips was found on the plug (Figure 7).

Subsequent analysis<sup>8</sup> of the magnetic debris revealed a chemical composition that was consistent with that of high-carbon SAE-AISI M-50 alloy steel, which was the specified material for the mast bearing steel.

**Figure 7: The magnetic drain plug showing metallic particles amassed around the tip**

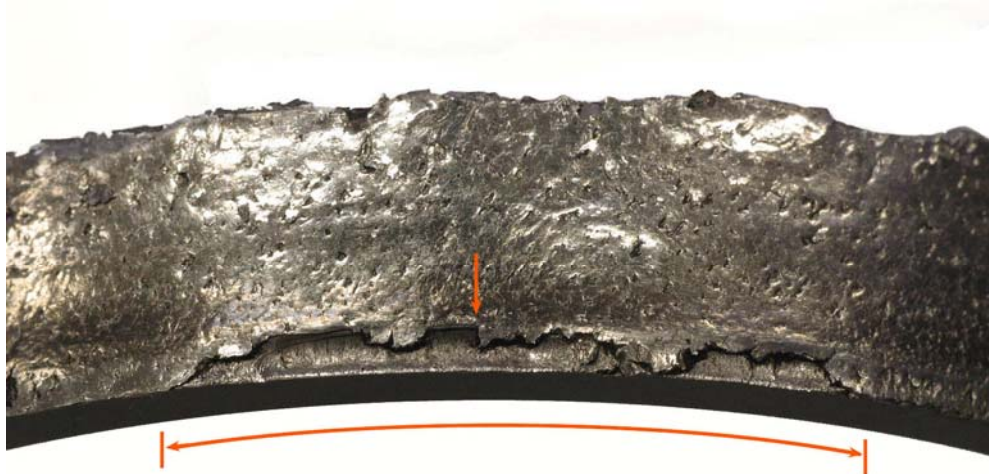
Magnified examination of the thrust-half inner race revealed that a major section of the raceway curvature had collapsed. While most of the damage had been over rolled through contact with the bearing balls, a small section of inner raceway spalling was found (Figure 8). Similar spalling was found on the outer race.

**Figure 8: Close view of the thrust-half inner race showing a location of spalling (arrowed) along the rolling surface**

The thrust-half of the inner race had sustained gross physical damage and dimensional changes which led to the collapse. Some spalling was found on the raceway surfaces and signified that the bearing had reached the end of its rolling-contact fatigue life.

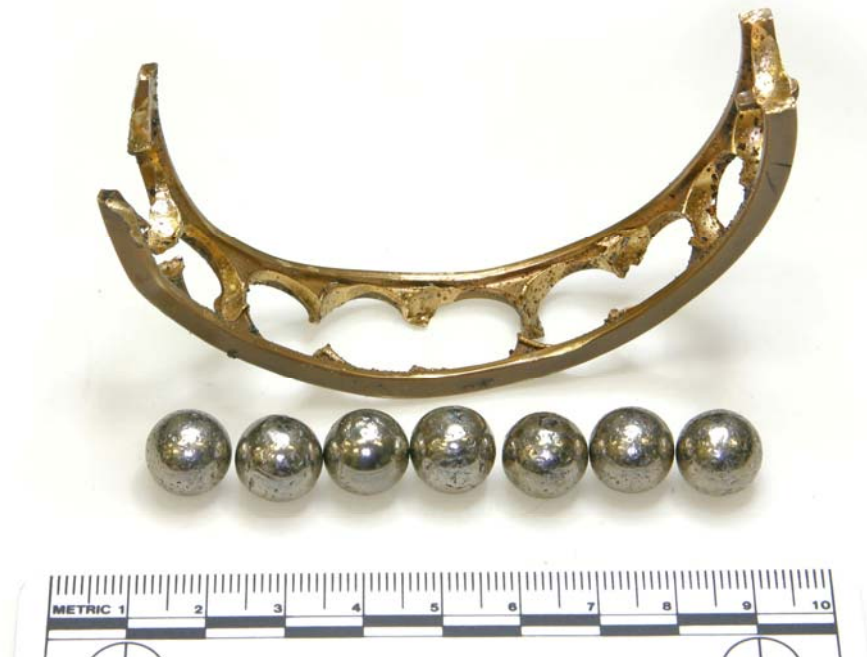
Examination of the fractured bearing cage revealed elongation and wear to the cage pockets. Such deformation signalled unstable bearing ball and cage interaction had occurred during the final phase of the bearing life. Close examination of the bearing balls showed extensive spalling and over-rolling of the surfaces (Figure 9).

**Figure 9: The fragmented cage and some of the bearing balls as-recovered from the mast bearing assembly**
