OUTLINE OF INCIDENT

Shortly before 1700 hours Eastern Standard Time on 9 May 1987 the Australian flag bulk carrier RIVER EMBLEY, on passage from Weipa to Gladstone, grounded momentarily south of Alert Patches Buoy in the eastern approaches to the Prince of Wales Channel, Torres Strait. The vessel sustained damage forward and commenced to flood the forepeak and No 1 void space. The reported position of the grounding was not immediately fixed but was subsequently deduced by ship staff.

RIVER EMBLEY

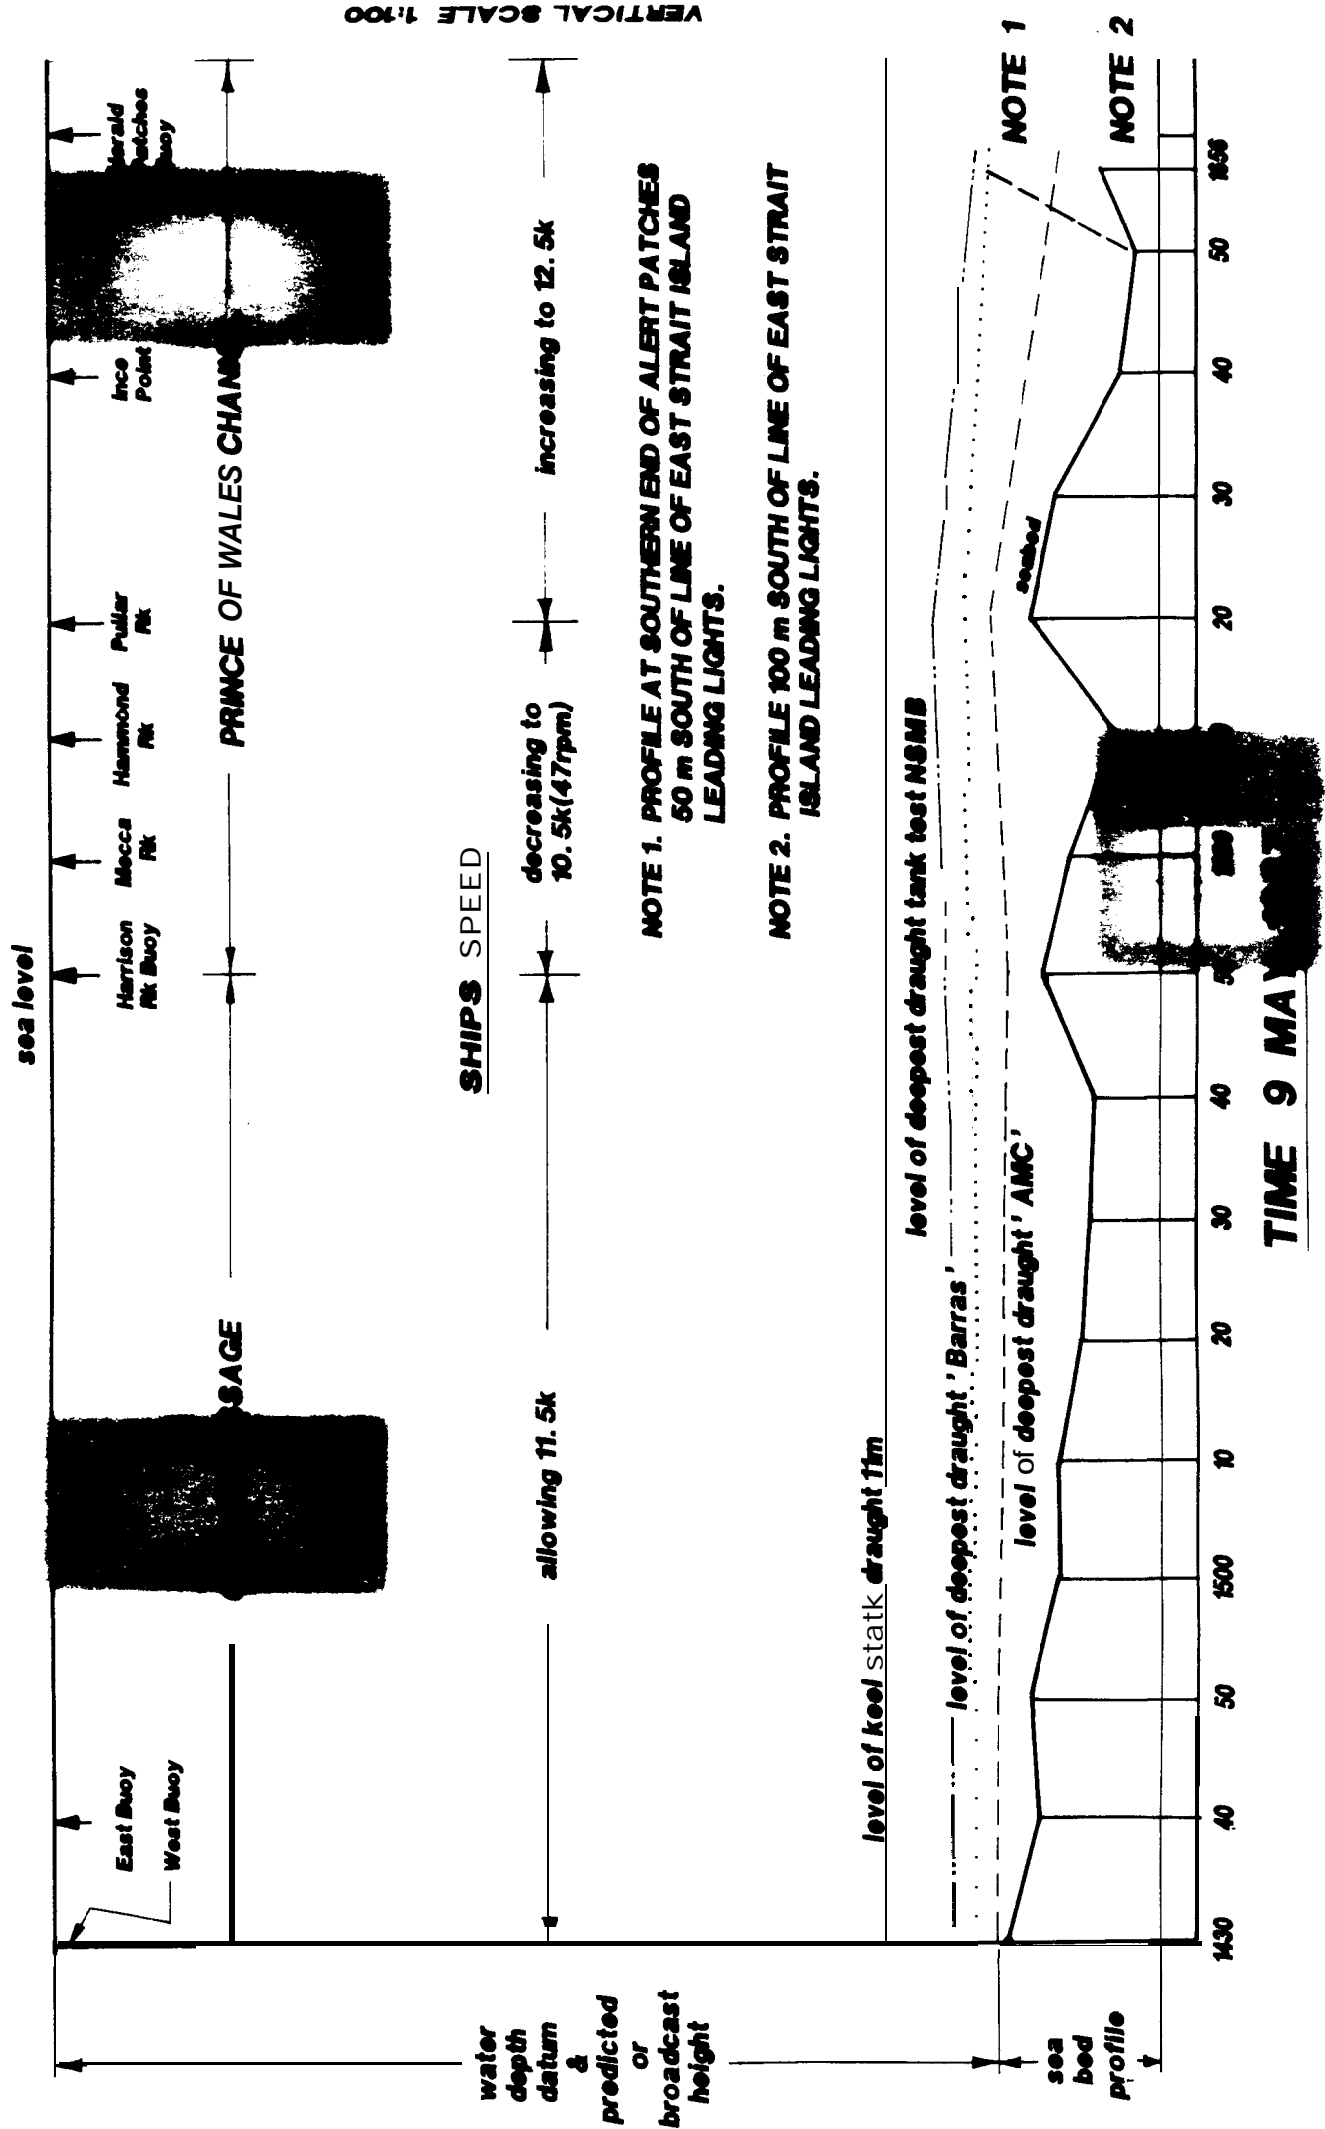
SEABED PROFILE - TORRES STRAIT - BASED ON SCALE OF TIME

NOTE : Data used in this diagram was taken from the deck log book , and chart in use aboard the 'RIVER EMBLEY' and from the various

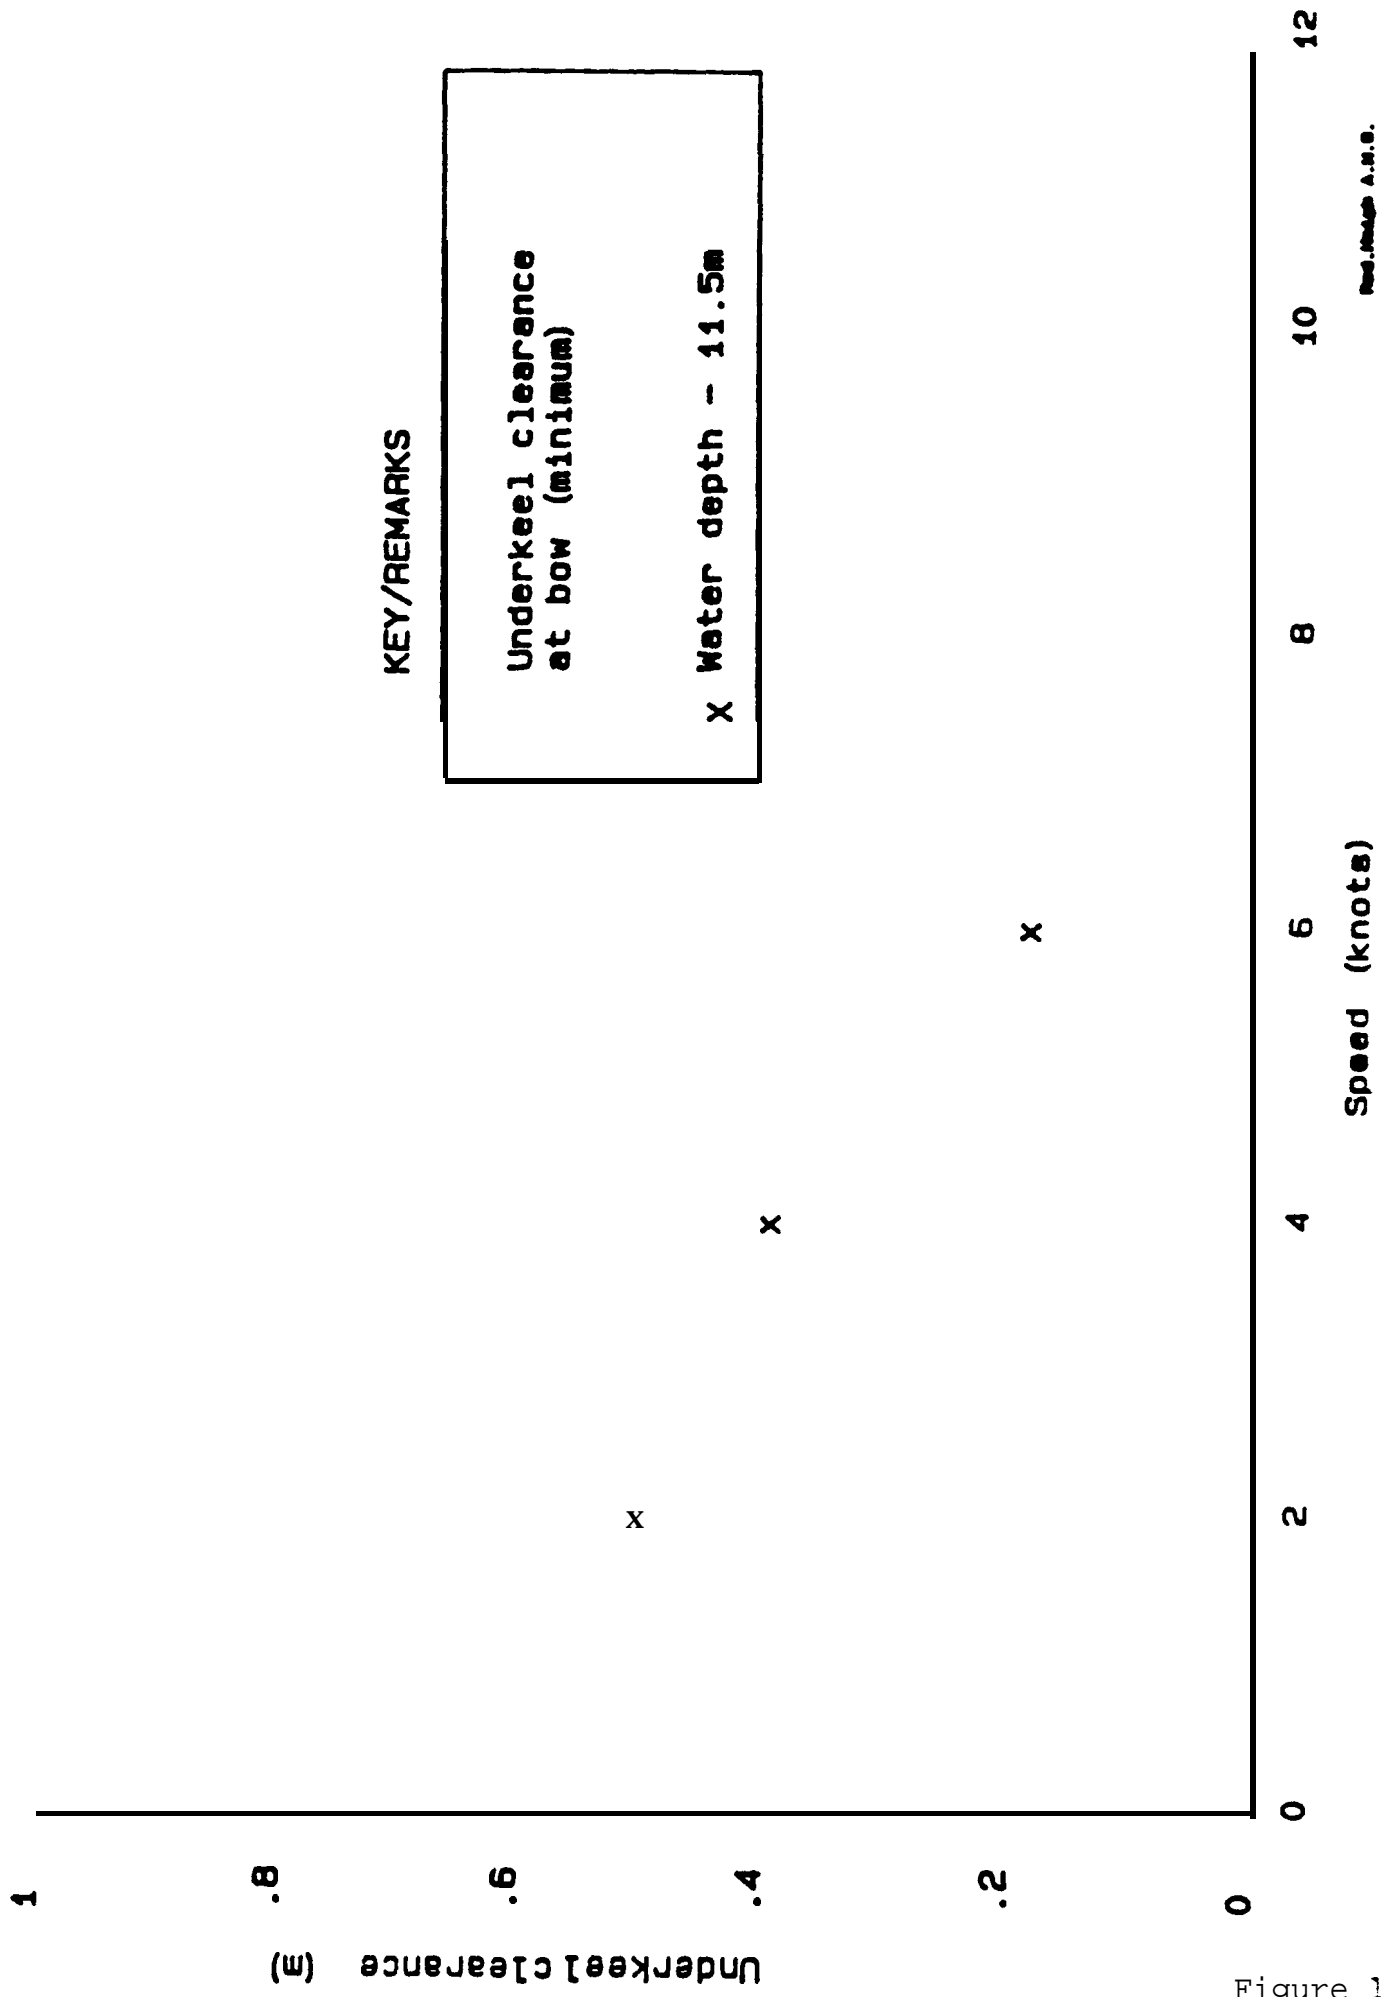
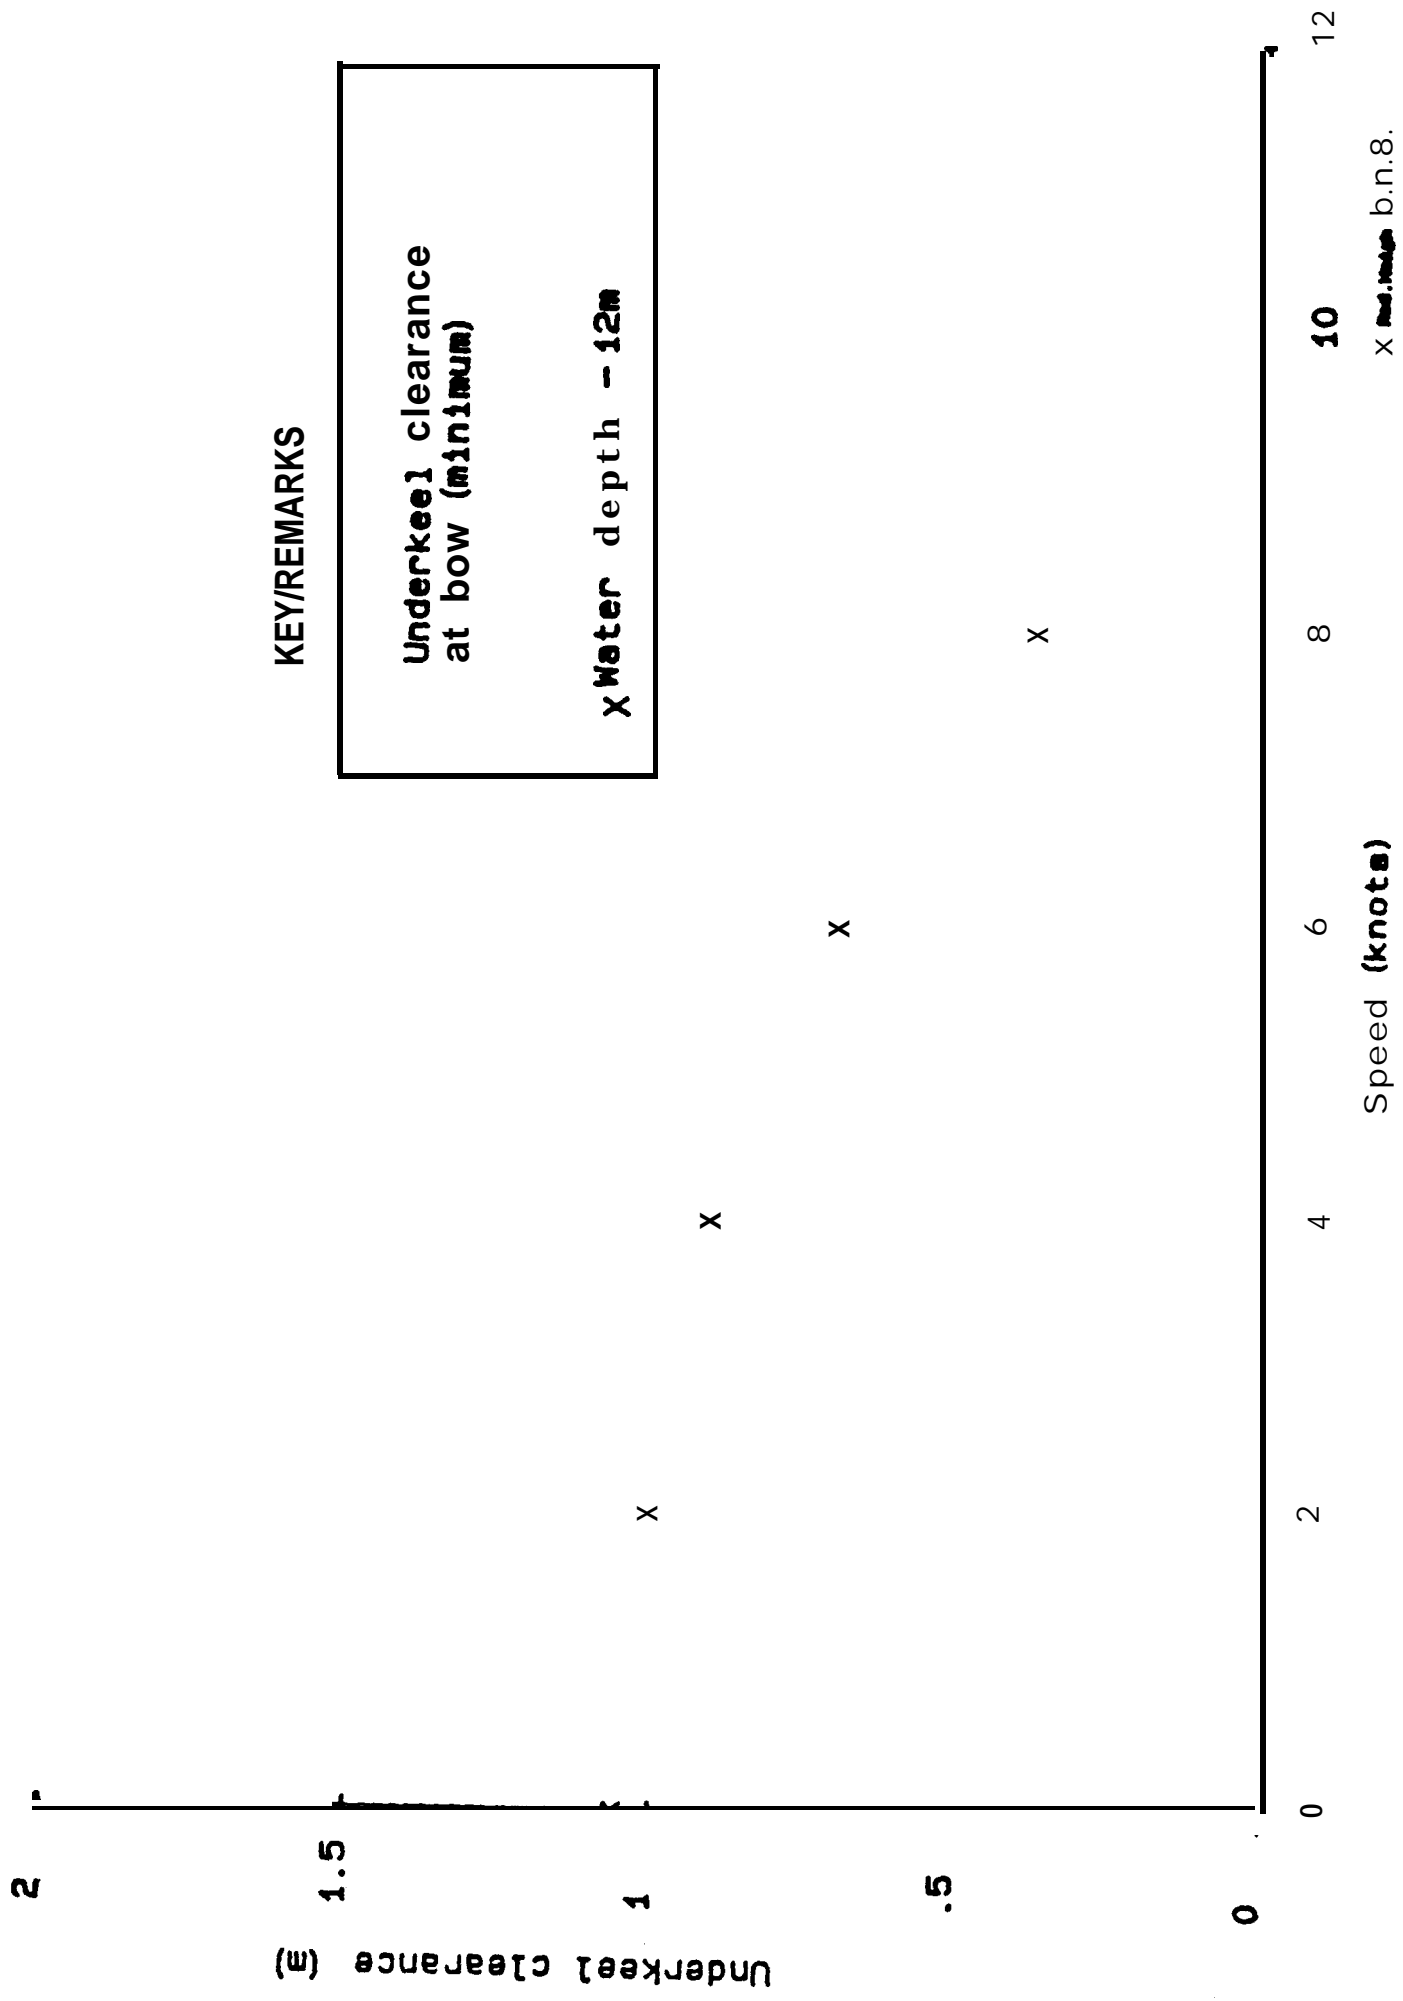
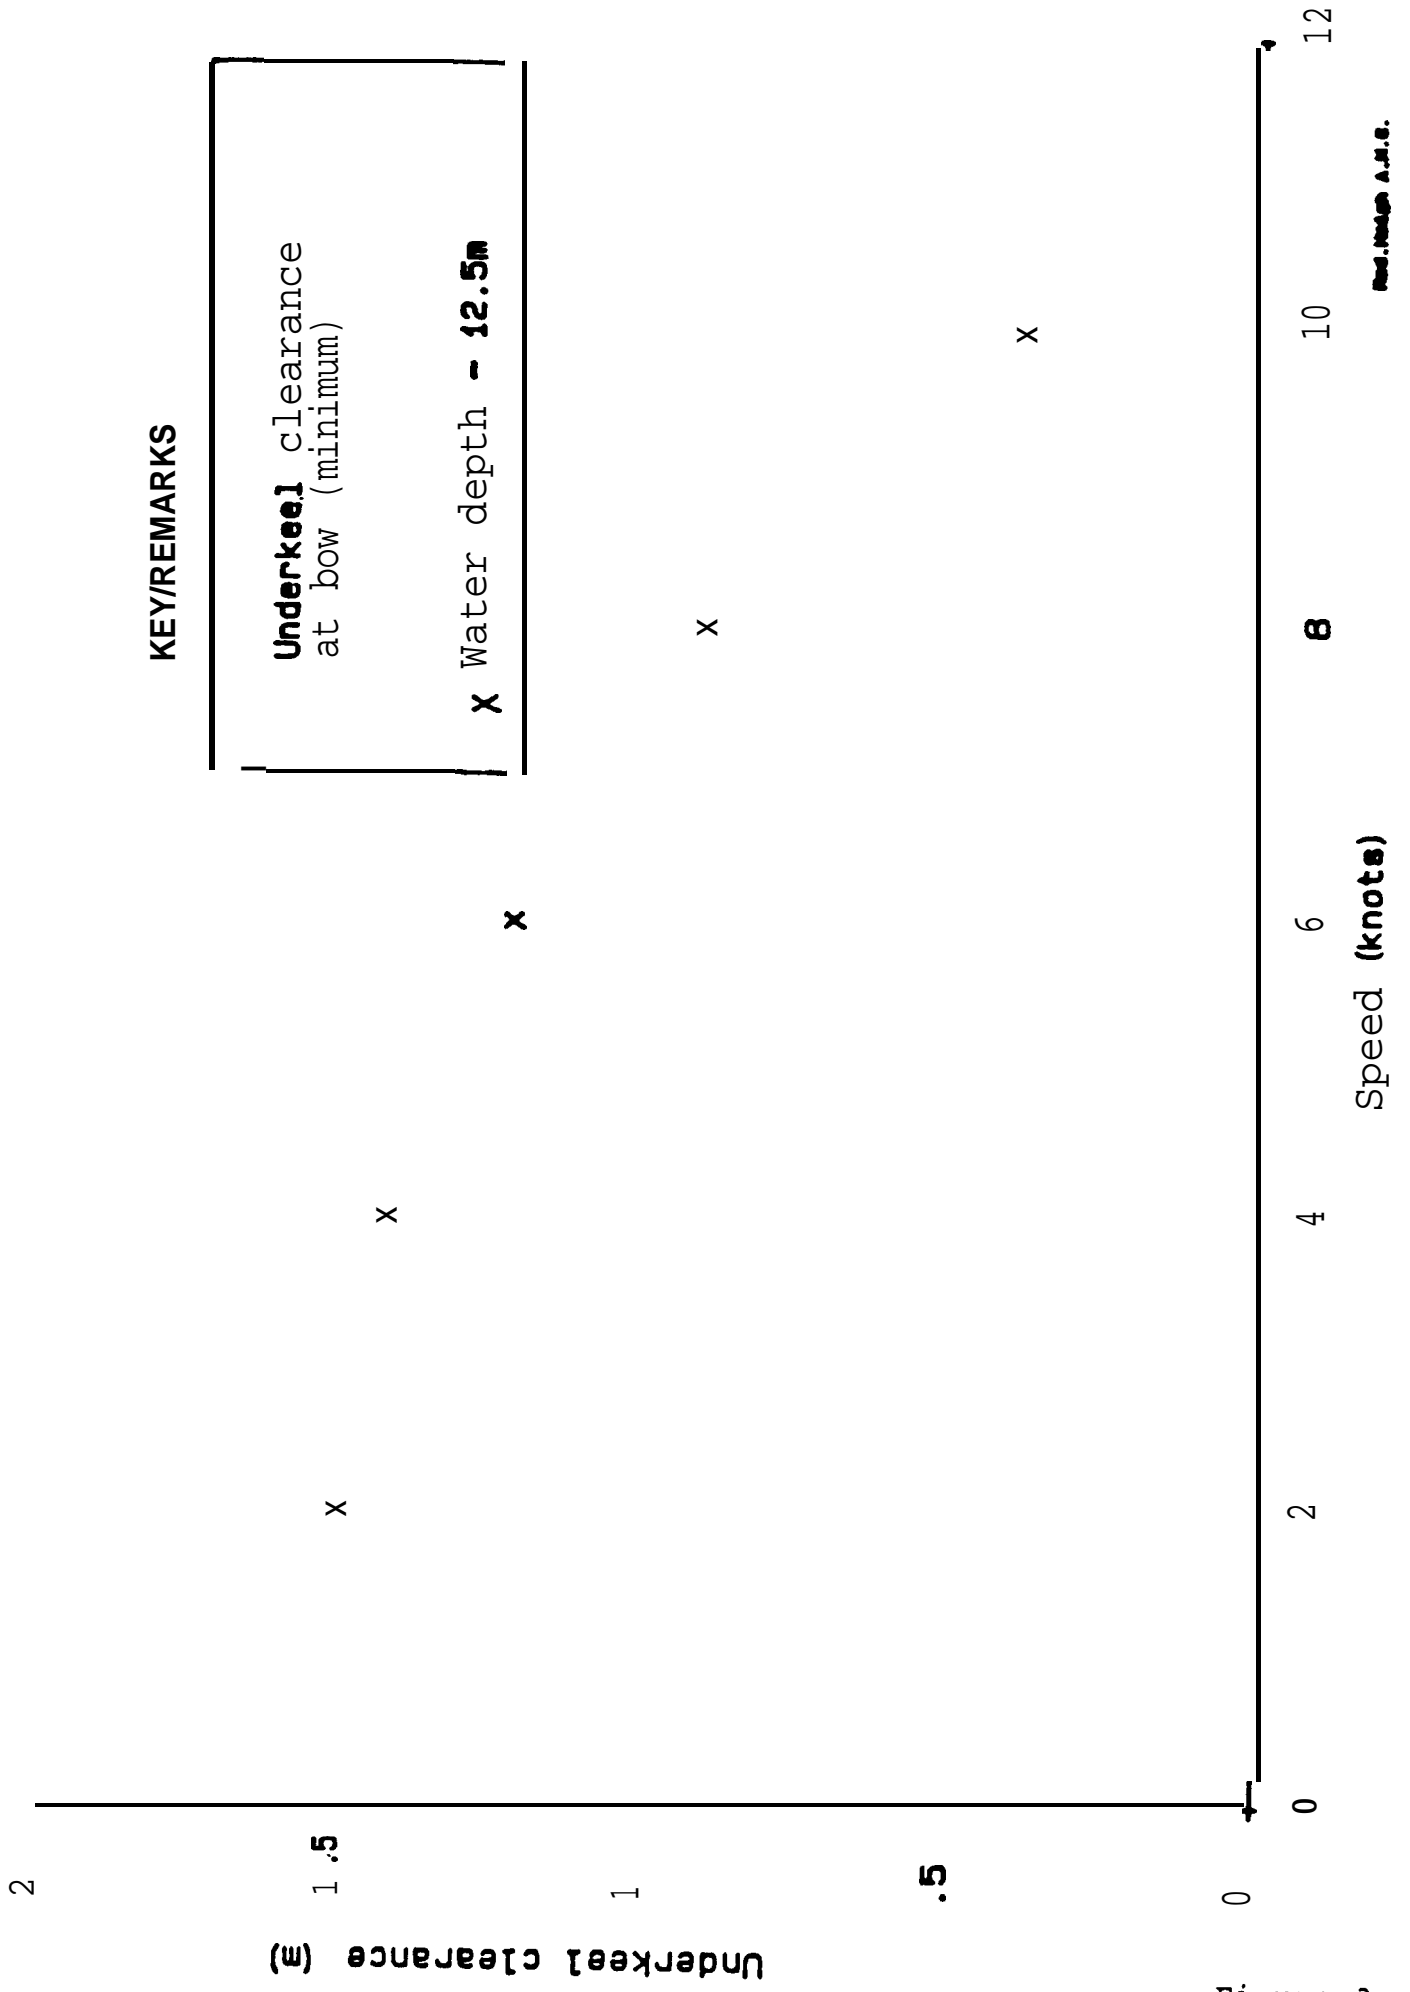
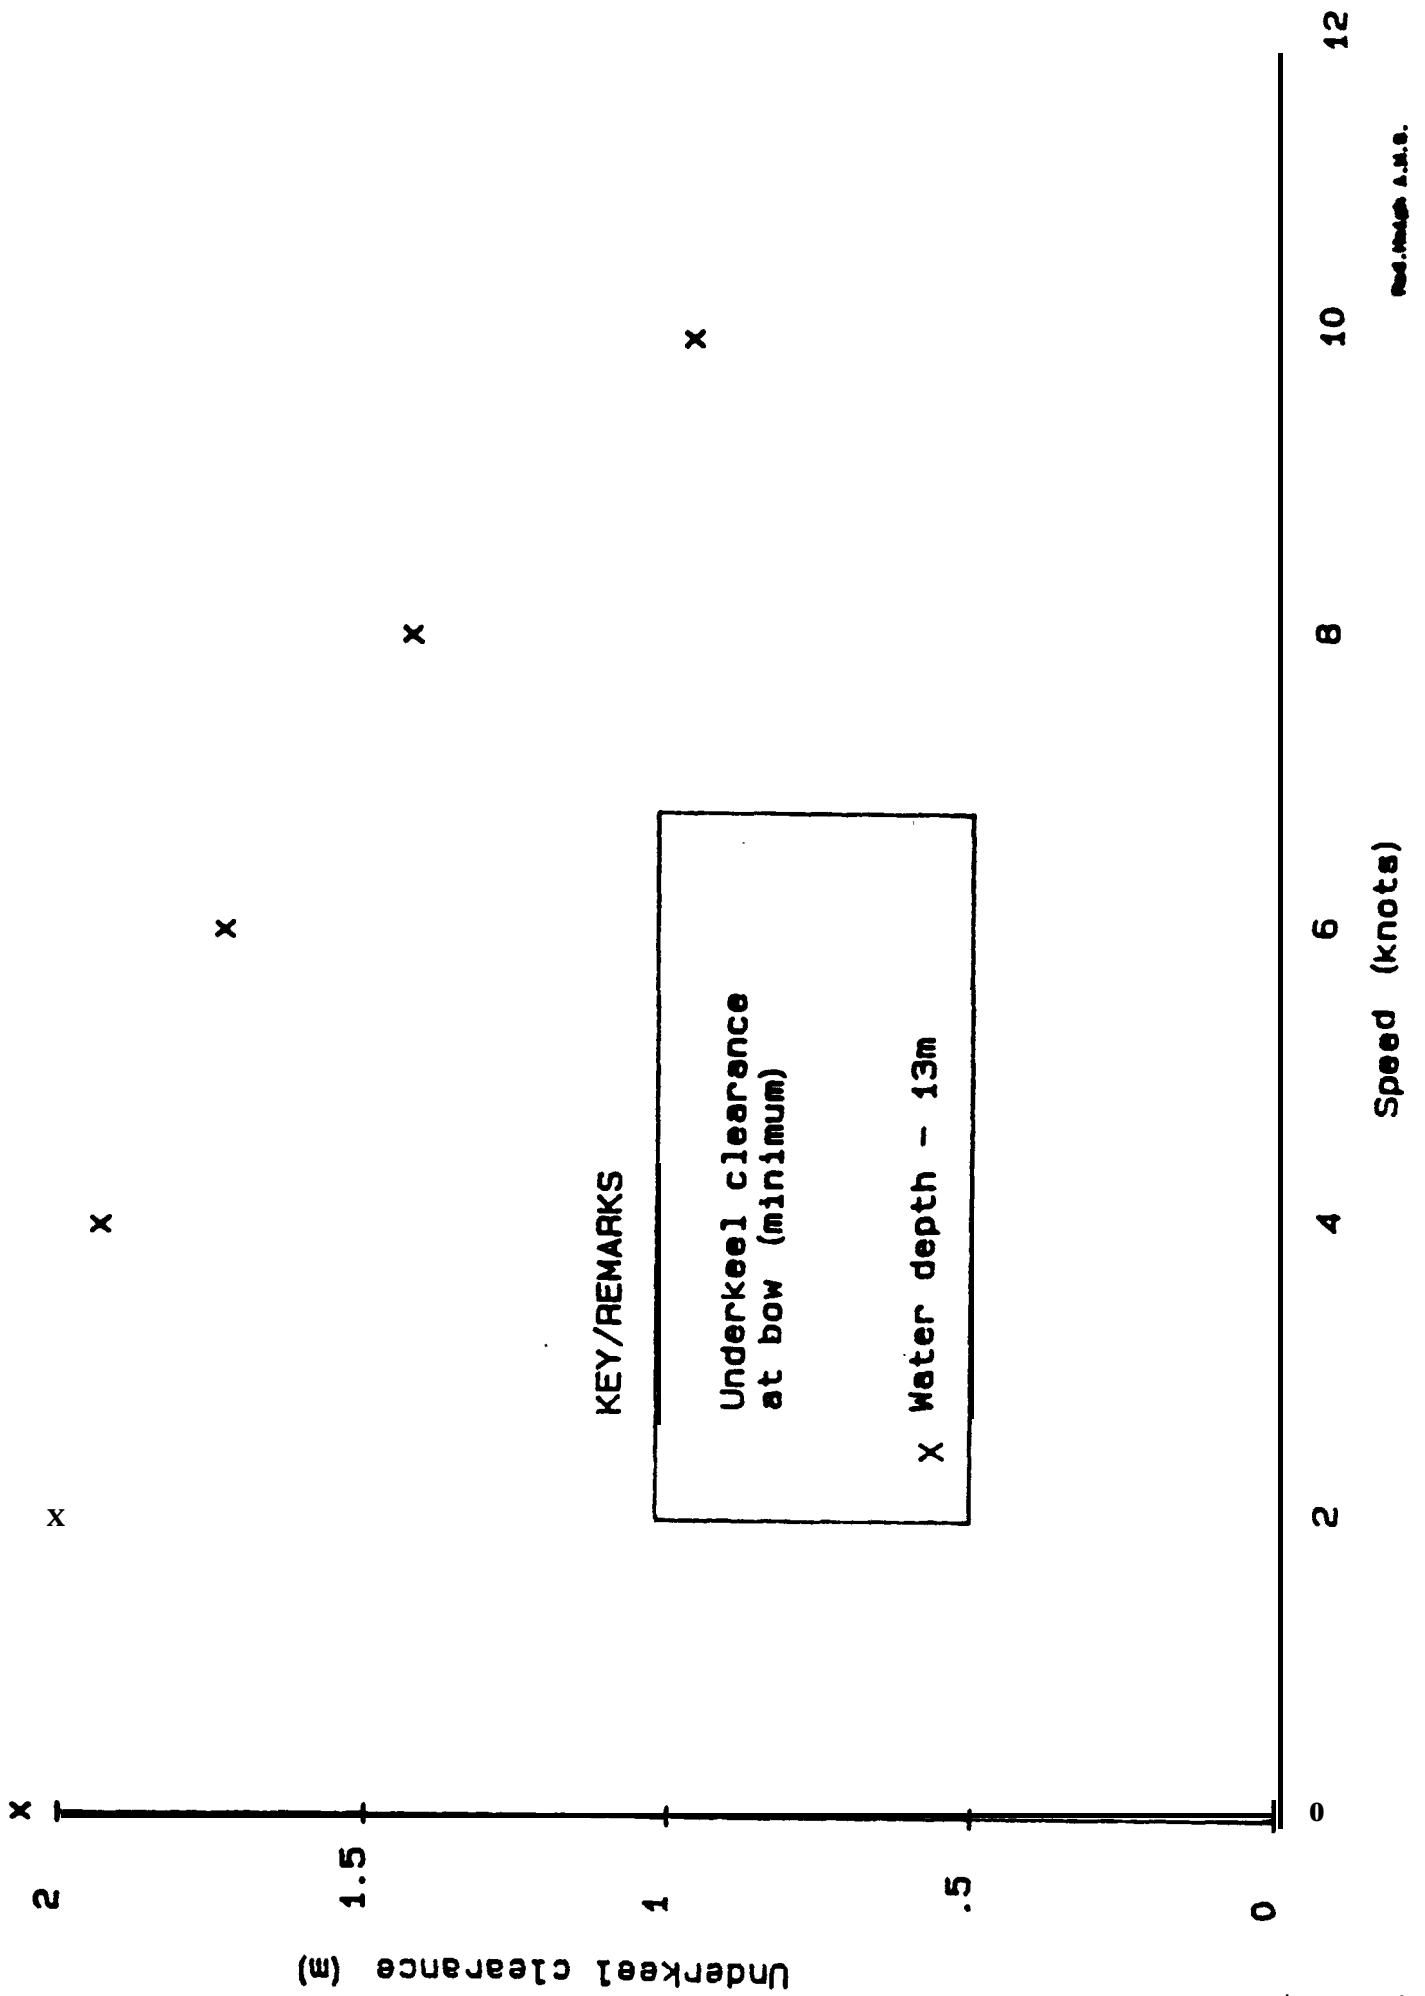
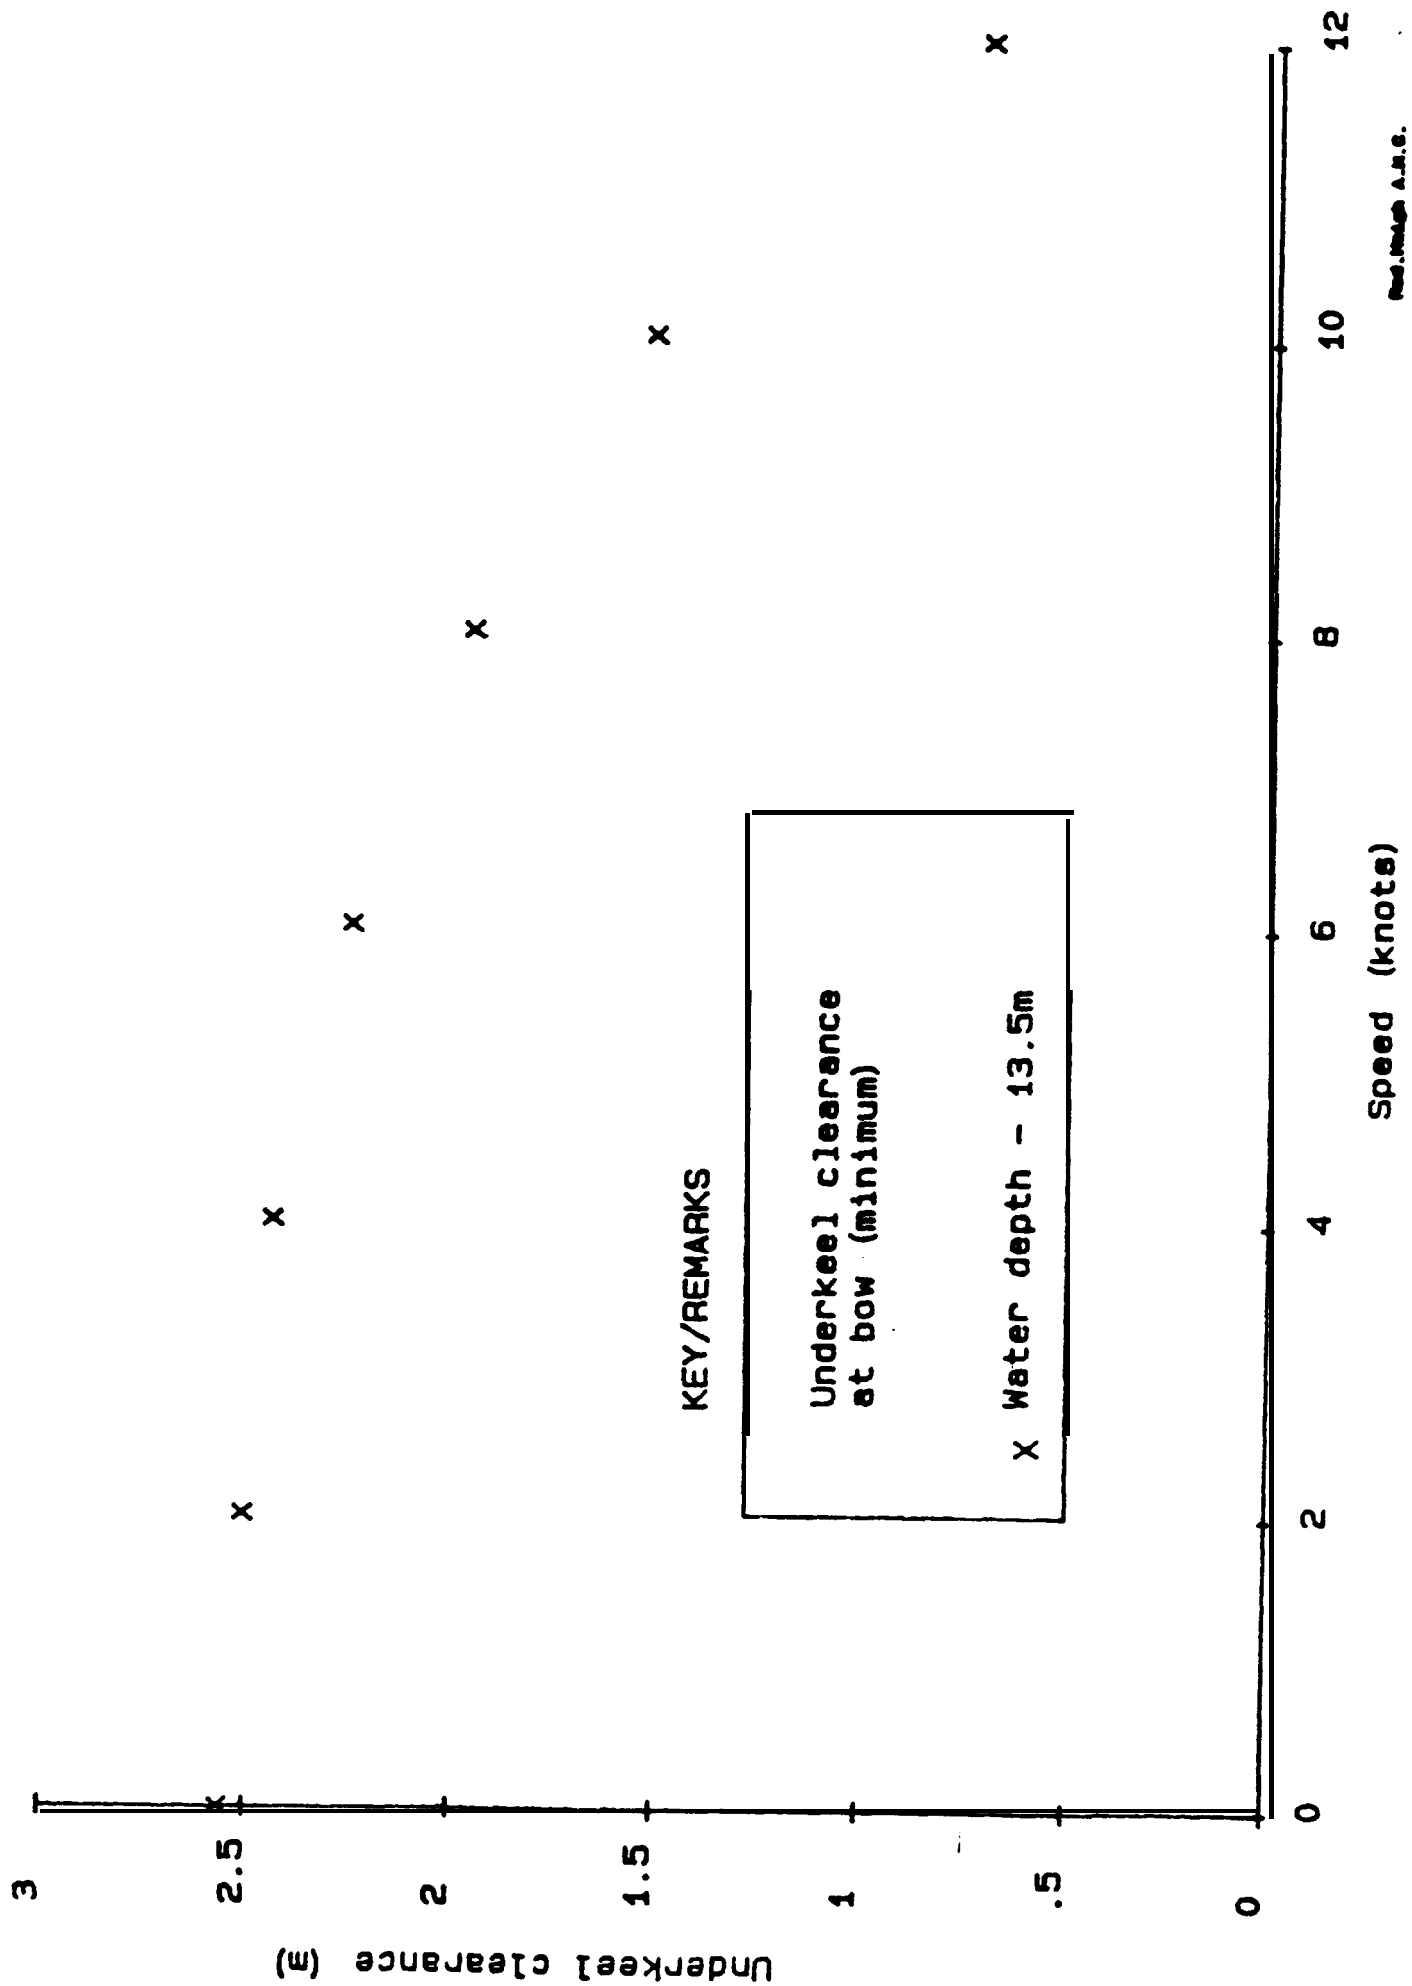
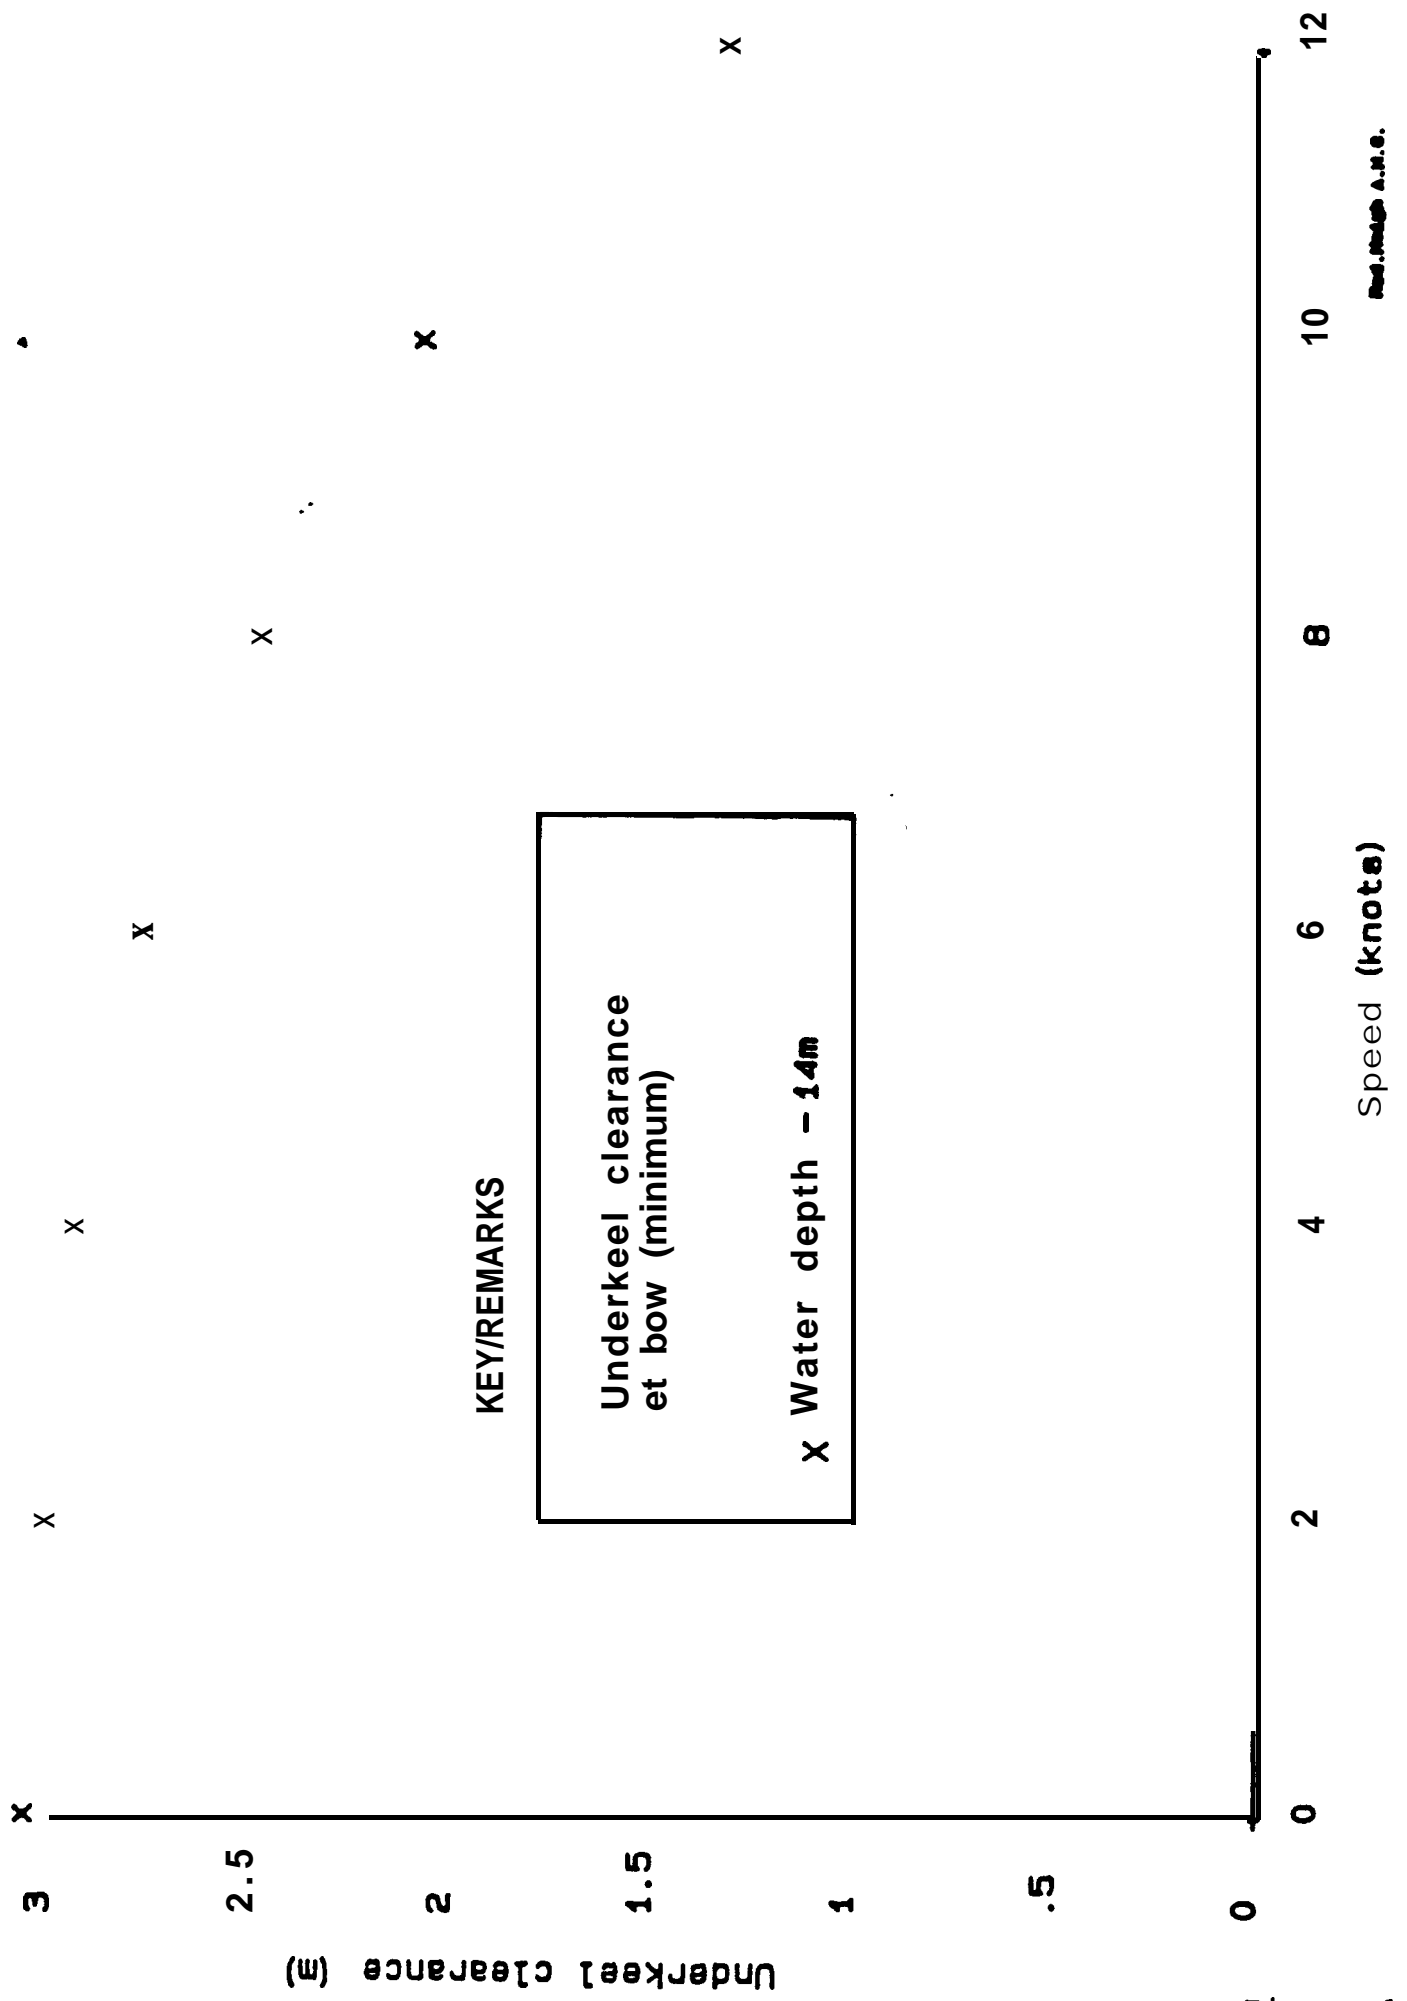
From the sinkage at the bow in the different conditions the Bow Underkeel Clearance was obtained. (Figures 1-8).

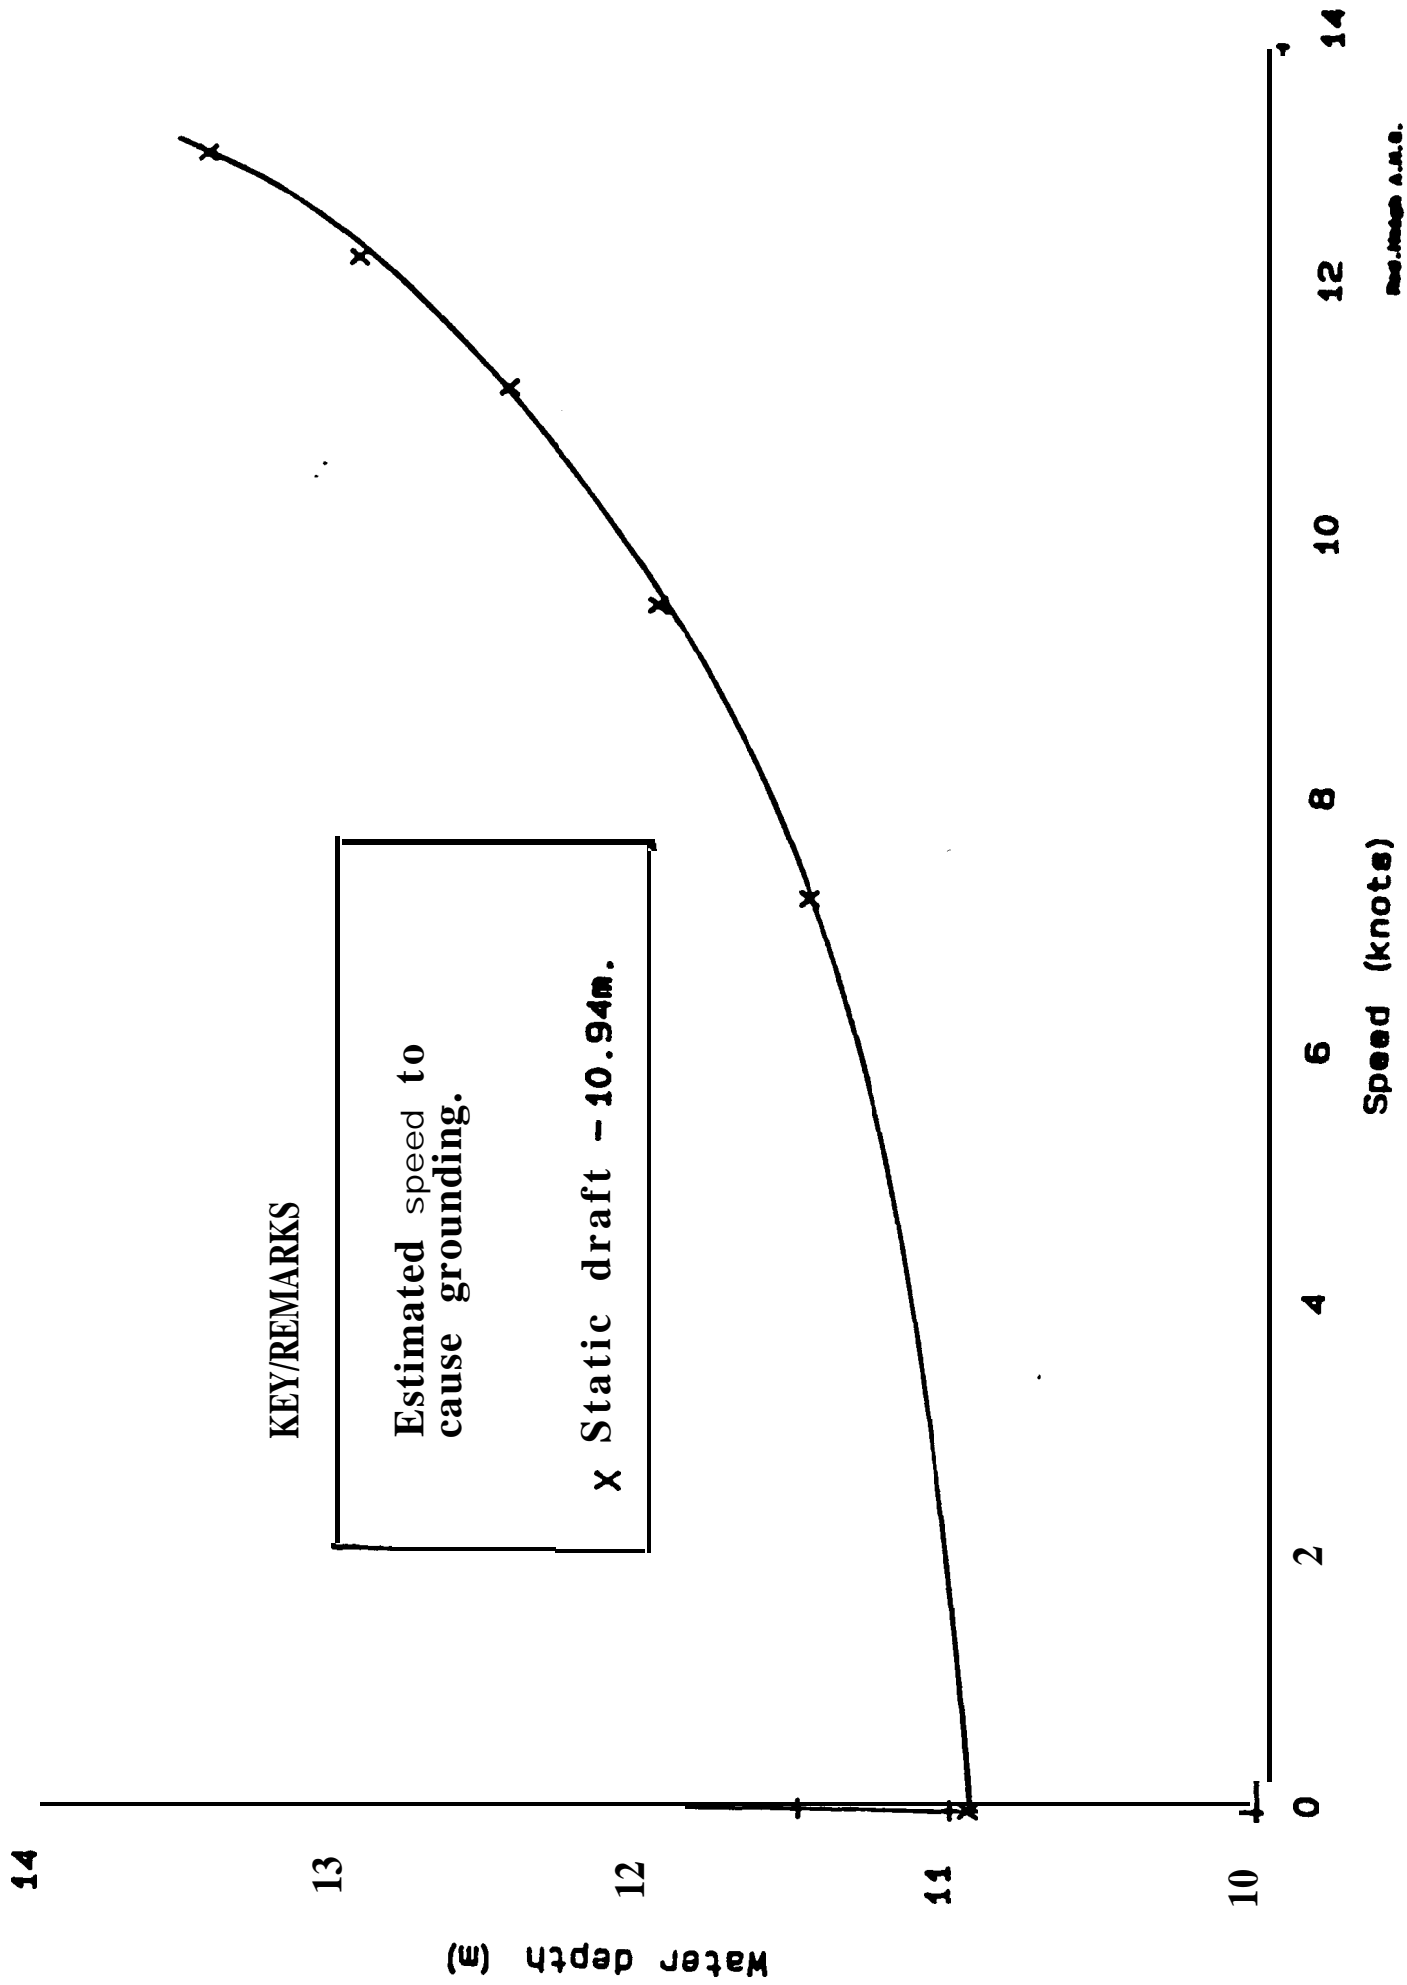
The estimated speed required to cause grounding is plotted in Figure 9 against water depth using the method given in Reference 1.

If it were intended to operate a vessel of this size in condition which would approach those shown as causing grounding in Figure 9 then it is strongly recommended that a further study involving model tests be carried out.
