SUMMARY

The Chinese motor bulk carrier Jin Shan Hai of 34,990 tonnes summer deadweight passed Low Isles at about 0000 Eastern Standard Time, 17 June 1991, on a course of 1520 at a speed of approximately 13 knots, while on passage from the port of Gove, Northern Territory, to Gladstone, Queensland, with a part cargo of alumina. The vessel was shaping a course for Cairns fairway buoy where the pilot of the Torres Strait and Queensland Coast Pilot Service was to be disembarked.

At about 0035 the two vessels collided in approximate position 160° 30.0' South 145° 40.2' East, about 26 miles north-north-west of Cairns. The visibility was clear with a calm sea and slight swell. The Kekenni subsequently sank and the three crew took to the trawler's dinghy.

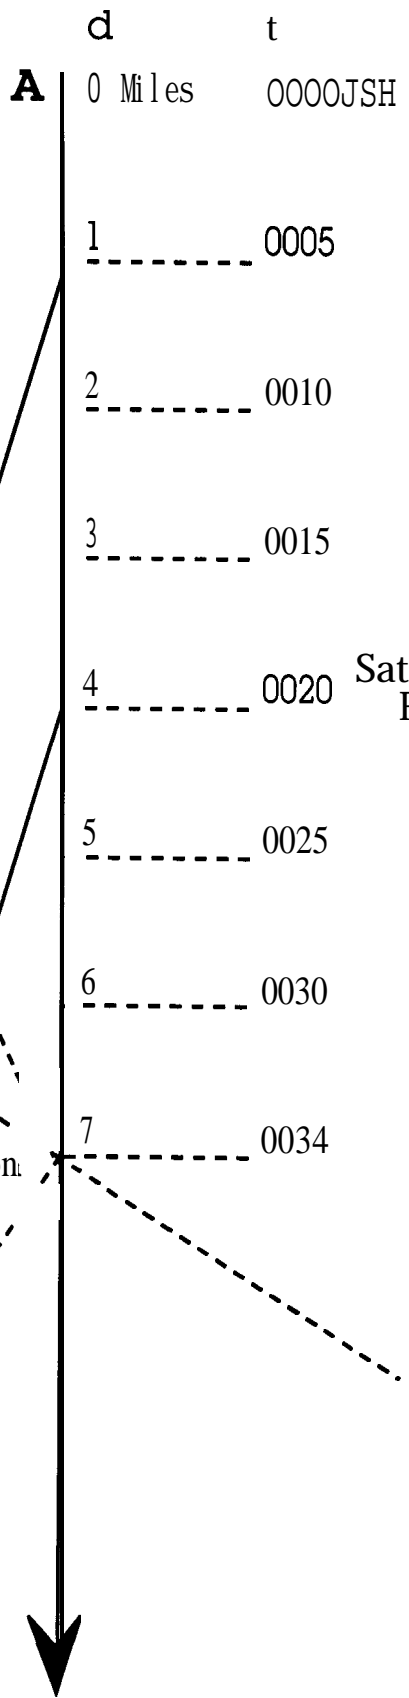
DIAGRAM 1

PLOT OF THE VESSELS' RELATIVE POSITIONS BASED ON EVIDENCE OF SECOND MATE JIN SHAN HAI

1. The distance and bearings recalled by the Jin Shan Hai's Second Mate were accurate.

If the two bearings of 167° and 170° and the distance of 4.5 miles recalled by the Second Mate were correct and it is accepted that the collision occurred in position $16^\circ 30.00'S$ $145^\circ 40.2'E$, then the Kekenni must have been steering a course of about 123° at about 4.9 knots.

It is considered unlikely that the Kekenni was making 4.9 knots. It is therefore probable that at 0005 the Kekenni was at a greater distance from the Jin Shan Hai than the 4.5 miles recalled by the Second Mate, and the bearings were approximate only.

It must be stressed that the above plot is based on the two observations recalled by the Second Mate only and their accuracy is open to question. Given the relative speeds of the vessels, a relatively small variation in time, bearing or distance, would make a significant difference to the plot. The Second Mate did have time and the opportunity to undertake a proper plot, at practical time intervals, to establish the fishing vessel's course, speed and possibility of a close quarter situation.

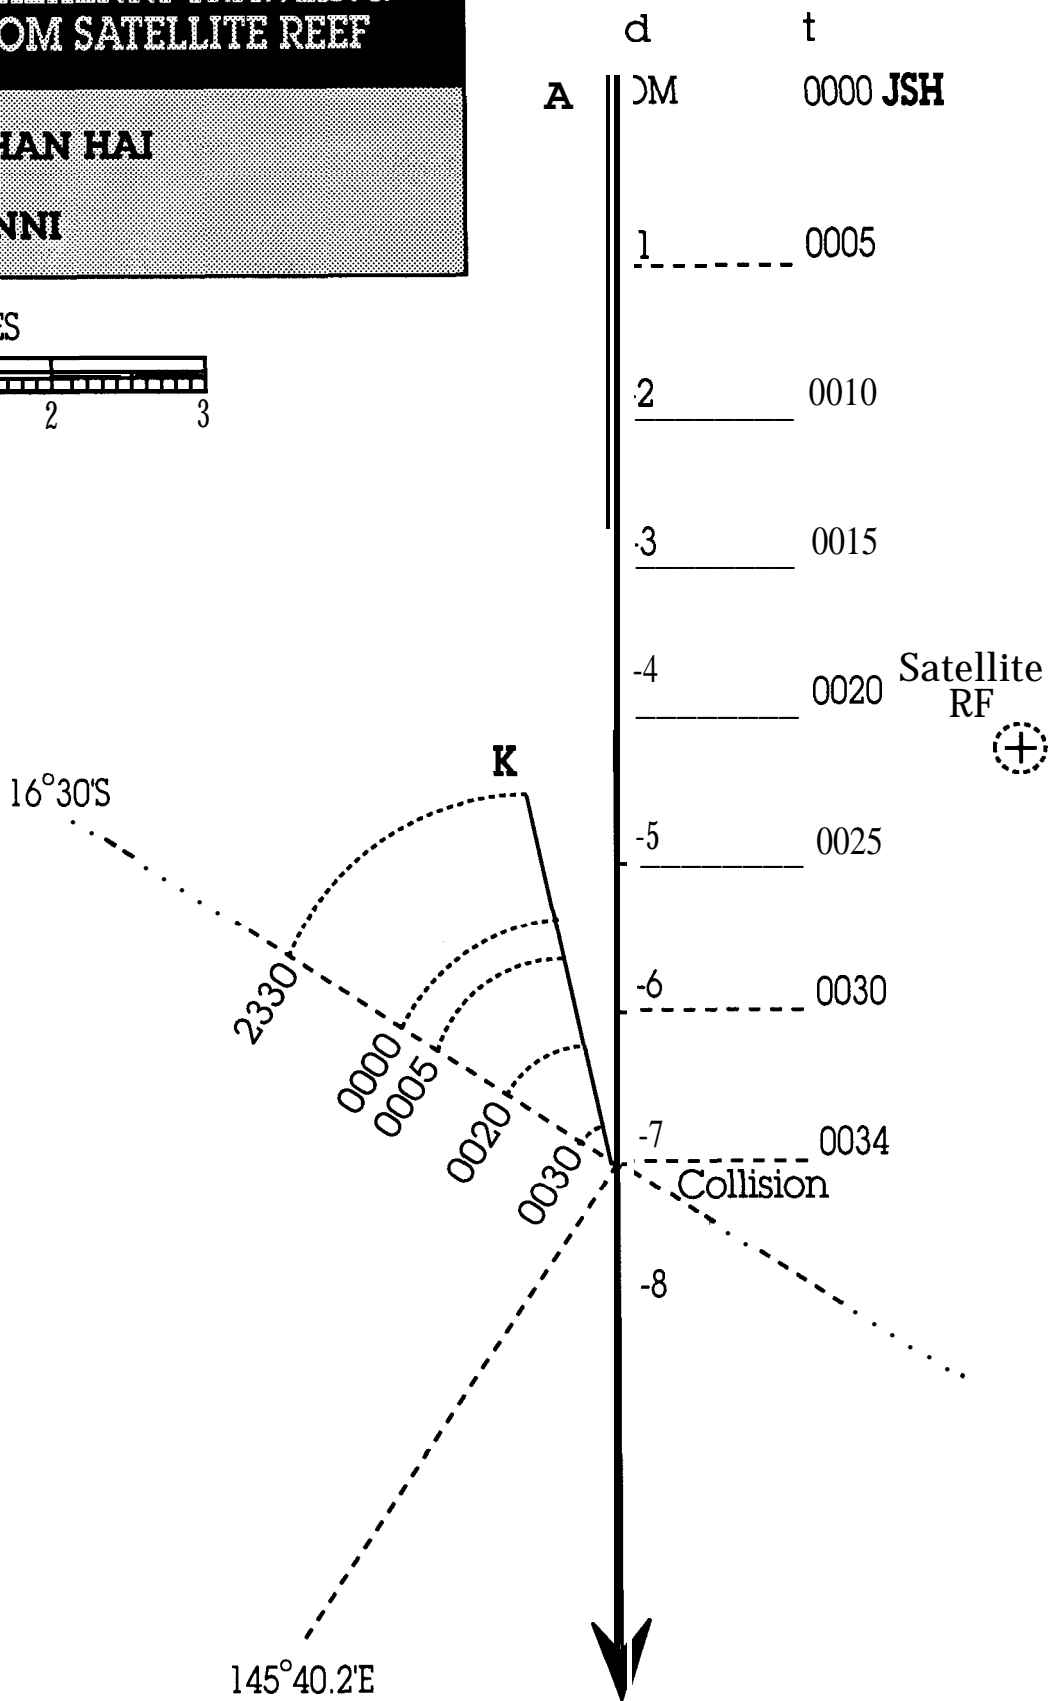
DIAGRAM 3

**PLOT OF THE TWO SHIPS
ASSUMING KEKENNI TRAWLING
3 MILES FROM SATELLITE REEF**

3. The Kekenni began trawling about 3 miles from Satellite Reef at a speed of 3 knots.

There are no records of the Kekenni's course and speed. But Mr Inglis stated that his approximate course was south-east at about 3 knots. He also recalled that at the start of his third run he was approximately 3 miles off Satellite Reef.

It is therefore probable that, given the initial approximate position and the position of the collision, the fishing vessel's course was south-east as stated.

From all the information available, given the known normal operating speeds of prawn trawlers and their mode of operation, the Inspector concluded that the information given by the fishing vessel relating to its course and speed is more reliable than the bearings and distance given by the Second Mate of the Jin Shan Hai. This is not to say that the Second Mate in any way attempted to deceive the investigation. As previously stated, given the relative speeds and positions of the vessels involved, any minor error in time or bearing would have a significant effect on any plot.

It is more likely that at 0005 the fishing vessel's bearing from the Jin Shan Hai was about 157° at 5.4 miles, and there was little subsequent change in the bearing over the next 28 minutes.

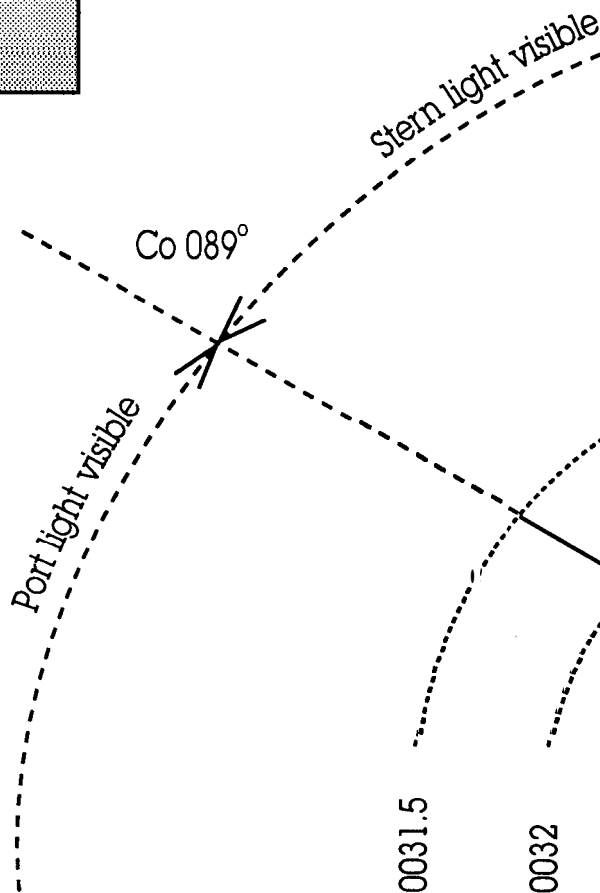
DIAGRAM 4

**PLOT OF
KEKENNI AND JIN SHAN HAI
IMMEDIATELY BEFORE COLLISION
FROM 0032 TO 0034**

4. One or both vessels altered course when they would otherwise have passed clear.

The Jin Shan Hai was on a course of 152° or 153° , which is the course from the ship's position off Low Isles to Cairns fairway buoy. There was no reason for the Jin Shan Hai to alter course other than to avoid collision.

The three men on the Jin Shan Hai's bridge stated that the ship's rudder was put hard to starboard and the ship responded at a time put as 30 seconds to two minutes before the collision. The Second Mate gave the appropriate whistle signal for a ship altering course to starboard.
