Summary

Incident 1

Incident 2

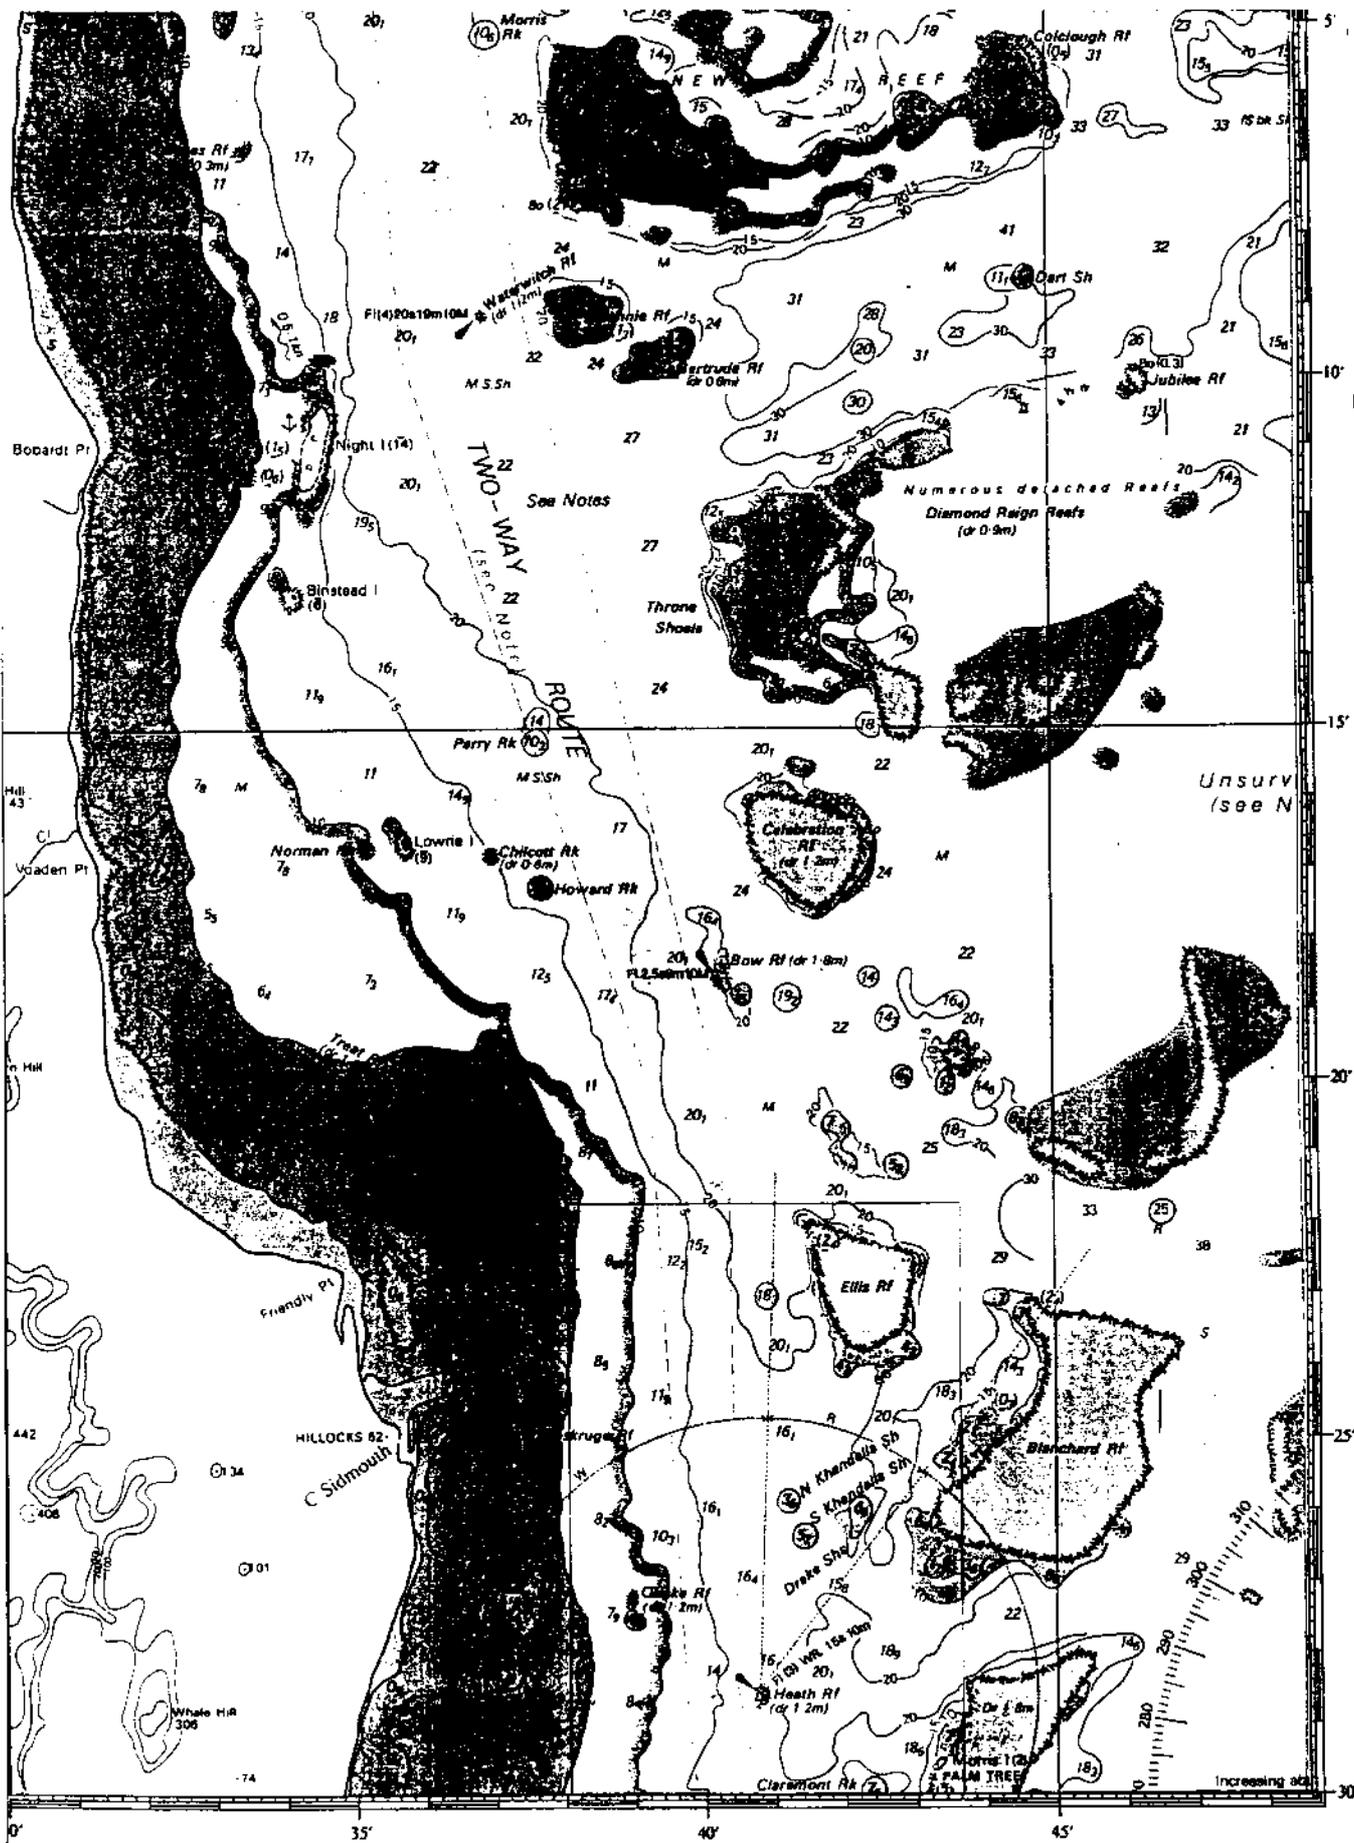
Extract from chart AUS 834

According to the Pilot of Pearl Prosperity, between Waterwitch and Bow Reef he became concerned at the closeness of Blossom Forever, which was by this time between 30 and 60 degrees on the vessel's port quarter. Pearl Prosperity's Master was on the bridge with the officer of the watch, the Chief Mate, and remarked on the closeness of the other vessel. The Pilot assured him that Blossom Forever would soon alter course. He adjusted course to starboard to pass an estimated 8 or 9 cables (1480 to 1670m) off Bow Reef, when his normal passing distance was about 5 cables or (900m).

The Pearl Prosperity's Pilot stated that he monitored the approach of Blossom Forever on the radar and the overtaking ship came within 1 cable (185m) as measured from the radar mast. At this stage, he again spoke with the other Pilot by VHF and suggested that he alter course to port.

The Pilot on board the Blossom Forever did not check the distance off by radar. He estimated that the two ships were about 3 cables, and certainly no less than 2 cables apart, when the Pilot on Pearl Prosperity called up on VHF and expressed concern at the close approach of the Blossom Forever. Blossom Forever altered course and the two ships diverged. According to a statement signed by the Master and Mate, Blossom Forever passed less than 5 cables from Bow Reef.

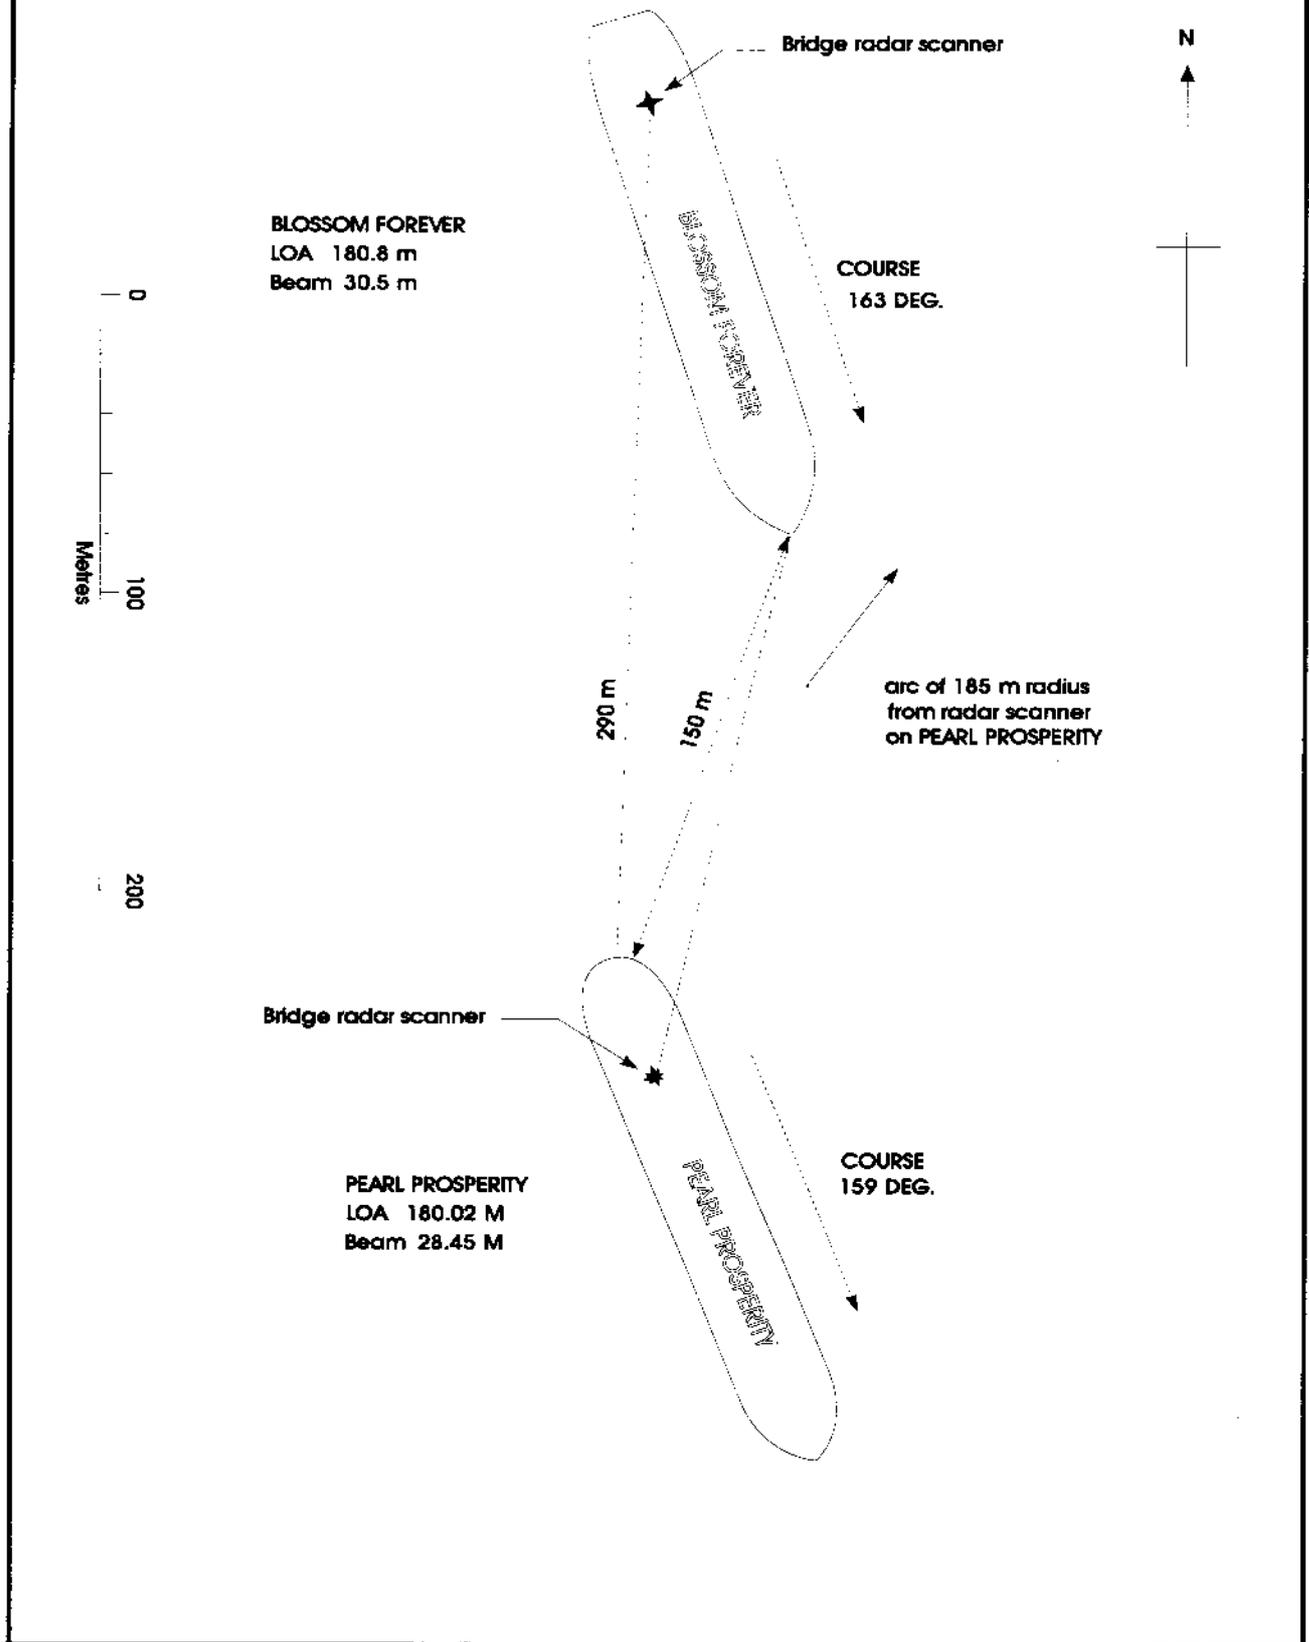
**Blossom Forever / Pearl Prosperity
Reconstruction of nearest approach**

North of Bow Reef, Blossom Forever came within 185 to 240m of the Pearl Prosperity's radar mast, which was 40m from the ship's stern. The distance between the two ships at their closest encounter was therefore between 140 and 200m. This was, under the circumstances, unnecessarily close and was contributed to, in part, by the converging courses adopted by the two ships and their closeness in speed.

The distance from Blossom Forever's bow to its bridge is about 140m. In overtaking Pearl Prosperity its bow reportedly came as close as 160m from the overtaken vessel's port quarter. However, the distance from Blossom Forever's bridge to Pearl Prosperity's quarter was nearly twice this distance. This may, in part, account for the different perspective from which those on the bridges of the two ships viewed the situation.

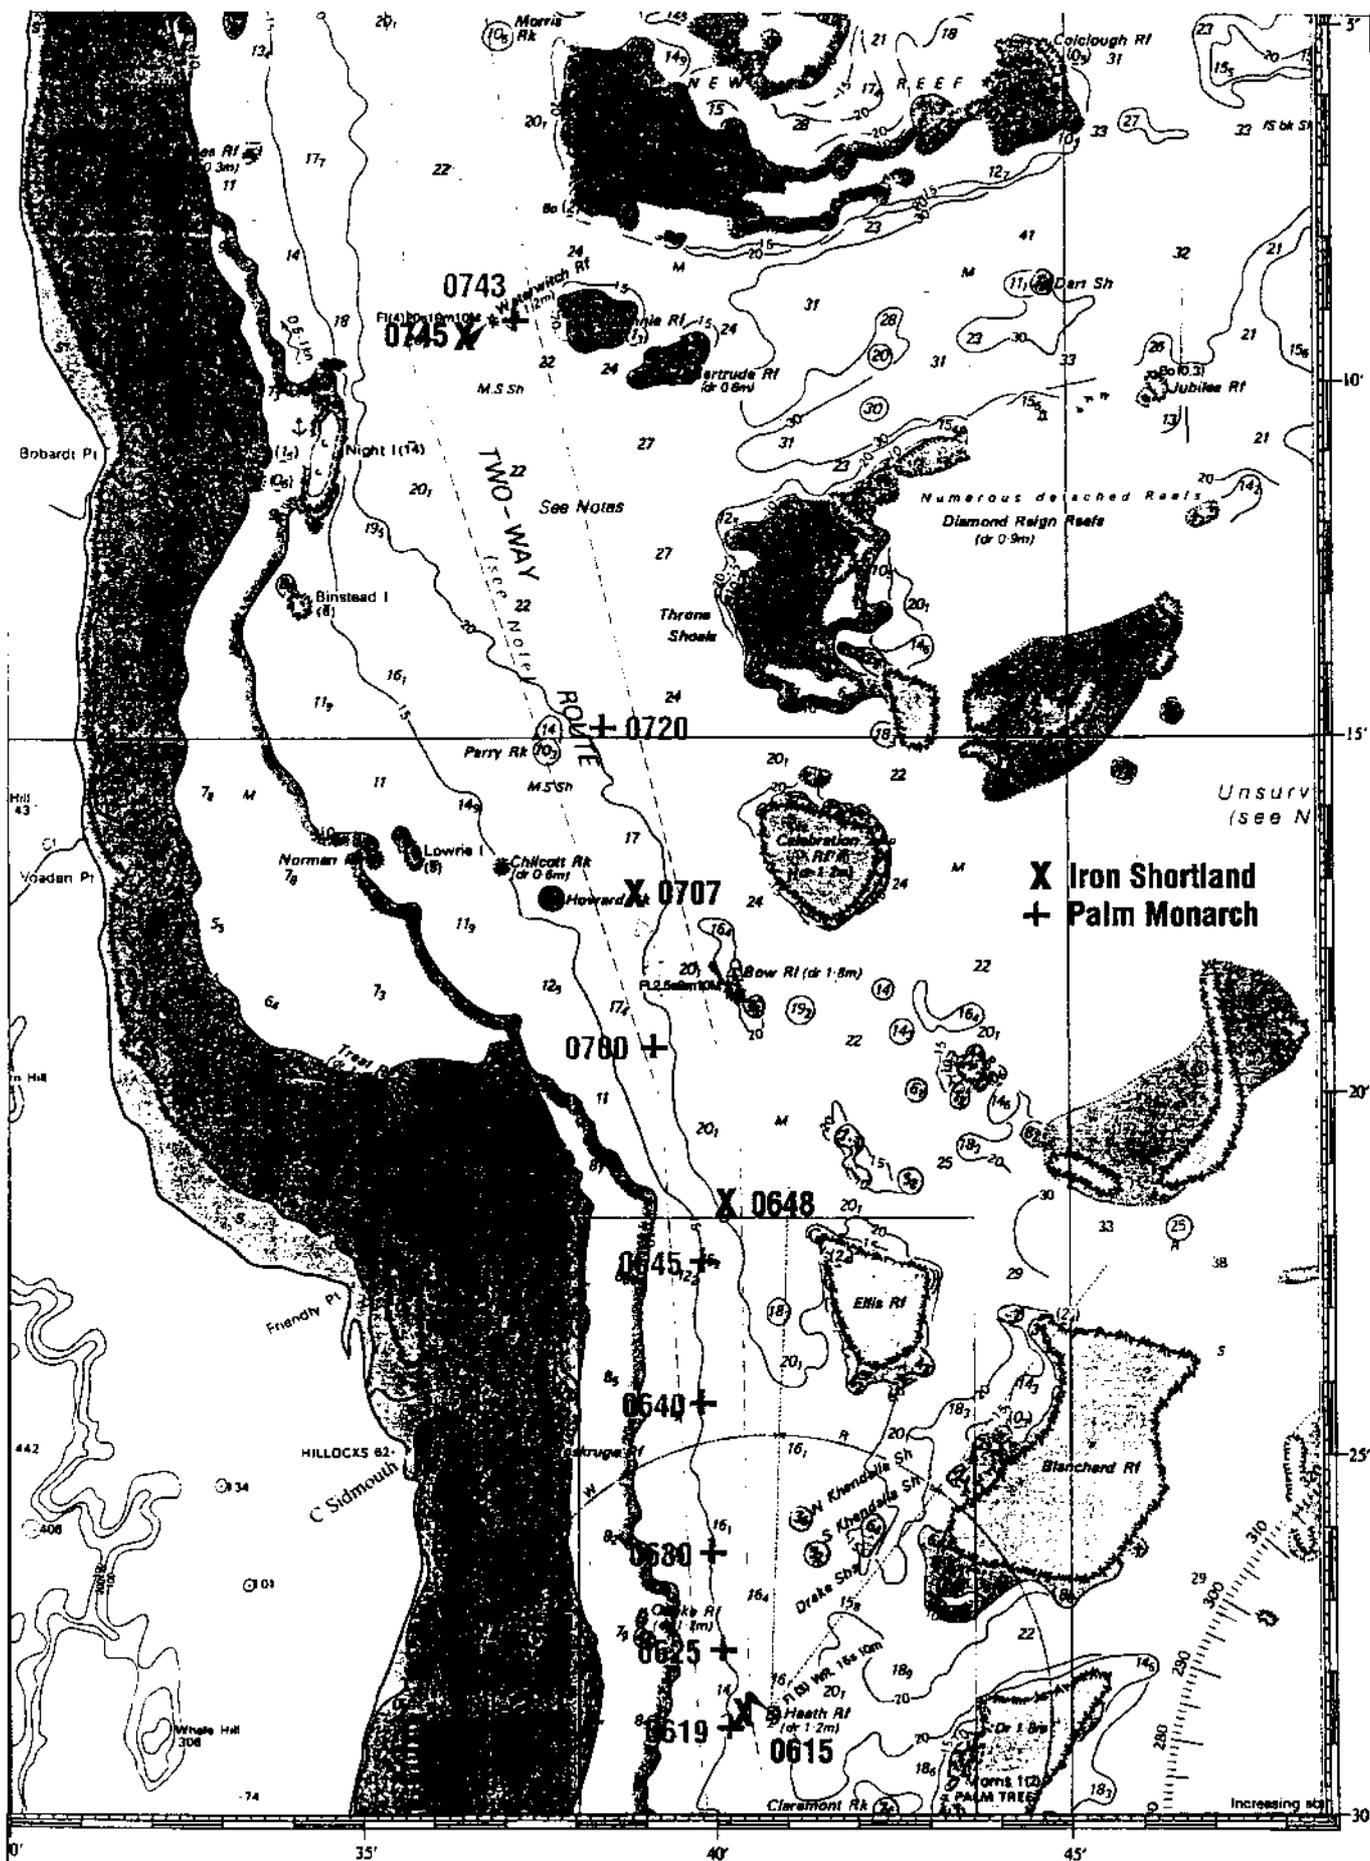
Iron Shortland/Palm Monarch
Relative positions as plotted on chart AUS 834

Iron Shortland passed Fife Reef at 0526 on 15 November, by which time Palm Monarch was about 6 minutes astern at a distance of 1400m or 7.6 cables. The Pilot on board Iron Shortland made VHF contact with a south-bound ship, Sevastapol. With the intentions of Sevastapol confirmed, the Pilots of the two north-bound ships discussed the overtaking manoeuvre. Iron Shortland's Pilot suggested that his ship would stay to the east of the route, in the region of Khandalla Shoals, after the two vessels passed Heath Reef. A south-bound ship, Star Mikhailis, which was approaching the two vessels, confirmed that it had a draught of only 6m and would stay to the west.

Iron Shortland passed Heath Reef at 0615, closely followed by the Palm Monarch at about 0621. Iron Shortland was on a course of 006 degrees, to take the ship to the east side of the two-way route and toward Khandalla Shoals. Palm Monarch increased engine revolutions by 2rpm giving a speed of about 14.52 knots, steering 350 degrees and making good about 354 degrees. At approximately 0622, once north of Heath Reef and at the eastern extreme of the two-way route, the Pilot on board Iron Shortland altered course to 000 degrees putting Bow Reef ahead. By this time Palm Monarch had started to overtake Iron Shortland at a distance estimated at 2 to 4 cables. The Star Mikhailis passed to the west of both ships.

Marginally before 0707, the Iron Shortland's Master measured the distance between his ship and Palm Monarch by radar, as 2 cables (370m). The Pilot altered course to 342 degrees to increase the distance between the ships. Although his original plan was to pass to the east of Waterwitch Reef, he decided to pass to the west. Palm Monarch passed to the east of Waterwitch Reef at 0743 and Iron Shortland passed to the west of Waterwitch Reef at 0745. By the time the two vessels passed Chapman Reef, a little over 15 miles north of Waterwitch Reef, Palm Monarch was 7 minutes (1.6 miles) ahead.

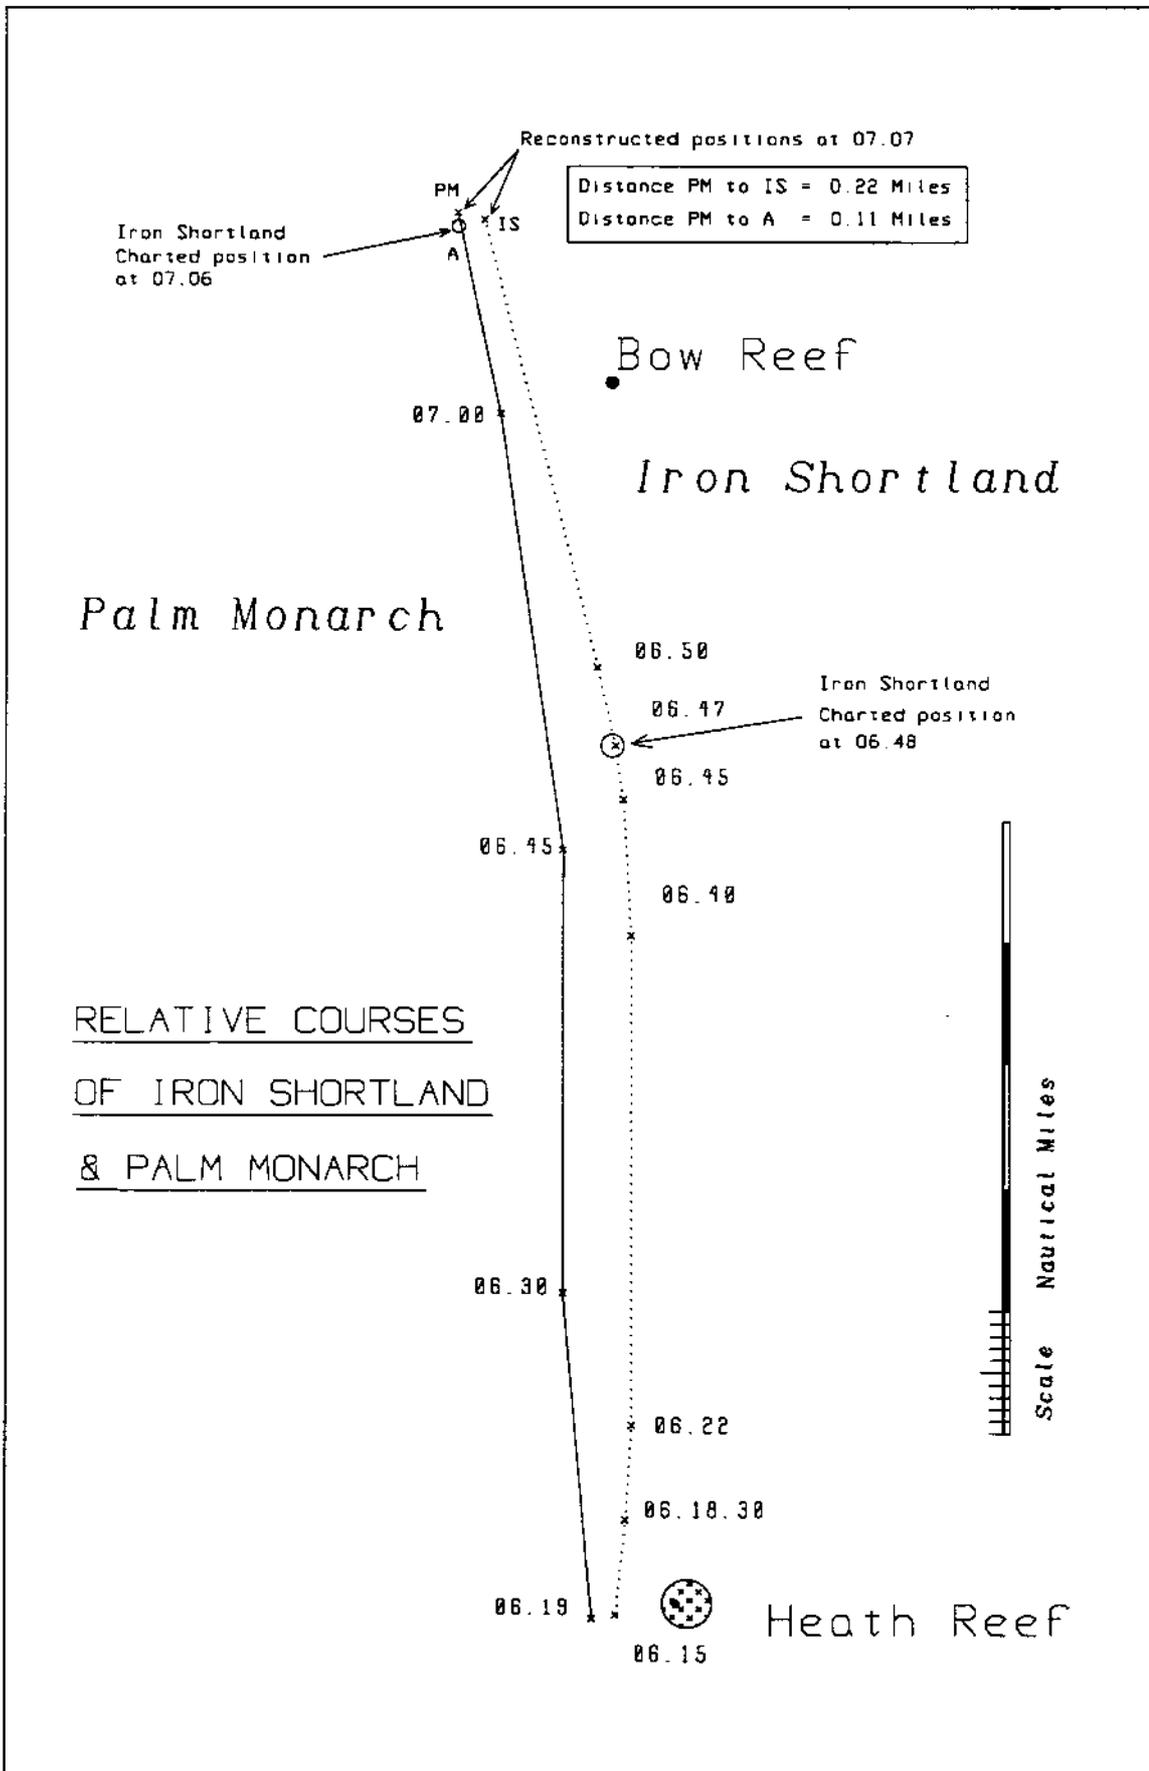
Iron Shortland / Palm Monarch
Relative courses vicinity Bow and Heath Reef

Between 0600 and 0630 Palm Monarch maintained a course of 350 degrees and the two ships diverged. Between 0630 and 0645 Palm Monarch altered course to starboard to 000 degrees on a track generally parallel to Iron Shortland. At 0645 Palm Monarch altered course to 352 degrees, at a time when Iron Shortland was slowly coming to a heading of 346 degrees, a course to take the vessel east of Waterwitch Reef. Unknown to either ship the two courses

were converging. At 0700, Palm Monarch made a final course adjustment to port to bring the ship's course to a heading of 348 degrees, to pass east of Waterwitch Reef. Although these 4 degrees reduced the rate of convergence marginally, it was not done with this conscious intent.

From these courses and the log book entries made by the officer of the watch, the Inspector is satisfied that between Heath Reef and Bow Reef, Iron Shortland kept to the east side of the two-way route. However, it would appear from the positions taken by the Master that Iron Shortland passed about 0.7 cables off Bow Reef and by 0707 was more or less in the middle of the two-way route.

(413 and 448m/min). The speed differential of 35m/min meant that Palm Monarch would take 7 minutes to gain 250m (the length of Iron Shortland) on the overtaken ship. The evidence is that a little after 0655 Palm Monarch's bridge was just forward of Iron Shortland's beam. Therefore, twelve minutes later, when altering course to 348, Palm Monarch would have gained a little over two cables as measured from Iron Shortland's bridge shortly before 0707. This is consistent with the radar distance taken from Iron Shortland and the reconstruction shown in the diagram. Allowing for the length of the ship from the bridge to the bow being about 200m, the two ships were about 170m apart at their nearest point of overtaking.

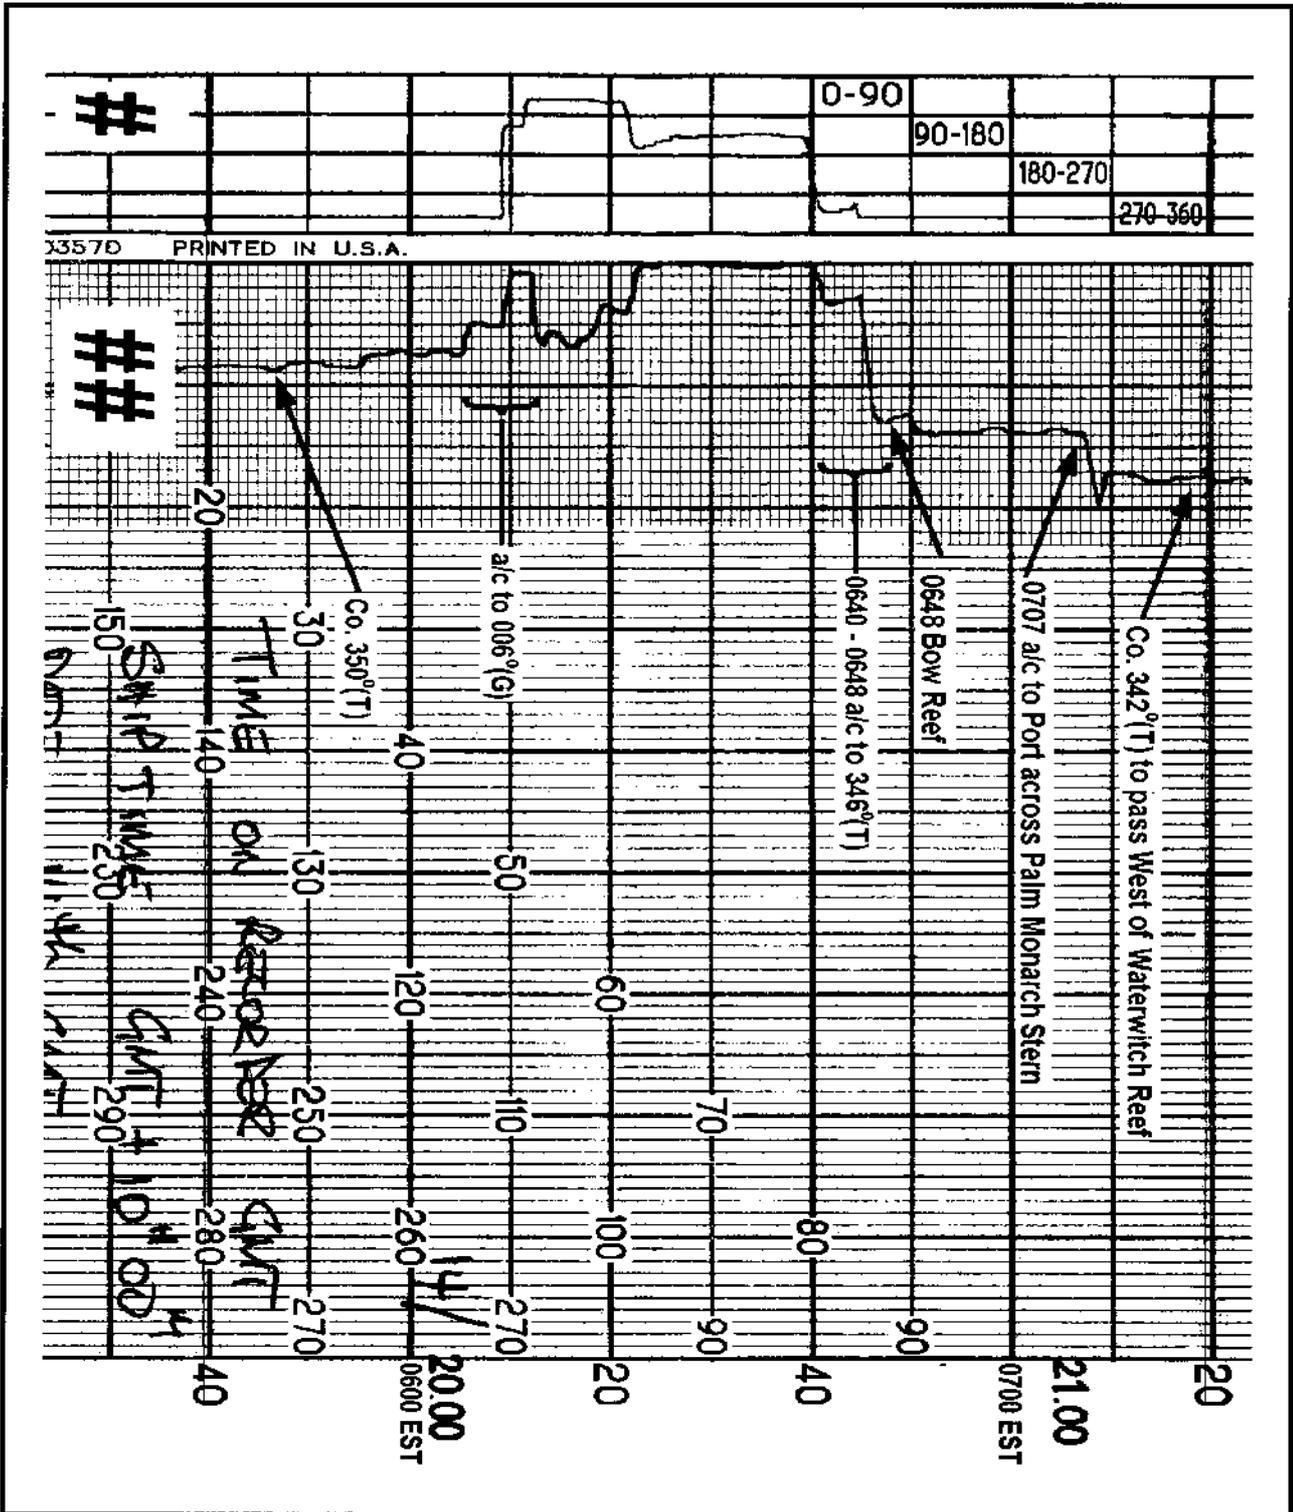
**Iron Shortland
Course recorder trace 15 November 1993**

The Master of Iron Shortland submitted the ship's course recorder trace. The sections of the trace from 1800 to 2300 UTC, 14 November (0400 to 0940 EST, 15 November) were analysed. It was not possible to establish the accuracy of the time shown on the chart or any time difference between the times the Pilot kept or the ship's clocks. However it is evident that the trace is accurate to within two minutes of the times recorded in the ship's log book.

Iron Shortland's course recorder shows that, at about 0438, course was altered off Magpie Reef from 329 degrees to 351 degrees. This general course was maintained until 0606 when the course was altered over a period of 8 minutes to about 006 degrees. This, in turn, was maintained for about 9 minutes when, at 0622, the ship was then brought onto a course of 000 degrees. At 0640, course was altered to port and by 0648 Iron Shortland was steady on a course of 346 degrees. At 0707, course was altered to 342 degrees. This final course took Iron Shortland west of Waterwitch Reef.
