On 14 February 1994, while Searoad Mersey was sailing from Grassy Harbour and making the turn around Grassy Island, fog obscured the leading marks which when in line indicate the centre line of the main channel. The Master continued his manoeuvre onto the correct course, but the ship made contact with the northern end of Omagh Reef.

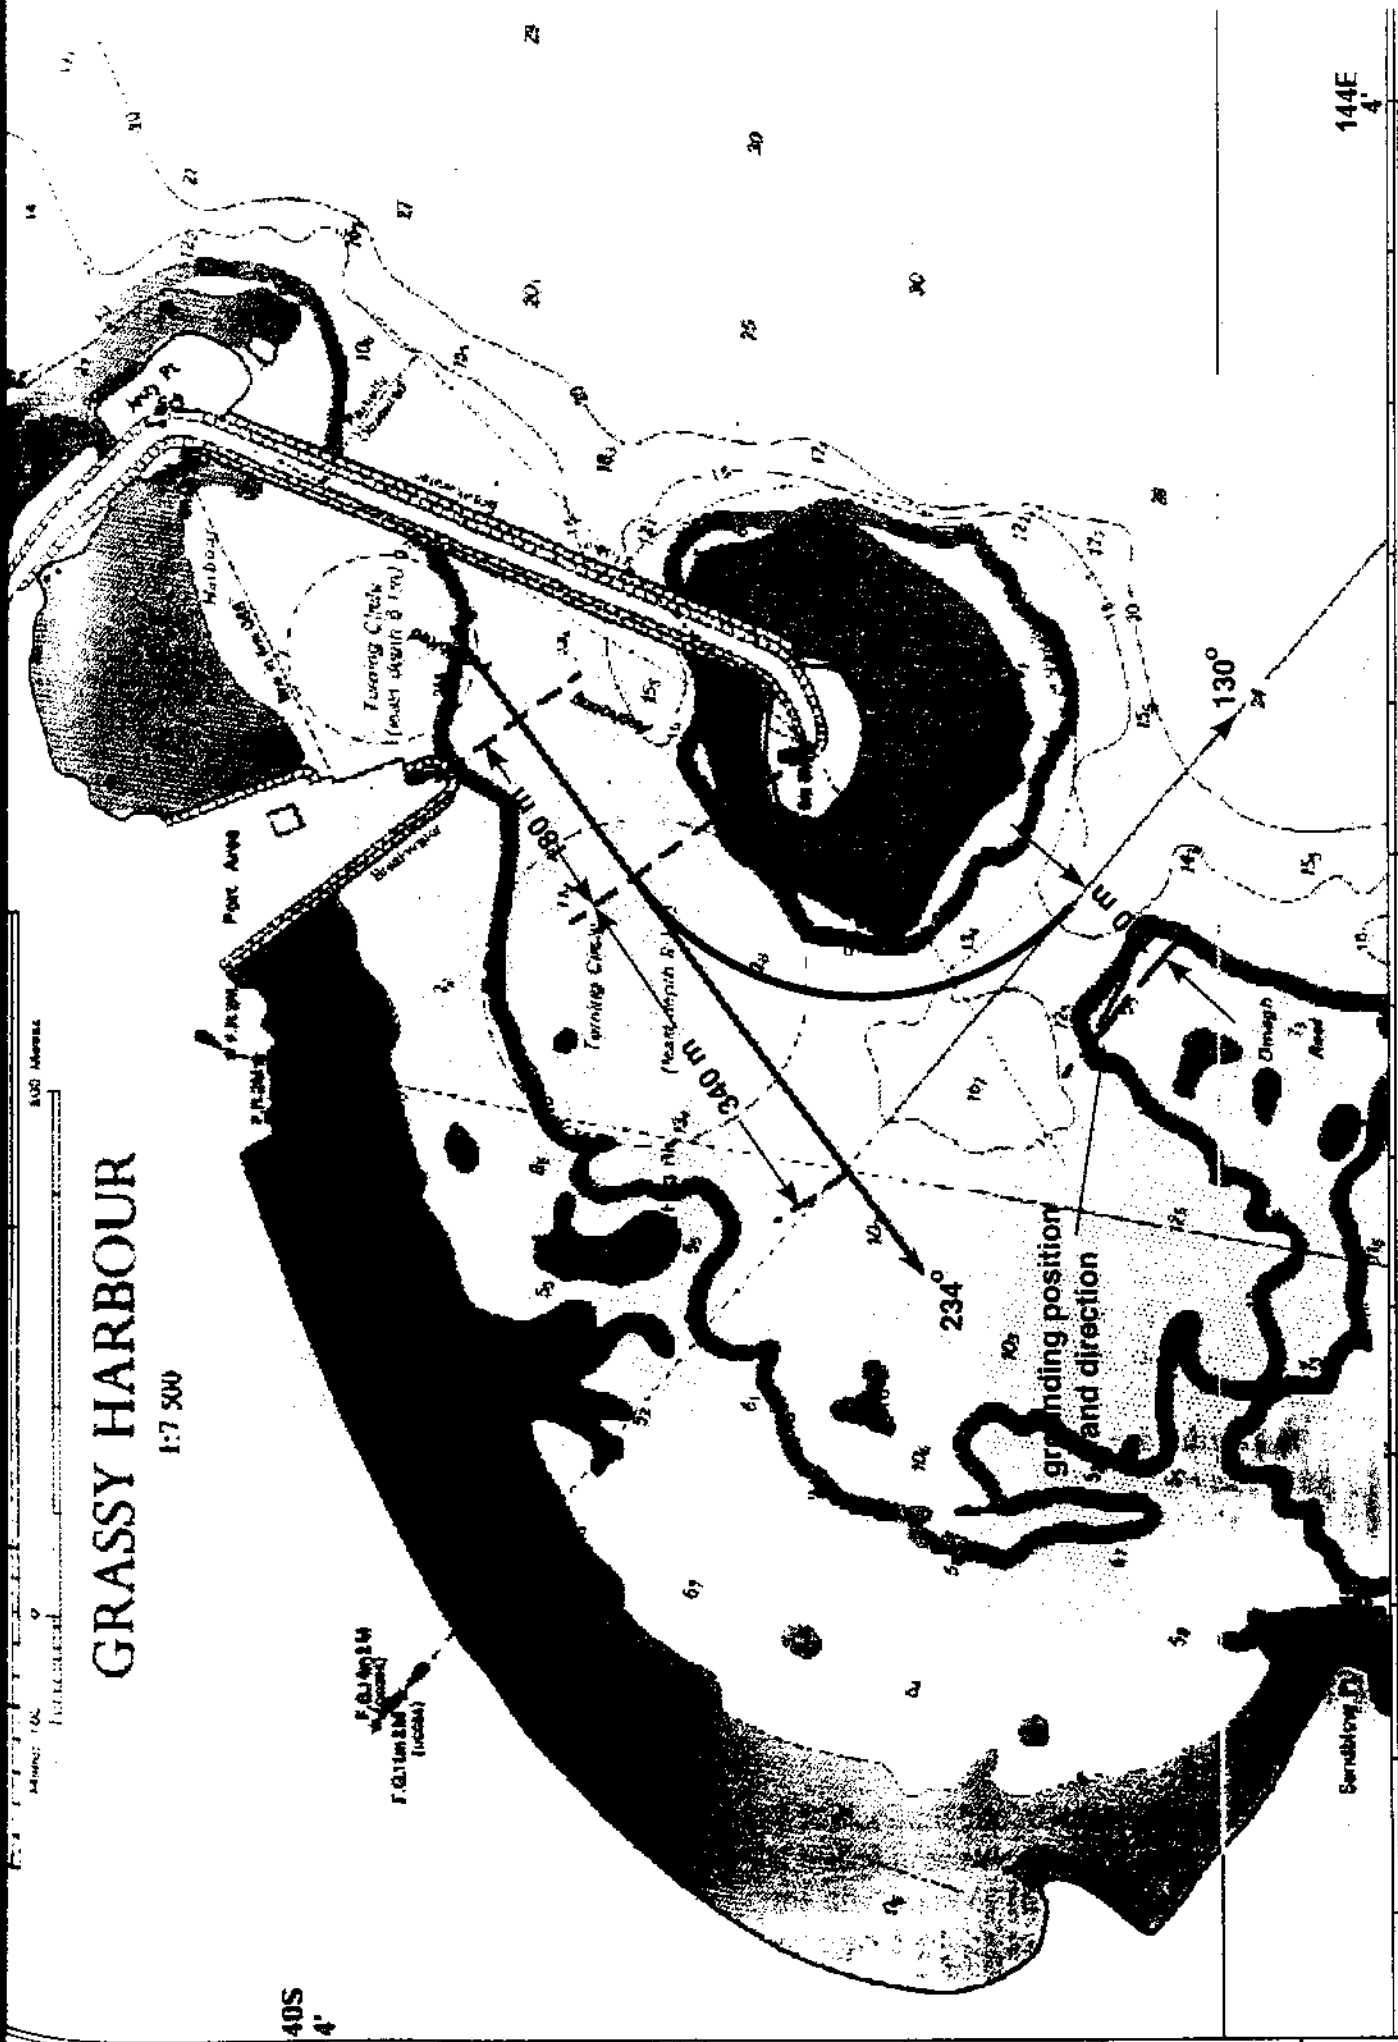
GRASSY HARBOUR

Inspection of Omagh Reef by divers, on behalf of King Island Marine Board, indicated that Searoad Mersey had grounded on the Reef immediately

north and east of the 5.5m sounding depicted on the plan of Grassy Harbour (Chart Aus 789), which lies 100m south-west of the line of the leads.

Omagh Reef, with minimum depths of less than 5m, lies roughly midway between Grassy Island and Sandblow Point. Shoal water extends 133m to the south-west of Grassy Island, the main entrance channel lying between this shoal water and Omagh Reef with a width of about 150m.

Ideally, both the 4.2m sounding off Grassy Island and the 5.5m sounding at the northern extremity of Omagh Reef should be marked with beacons, indicating the safe width of the channel. However, a single beacon on the 4.2m sounding would provide an immediate reference point on the inside of the turn around Grassy Island. Also, a beacon at that location would not only provide a lead with Frog Rock, indicating the northern limit of the channel, but it would not be lost to sight in other than quite thick fog.

looked at installing a beacon on Omagh Reef and on the shoal water immediately west of Grassy Island. Discussions between the Marine Board, ANL and ASP Ship Management have resulted in the decision to install a navigation beacon on the 4.2m sounding to the west of Grassy Island.

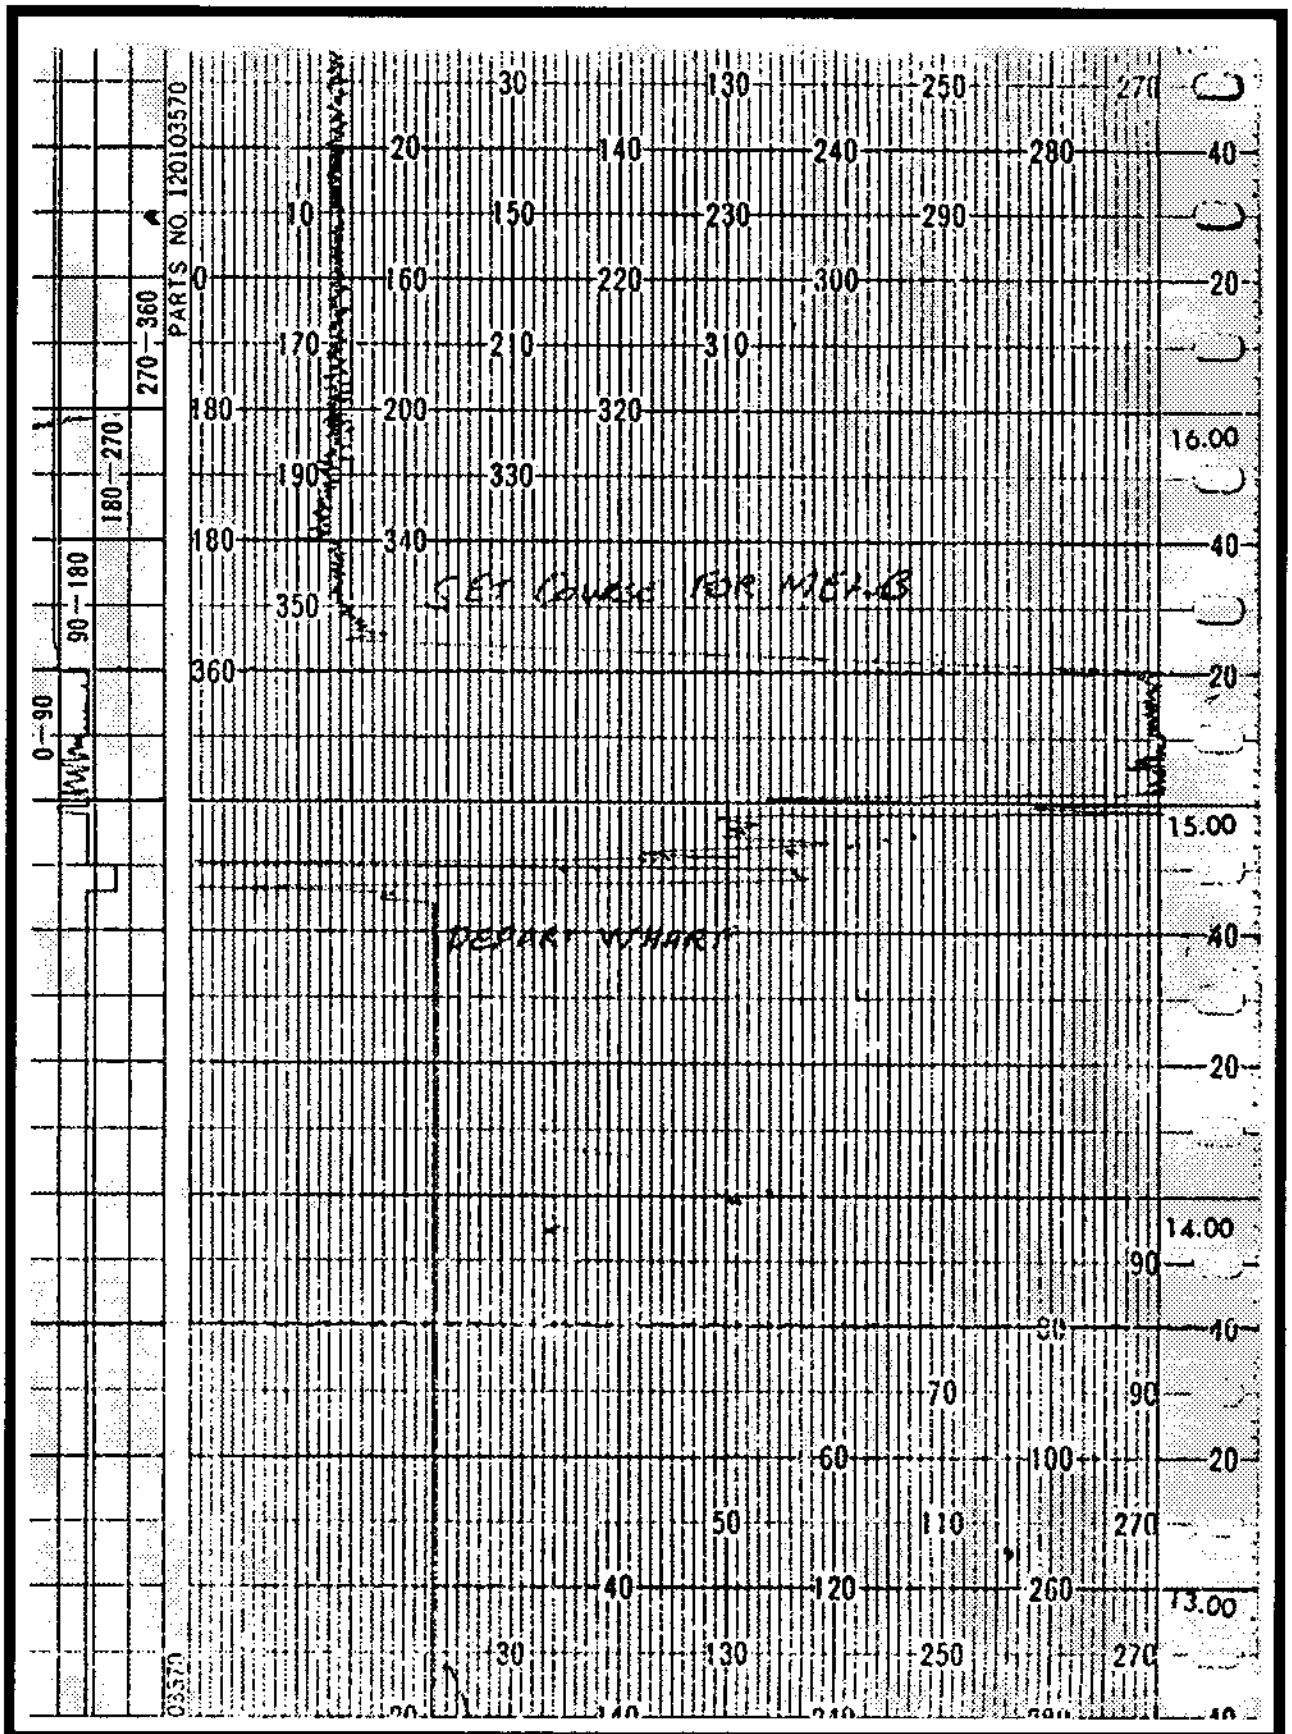
Section of course Recorder chart for period of Incident

From the course recorder chart, Searoad Mersey took two minutes (from 1446 to 1448) to make the turn to starboard after coming off the berth, to a heading of 234°. The ship maintained this heading for a further two minutes, after which the turn to port, rounding Grassy Island, was commenced at 1450. The ship reached a heading of 129° at 1451-42, then swung back to starboard to a heading of 142° at 1452-20, followed by a swing back to port to 121° at 1453-40, settling on a course of 129° at 1454-30. The course of 129° was maintained for about three minutes (to clear the entrance) and then the ship came around to a heading of 090° (to stand off the entrance, while damage was assessed).

The time of impact was recorded on board as being 1454. However, a slight "step" in the trace on a heading of 130° at 1453, during a swing to port, indicates the possible time of initial impact. The direction of the contact marks on Omagh Reef, as reported by the divers who conducted the underwater inspection for the King Island Marine Board, are consistent with Searoad Mersey travelling in a direction of less than 130°.
