MARINE SAFETY INVESTIGATION
No. 202

**Independent investigation into the
engine room flooding of the
Panamanian registered bulk carrier
Harmonic Progress
in the Coral Sea on
16 April 2004**

March 2005

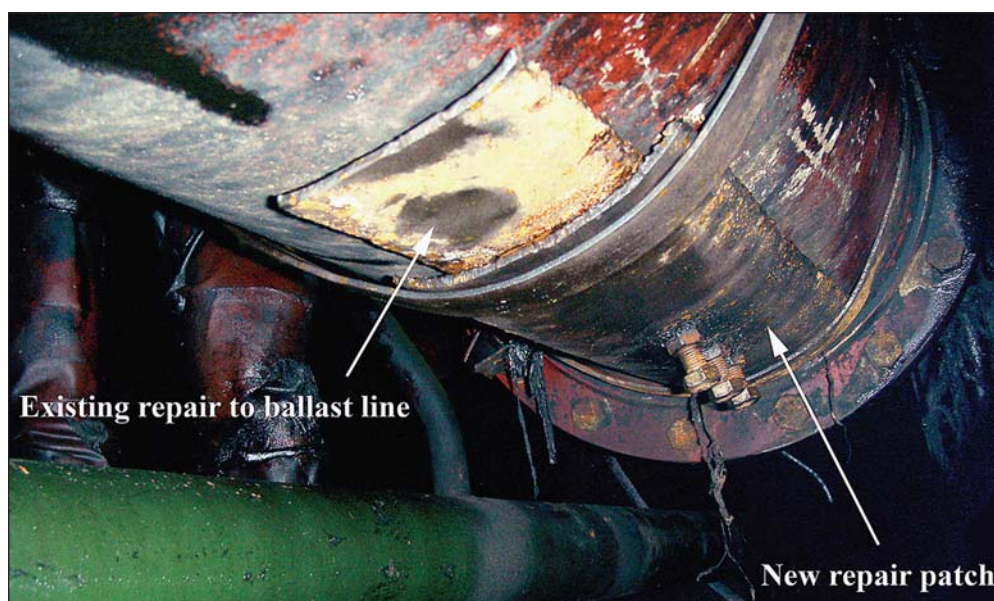
FIGURE 6:
Area of leak and patch

At about 0500 on 20 April, when the water level in the engine room dropped to the point that the area of the leak could be seen clearly, it was observed that there was an older repair patch welded on the ballast line adjacent to the leak (Fig. 6). The chief engineer adjusted the new patch he had made so that it better sealed the entire area near the leak. He then tightened the bands holding it onto the ballast line. This had the effect of finally stopping the leak.

On 16 April 2004, *Harmonic Progress* became disabled after ballast water caused both main engine L.O. pump motors to short circuit. The ballast water had entered the engine room bilge via a leak in the ship's main ballast line, which ran under the lower floor plates towards the forward end of the engine room. Leaking ballast tank valves and a crossover valve, which had been left open following ballast operations, caused the ballast line to be pressurised. The area of the leak had been weakened as a result of corrosion and erosion during the life of the ship and had been repaired sometime in the past. This earlier repair consisted of a small doubling plate welded over a section of the pipe adjacent to the leak discovered on 16 April.

The ship was dry docked at the FORGACS Cairncross Dockyard in Brisbane (an 85 000 deadweight tonne panamax graving dock). During the time the ship was in dock, the ballast line in the engine room was permanently repaired and all butterfly valves in the ship's ballast tanks were removed from the tanks and opened for inspection and cleaning. The rubber seal in the valve in number two port topside/double bottom WBT was replaced. All the WBT butterfly valves were operationally tested and refitted to the ballast lines.

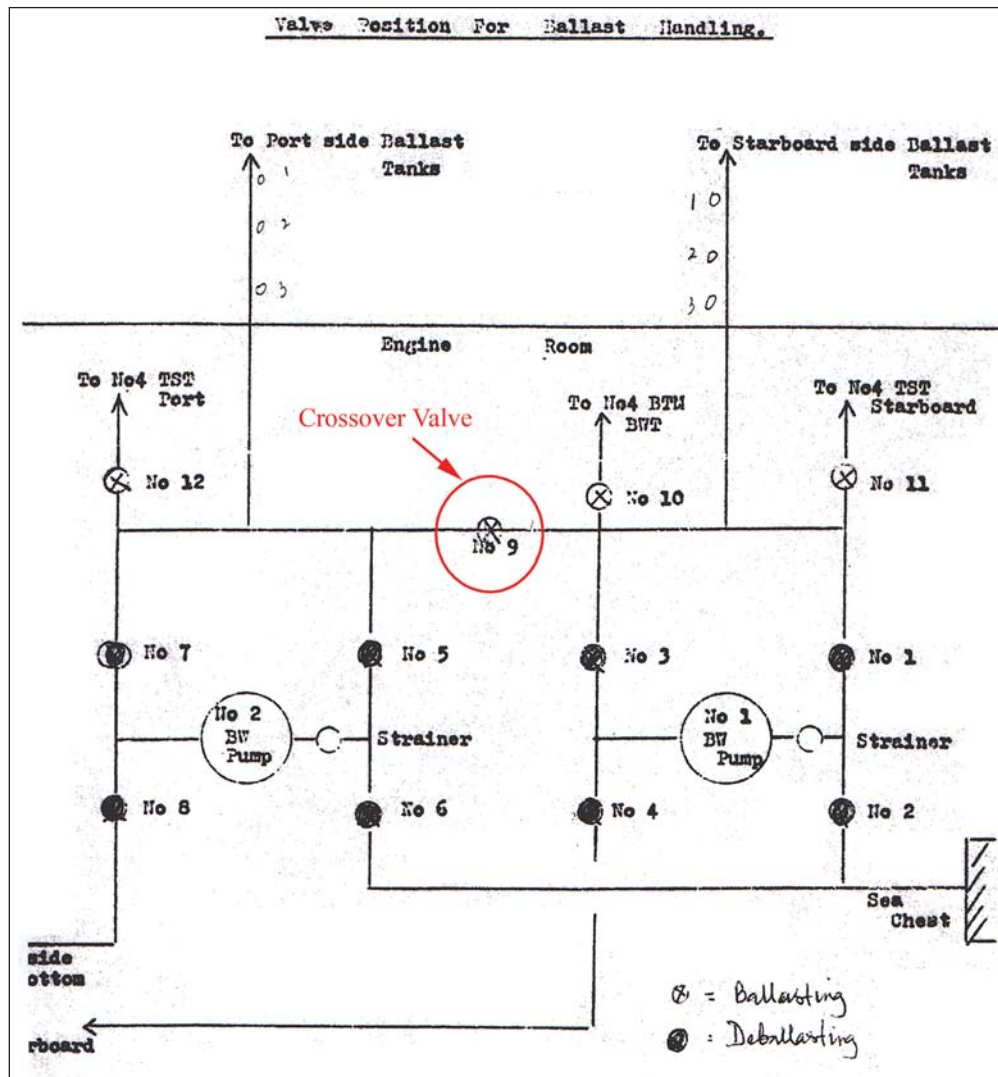
FIGURE 8:
Portion of mate's ballast instructions

Instructions for the engine room staff on which valves to use to perform the required ballasting operation requested by the mate were located adjacent to number two ballast pump. These instructions were written on a piece of cardboard, hanging from a valve (Fig. 9). There was no reference to the crossover valve in these instructions (valve number nine in Fig.8).

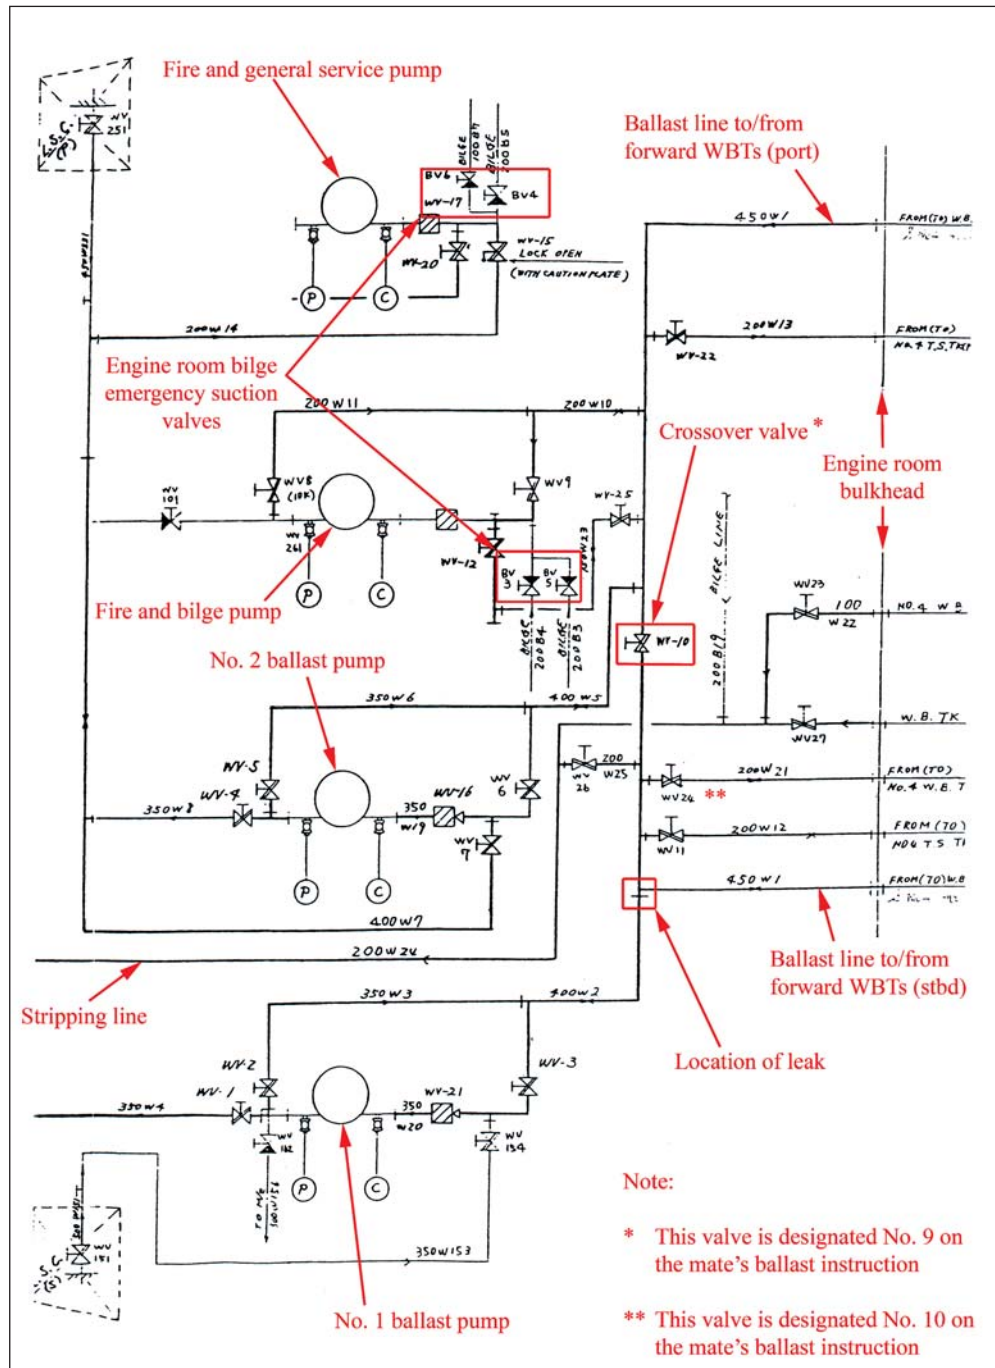
FIGURE 10:
Schematic drawing of ballast arrangement in engine room

crossover valve must be opened. There was no mention made in the instructions to close that valve after ballast operations are finished. However, it would be reasonable to assert that a seafarer with any experience in ballast operations would return the system to its pre-existing state, or at least, close any major valves in the system, on completion of ballast operations.

This crossover valve proved critical to the flooding of the engine room. Had it been closed, the water from the leaking port side WBT valves would not have flowed to the leaking section of the ballast main.

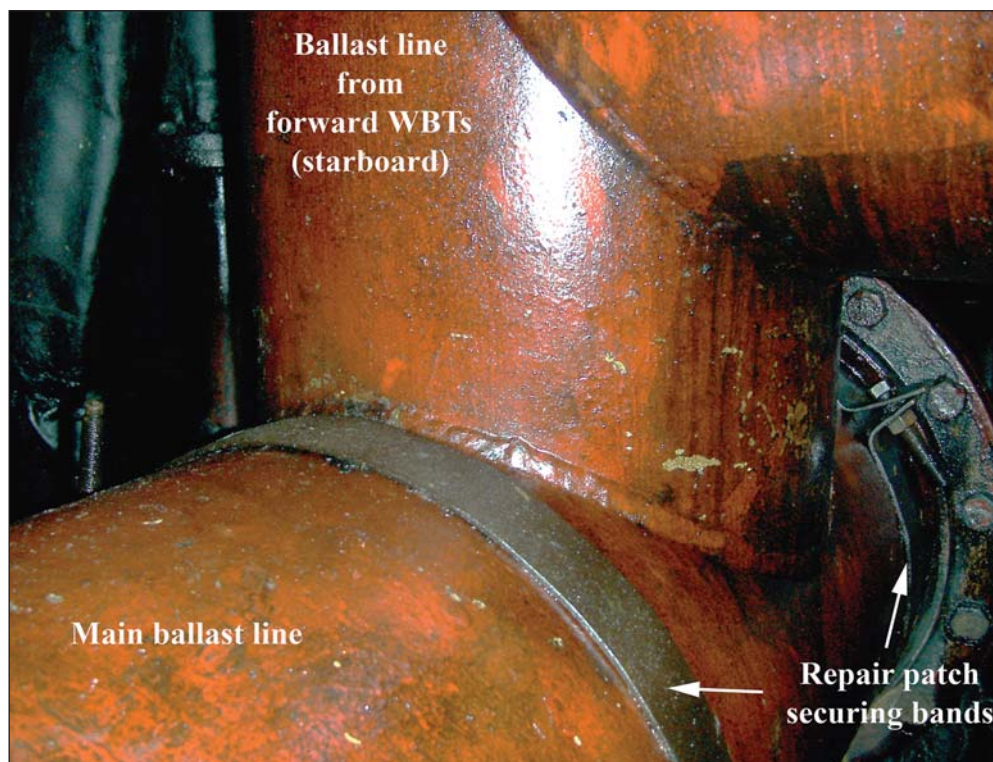
FIGURE 11:
'T' junction above leak

The area at which the leak developed was at the bottom of a 'T' junction in the main ballast line (Fig. 11). This junction was where the 450 mm diameter starboard ballast line to/from the forward WBTs joined the main 450 mm diameter main ballast line in the engine room. Evidence shows that this area had been the subject of repairs in the past. Previous repairs were not sufficient to ensure that the problem did not recur.

The bottom of 'T' junctions on all salt water piping has been proven to be prone to problems with regard to corrosion and erosion. On this particular section of ballast piping, the problem has arisen because of the aeration, and the impact and redirection of the water coming from the forward ballast tanks during normal operations. These areas of salt water piping are not required to be the subject of regular, close-up inspection or thickness testing during surveys. Under current enhanced survey programs for bulk carriers greater than 15 years of age, there is no requirement for thickness measurement of any part of the ballast piping system that is outside cargo or fuel oil tanks; cofferdams; pump-rooms; pipe tunnels, void spaces within the cargo area and all ballast tanks¹⁵. Class societies only visually inspect sections of ballast lines.

The presence of an existing repair on the area of the leak in the ballast line was not visually identified during surveys prior to the incident.
