Total power loss, VH-UMV near Cairns Airport, Queensland 31 December 2009

Abstract

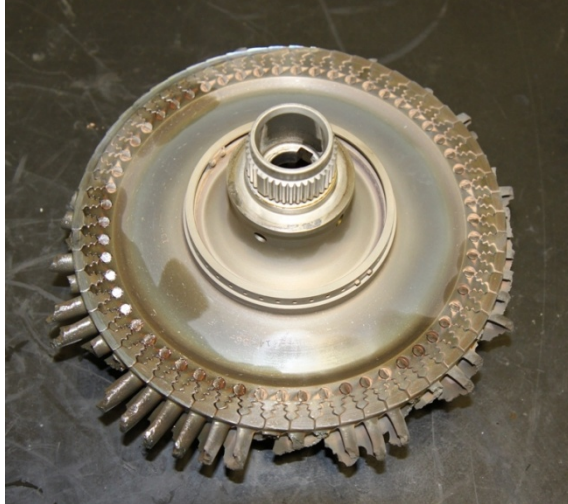
Figure 2: Compressor turbine rotor assembly

Separation of the hot section revealed significant damage to the compressor turbine (CT) rotor

assembly (Figure 2). All of the blades were fractured through the airfoil section; the majority close to the blade platform. Many of the blade sections exhibited deformation, cracks and nicks associated with impacting circulating blade debris. The compressor turbine shroud and vane ring had also sustained extensive impact damage and gouging. The anti-rotation lugs on the vane ring were fractured.

Damage sustained by engine serial number 17154 was consistent with the fracture and collapse of the compressor turbine blade set. It was found that the FAA-PMA T-102401-01 CT blades installed during the last overhaul were not approved for a PT6A-114 engine. The fact that the unapproved blade part number was documented in the engine maintenance logs indicated that the maintenance provider was unaware, or did not detect, that the incorrect parts were installed or that those parts were not approved for that engine.

- The loss of engine power was probably brought about by failure of the compressor turbine blades.

CASA recommended that operators and maintainers of PT6A engines check engine maintenance logs to ensure that the compressor turbine blade part number(s) installed are correct for the engine variant according to FAA PMA approval information.

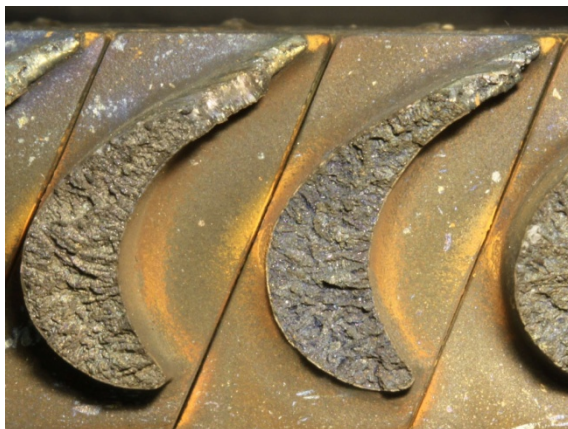
Figure 3: Typical CT blade fracture surfaces

Some of the CT blade fracture surfaces were obscured by metal smearing, but the remaining fractures were typical of ductile rupture in cast superalloy components (Figure 3) and did not

show any evidence of progressive cracking, corrosion or other pre-existing defects.

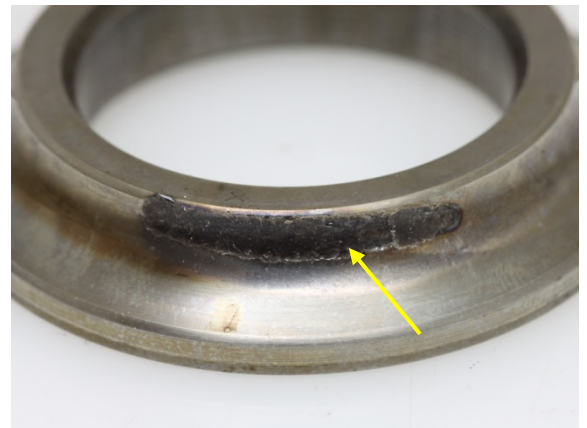
Figure 4: Number-1 bearing inner race showing electrical discharge damage

The number-1 bearing inner race showed a localised area of metal flow and associated

spalling, as well as surface discolouration and chromatic heat-tinting (Figure 4). This was consistent with electrical arcing across the bearing, commonly referred to as electrical discharge damage (EDD). Several of the rolling elements also exhibited minor surface pitting. The bearing had not failed during operation and the point at which the EDD occurred was not able to be conclusively determined by this investigation.

- The number-1 bearing showed evidence of electrical discharge damage but was still operational at the time of the occurrence.

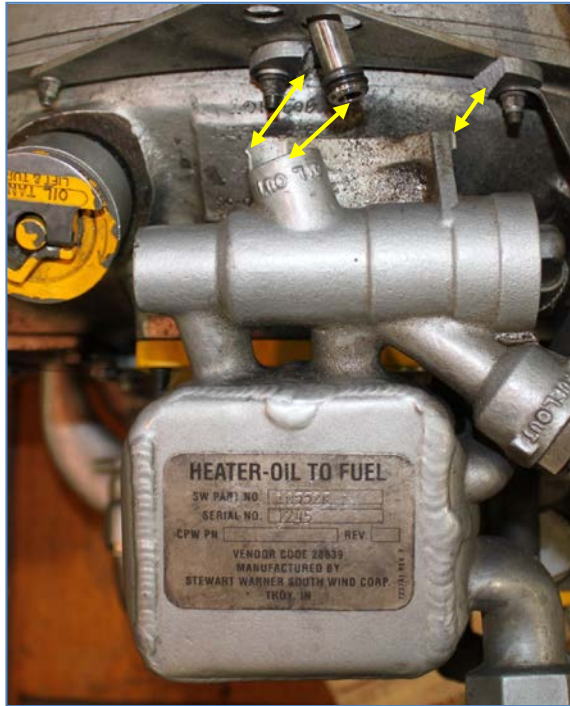
Figure 5: Fracture of oil-to-fuel heater mounts

The oil-to-fuel heater had fractured at the mounting lugs, allowing separation of the oil transfer tube (Figure 5). The pressure oil transfer elbow mounted on the A-flange had also sustained a fracture of the mounting lug (Figure 6). Examination of the mounting lug fracture surface revealed no evidence of pre-existing cracking or other defects.

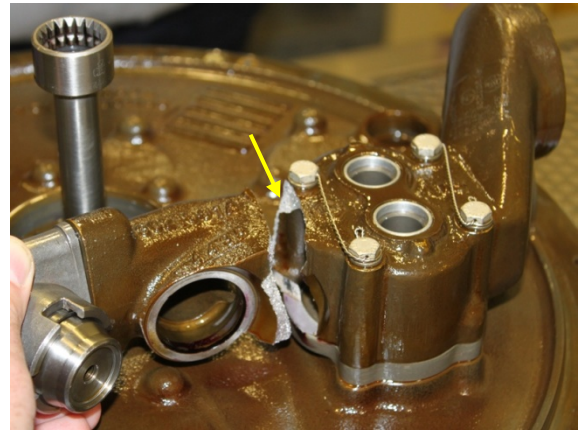
Figure 7: Fracture of oil pump housing

The main oil pressure pump housing had fractured, exposing the pump gears (Figure 7). In this condition, oil pressure could not have been maintained during engine operation. When examined under the Scanning Electron Microscope (Figure 9), approximately two thirds of the pump housing fracture surface presented with a highly crystallographic morphology; consistent with a low-stress, high-cycle fatigue cracking mechanism. The remaining area of fracture presented as ductile overstress (Figure 8).

The engine manufacturer indicated that the first components to show distress due to loss of oil supply would be the first stage planet gears, which would occur after only a few seconds. This was consistent with oil supply interruption to the RGB after the initial engine failure. Final fracture of the oil pump housing therefore probably occurred due to vibrations resulting from disruption to the turbomachinery.

The engine manufacturer was not aware of any engine failure events resulting from fatigue cracking of the oil pump housing. Non-destructive inspection of pump housing was specified during overhaul and it was possible that the crack initiated after this time.

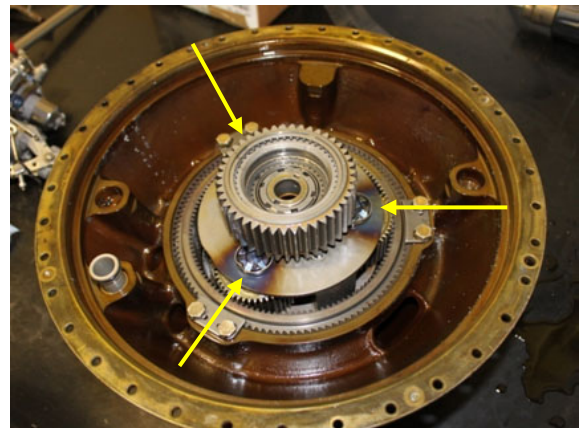
Figure 10: Overheating of the three planet reduction gears

The propeller shaft was unable to rotate due to overtemperature-induced seizure of the three, first-stage planet gears - evidenced by localised chromatic heat tinting of the gear carrier (Figure 10). Seizure of the gears was likely related to disruption of the oil system and oil starvation to the RGB.

Overheating of the first stage planet reduction gears was the only physical evidence of engine damage resulting from interruption to the oil supply. The pilot also reported that there were no oil pressure warnings in the minutes leading up to the engine failure and that the propeller continued to rotate after the event, until feathered.

- Seizure of the reduction gearbox first stage planet gears was the result of oil starvation, precipitated by fractures of oil system components.
