A U S T R A L I A N T R A N S P O R T S A F E T Y B U R E A U

MARINE SAFETY INVESTIGATION

REPORT 166

Independent investigation into the grounding
of the British flag passenger ship

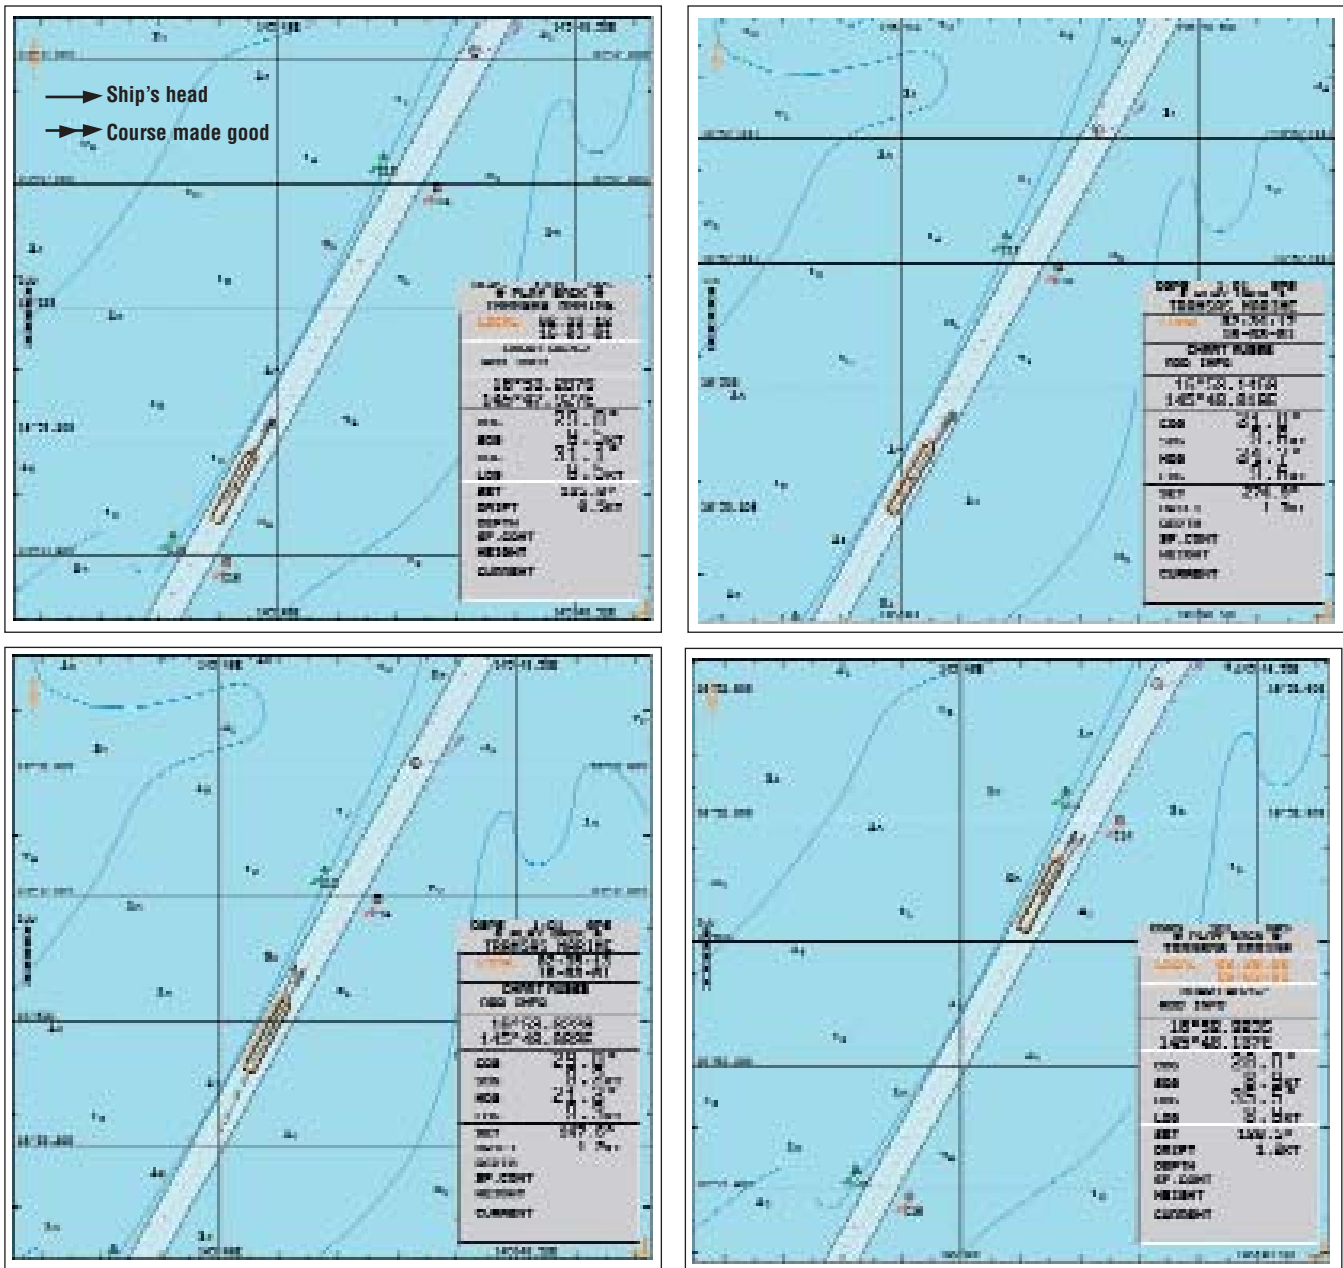
FIGURE 2:
Printouts from the ECDIS recording for minutes 33,34,35 &36 just prior to the grounding.

At 0233, *Regal Princess* was still slightly to port of the centre line of the channel on a heading of 031° (T), making good a course of 029° (T) at a speed of 9.5 knots. At 0233:17 the ship was on the centre line of the channel, moving to starboard. At 0234 the ship's centre line was about 45 m to starboard of mid channel. The ship's heading changed to 034.7° (T) and the course made good 031° (T) at a speed of 9.6 knots.

One minute later, at 0235, the ship was in mid channel when the heading altered rapidly, nearly 14° to port, to a heading of 021° (T) and the course made good to 029°. The speed reduced slightly to 9.2 knots. At 0236 *Regal Princess* was to port of mid channel when the head altered rapidly to starboard to a heading of 035° and the speed dropped further to 8.9 knots. At about 0236:35 the ship's bow crossed the toe line. At 0237 the ship's head was on 040.7° (T) and the speed fell to 8 knots. The ship decelerated to a stop over a period of about 3 minutes.

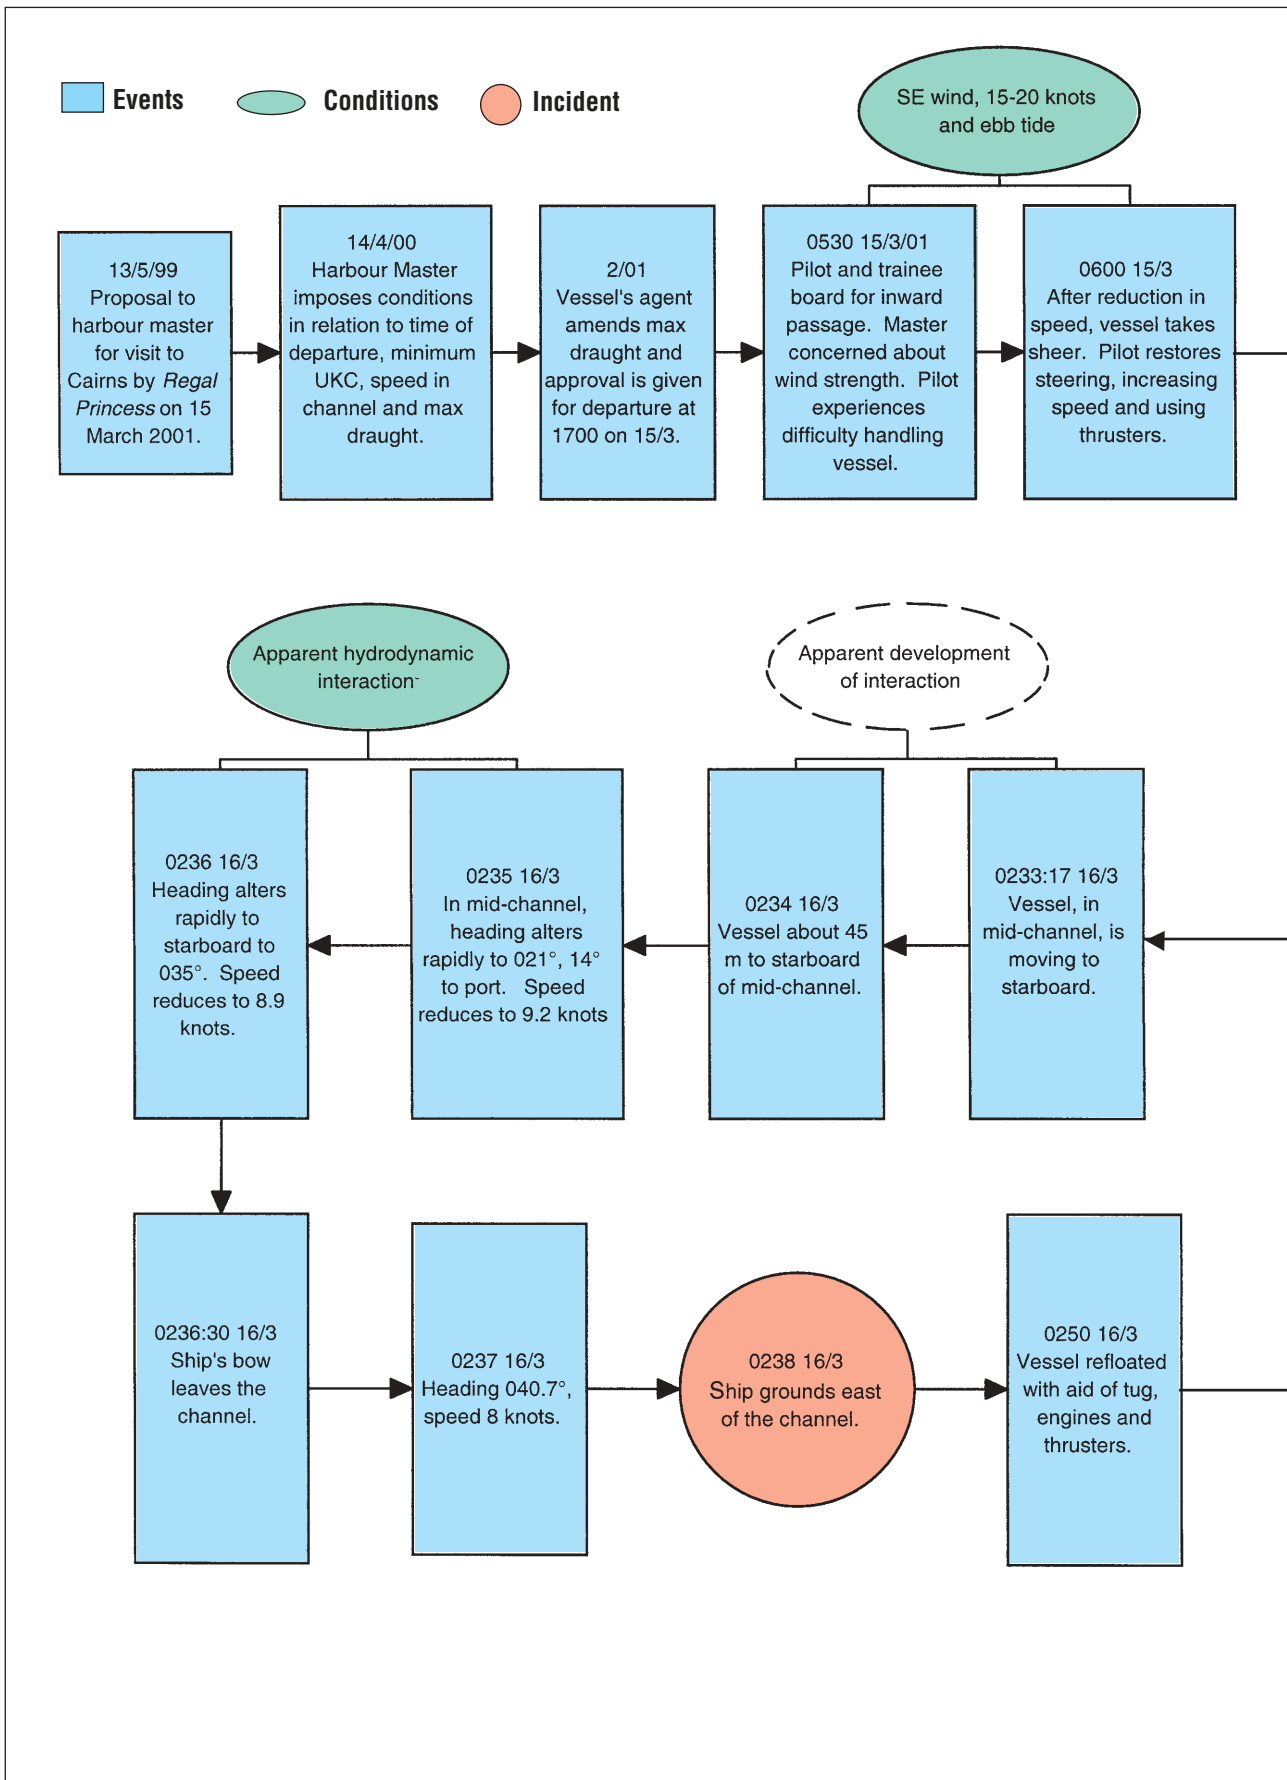
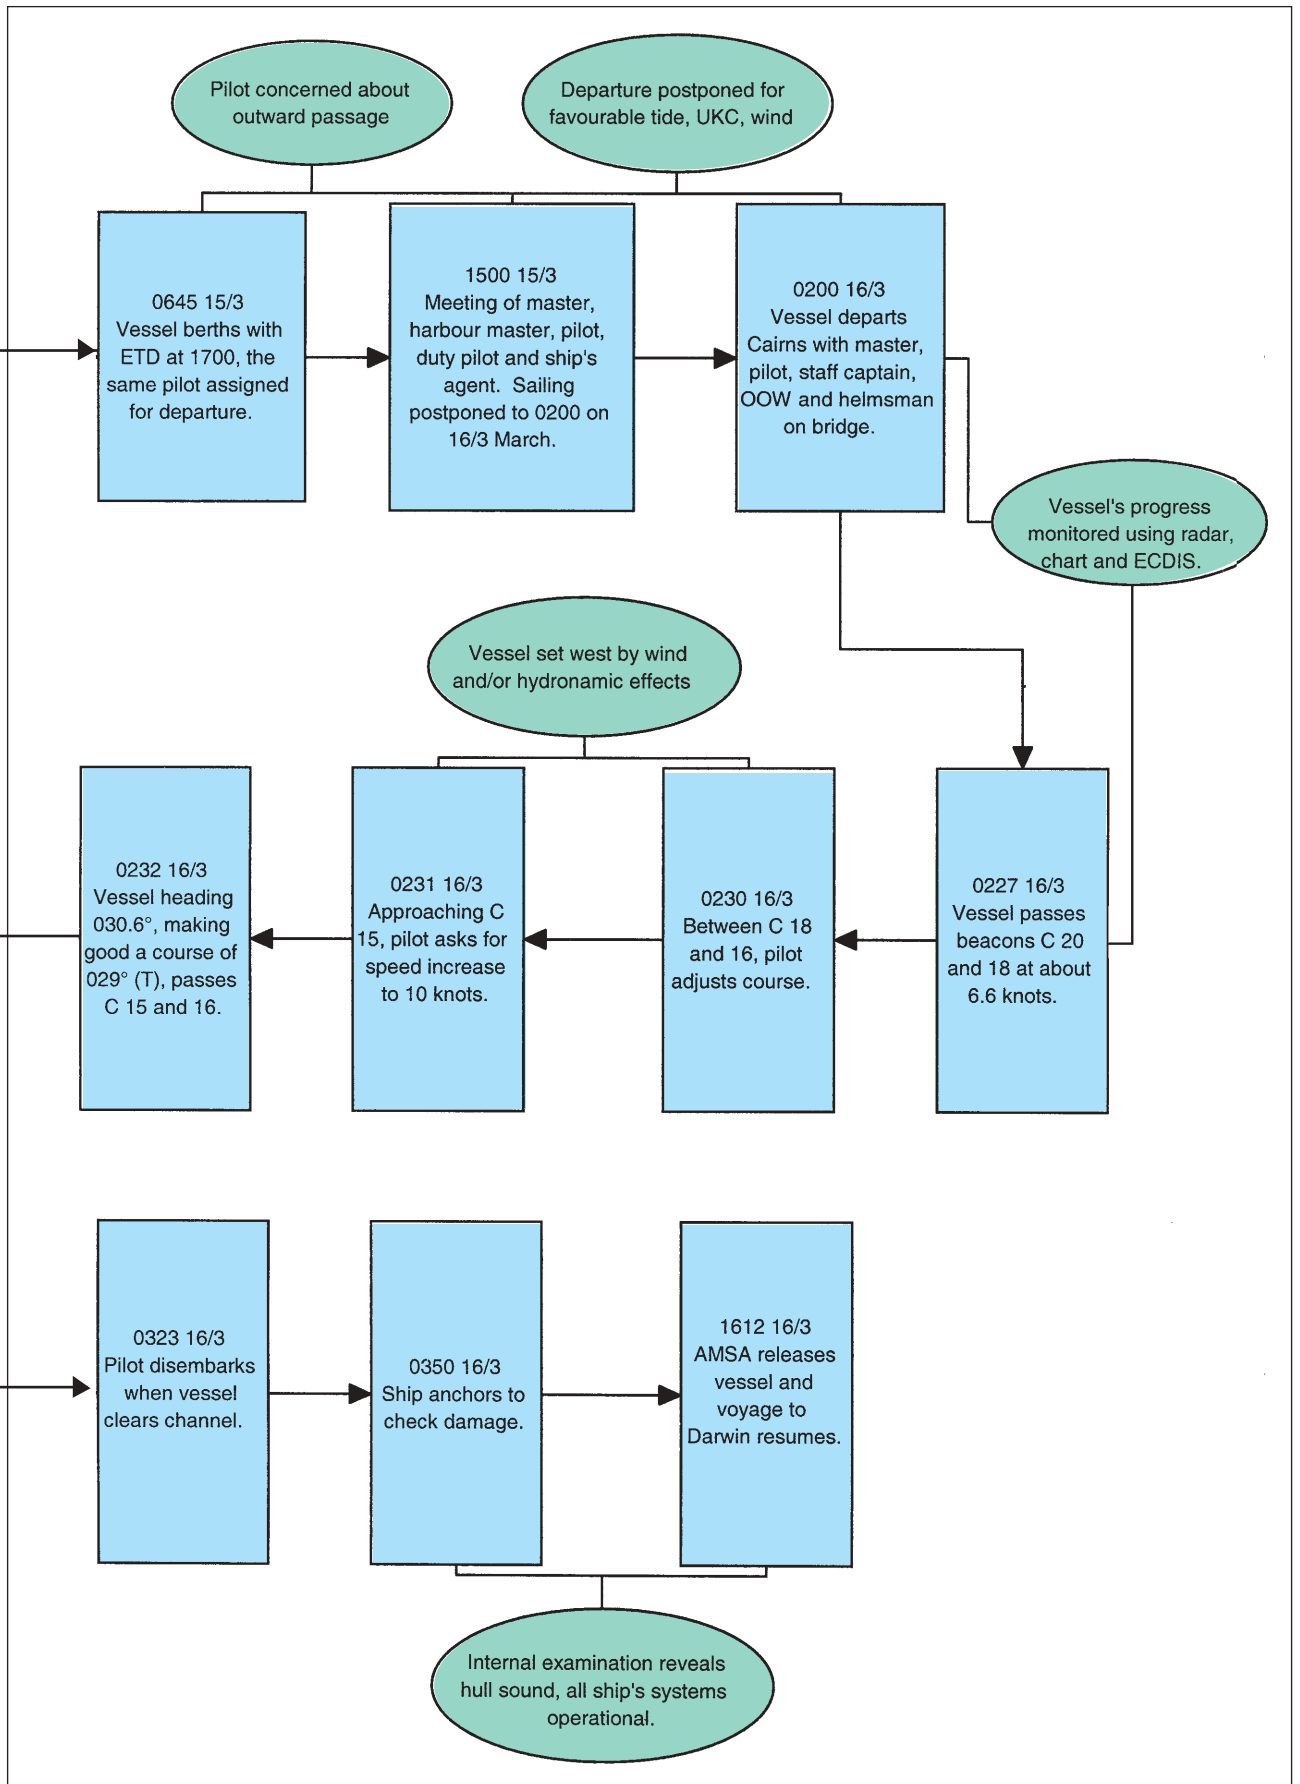
FIGURE 4:
Regal Princess: Events and causal factors chart

Contributing to the grounding was a combination of the following factors:

1. Trials should be implemented to examine the effectiveness of tug, or other external assistance, for large vessels with limited manoeuvring characteristics and rudder effect that are required to use the Cairns port channel.
