The Hong Kong registered motor bulk carrier *Mineral Diamond* of 141028 tonnes summer deadweight, sailed from the Western Australian port of Dampier on 11 April 1991 for the Netherlands port of Ijmuiden, by way of the Cape of Good Hope. On sailing the vessel filed a voyage plan and indicated that it would participate in the Australian Ship Reporting System (AUSREP).

It is assumed that the *Mineral Diamond* foundered with the loss of all hands in a position some 1500 miles to the west of Perth.

THE MINERAL DIAMOND

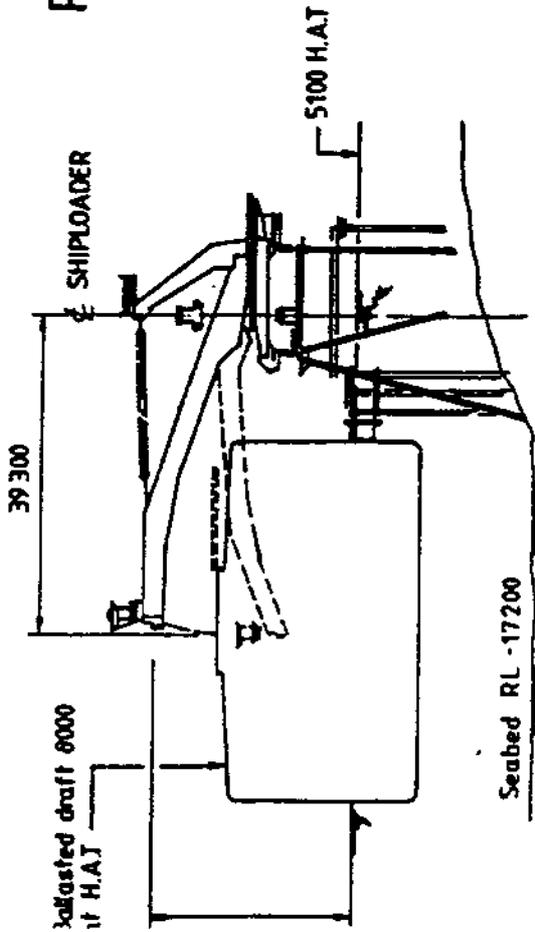
HAMERSLEY IRON PTY LIMITED
 PORT OF DAMPIER PARKER POINT WHARF

At 1330 10 April a Terminal employee working on the jetty noticed a thick expanse of oil on the water between dolphins Nos 6 & 7 (Attachment 4). He advised the supervisor, who in turn advised the ship. The Master and Chief Officer immediately went to the ship's side and noted a patch of black oil lying aft of the ballast discharge. According to the Master this oil was becoming mixed with the discharging ballast, giving the effect that the oil was being discharged with the ballast. The ballast pumps were immediately stopped and for a while no further oil was observed, then a globule of oil rose to the surface abreast of No.9 Hold. After a while more globules were observed rising to the surface some 10 to 15 feet away from the ship's side.

Globules of oil continued to rise to the surface, concentrated between the ship's side aft of the ballast discharge pipe and the jetty piles between Dolphins Nos 6 & 7. According to one observer the Bridge front of *Mineral Diamond* was aligned with the after side of No.6 Dolphin.

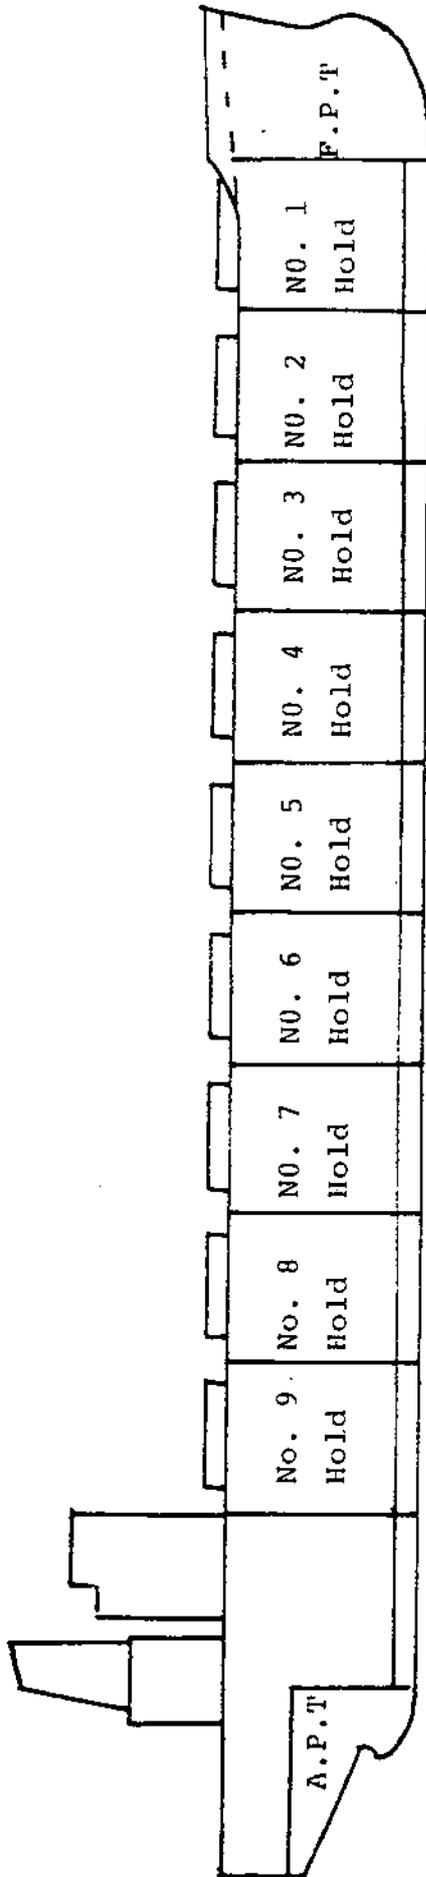
ATTACHMENT 7

The cargo distribution, as loaded, was entered into the loading computer of a 'near sister ship', the *Orinoco* (Attachment 7). Sheer stress loadings in the harbour condition were all well within the limits; however in the sea condition a high sheer stress loading of 104 was evident at the engineroom forward bulkhead (frame No. 53). Aboard the *Orinoco* this condition was well known and the practice aboard that ship was to ballast the Aft Peak tank. Applying this to the *Mineral Diamond* loading reduced the sheer stress loading at frame 53 to 96.

5. The cargo as loaded in the ship resulted in a high sheer stress loading at the bulkhead at frame 53, which would have been greatly increased in abnormal sea conditions and therefore may have been a contributing factor to the loss.

Frame No.	53	80	113	143	167	199	223	253	286	313
Harbour Condition	85	48	37	34	15	43	32	44	58	37
Sea Condition	104	63	48	43	18	52	40	60	76	41
Aft Peak Added	96	65	49	41	23	47	43	56	79	40

Sheer Stress readings ascertained by entering MINERAL DIAMOND loaded condition in computer aboard 'near sister ship' ORINOCO BUILT Hyundai 1982 LOA 266.50 Beam 42.47 Deadweight 140,784.3
