SUMMARY

On 9 September 1991 the 6710 tonnes deadweight Panamanian registered motor tanker Jovian Loop grounded on Unison Reef in the inner two-way route of the Great Barrier Reef, while on passage from Broome to Townsville with a part cargo of tallow.

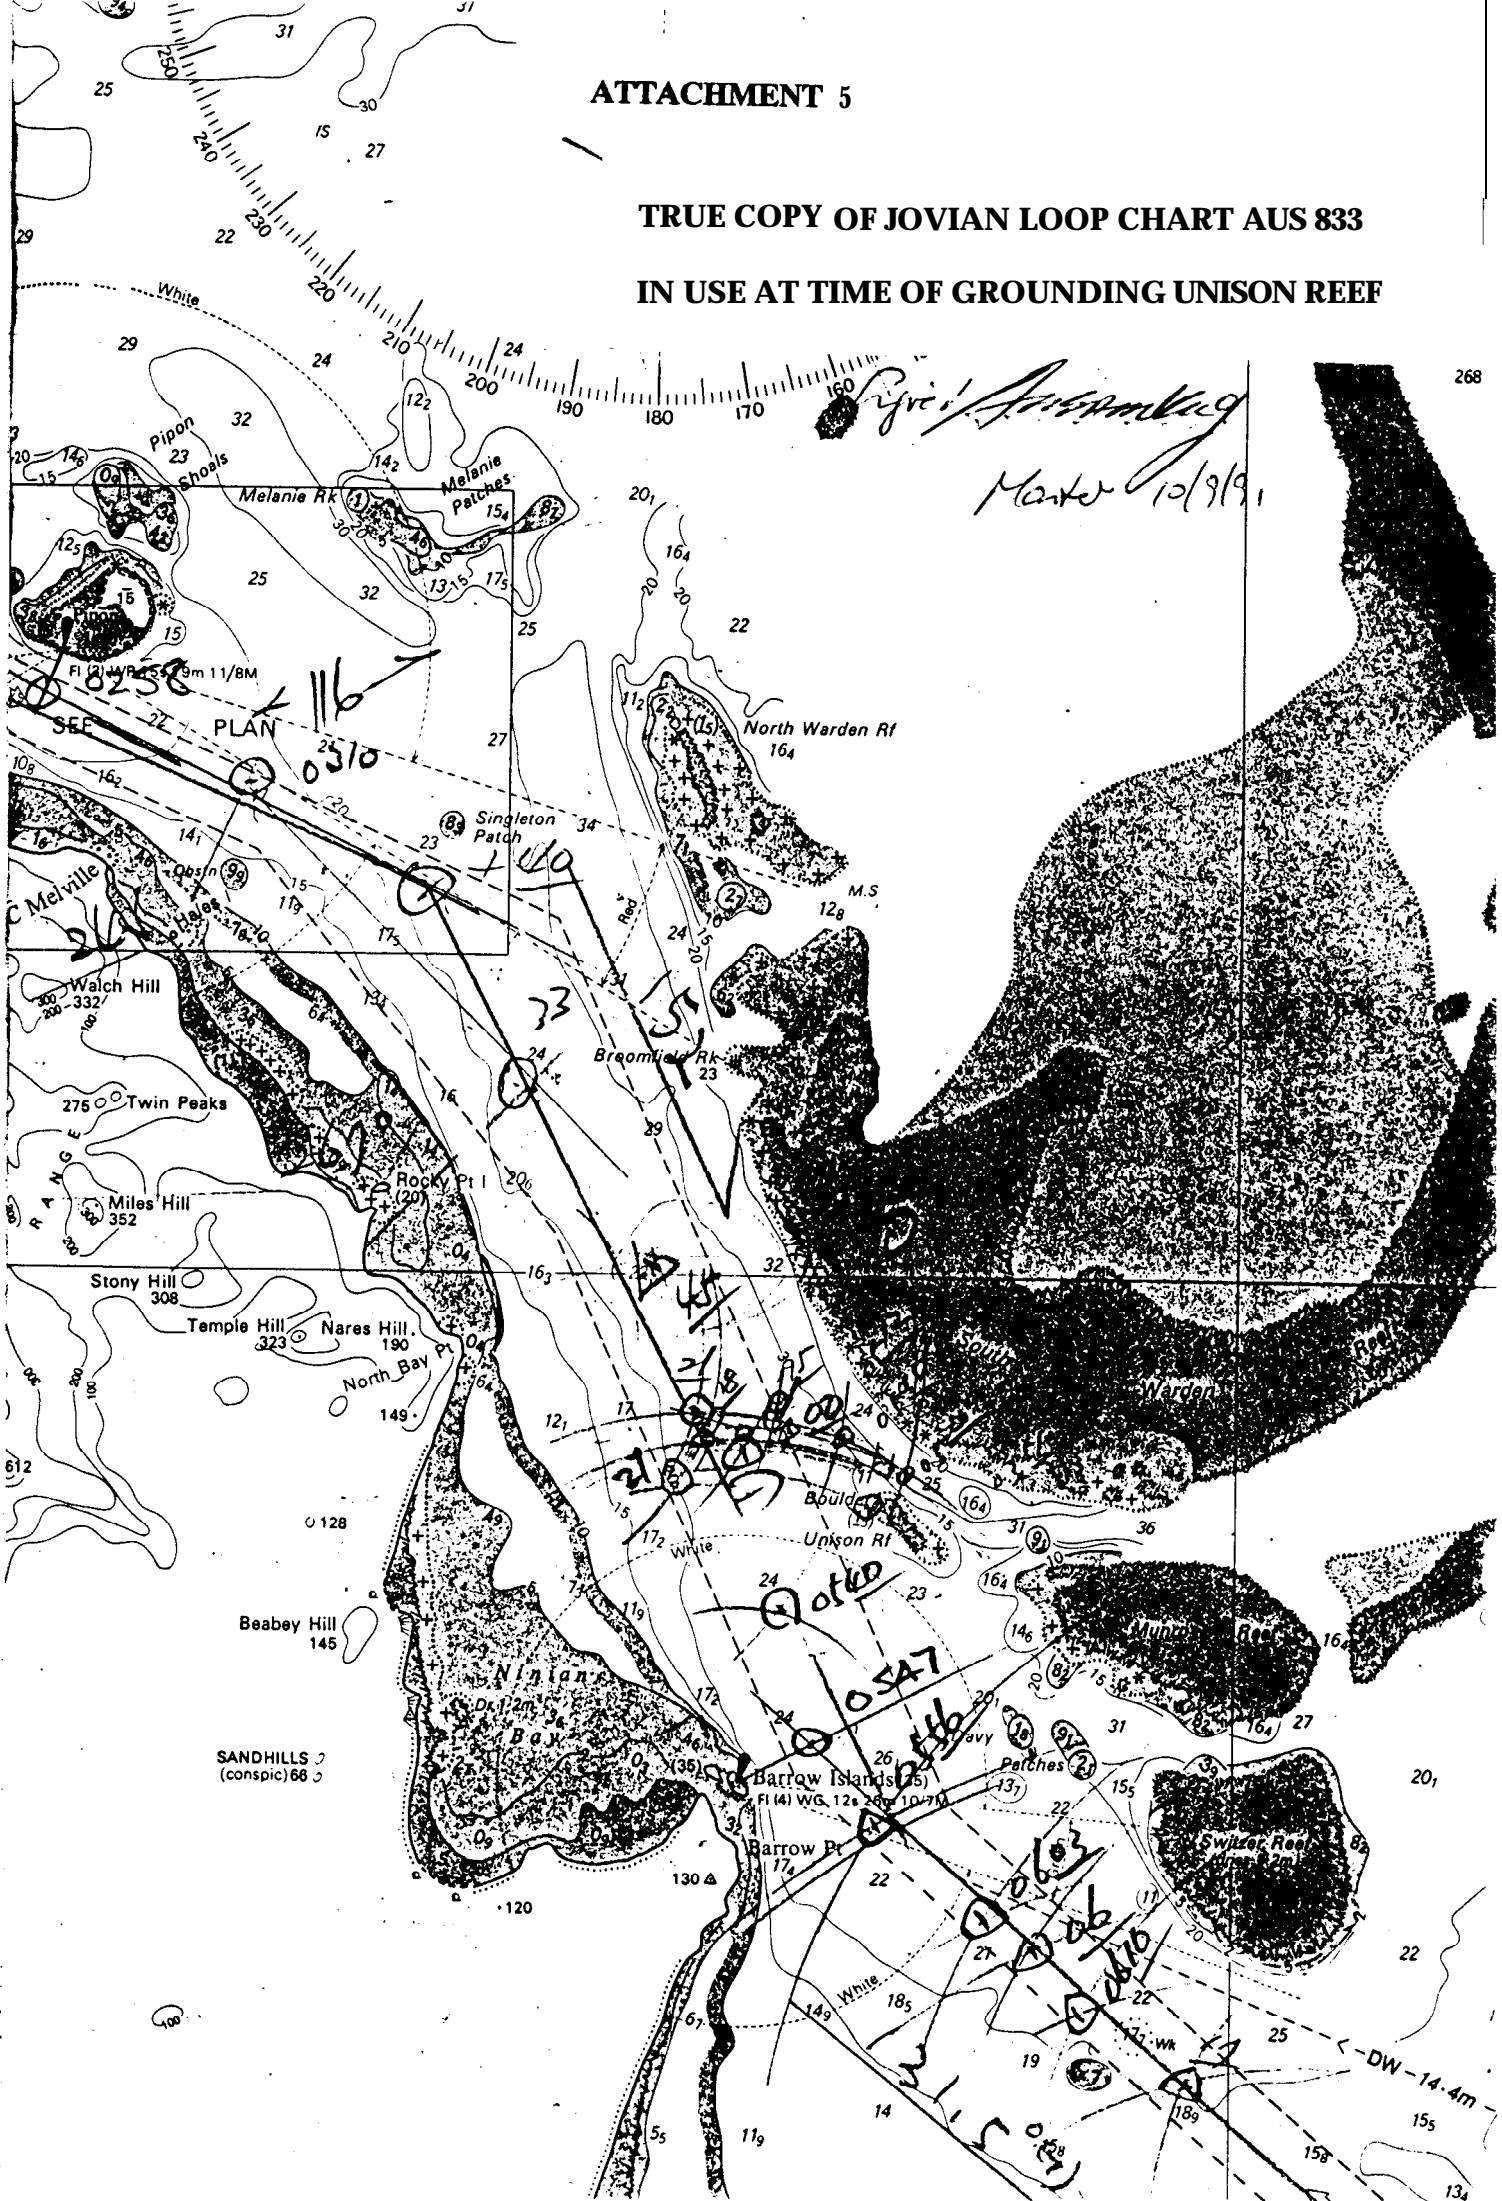
TRUE COPY OF JOVIAN LOOP CHART AUS 833

The area on the chart where, according to the Pilot, he had marked the position at which he was to be called, had been erased prior to the plotting of the ship's position at 0540. This may have been because the Pilot's notation would have obscured the plotted position.

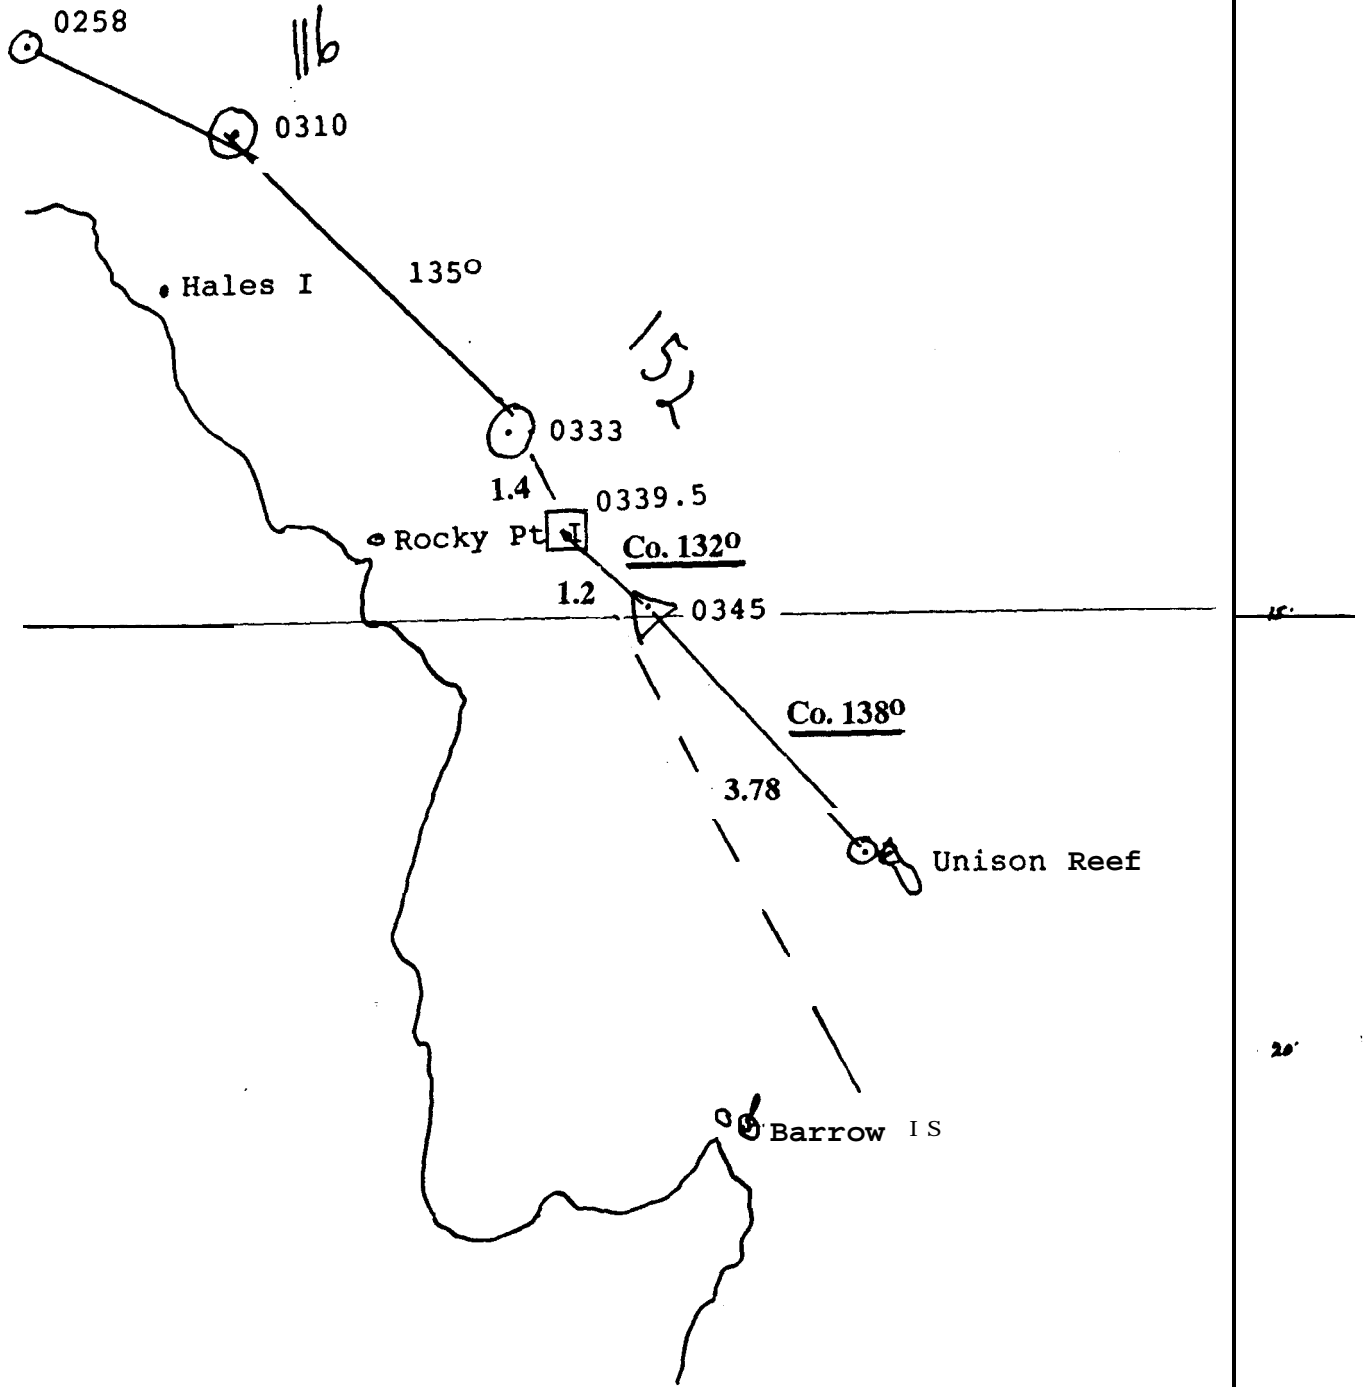
PROJECTED COURSE LINES

The distance from the position as plotted on the chart by the 2nd Mate at 0345 to that marking the grounding position is 3.78 miles on a course of 138°T (Attachment 6). The time required to travel this distance at 13.1 knots is 17.3 minutes, providing a notional time of grounding of 0402.3.

Projecting a course of 132°T back from the 0345 position (Attachment 6) intersects the 152° track 1.4 miles from the 0333 position, indicating that an alteration took place at 0339.5 as, or just after, the pilot left the bridge.

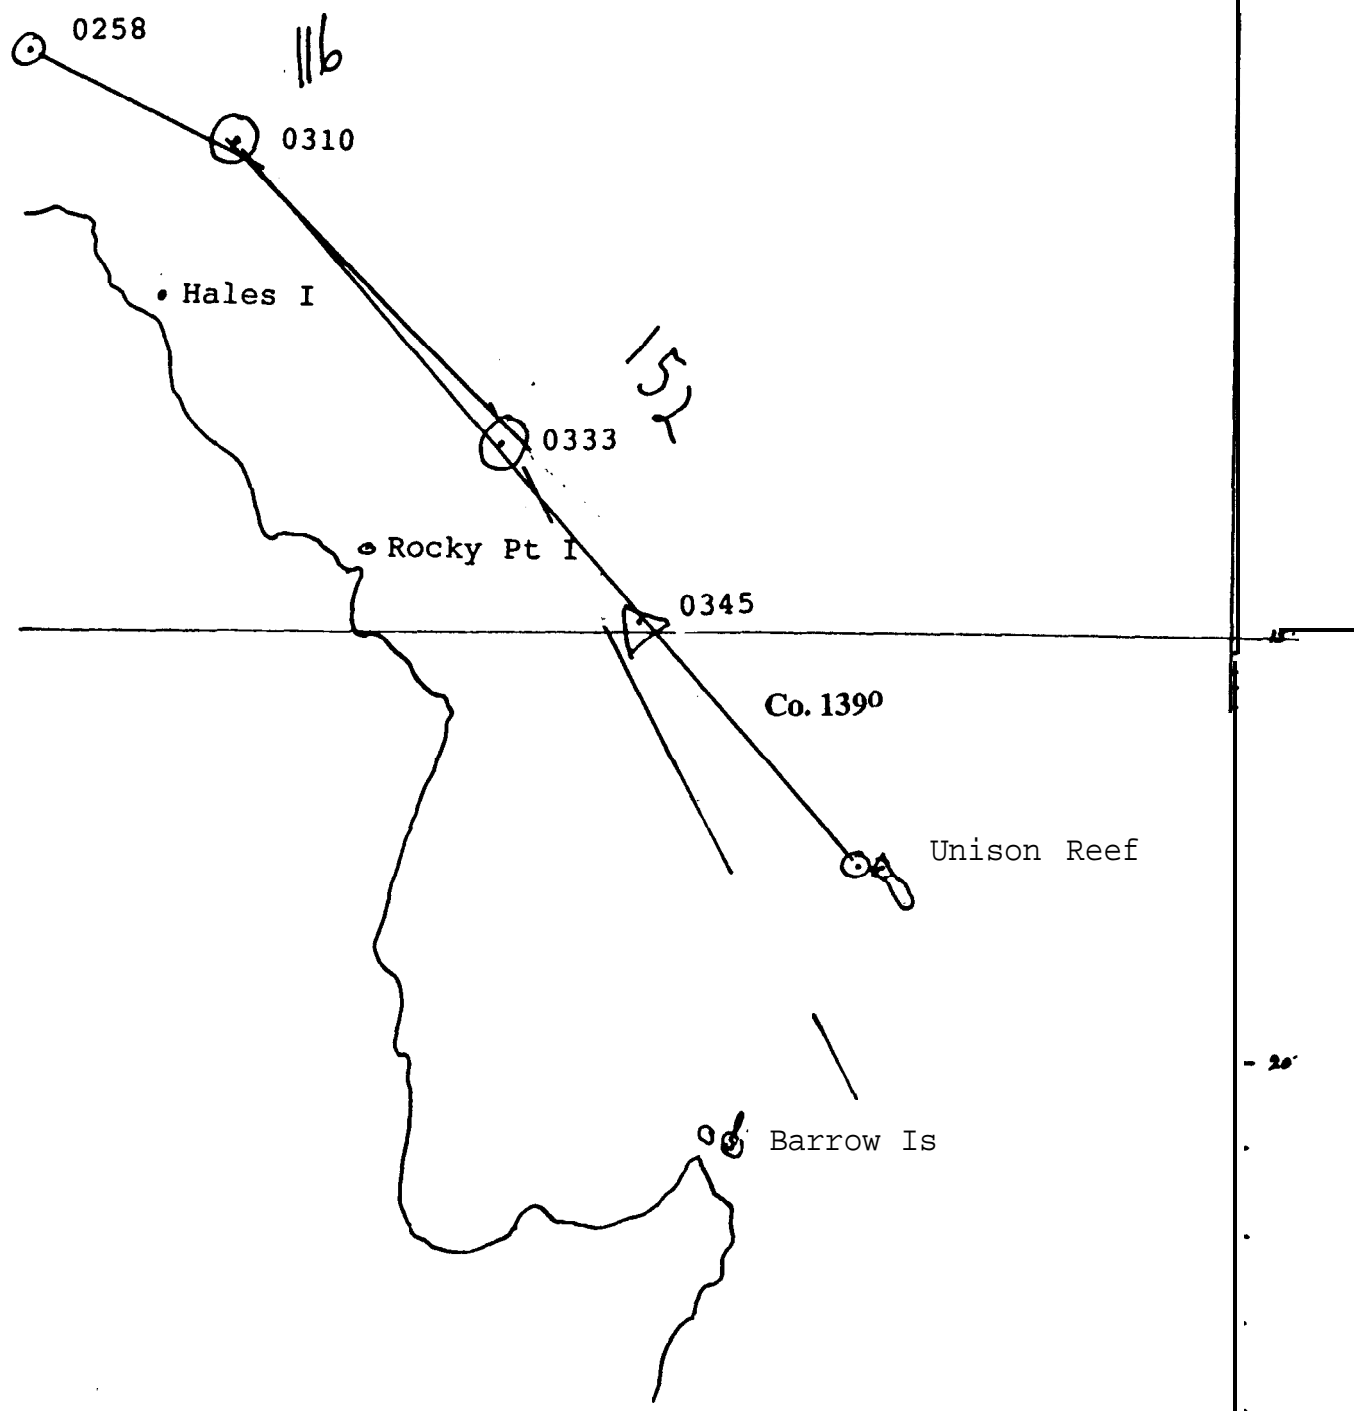
ALIGNMENT OF POSITIONS

It is noted that a line joining the plotted position of 0310, off Hales Island, and the grounding position passes very close to both the 0333 and the 0345 positions (Attachment 7). This line gives a track of 139°T and a distance of 11.1 miles, which at 13.1 knots (50.8 minutes) provides a grounding time of 0400.8.

There is no record in the ship's log books of the course alterations. From the Pilot's account of his actions and the evidence of the positions plotted on the navigation chart at the appropriate alter course positions, it is considered that at 0310 the Jovian Loop was brought onto a heading of 135° and at 0333 onto the correct heading of 152°T. The Inspector accepts that the Pilot performed his usual checks, both visual and radar. In support of this is the 2nd Mate's statement that the light (Barrow Island) was off the bow. This is consistent with the Pilot's statement of the light being fine to starboard and also with the heading being 153°G, as at that time the bearing of the light would have been 165°G. The fact that a line joining the 0310 and grounding positions passes very close to the 0333 and 0345 positions is considered to be purely coincidental.
