Summary

The Japanese-registered wood-chip carrier Daishowa M&u arrived off Twofold Bay, New South Wales at 1818 local time on 10 February 1992. As the ship was not to berth until 0700, 11 February, the Master proceeded to the Quarantine Anchorage, where the ship anchored at 1930 on 10 February 1992.

大 昭 和 丸
DAISHOWA MARU

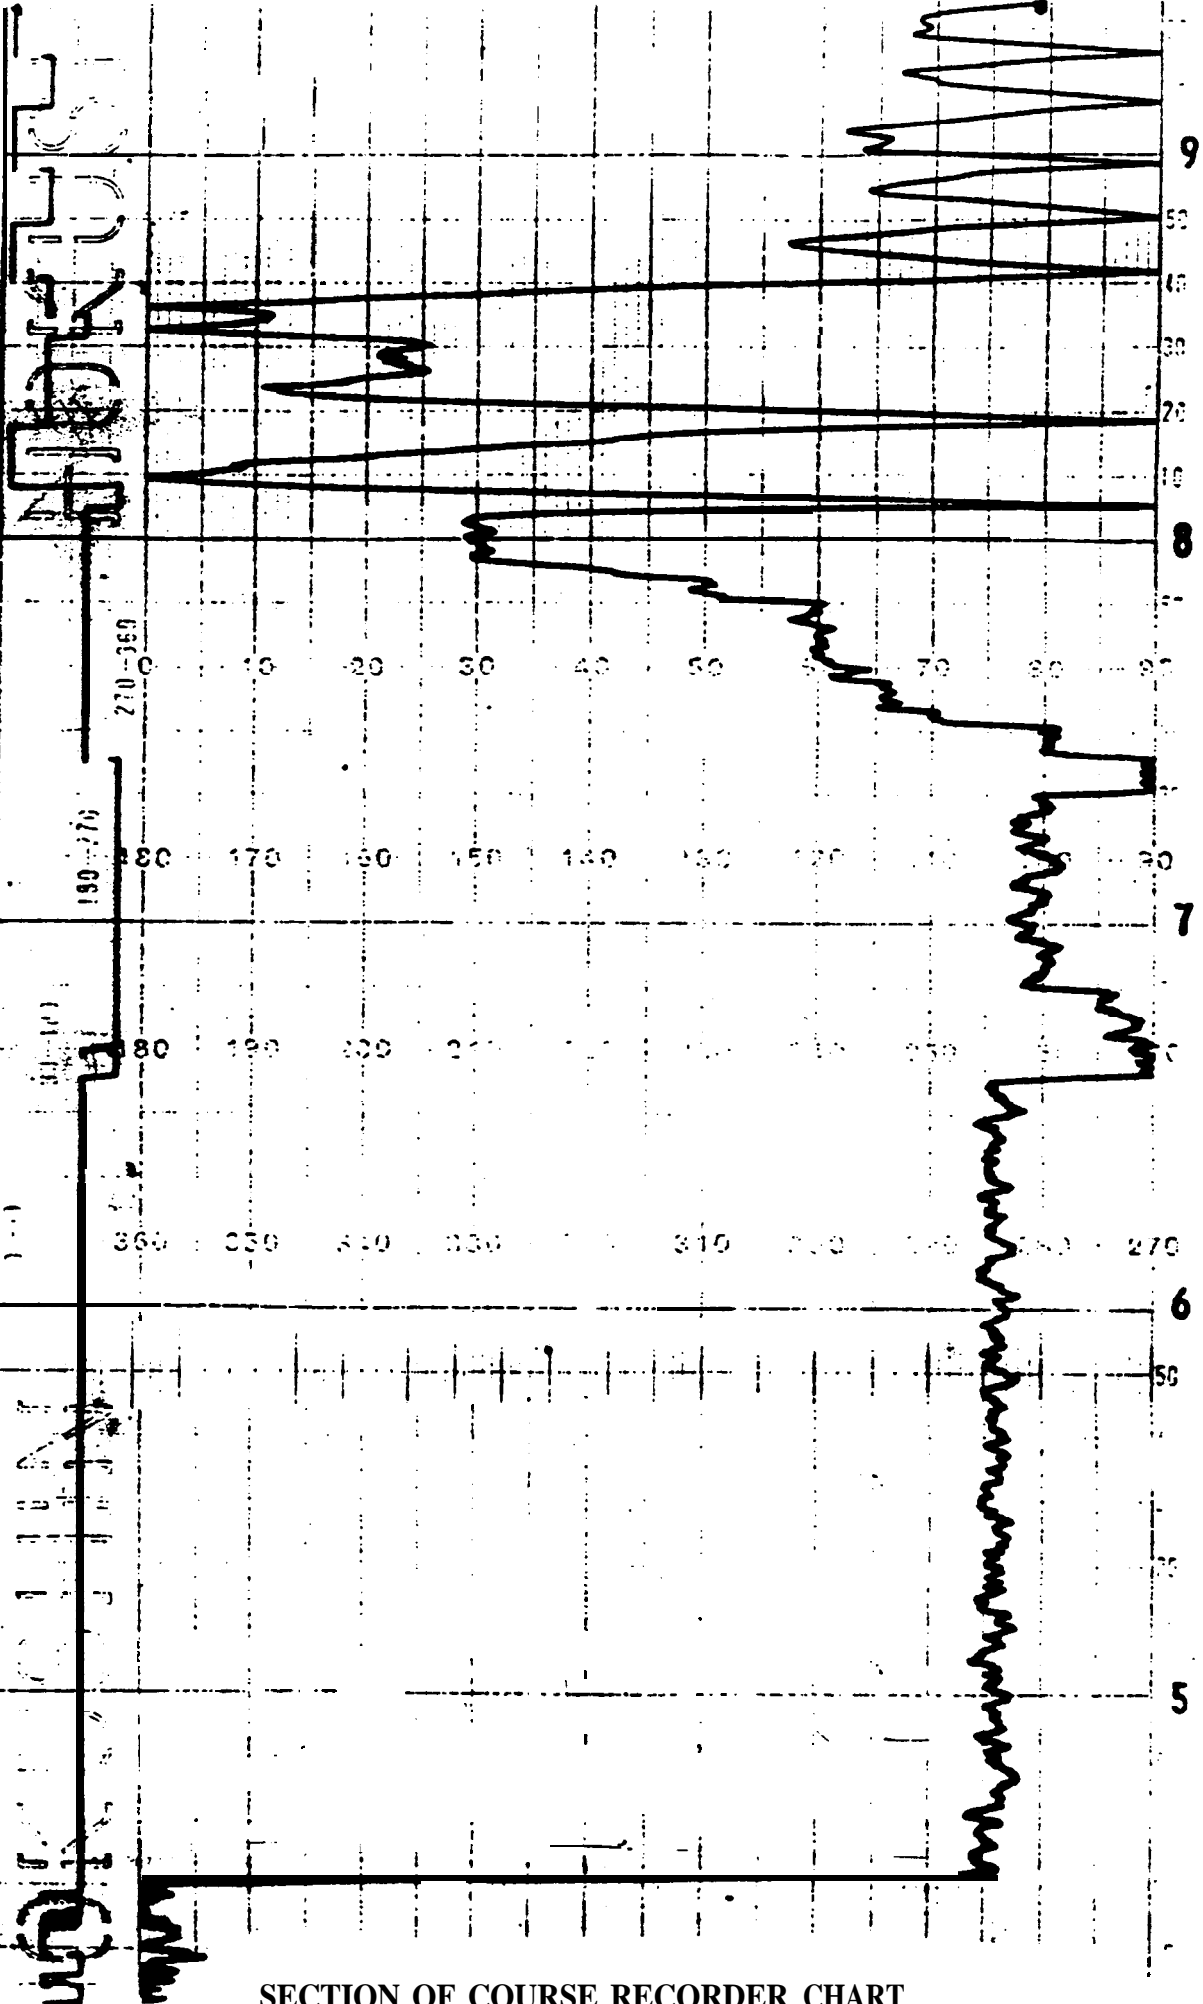
SECTION OF COURSE RECORDER CHART

In line with normal practice on board, the course recorder was switched off after the ship was anchored, although in this instance not until 2025. From the course recorder chart (see page 15) it is apparent that the recorder had not been adjusted to the correct local time, being one hour behind.

Study of the course recorder chart indicated that at the time of anchoring, the Daishowa Maru was steadied on a heading of 155 degrees. The ship then swung to starboard, most probably due to the transverse thrust effect of the propeller turning astern, to a heading of 191 degrees. Following this, the ship swung back to port, to a heading of 057 degrees and then proceeded to yaw either side of a mean heading of 090 degrees (East). At 2025, when the recorder was switched off, the ship appears to have settled into a pattern of yaw of 45 degrees (between headings of 068 degrees and 113 degrees) over a nine-minute period. This is at variance with the evidence of the officers, who stated that the ship was headed into the wind, towards the berth (south-easterly) and was not yawing very much.

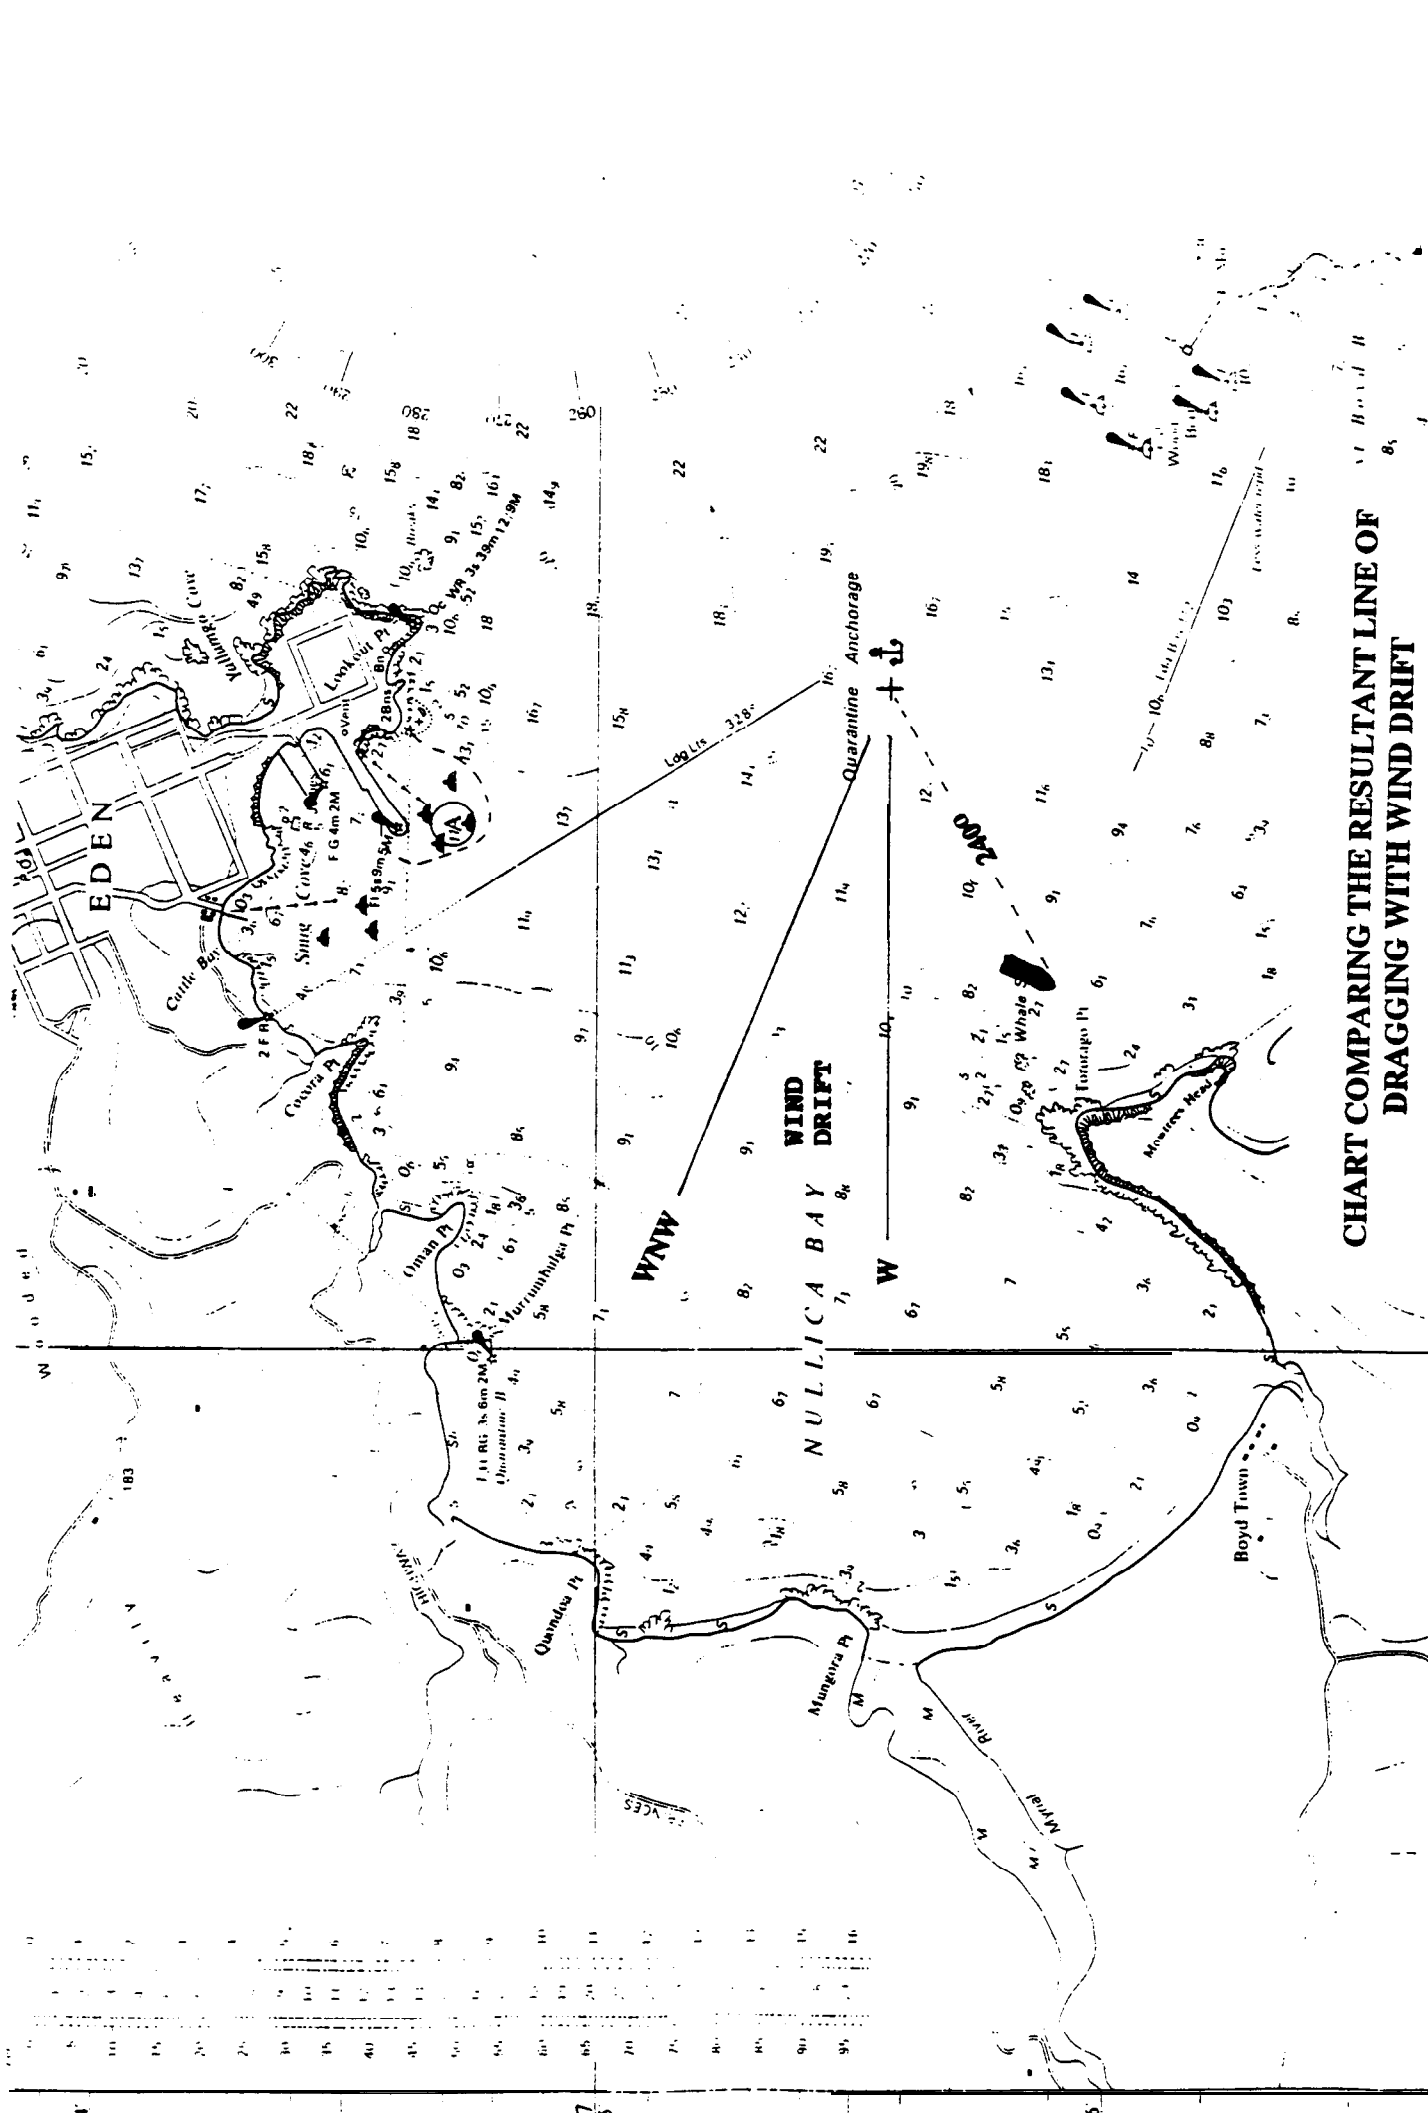
CHART COMPARING THE RESULTANT LINE OF DRAGGING WITH WIND DRIFT

In a free drift situation there is a tendency for large ships, such as tankers and bulk carriers, to not only drift down wind but also to "sail" across wind. This sailing effect is dependent upon such factors as draught and trim. Guidelines on rates and direction of drift of large oil tankers and gas carriers are contained in the International Chamber of Shipping publication *Peril at Sea and Salvage - a Guide for Masters*. Similar principles are also relevant to large dry-bulk carriers, such as the Daishowa Maru.

Although the wind was from an east-south-easterly direction, rather than dragging the anchor straight down wind (in a west-north-westerly direction), the Daishowa Maru, trimmed by the stem and having the wind on the port side, would have more probably dragged in a westerly direction. This would have taken the ship close to, but north of Whale Spit into Nullica Bay (see page 19). The line of dragging, from the original anchor position to the grounding position, was around 240 degrees. By using the engine ahead for most of the 10 minutes between the engines being ready and the grounding, the Master increased the across-wind movement, possibly by as much as two ship lengths, which resulted in the ship grounding on the eastern extremity of Whale Spit. The ship would have initially grounded aft and then would have continued to swing to starboard until grounded in more forward areas.

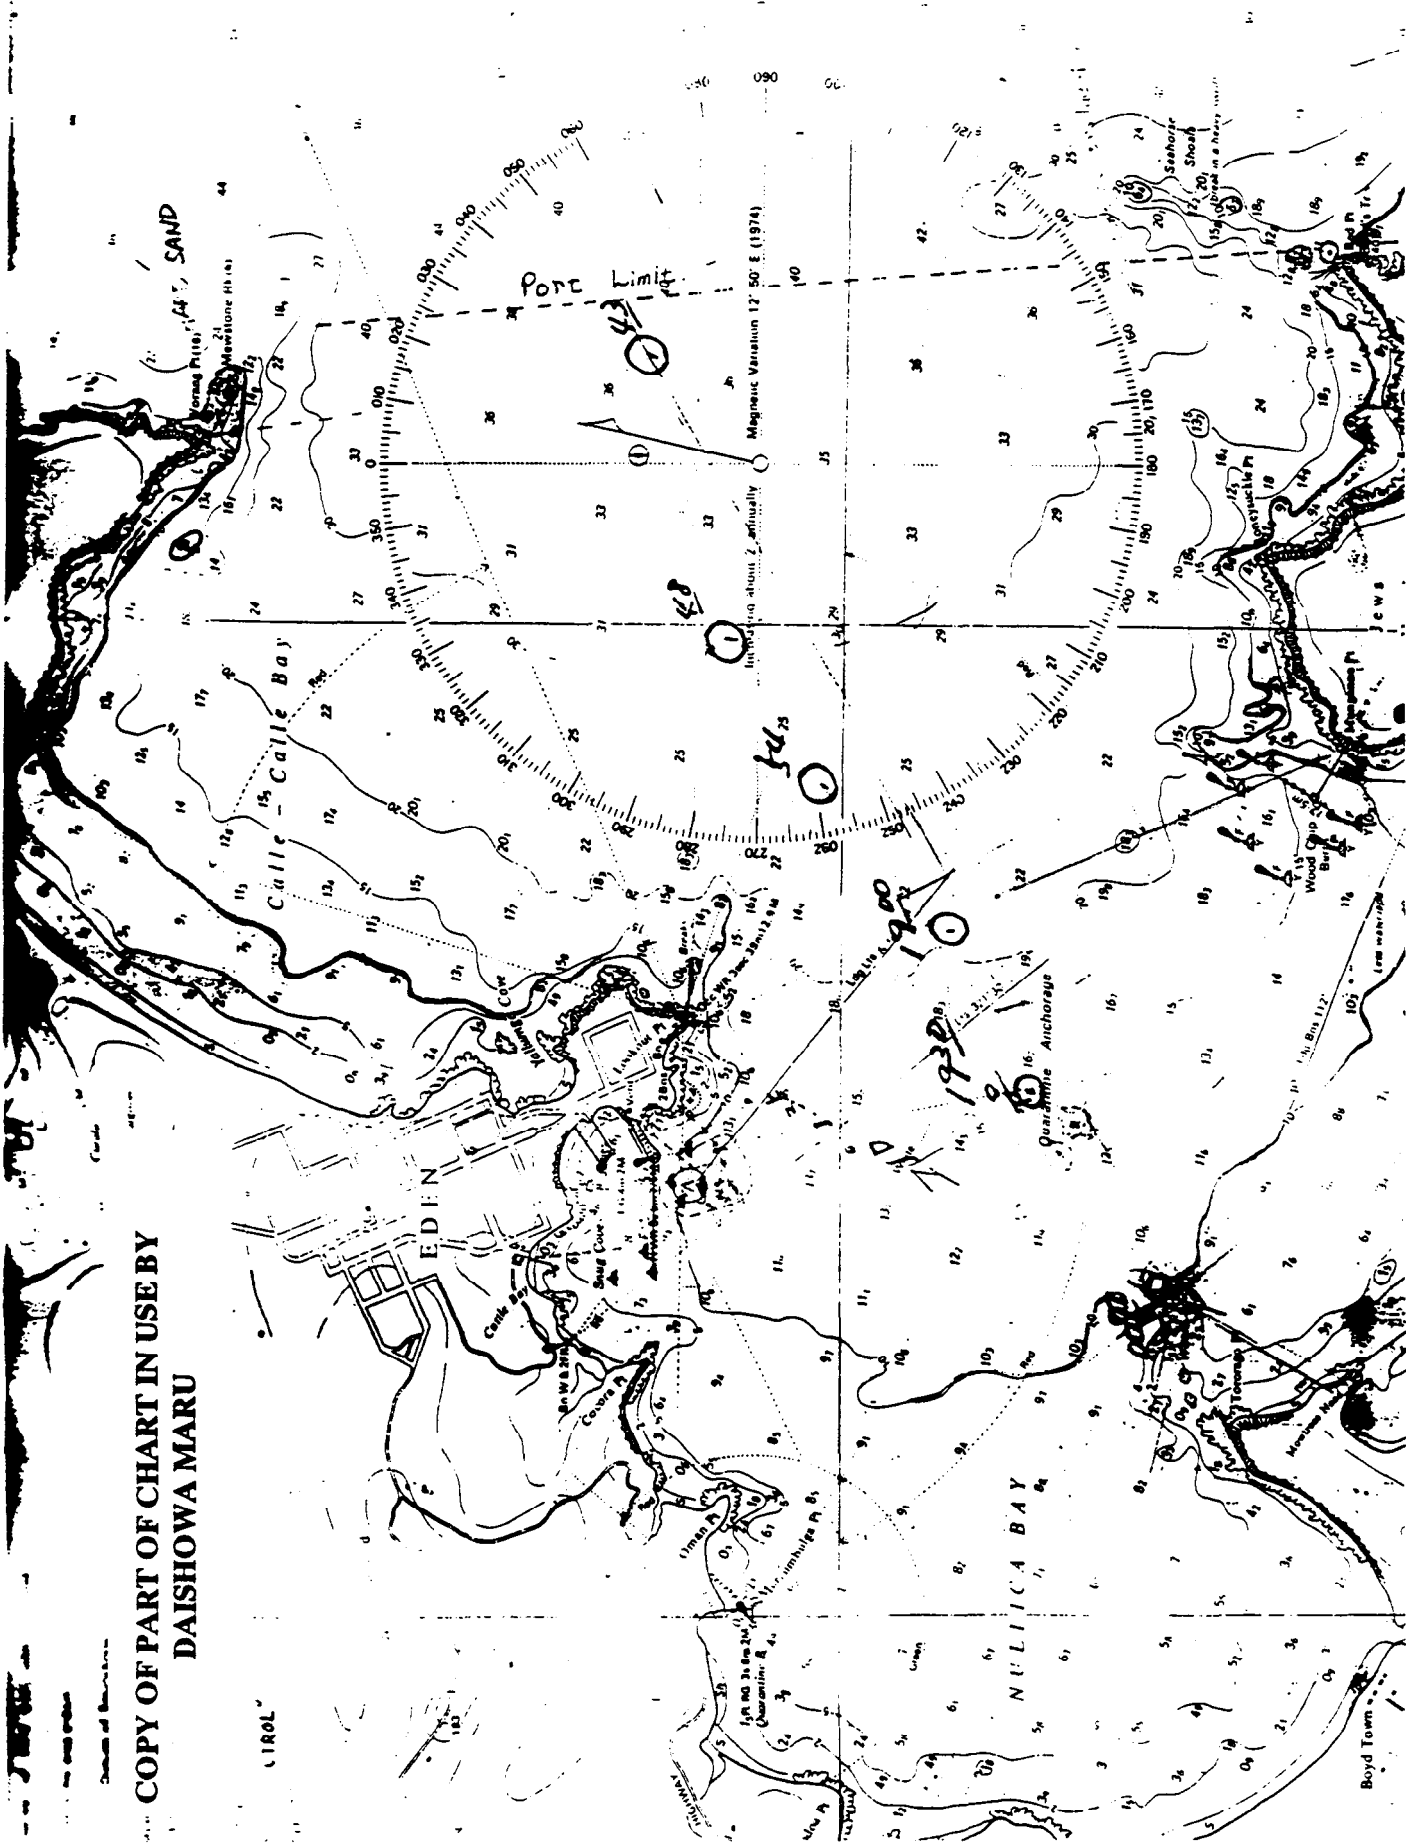
COPY OF PART OF CHART IN USE BY
DAISHOWA MARU

According to the Pilot, the seabed is hard sand and is considered to be good holding ground. The navigation chart in use aboard the Daishowa Maru bore the hand-written notation 'HARD SAND' off Worang Point. Of note was a second hand-written annotation in English, at the southern end and to seaward of the Port Limit line, which read "Don't pass this line before pilot boards".

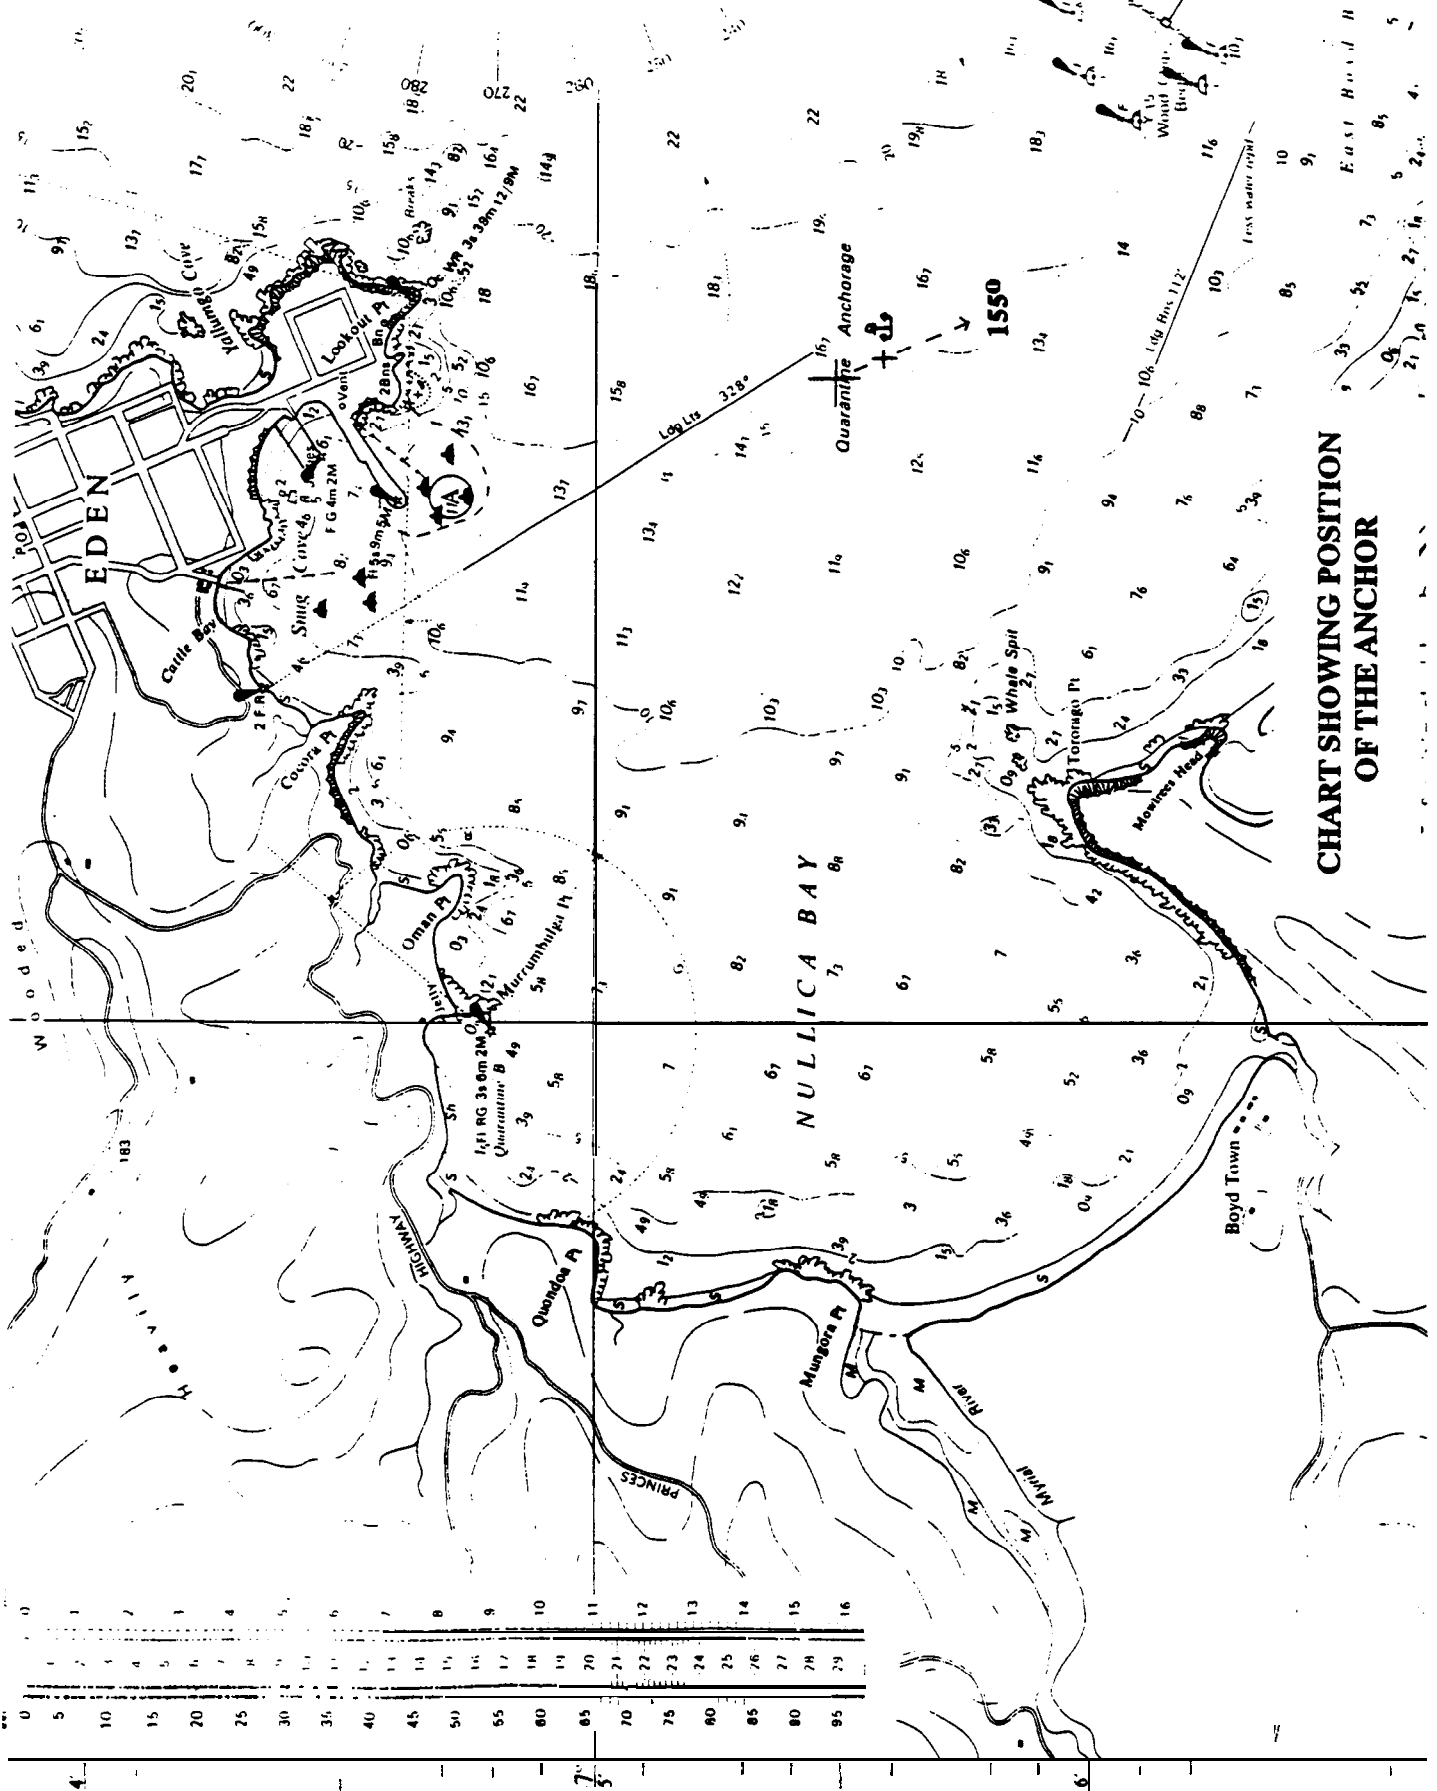
CHART SHOWING POSITION OF THE ANCHOR

The position fixed at 1930 by the Second Officer was the position of the navigating bridge at that time. The position where the anchor was dropped, from the evidence of the course recorder chart, was 155 degrees 195.5m from that position (Attachment 2). The amount of cable paid out was seven shackles, or 192m, in the water plus 14m, the height of the hawse pipe above the water. At maximum stretch, in the water depth of 15m, the bridge would be 399m from the anchor, the stem 427m from the anchor (Attachment 3). The Daishowa Maru would therefore yaw about the anchor on an arc having a maximum radius of 427m. At maximum radius the stem of the Daishowa Maru would have been only four cables, or 740m, from the shoal water off Whale Spit.

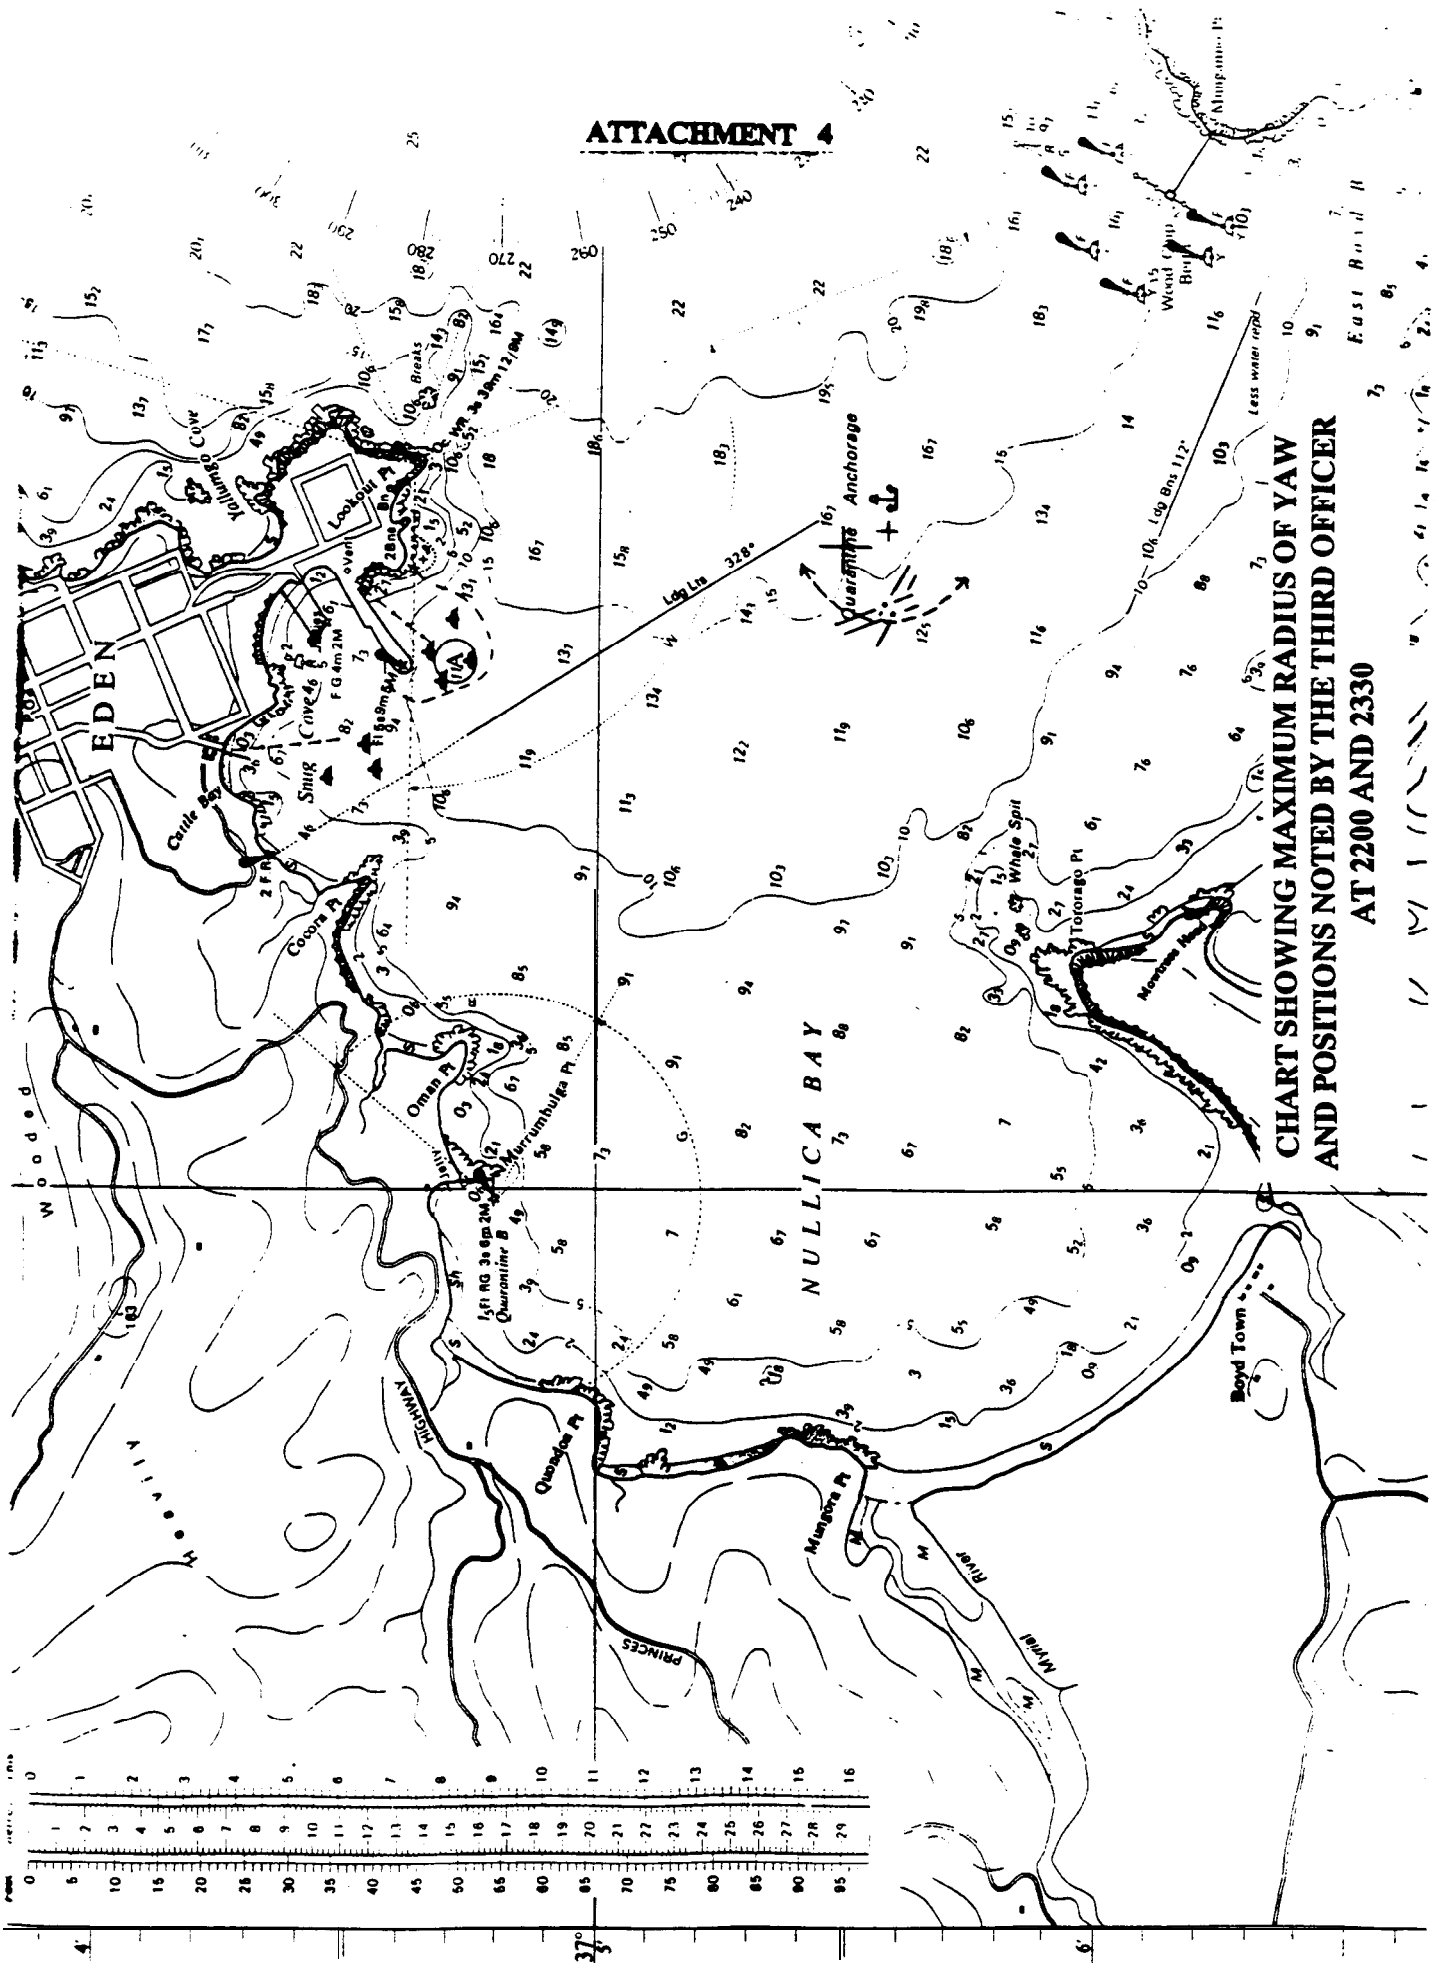
**CHART SHOWING MAXIMUM RADIUS OF YAW
AND POSITIONS NOTED BY THE THIRD OFFICER
AT 2200 AND 2330**

The Second Officer fixed the ship's position at the time of anchoring, but the radar bearings and distances were not recorded, the position being logged as a latitude and a longitude. The Chief Officer and Third Officer both checked the bearings and distances, but again, these bearings and distances were not recorded, nor were positions plotted on the chart. Only the Third Officer was able to recall what the visual bearings were, these providing positions west (inshore), but within the maximum radius of the initial anchor position (Attachment 4).

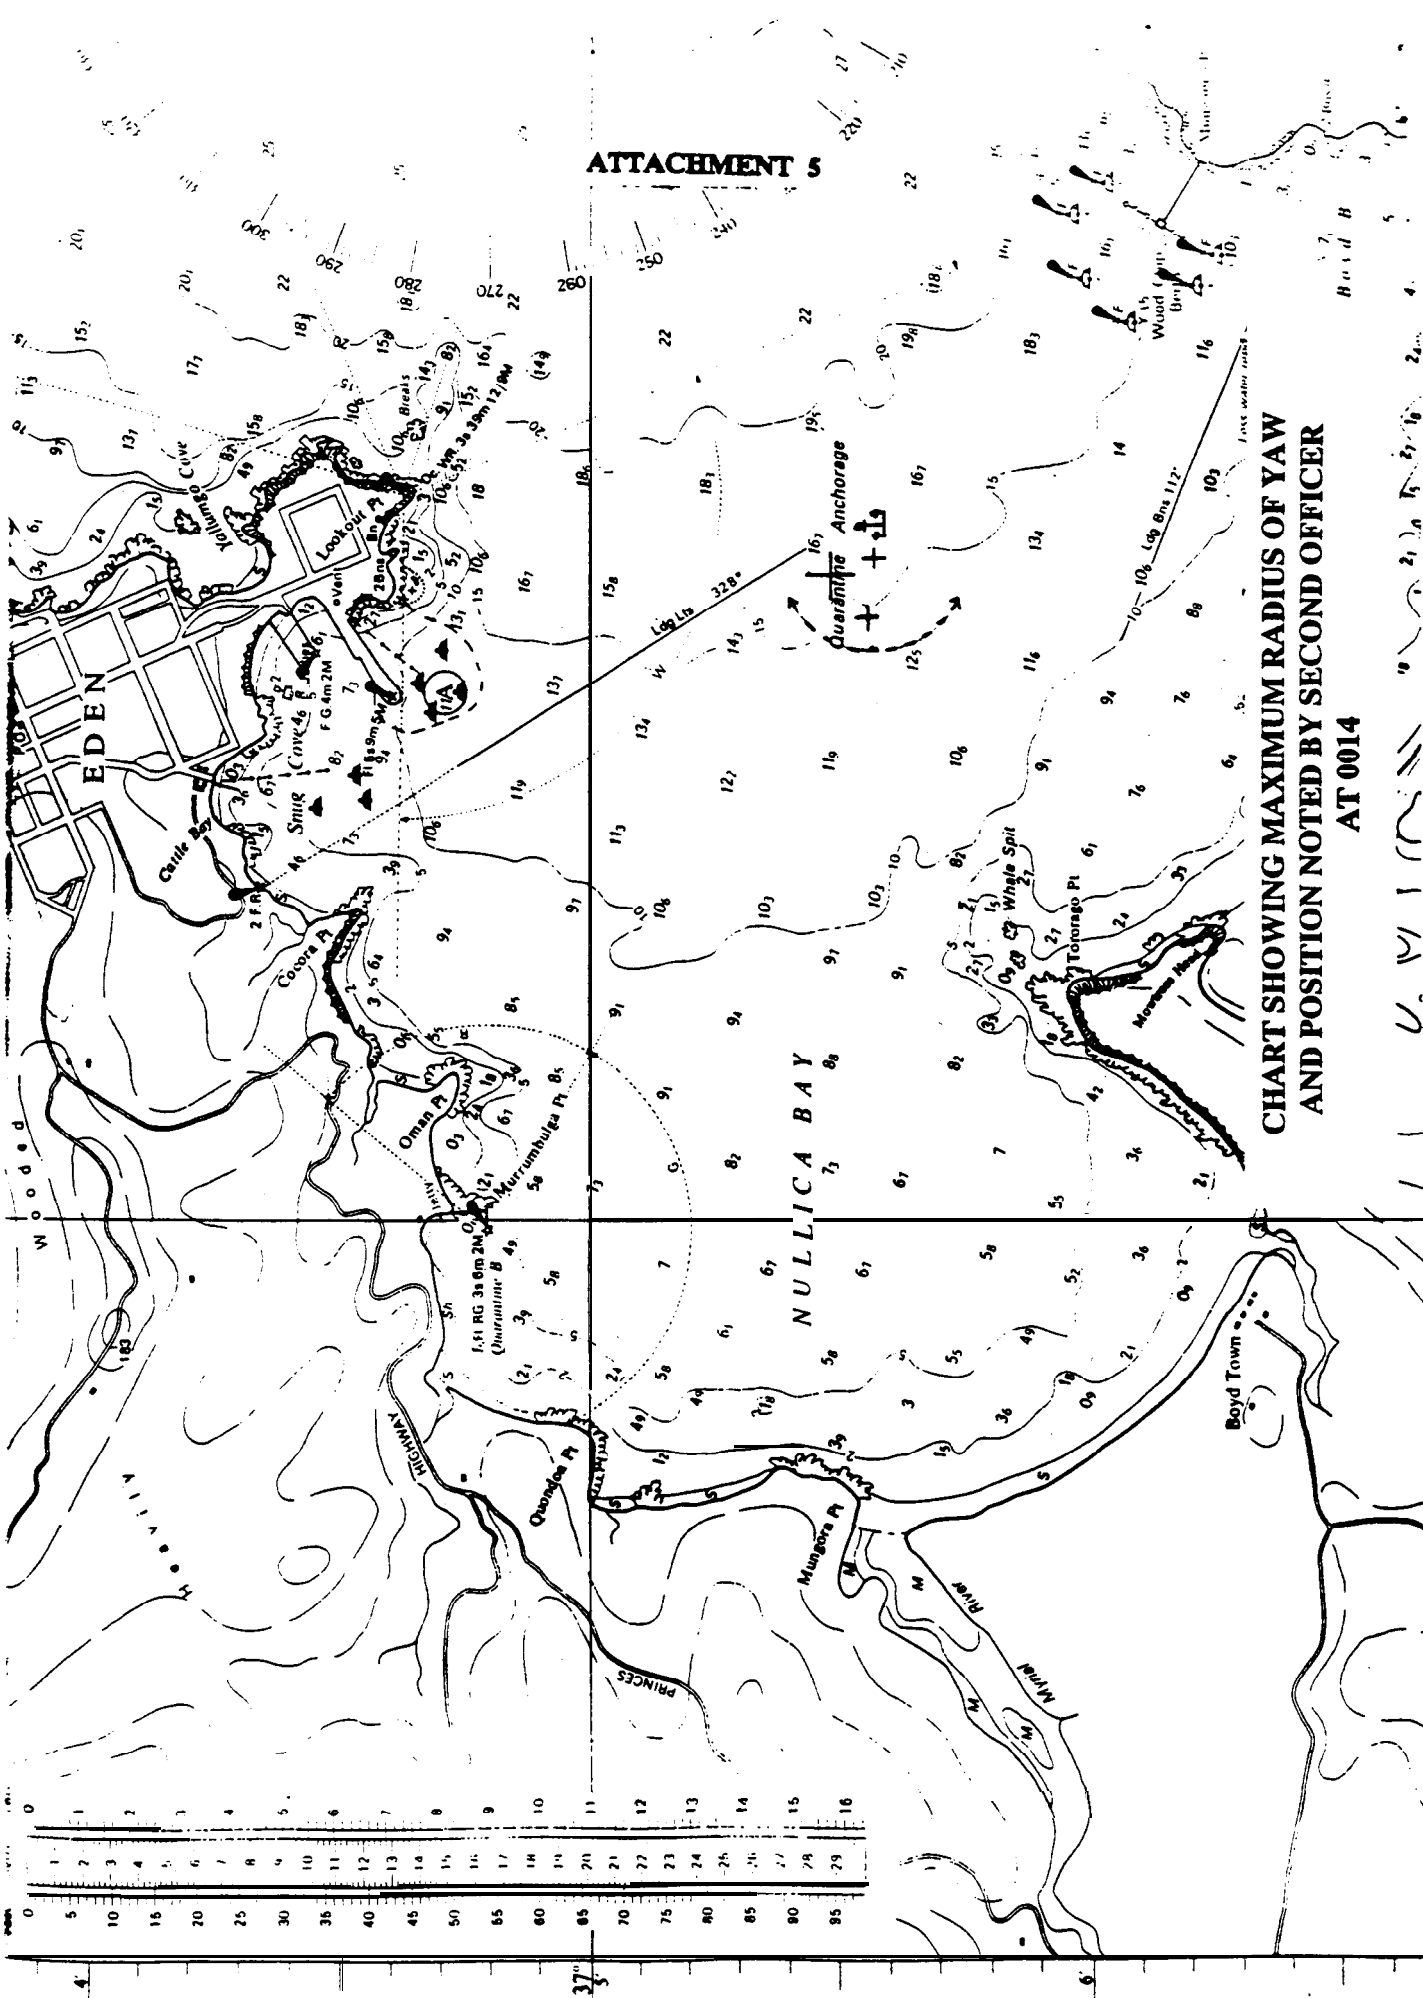
CHART SHOWING MAXIMUM RADIUS OF YAW
AND POSITION NOTED BY SECOND OFFICER
AT 0014

The position plotted on the chart by the Second Officer at 0014 (Attachment 5) was 0.2 cables (37m) to the east of the position provided by the bearings obtained by the Third Officer at 2200 and 0.6 cables (111m) within the maximum radius of yaw. This would indicate that the Daishowa Maru had not dragged anchor at that time, rather that the anchor most probably broke out at the time that the squall was at its height, at a time put by the Second Officer as being 0017.

- The anchor broke out of its holding and the Daishowa Maru commenced dragging anchor during the height of the passing squall, at sometime between 0015 and 0020 on 11 February.
